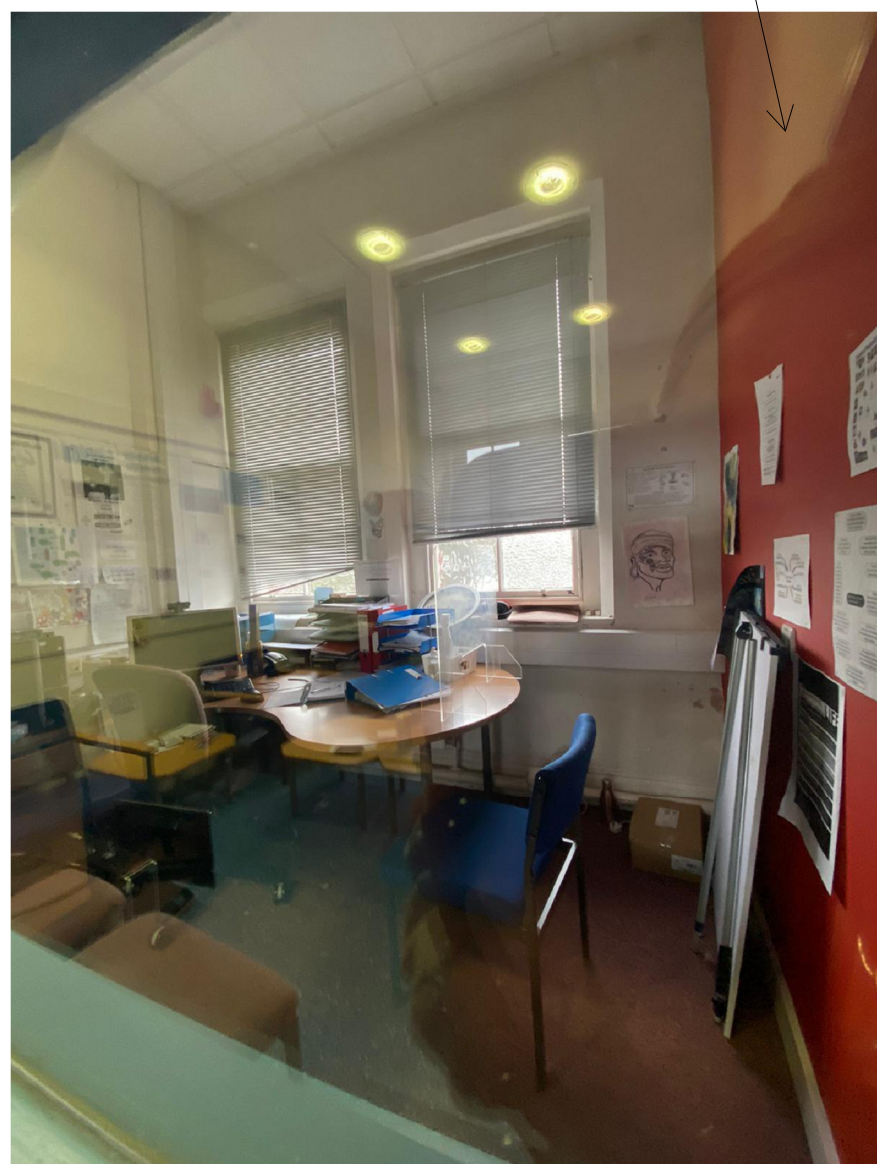
Image 01:  
Image of existing wall prior to  
construction (all existing tiles are  
concealed underneath plasterboard)

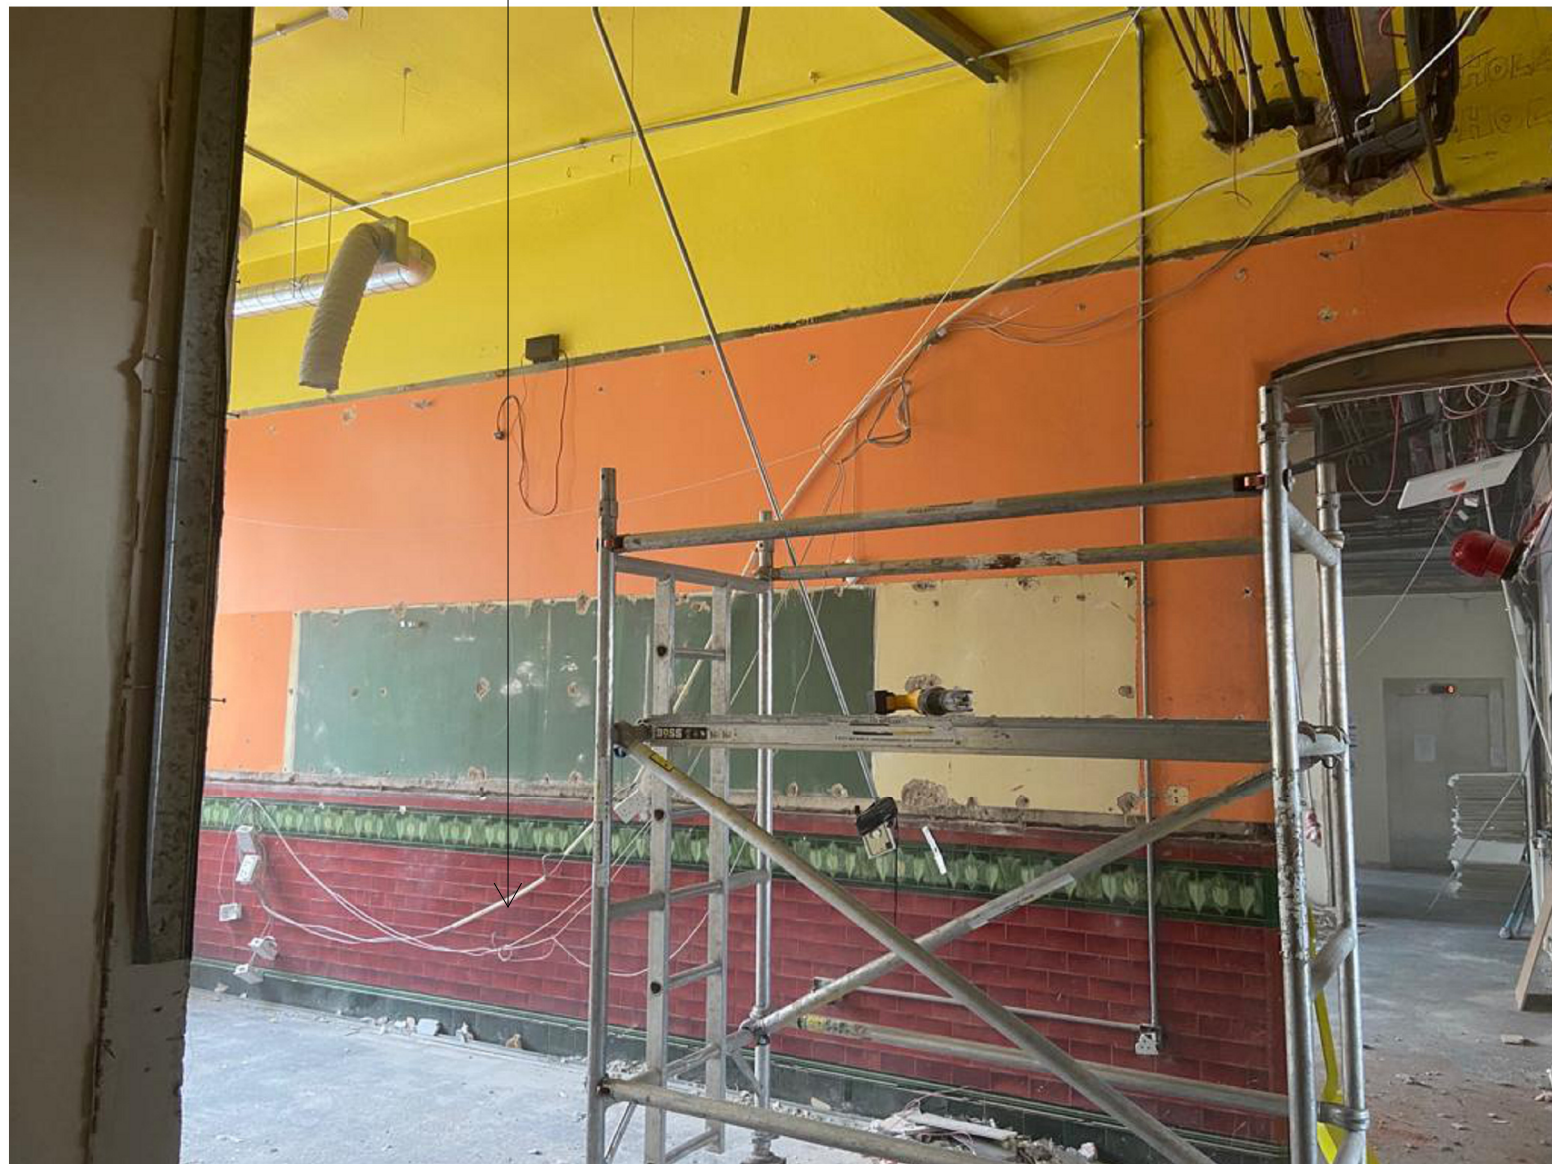
Image 02:  
Image of existing wall during construction (removal of plasterboard layer revealed existing **green** / **red** tiles at low level, but no features at upper level)

Upper portion of wall (which has no original features) to be removed. Lower portion (which does have tiling) to be retained and used to support a high ceiling over dining area.

Upper portion of wall (which has no original features) to be removed. Lower portion (which does have tiling) to be retained and used to support a high table (as part of dining strategy).

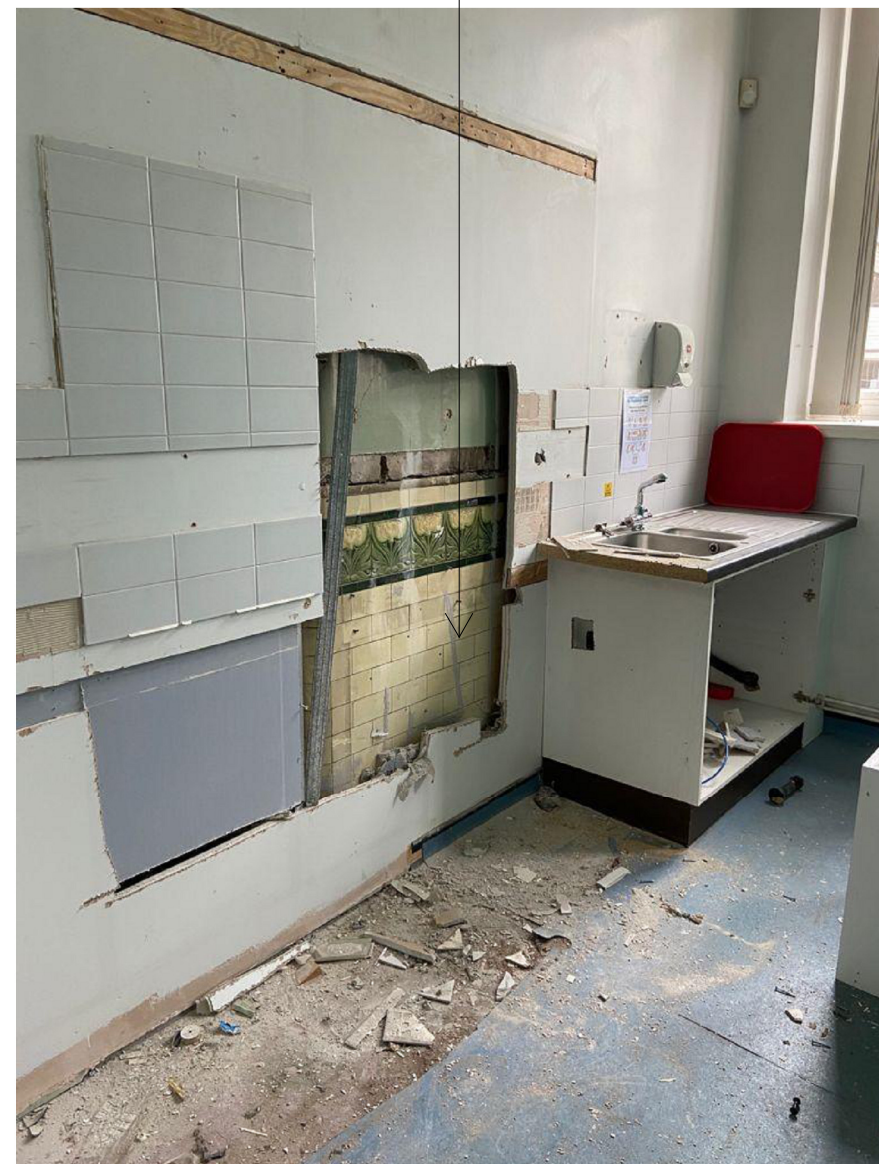
Image 03:  
Image of existing perimeter walls during  
construction (removal of plasterboard layer  
revealed existing **green** / **cream** tiles at low level)

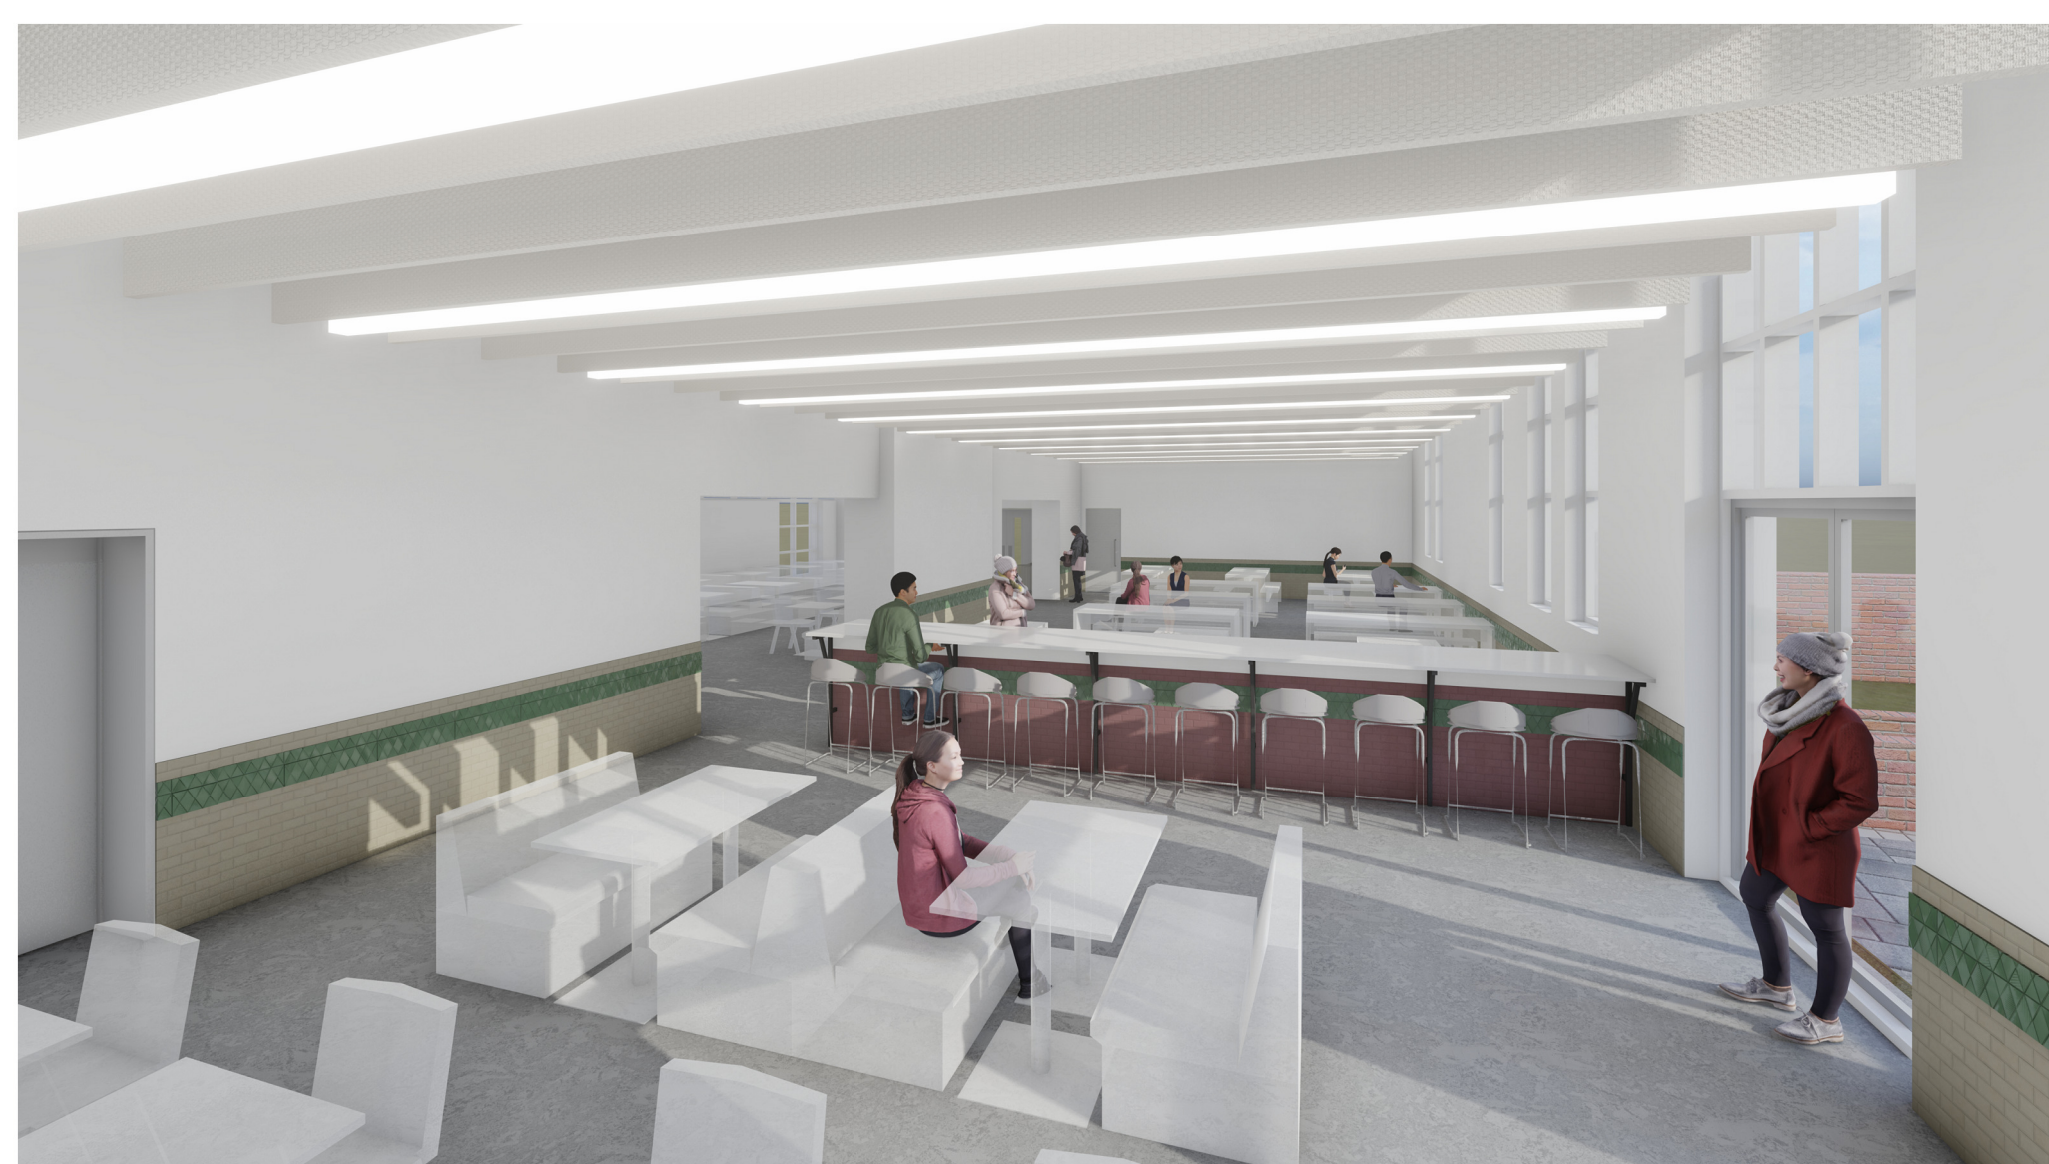
Image 04:  
Artist impression of proposed space in 3D. Green / cream tiles are retained on perimeter walls. Green / Red tiles are retained on the central wall, which has been reduced in height so as to incorporate a high table. High table surface / supports to be designed by specialist in such a way that tiles are not to be impacted by the construction (for example, floor mounted supports where necessary, rather than fixings through tiles).
