# 2 & 3 Angel Square and NOMA Marketing Suite, Manchester

## Report on Ground Investigation

Project No: 765325

Client: MEPC Ltd

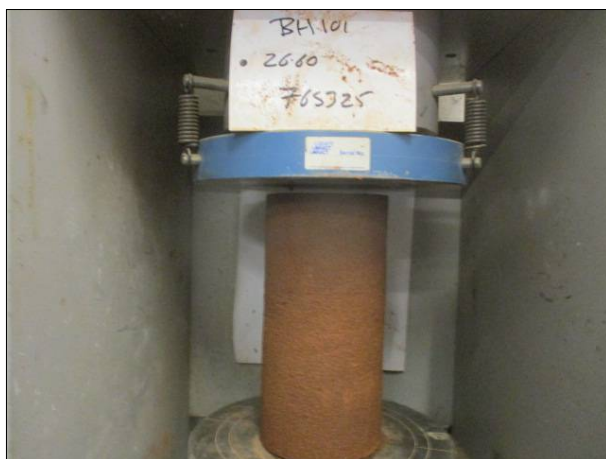
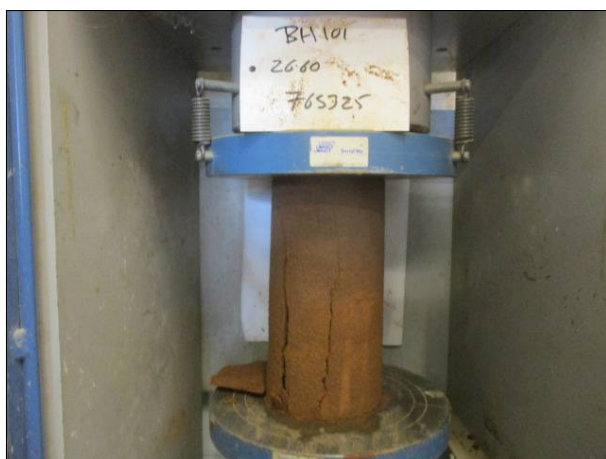
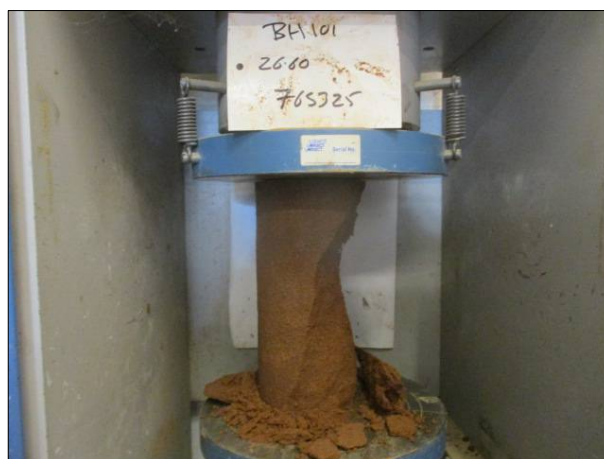
Load at Failure (kN): **47.8**

Failure Type: **Simple shear**

Samples delivered from site to storage facility. Samples are stored in a frost free environment, at temperatures  $>4^{\circ}\text{C}$   
Compression machine: Impact CT340 2000kN Auto Compression Machine Serial No. CT340-22. SSL No. 011076

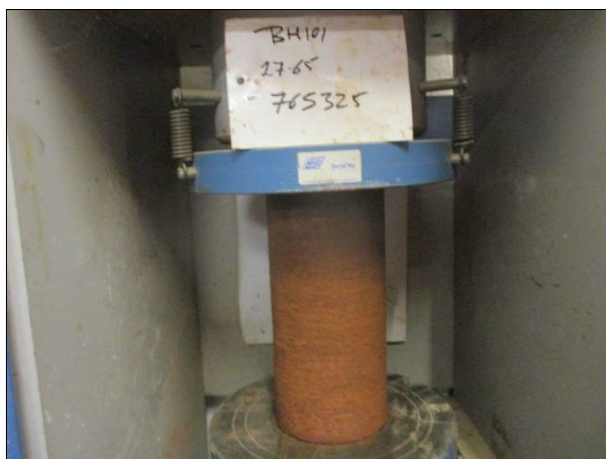
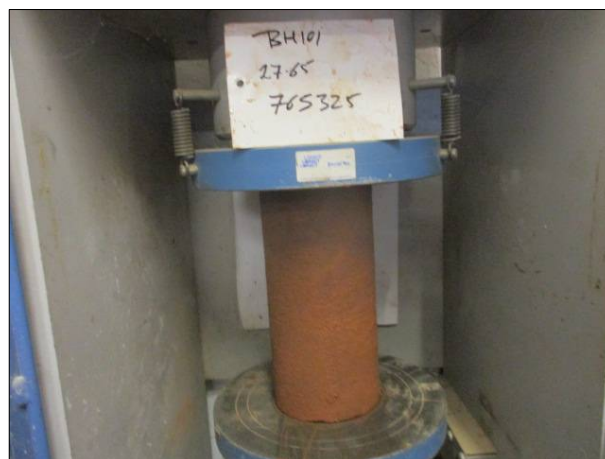
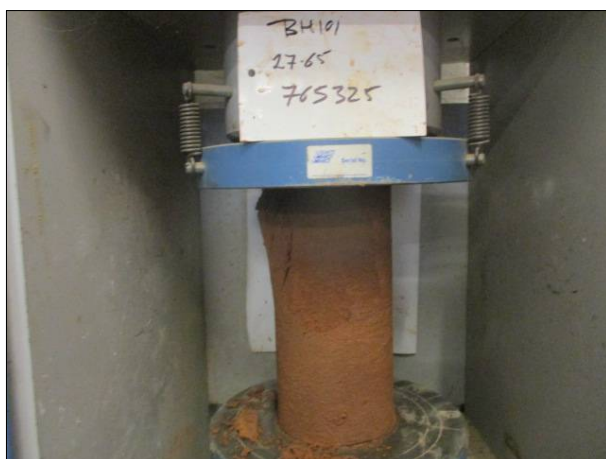
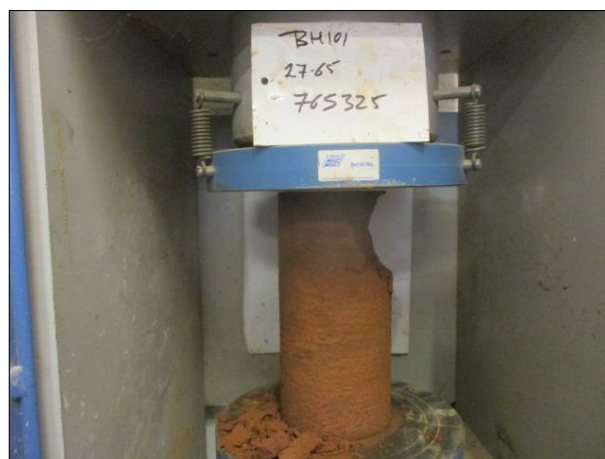
Load at Failure (kN): **45.2**

Failure Type: **Simple shear**

Samples delivered from site to storage facility. Samples are stored in a frost free environment, at temperatures  $>4^{\circ}\text{C}$   
Compression machine: Impact CT340 2000kN Auto Compression Machine Serial No. CT340-22. SSL No. 011076

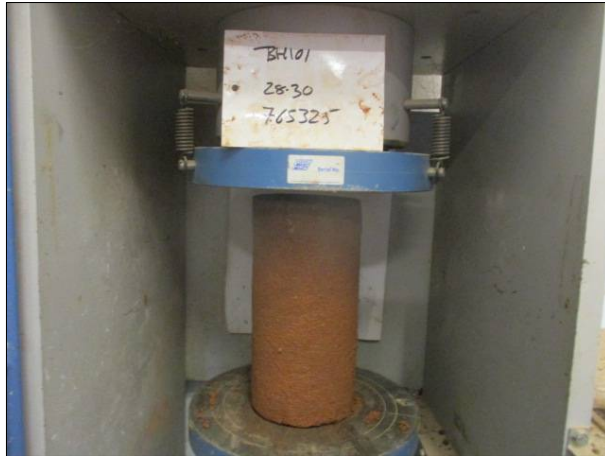
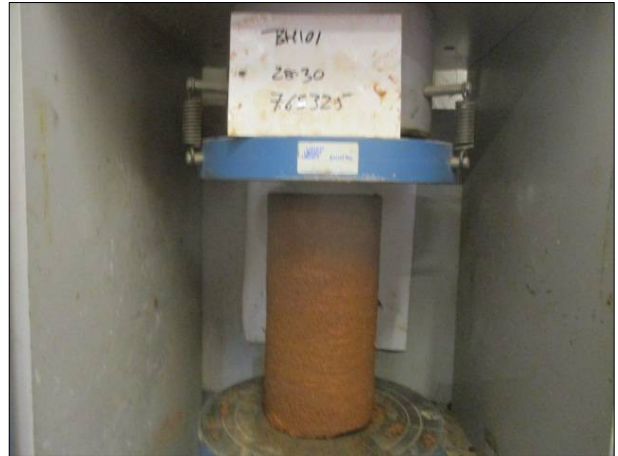
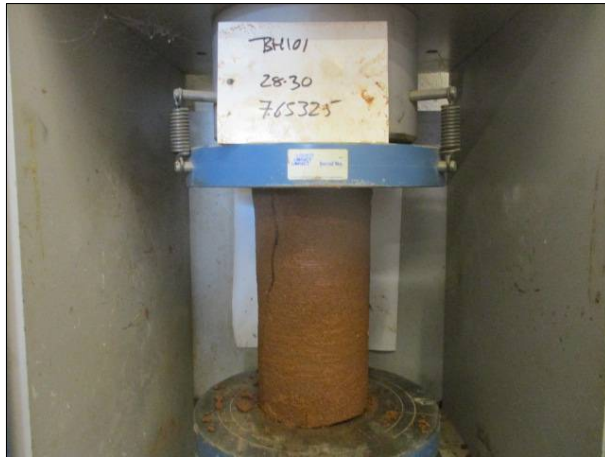
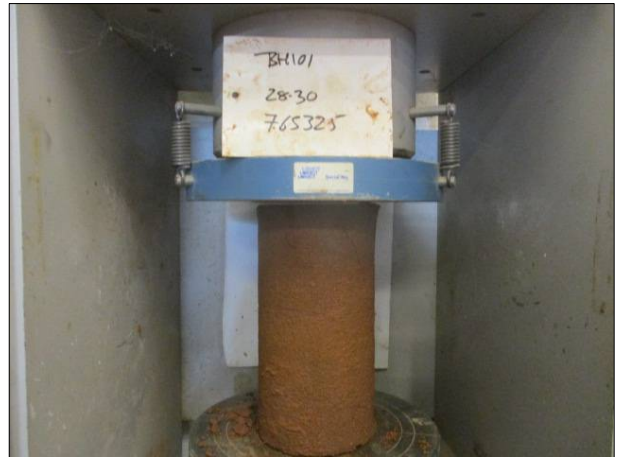
**PRE-TEST FRONT**

**PRE-TEST BACK**

**POST-TEST FRONT**

**POST-TEST BACK**

Samples delivered from site to storage facility. Samples are stored in a frost free environment, at temperatures  $>4^{\circ}\text{C}$   
Compression machine: Impact CT340 2000kN Auto Compression Machine Serial No. CT340-22. SSL No. 011076

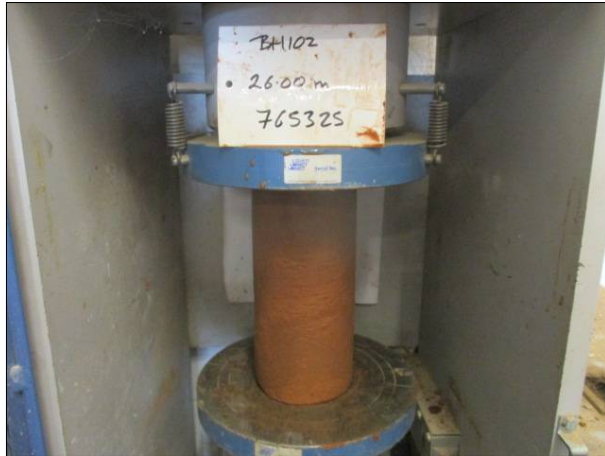
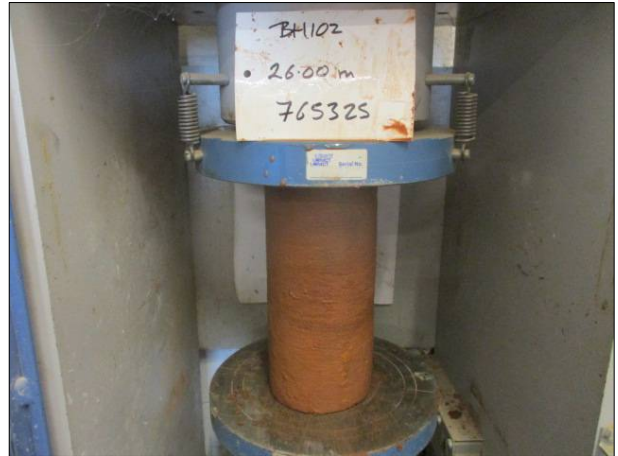
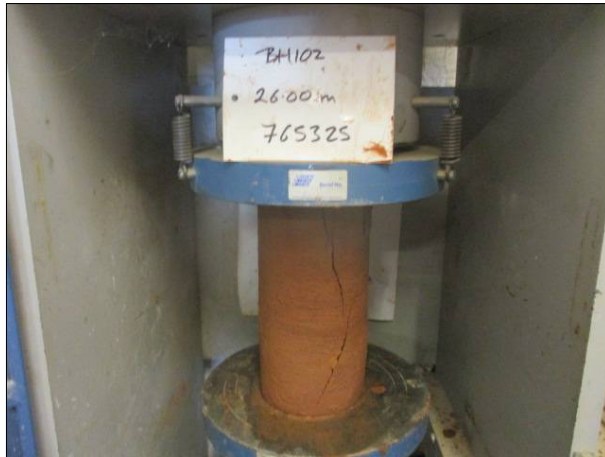
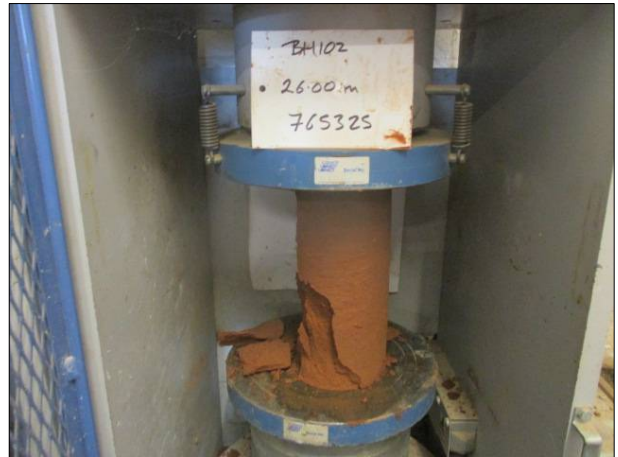
**PRE-TEST FRONT**

**PRE-TEST BACK**

**POST-TEST FRONT**

**POST-TEST BACK**

Samples delivered from site to storage facility. Samples are stored in a frost free environment, at temperatures  $>4^{\circ}\text{C}$   
Compression machine: Impact CT340 2000kN Auto Compression Machine Serial No. CT340-22. SSL No. 011076

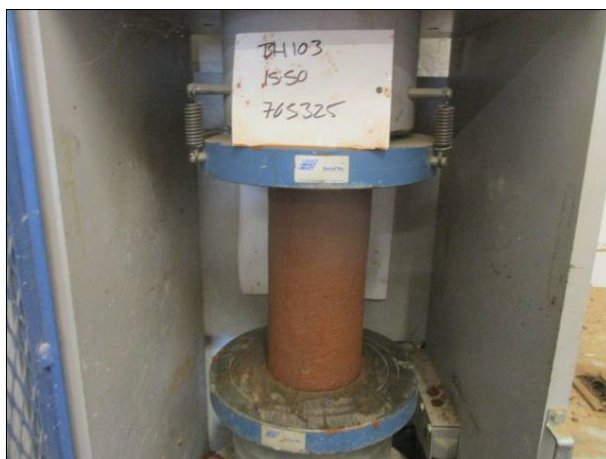
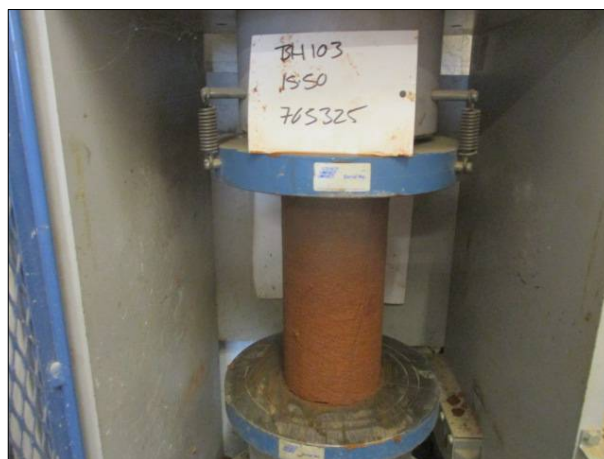
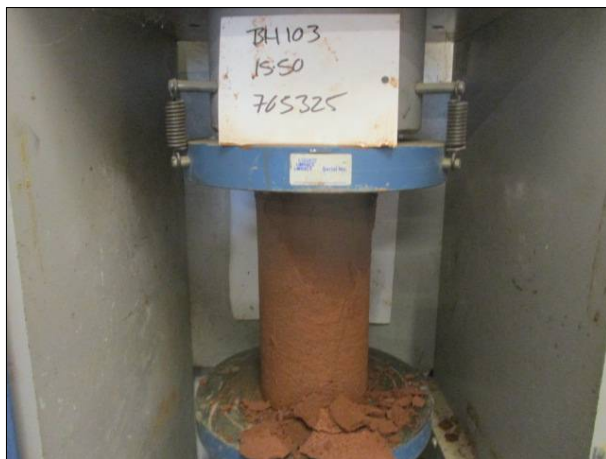
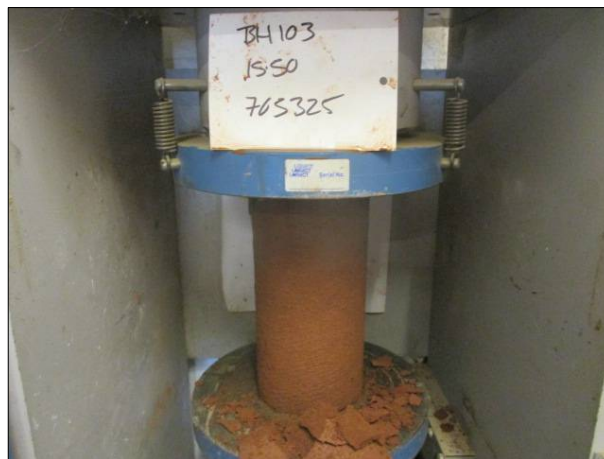
**PRE-TEST FRONT**

**PRE-TEST BACK**

**POST-TEST FRONT**

**POST-TEST BACK**

Samples delivered from site to storage facility. Samples are stored in a frost free environment, at temperatures  $>4^{\circ}\text{C}$   
Compression machine: Impact CT340 2000kN Auto Compression Machine Serial No. CT340-22. SSL No. 011076

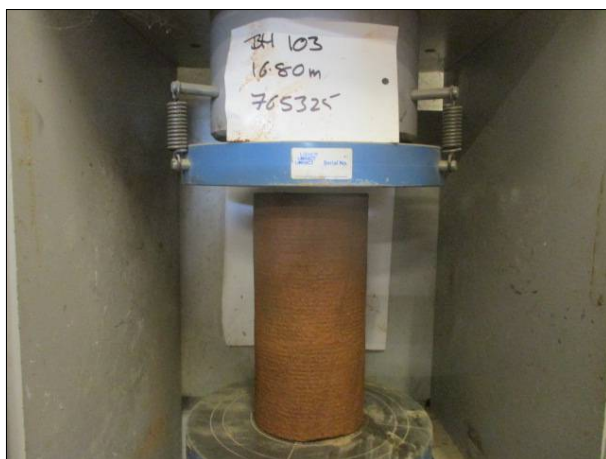
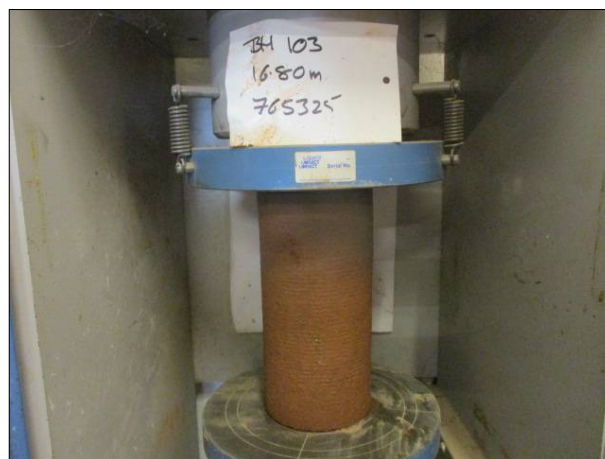
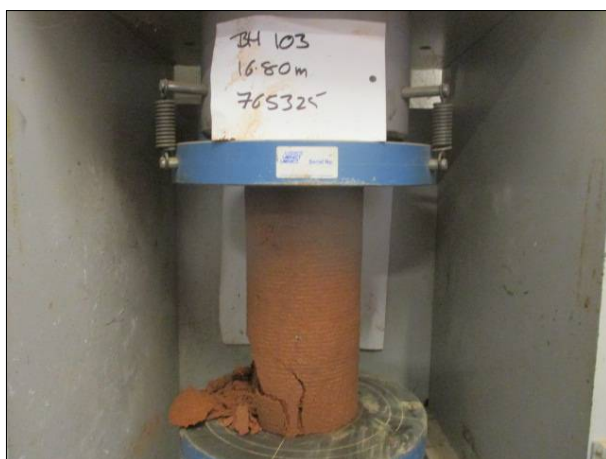
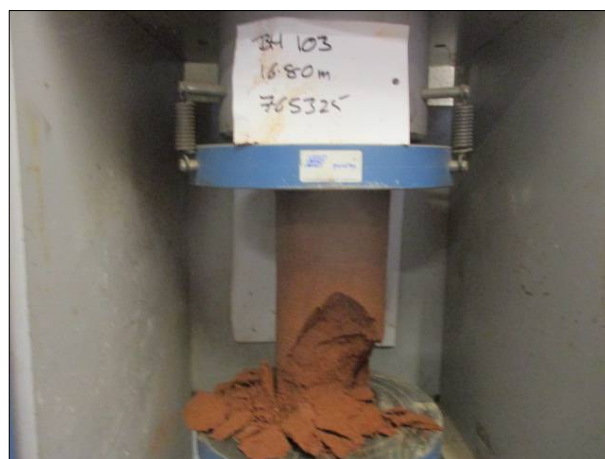
**PRE-TEST FRONT**

**PRE-TEST BACK**

**POST-TEST FRONT**

**POST-TEST BACK**

Samples delivered from site to storage facility. Samples are stored in a frost free environment, at temperatures  $>4^{\circ}\text{C}$   
Compression machine: Impact CT340 2000kN Auto Compression Machine Serial No. CT340-22. SSL No. 011076

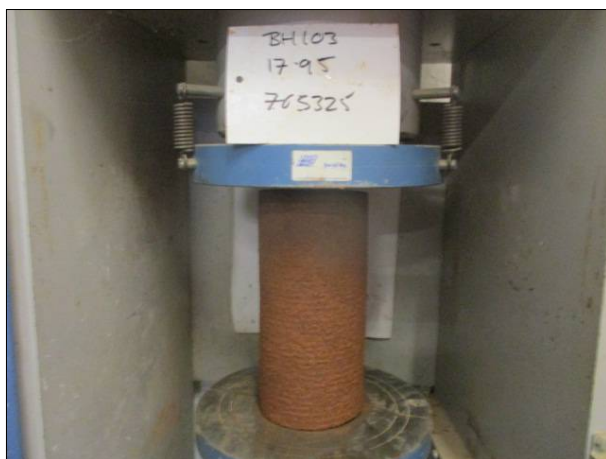
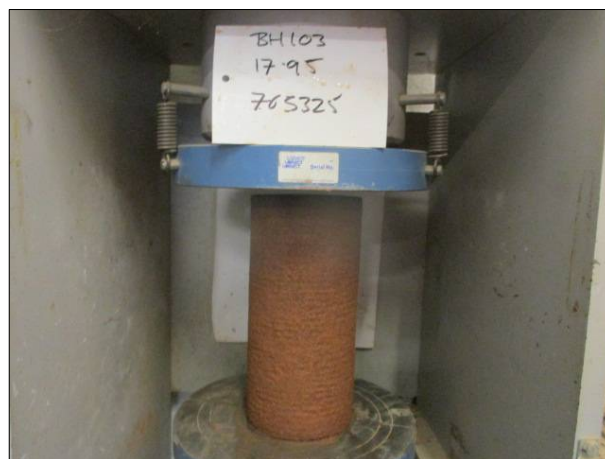
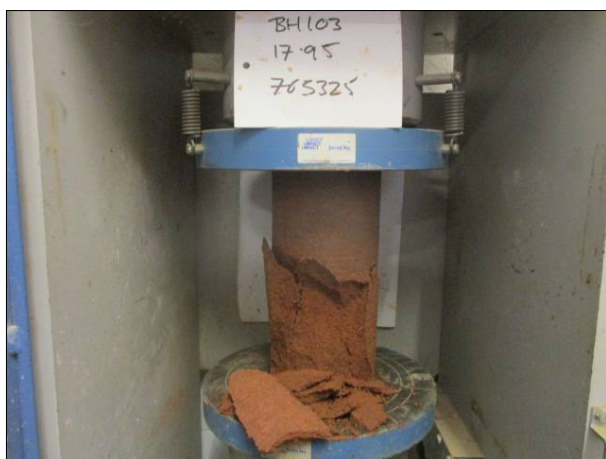
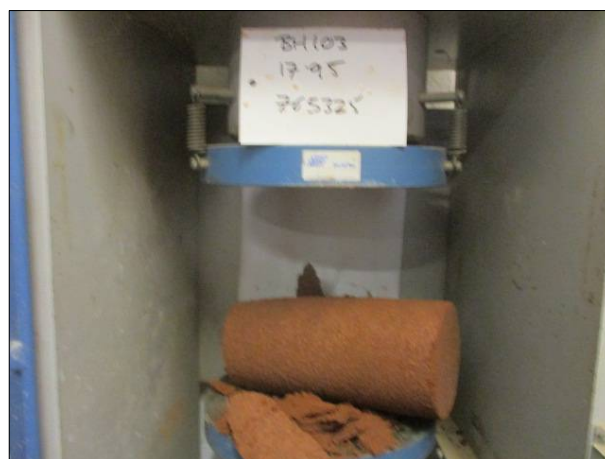
**PRE-TEST FRONT**

**PRE-TEST BACK**

**POST-TEST FRONT**

**POST-TEST BACK**

Samples delivered from site to storage facility. Samples are stored in a frost free environment, at temperatures  $>4^{\circ}\text{C}$   
Compression machine: Impact CT340 2000kN Auto Compression Machine Serial No. CT340-22. SSL No. 011076

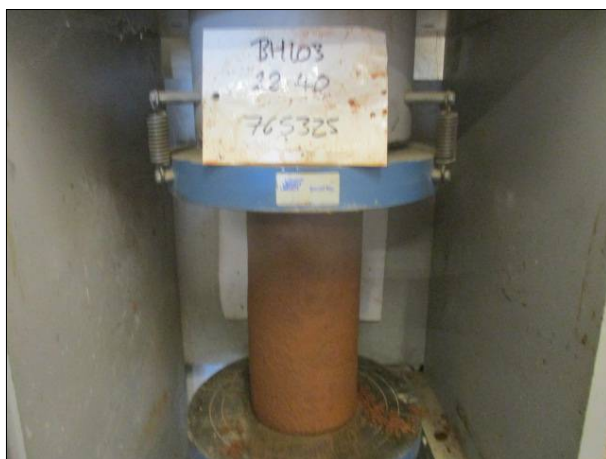
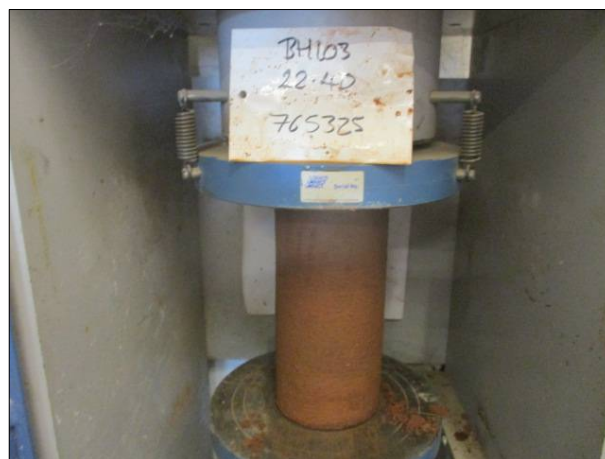
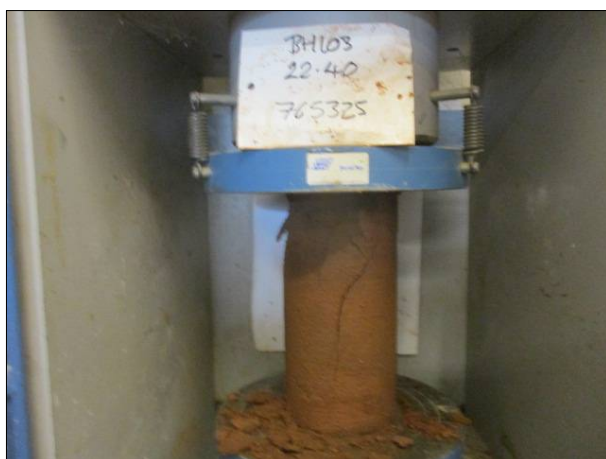
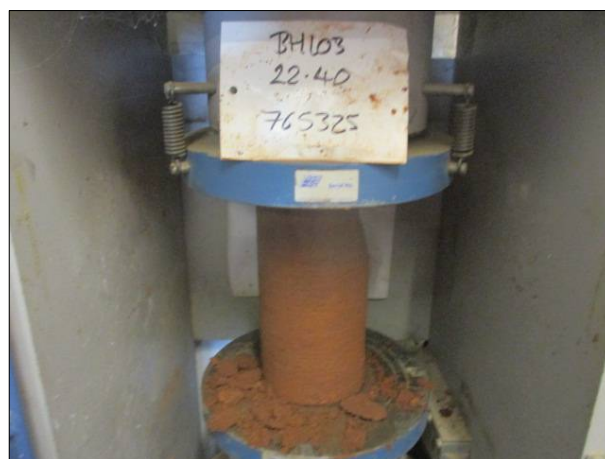
**PRE-TEST FRONT**

**PRE-TEST BACK**

**POST-TEST FRONT**

**POST-TEST BACK**

Samples delivered from site to storage facility. Samples are stored in a frost free environment, at temperatures  $>4^{\circ}\text{C}$   
Compression machine: Impact CT340 2000kN Auto Compression Machine Serial No. CT340-22. SSL No. 011076

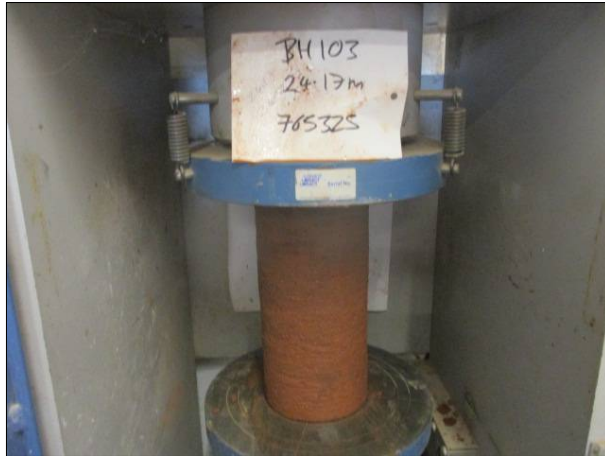
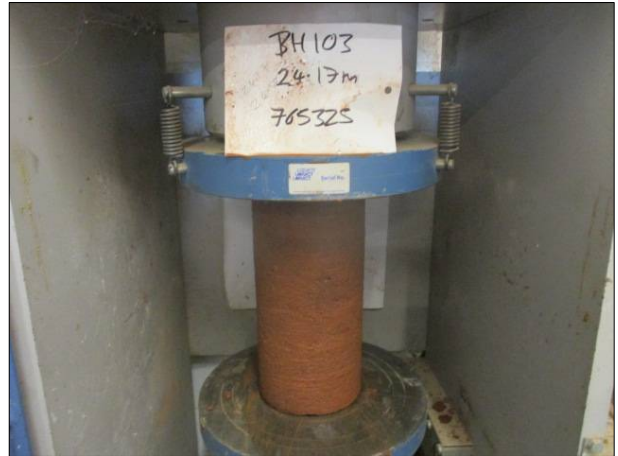
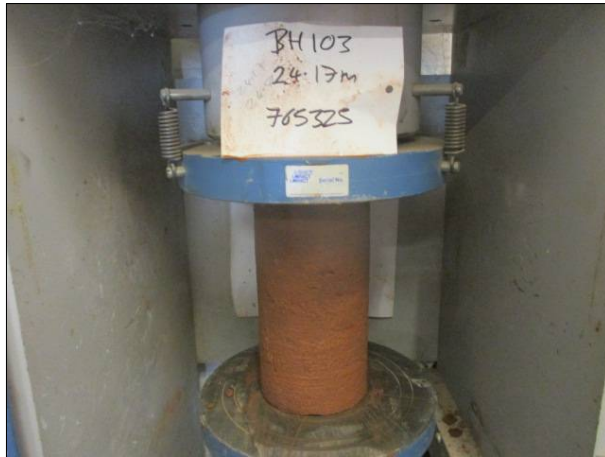
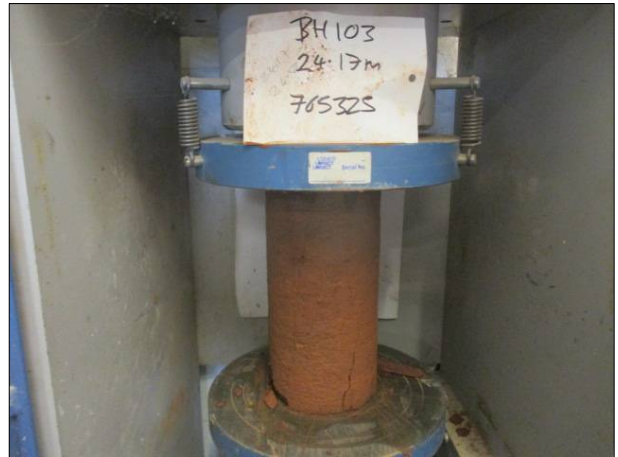
**PRE-TEST FRONT**

**PRE-TEST BACK**

**POST-TEST FRONT**

**POST-TEST BACK**

Samples delivered from site to storage facility. Samples are stored in a frost free environment, at temperatures  $>4^{\circ}\text{C}$   
Compression machine: Impact CT340 2000kN Auto Compression Machine Serial No. CT340-22. SSL No. 011076

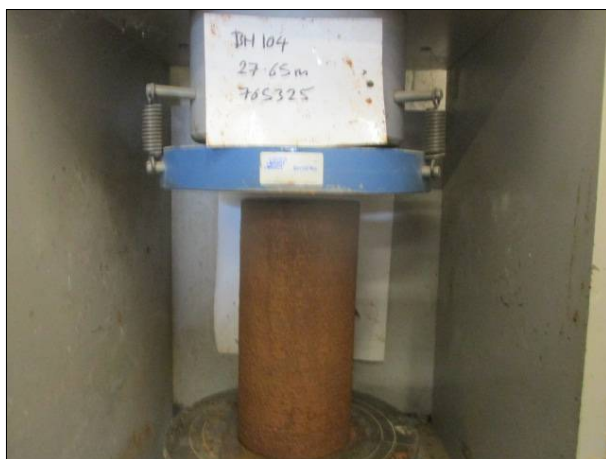
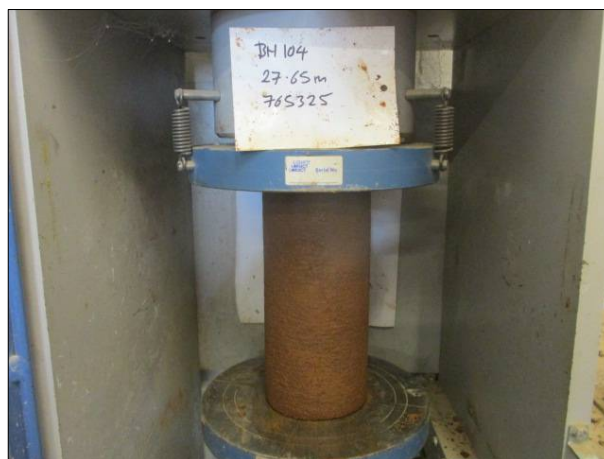
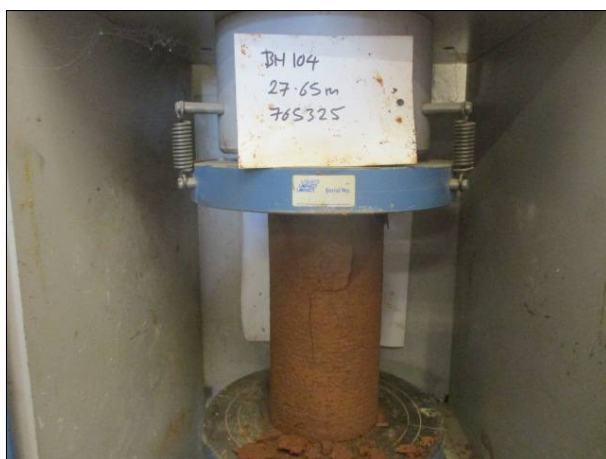
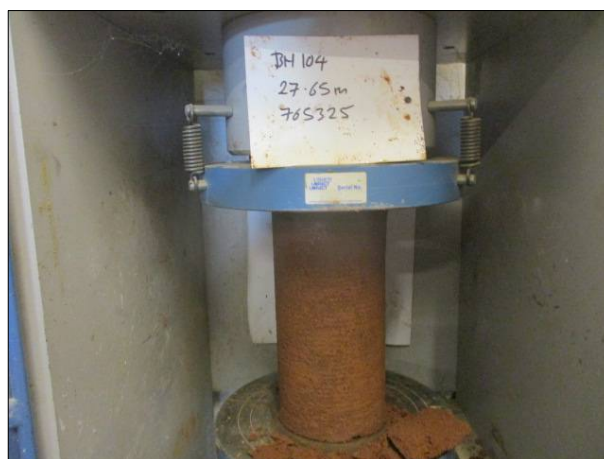
**PRE-TEST FRONT**

**PRE-TEST BACK**

**POST-TEST FRONT**

**POST-TEST BACK**

Samples delivered from site to storage facility. Samples are stored in a frost free environment, at temperatures  $>4^{\circ}\text{C}$   
Compression machine: Impact CT340 2000kN Auto Compression Machine Serial No. CT340-22. SSL No. 011076

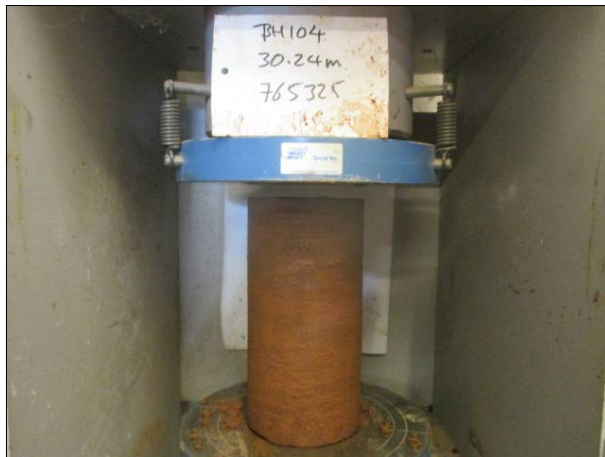
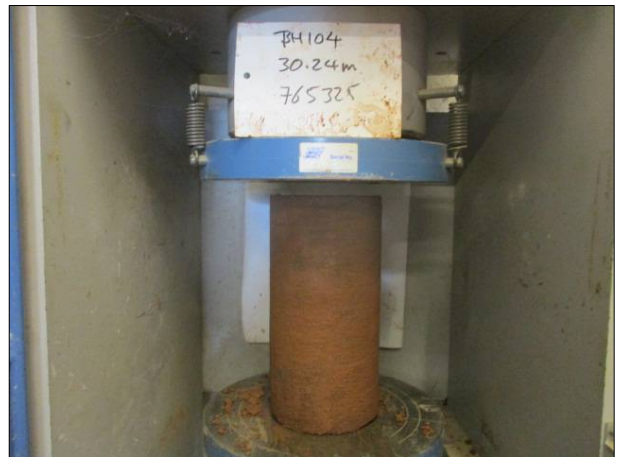
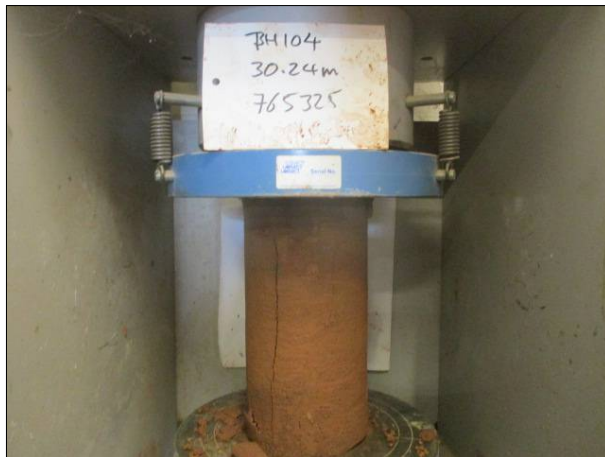
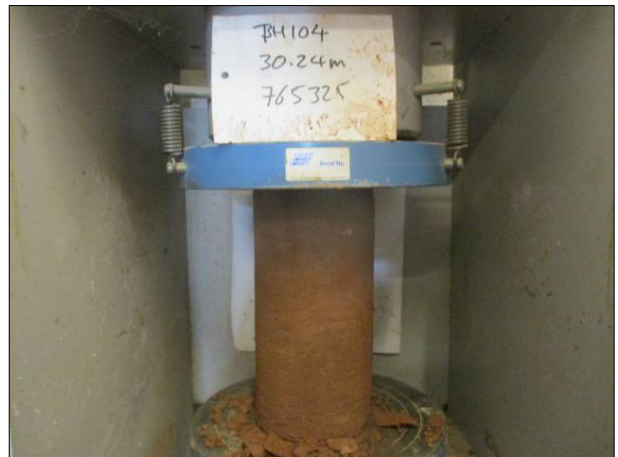
**PRE-TEST FRONT**

**PRE-TEST BACK**

**POST-TEST FRONT**

**POST-TEST BACK**

Samples delivered from site to storage facility. Samples are stored in a frost free environment, at temperatures  $>4^{\circ}\text{C}$   
Compression machine: Impact CT340 2000kN Auto Compression Machine Serial No. CT340-22. SSL No. 011076
