# Dilapidation Survey

Varsity Quarter - Sale Road and Wythenshawe Road

Date: 22.12.21

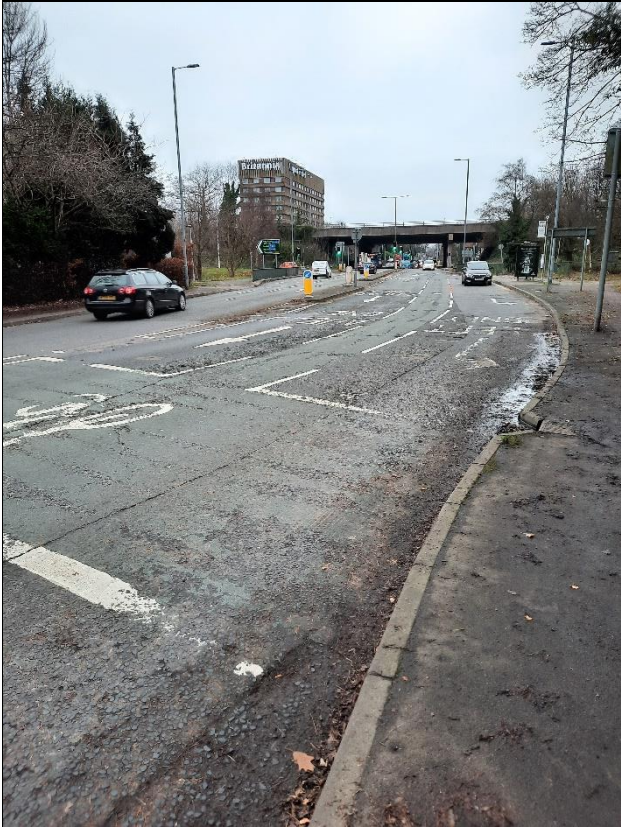
| <p>Location:<br/>1 - Junction of Wythenshawe Rd and Sale Rd.<br/>Facing East.</p> | <p>Location:<br/>1 - Junction of Wythenshawe Rd and Sale Rd.<br/>Facing East.</p> | <p>Location:<br/>2 - Junction of Wythenshawe Rd and Sale Rd.<br/>Facing West.</p> |
| <p>Highway Condition:<br/>Surfacing and lining in poor condition. Kerbs in fair condition.</p> | <p>Highway Condition:<br/>Surfacing and lining in poor condition. Kerbs in fair condition.</p> | <p>Highway Condition:<br/>Surfacing and Kerbs in fair condition. Lining in poor condition.</p> |

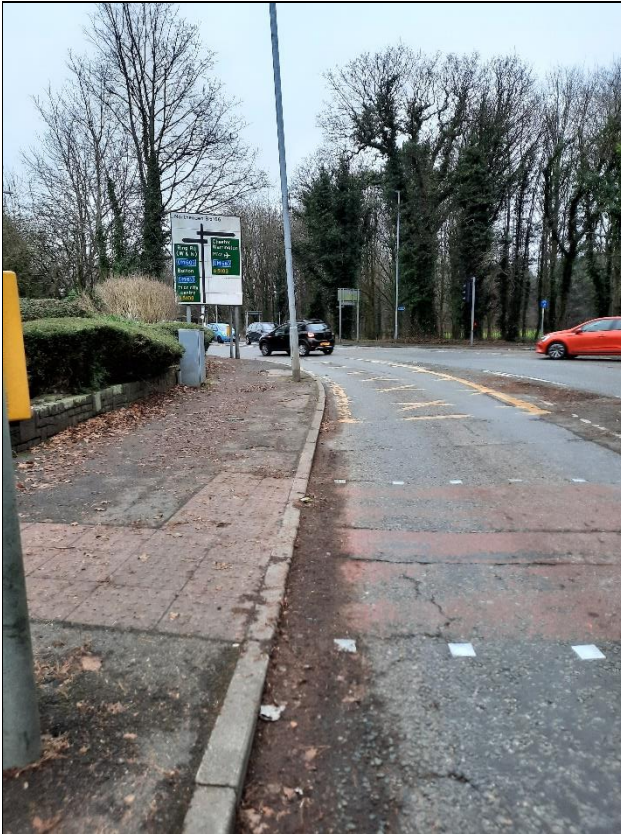
| <p>Location:<br/>2 - Junction of Wythenshawe Rd and Sale Rd.<br/>Facing South.</p> | <p>Location:<br/>3 – Sale Road. Facing North.</p> | <p>Location:<br/>3 – Sale Road. Facing North.</p> |
| <p>Highway Condition:<br/>Surfacing and Kerbs in fair condition. Lining in poor condition.</p> | <p>Highway Condition:<br/>Surfacing and Kerbs in fair condition.</p> | <p>Highway Condition:<br/>Surfacing and Kerbs in fair condition.</p> |

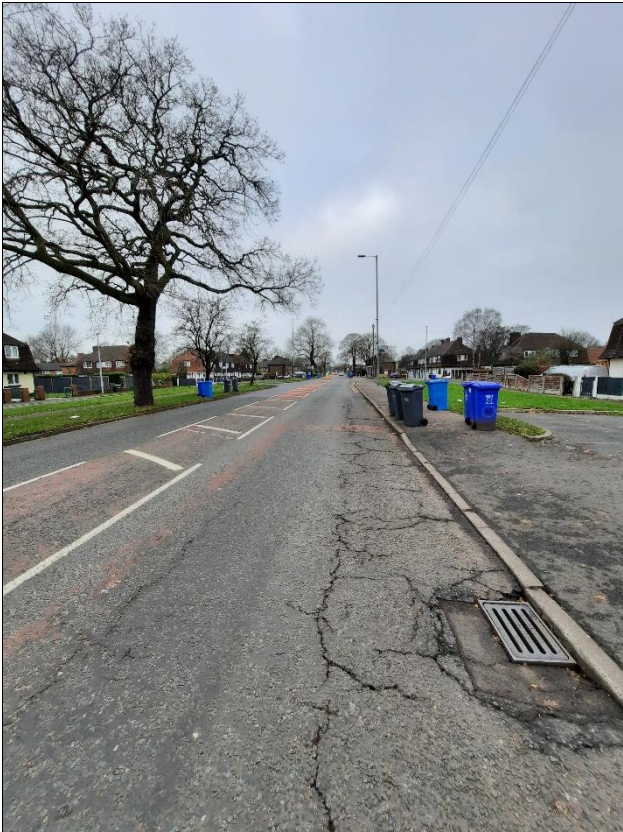
| <p>Location:<br/>4 - Sale Road facing North.</p> | <p>Location:<br/>5 – Junction of Sale Road and Moss Hey Drive facing North.</p> | <p>Location:<br/>6 – Moss Hey Drive.</p> |
| <p>Highway Condition:<br/>Surfacing in poor condition. Lining and kerbs in fair condition.</p> | <p>Highway Condition:<br/>Surfacing and kerbs in poor condition. All tactile pavers are broken. Lining in fair condition.</p> | <p>Highway Condition:<br/>Surfacing and kerbs in good condition. Lining in fair condition.</p> |

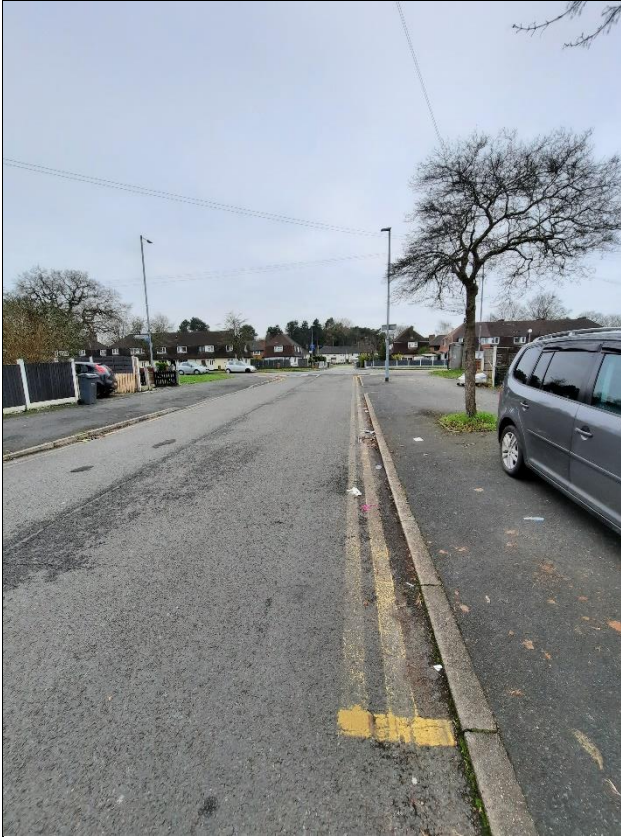
| <p>Location:<br/>7 - Moss Hey Drive.</p> | <p>Location:<br/>8 – Junction of Sale Road and Moss Hey Drive facing South.</p> | <p>Location:<br/>8 – Junction of Sale Road and Moss Hey Drive facing South.</p> |
| <p>Highway Condition:<br/>Surfacing and kerbs in good condition. Lining in fair condition.</p> | <p>Highway Condition:<br/>Surfacing and kerbs in poor condition. All tactile pavers are broken. Lining in fair condition.</p> | <p>Highway Condition:<br/>Surfacing and kerbs in poor condition. All tactile pavers are broken. Lining in fair condition.</p> |

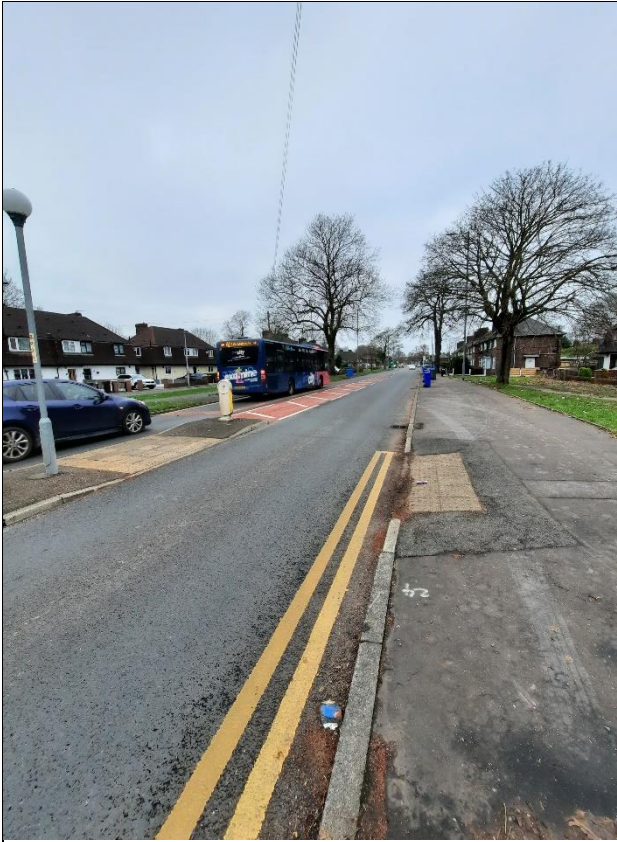
| <p>Location:<br/>9 – Sale Road facing North.</p> | <p>Location:<br/>10 – Junction of Sale Road and Shevington Gardens facing South.</p> | <p>Location:<br/>11 – Sale Road and Shevington Gardens facing North.</p> |
| <p>Highway Condition:<br/>Surfacing, Kerbs and lining all in good condition.</p> | <p>Highway Condition:<br/>Surfacing, Kerbs and lining all in good condition.</p> | <p>Highway Condition:<br/>Surfacing, Kerbs and lining all in good condition.</p> |

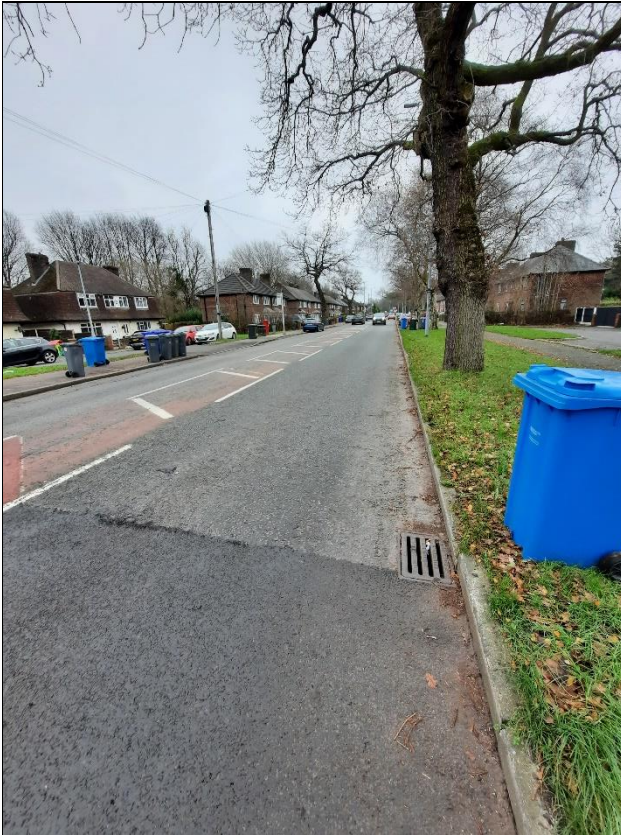
| <p>Location:<br/>12 – Sale Road facing South.</p> | <p>Location:<br/>13 – Sale Road facing South.</p> | <p>Location:<br/>14 – Sale Road facing South.</p> |
| <p>Highway Condition:<br/>Surfacing in good condition. Lining and kerbs in fair condition.</p> | <p>Highway Condition:<br/>Surfacing in good condition. Lining and kerbs in fair condition.</p> | <p>Highway Condition:<br/>Surfacing, lining and kerbs in fair condition.</p> |

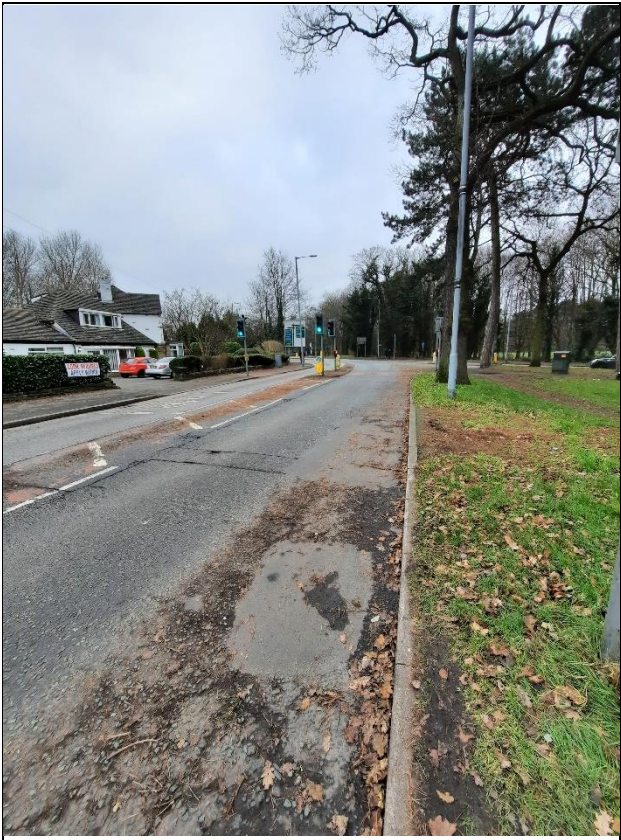
| <p>Location:<br/>15 – Sale Road facing South.</p> | <p>Location:<br/>16 – Junction of Wythenshawe Rd and Sale Rd.<br/>Facing South.</p> | <p>Location:<br/>16 – Junction of Wythenshawe Rd and Sale Rd.<br/>Facing East.</p> |
| <p>Highway Condition:<br/>Surfacing, lining and kerbs in fair condition.</p> | <p>Highway Condition:<br/>Surfacing, lining and kerbs in fair condition.<br/>Tactile paving in good condition.</p> | <p>Highway Condition:<br/>Surfacing, lining and kerbs in fair condition.<br/>Tactile paving in good condition.</p> |
