## Phase I GeoEnvironmental Desk Study

10 Moxley Road

Crumpsall

**Report No. A4255/21**

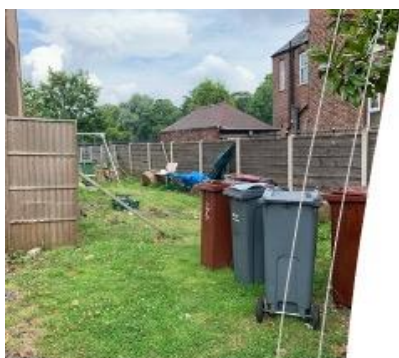
| <p><b>Plate 1 View of the site entrance from Moxley Road</b></p> | <p><b>Plate 2 View of the derelict site from the entrance gate on Moxley Road.</b></p> |

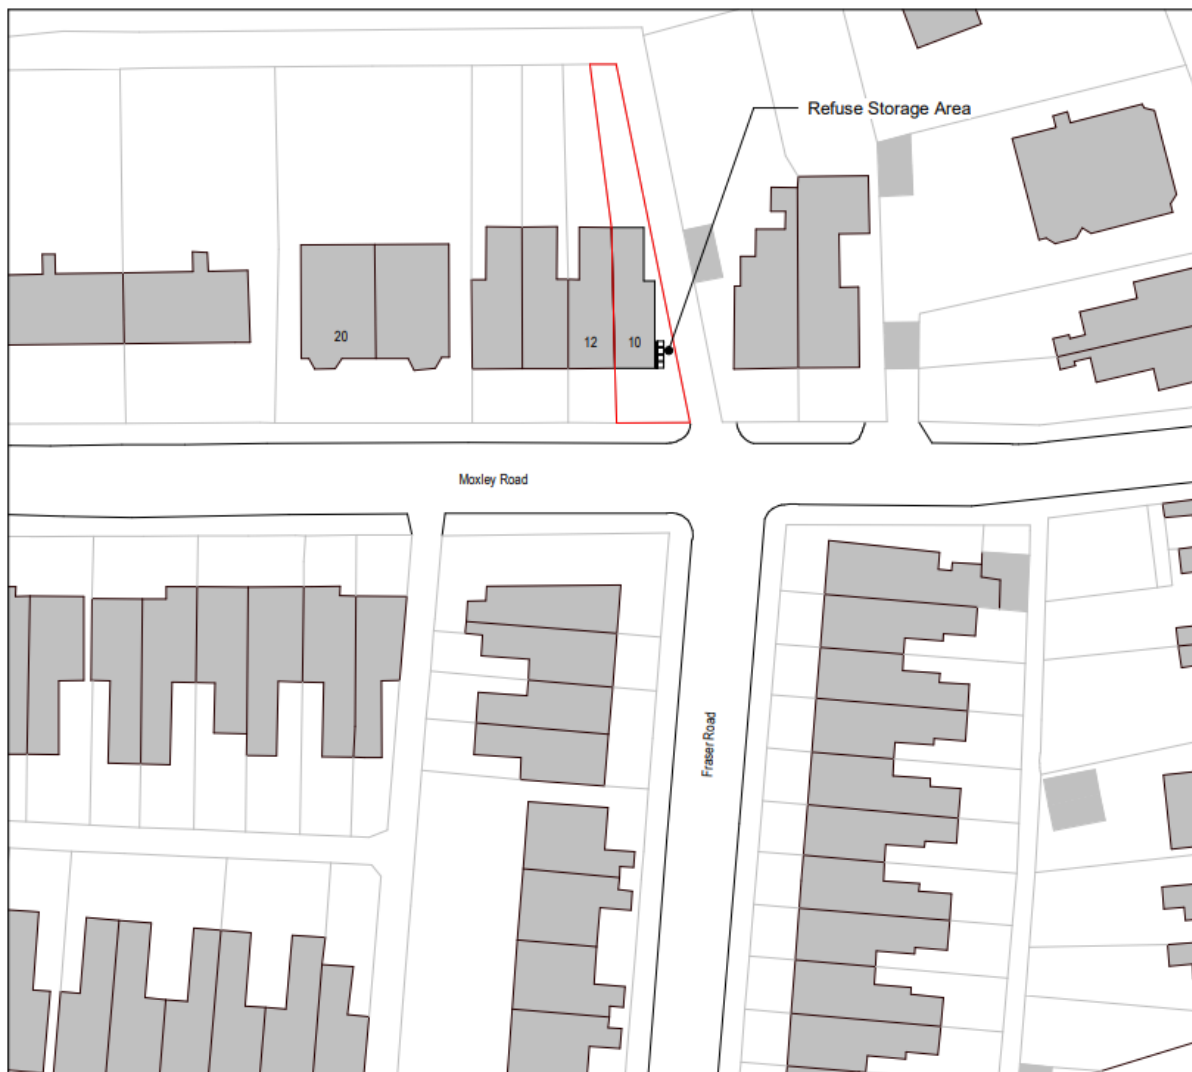
**Figure 1 Proposed Development Plan**

- 1.1 Earth Environmental & Geotechnical Ltd has been commissioned by DEBTAL Architecture on behalf of Welcome Estates (the client) to undertake a Phase I GeoEnvironmental Desk Study for the proposed development to the north of Moxley Road, Crumpsall, Manchester.
- 1.2 It is understood that the client intends to construct a residential development on the site comprising a three storey, end terrace dwelling house. The development will consist of 5no. bedrooms and front and rear gardens.
- 1.3 A proposed development plan for the site is shown in Figure 1 below.

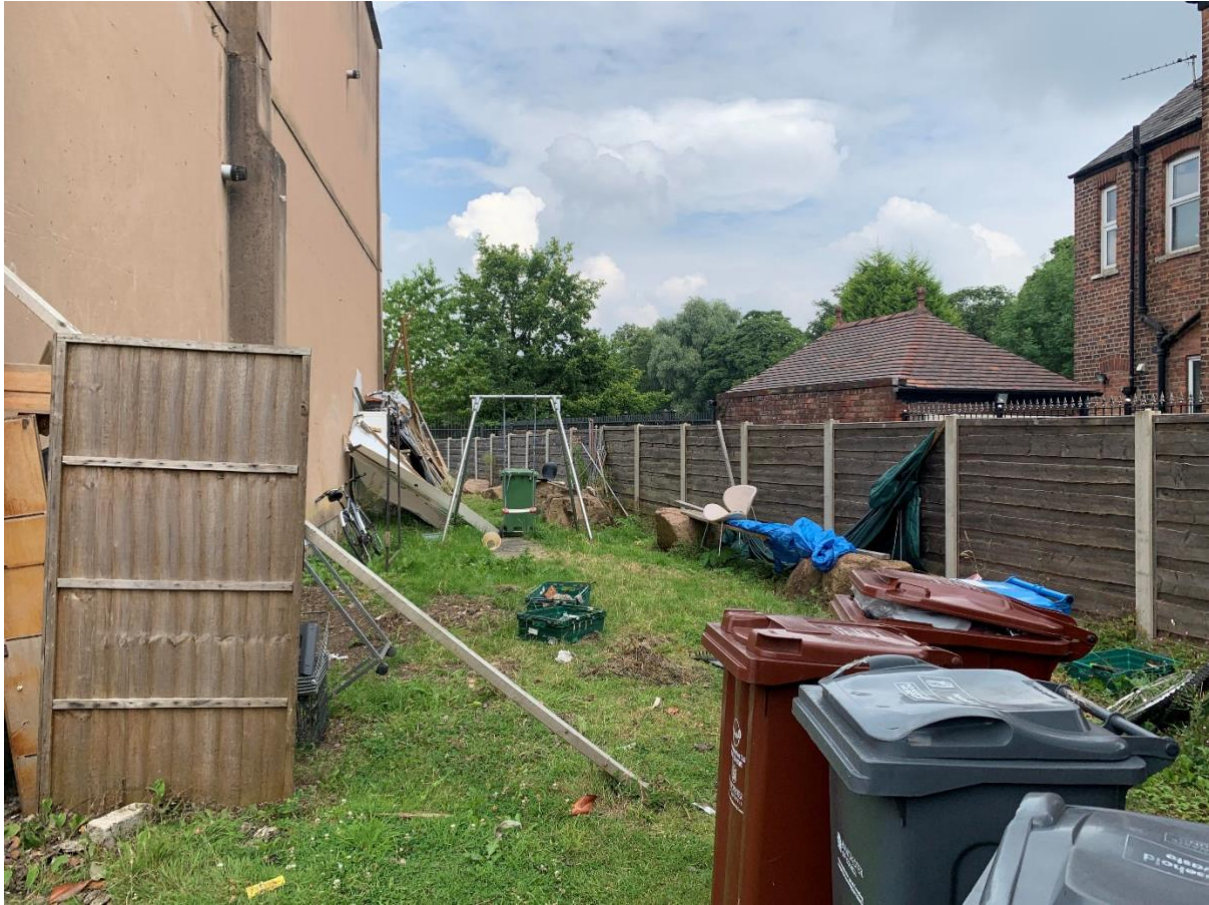
**Figure 3 Site Photograph**

- 2.3 The site is currently a derelict parcel of land demarcated by metal and wooden fence panels. Current site access is via a wooden gate on the southwest of the site. A tree is located on the southeast corner of the site. There are waste bins from the adjoining property and a swing located on the site. Suspected fly- tipped materials are located on site such as disused furniture, construction material and shopping crates.
