# Television Post-Construction Survey Report

Crown Street – Zone 1 – C2

Renaker Build Limited

October 2021

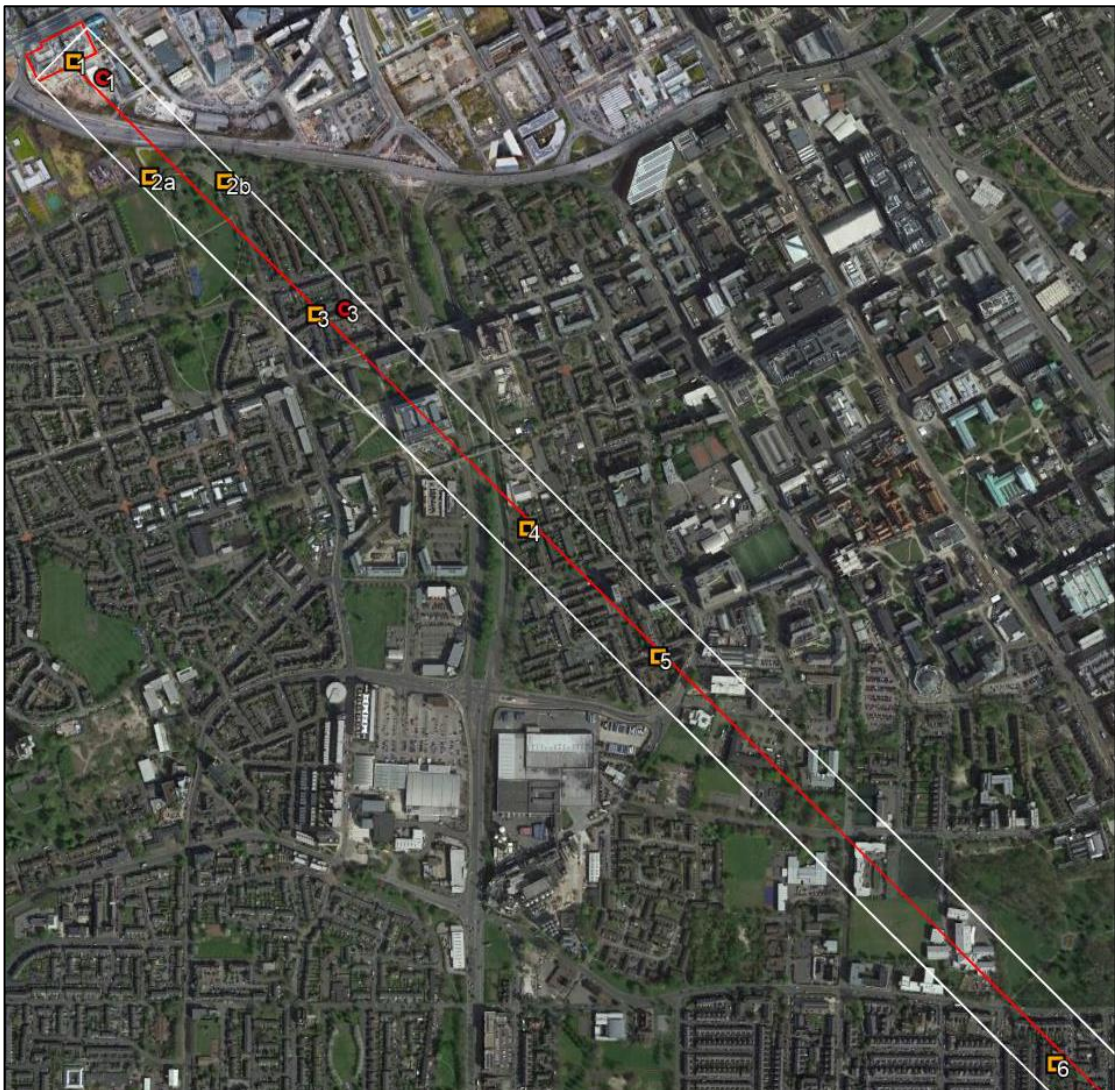
Figure 6 Survey locations

Figure 6<sup>6</sup> below shows the survey locations overlaid onto aerial photography. The proposed development location and the shadow zone are also shown. The survey locations chosen for the baseline survey were revisited as best as possible for the post-construction survey<sup>7</sup>. The locations below show the actual survey locations. The orange squares show the post-construction survey locations, the red circles show the baseline survey locations from 2017. Where they are closely located, only the post-construction icon is shown<sup>8</sup>. Baseline survey location 2 was re-visited during the post-construction at survey location 2b, post-construction location 2a was added to account for building C2. Survey location 2a is located on the southwestern side of the shadow zone.
