## Phase 1 GeoEnvironmental Desk Study

Moss Lane East

Manchester

September 2021

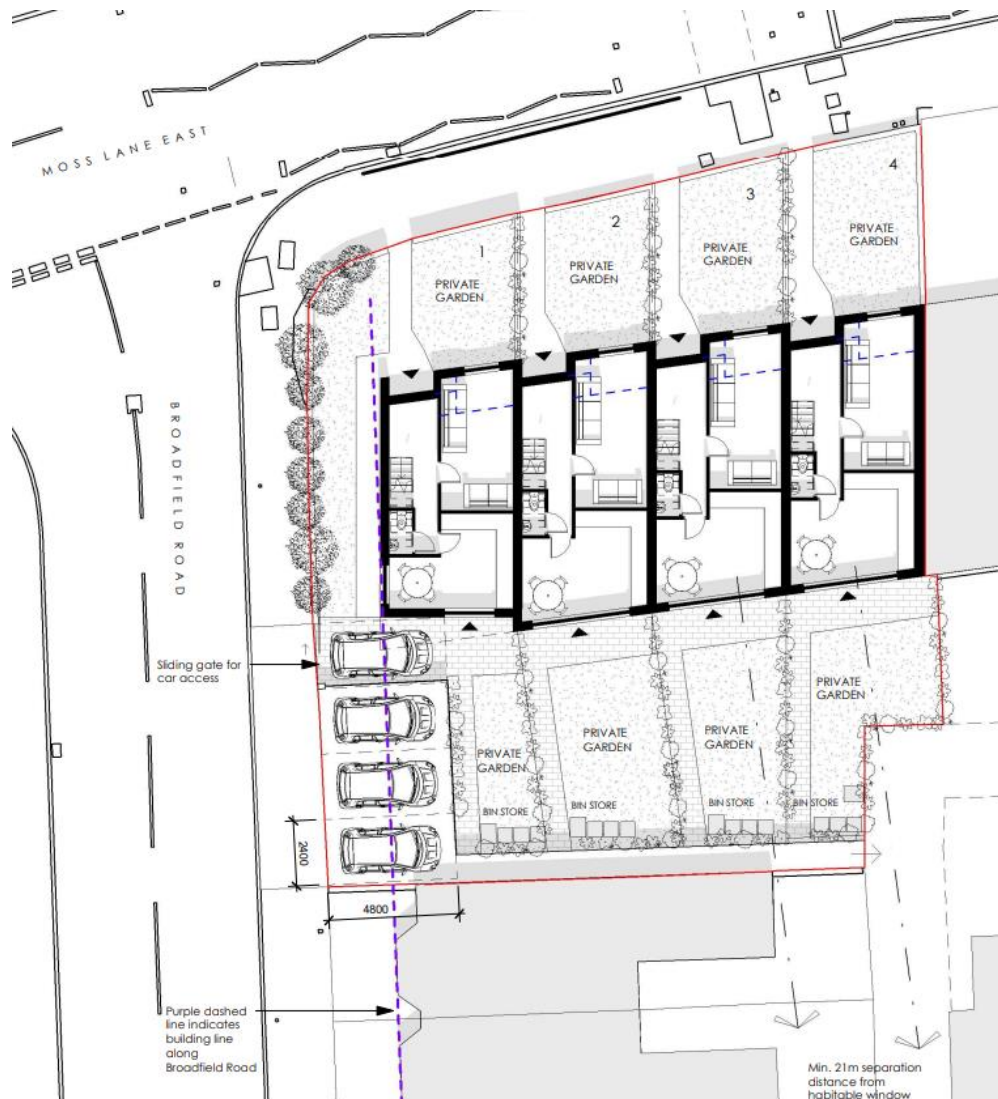
**Figure 1 Proposed Development Plan**

- 1.1 Earth Environmental & Geotechnical Ltd has been commissioned by MAI Construction Ltd (the client) to undertake a Phase I GeoEnvironmental Desk Study for the proposed development to the south of Moss Lane East, Manchester.
- 1.2 It is understood that the client intends to construct a residential development on the site comprising of terrace dwelling houses. The development will consist of four terrace houses with front and rear gardens, along with four car parking spaces.
- 1.3 A proposed development plan for the site is shown in Figure 1 below.

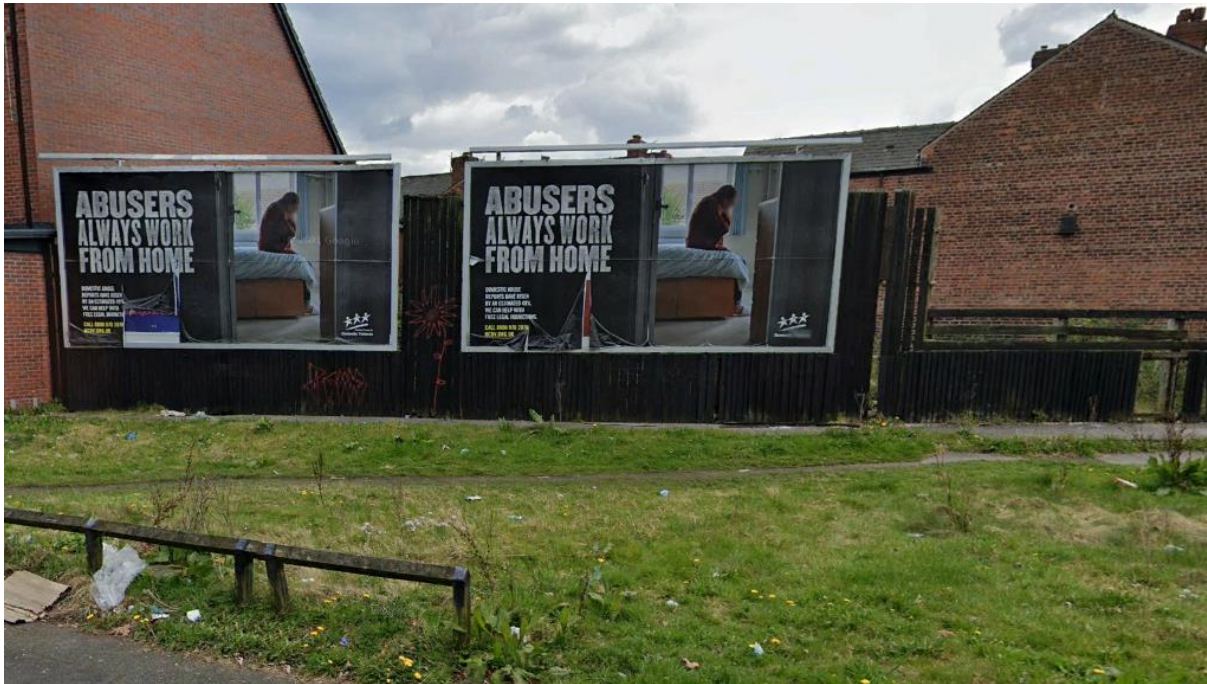
**Figure 3 Site Photograph**

- 2.3 The site is currently a derelict parcel of land demarcated by residential dwellings to the east and south. Current site access is available via a Moss Lane East and Broadfield Road. A wooden advertisement board intersects the site across the northeast to the south.

- 2.5 A location plan is shown below as Figure 2, together with a recent site photograph as Figure 3 (overleaf).
