# Heyrod Street

## Phase 2 Ground Investigation

Curtins Ref: 075424-CUR-00-XX-RP-GE-003

Issue Date: 29 October 2021

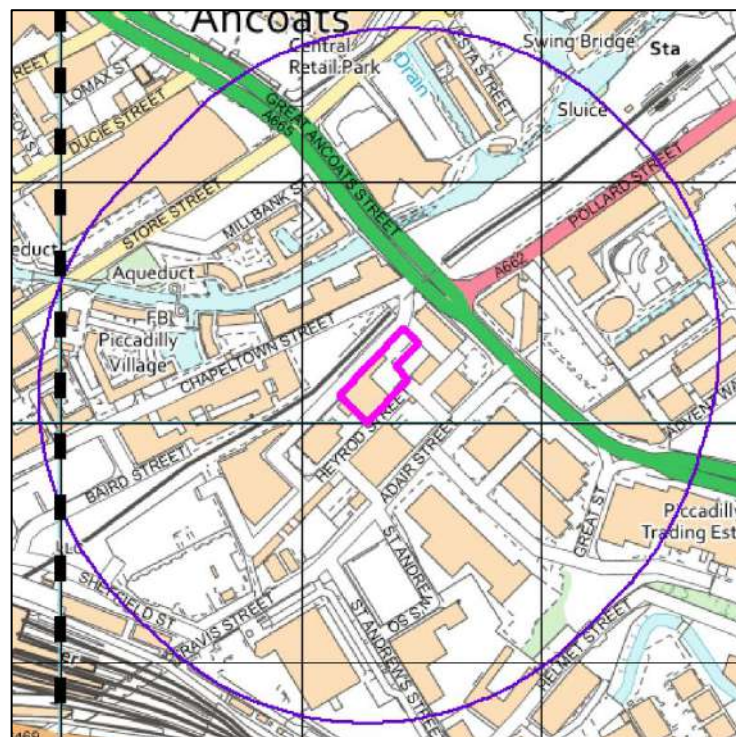
**Figure 2.1** – Site Location Plan (site boundary shown in pink. 250m buffer in purple).  
Crown Copyright. License Number 100022432.

The site generally slopes slightly, with a maximum approximate elevation of 47m AOD in the north east and a minimum of 45m AOD in the south west. Internal floor levels within the warehouse are relatively even.

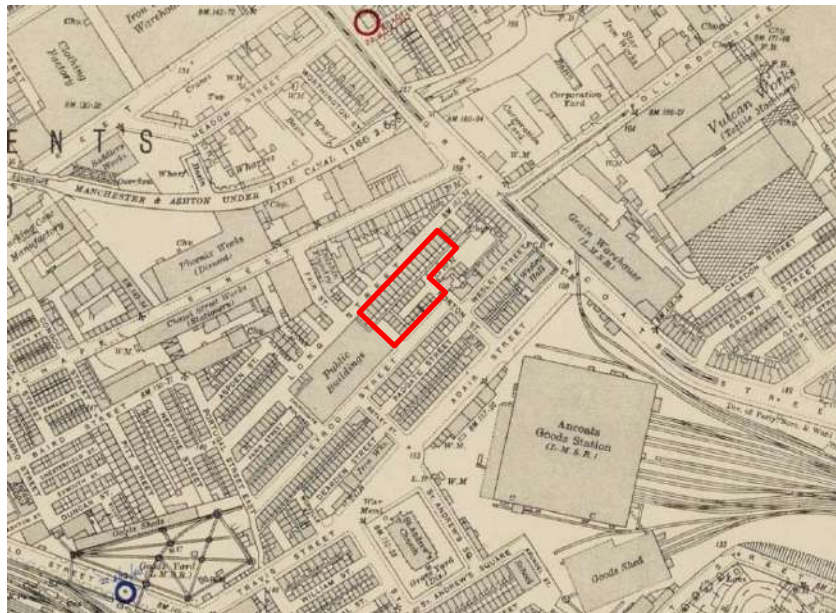
**Figure 2.5:** Site boundary shown in red. Red circles represent fire-bomb hits, blue circles represent high-explosive bomb hits.

Analysis of historical bomb mapping from the University of Manchester (Ref. 6) (*Figure 5.1*) shows that a high explosive bomb hit occurred approximately 250m south west of the site and a fire-bomb hit occurred approximately 250m to the north. Both hits occurred on the 22<sup>nd</sup> of December 1940.

A review of historical maps from the Envirocheck report within the Phase 1 Preliminary Risk Assessment (Ref.1) found that a "Ruin" is marked 30m north east of the site on post-war mapping, potentially indicating bomb damage in close proximity to the site.

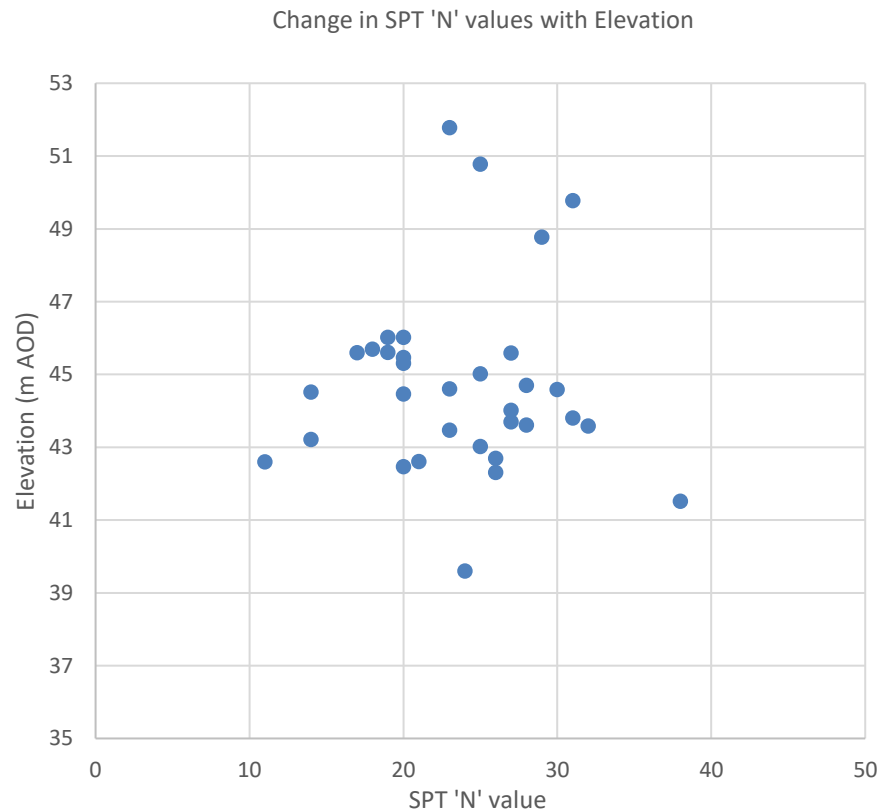
**Figure 6.2a – Summary of SPT 'N' Values from Cohesive Glacial Till**

The SPT N results are presented on *Figure 6.2a*, showing high variability.

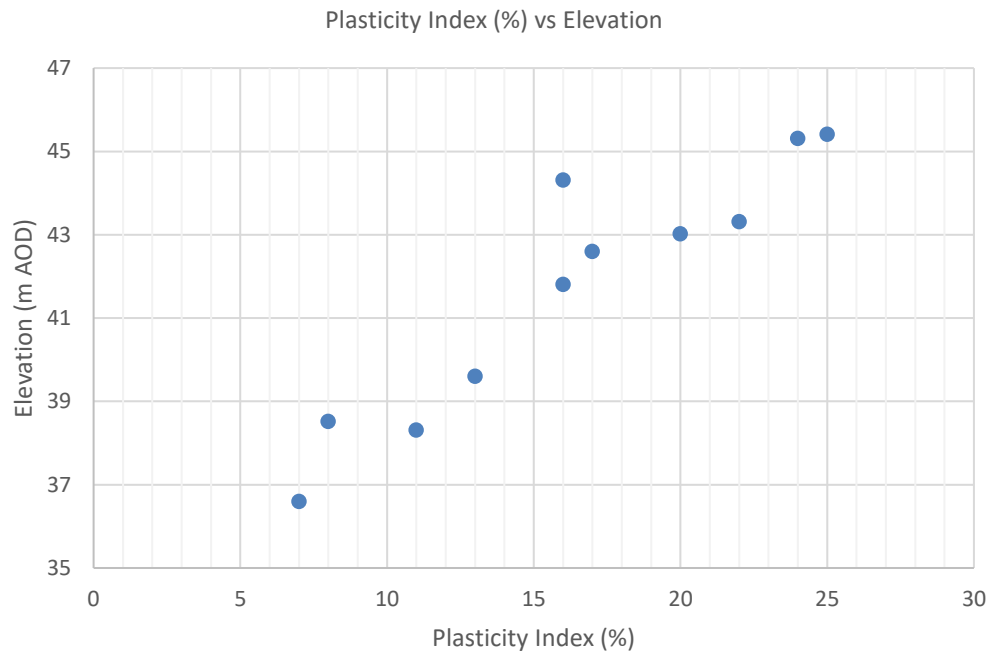
**Figure 6.2b – Plasticity Indices within Cohesive Glacial Till**

A total of six Atterberg Tests were undertaken in the cohesive material. The plasticity indices predominantly decrease with depth. Intermediate plasticity clay is typically recorded at <5.50m bgl, improving to low plasticity clays >5.50m.

Due to the limited cohort of results and variability in Glacial Till, an  $f_1$  factor of 5.2 for an average plasticity index of 16%, in accordance with CIRIA C504 Engineering in Glacial Till has been used. Figure 6.2b illustrates the variability in Plasticity Index within the cohesive glacial till.

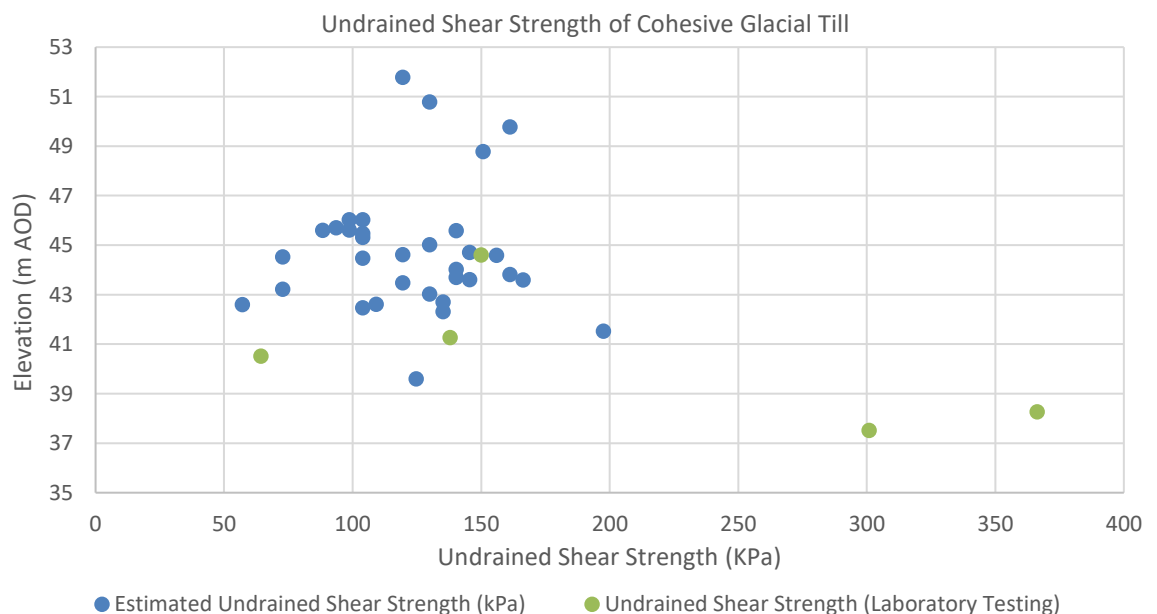
**Figure 6.2c – Undrained Shear Strength of Cohesive Glacial Till**

Figure 6.2c illustrates the change in undrained shear strength ( $C_u$ ) of Cohesive Glacial Till with depth. Based on the correlation between SPT 'N' Value and plasticity index, estimated  $C_u$  values were recorded ranging between 57.2 kPa and 197.6 kPa. Five triaxial compression tests were undertaken on Cohesive Glacial Till at depths of 3.00m and 10.50m bgl. Average  $C_u$  values between 64.33 kPa and 366.33 kPa were determined, respectively. These results indicate a medium to very high strength clay with high variability compared to elevation.

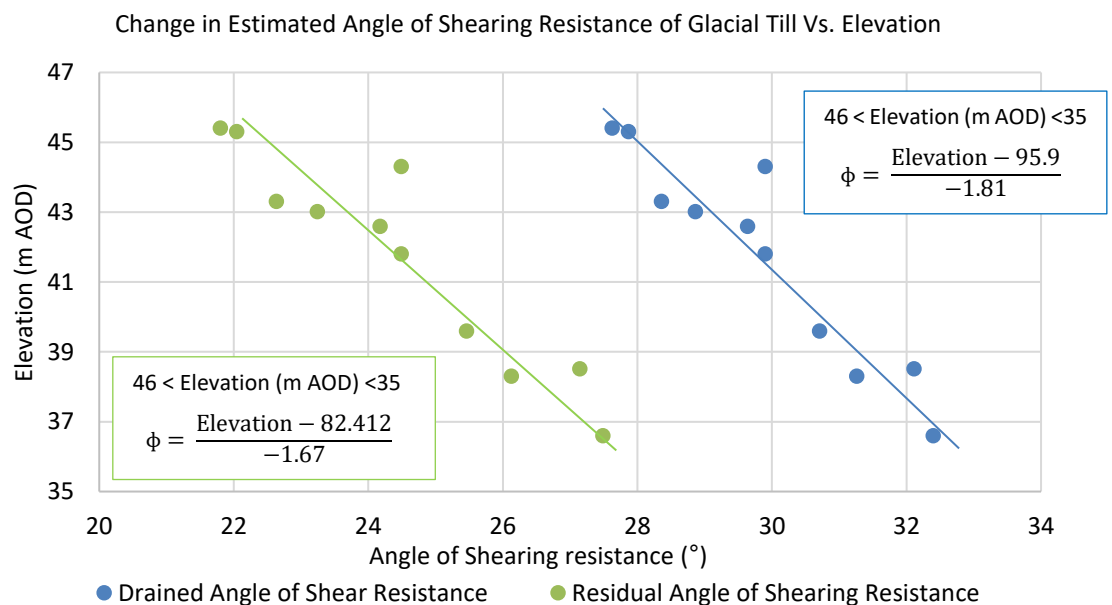
**Figure 6.2e – Summary of Angle of Shear Resistance vs. Elevation in Cohesive Glacial Till**

The Angle of Shearing Resistance,  $\phi'$ , for the cohesive Glacial Till has been derived from the correlation with Plasticity Indices (Ref. 13). Figure 6.2e summarises the change in angle of shearing resistance of cohesive soils with changes in elevation. Characteristic parameters for the drained and undrained angles of shearing resistance of the Cohesive Glacial Till are summarised in Figure 6.2e and Table 6.4

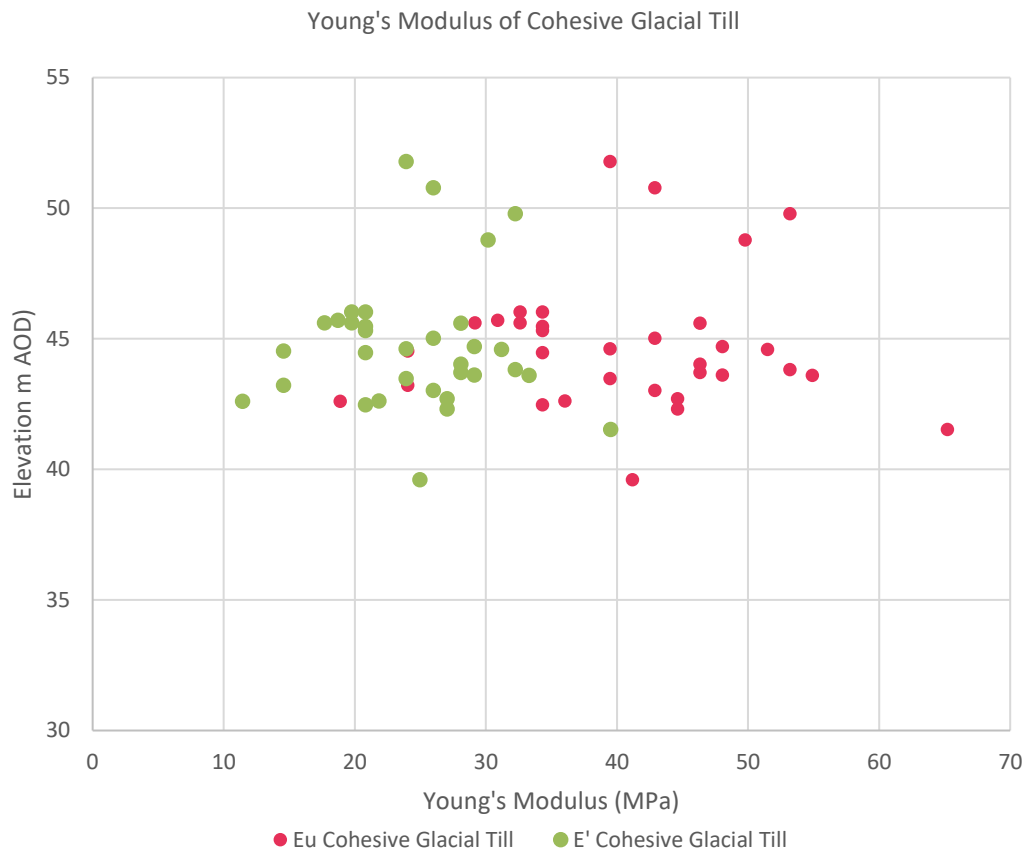
**Figure 6.2f** – Summary of Young's Modulus vs. Elevation in Cohesive Glacial Till

Moderately conservative Drained and Undrained Young's Modulus,  $E'$  and  $E_u$ , have been estimated using this correlation and are shown on *Figure 6.2f*. The stiffness of the soils appears to be variable with elevation.

The Drained and Undrained Young's Modulus,  $E'$  and  $E_u$ , can be derived for cohesive material from the relationship with SPT N values as presented in Equation 3 and Equation 4.

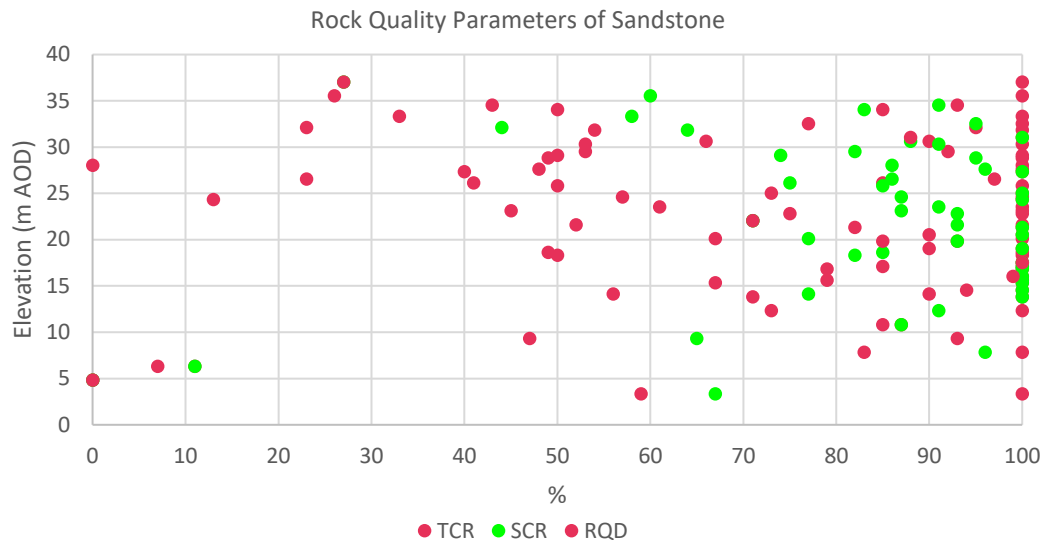
**Figure 6.4a** – Summary of Rock Quality Parameters v. Elevation for Sandstone

Total Core Recovery (TCR) was good, with values generally ranging between 71% and 100%. Lower values of 11% and 0% were recorded between 41.00 – 42.50m bgl and 42.50m – 44.00m bgl in BH01. Solid Core Recovery typically ranged between 27% and 100%, however lower values of 11% and 0% were recorded at 41.00 – 42.50m and 42.50m – 44.00m bgl respectively in BH01. Rock Quality Designation (RQD) recorded in the sandstone cored samples ranged from 13% to 100%, notwithstanding lower values between 41.00 – 42.50m and 42.50 – 44.00m bgl in BH01 (7% and 0%) and at 20.00 – 21.50m bgl in BH101 (0%). The RQD indicates the rock is classified as being of very poor to fair rock mass quality, however locally the rock has good rock mass quality. The Rock Quality Parameters are presented in *Figure 6.4a*.

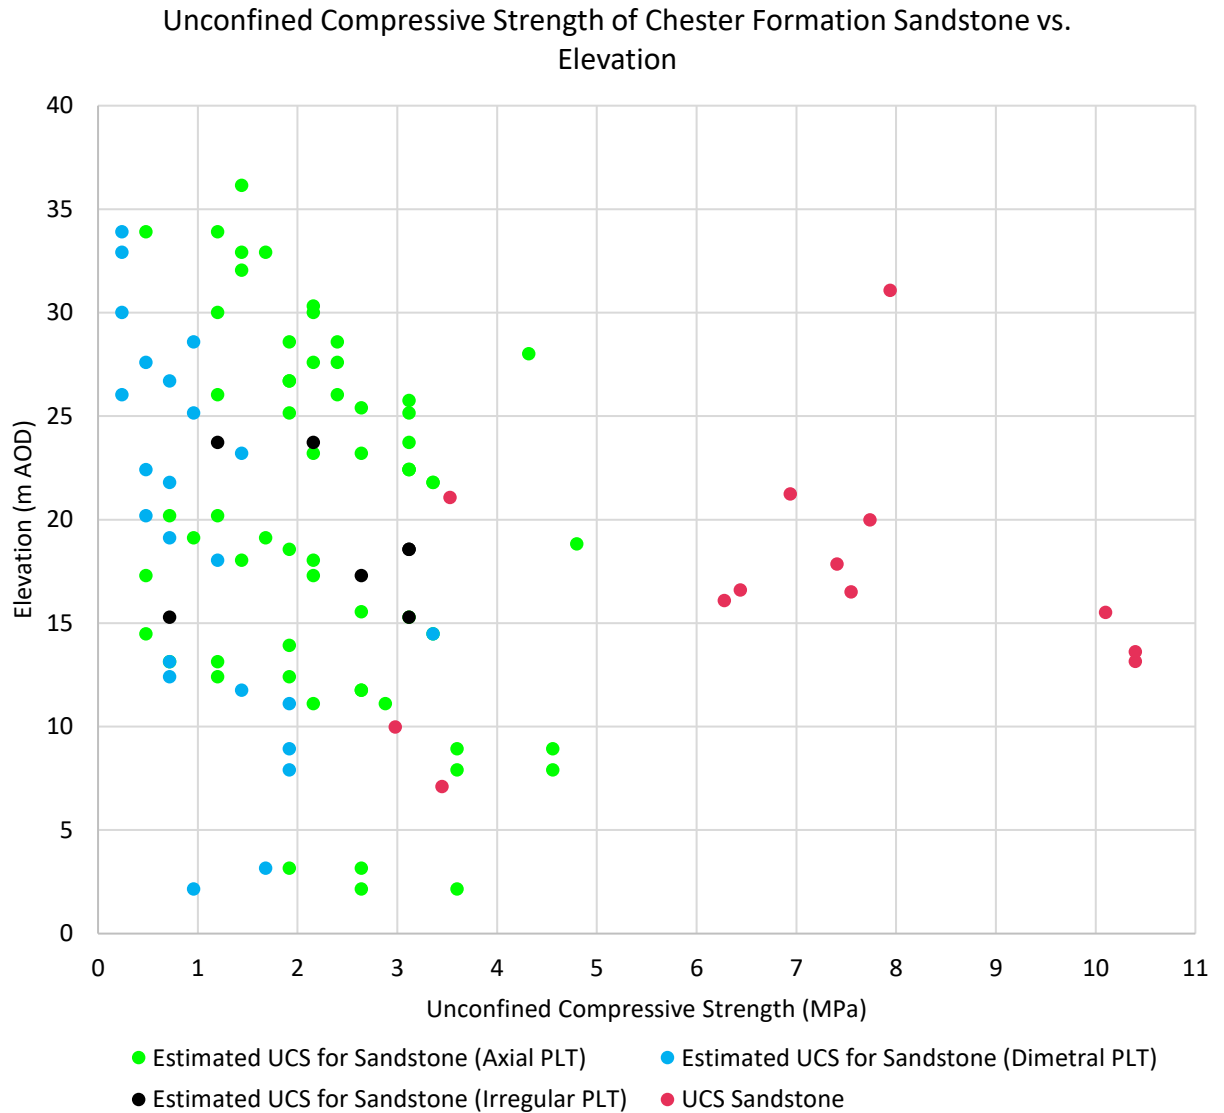
**Figure 6.4b – UCS of Sandstone**

The results of estimated UCS from PLT correlation and UCS testing are shown in *Figure 6.4b*.

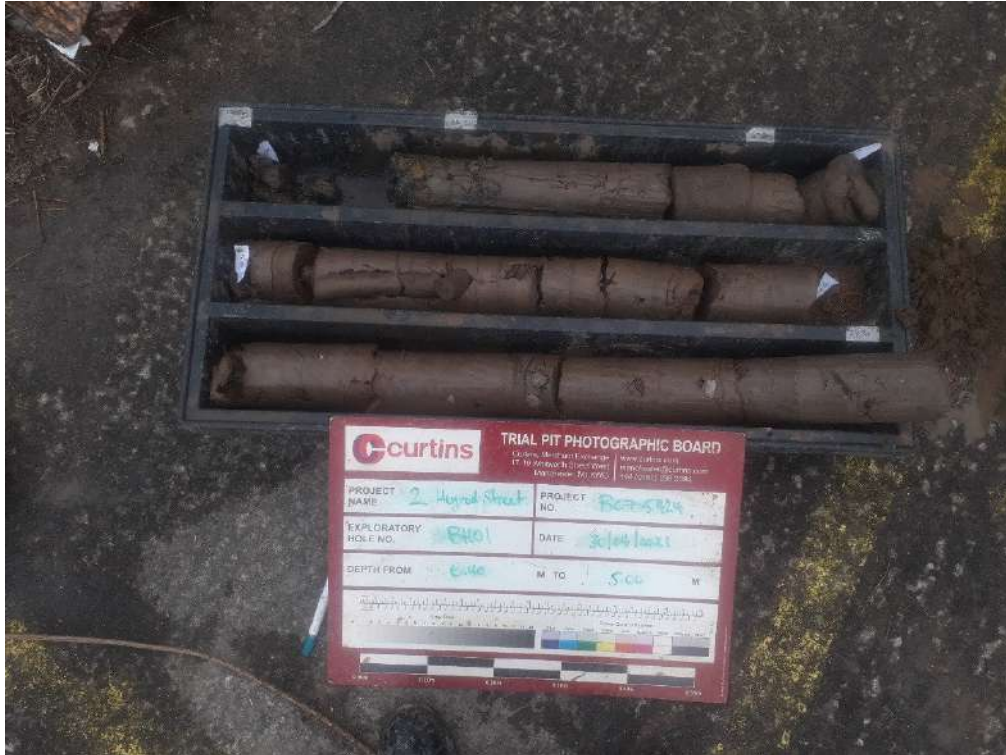
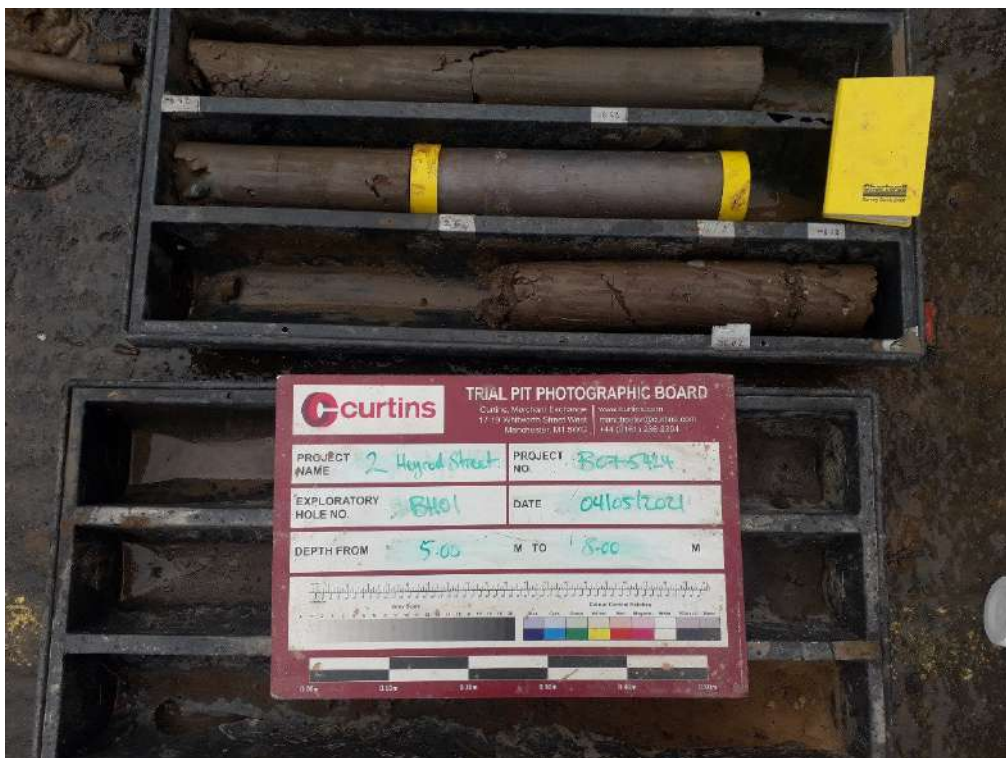
| <b>No.</b><br>1 | <b>Date:</b><br>30/04/2021 to<br>04/05/2021 | <b>Description:</b><br>BH01 Logging Photographs 0.40m to 8.00m bgl. | |

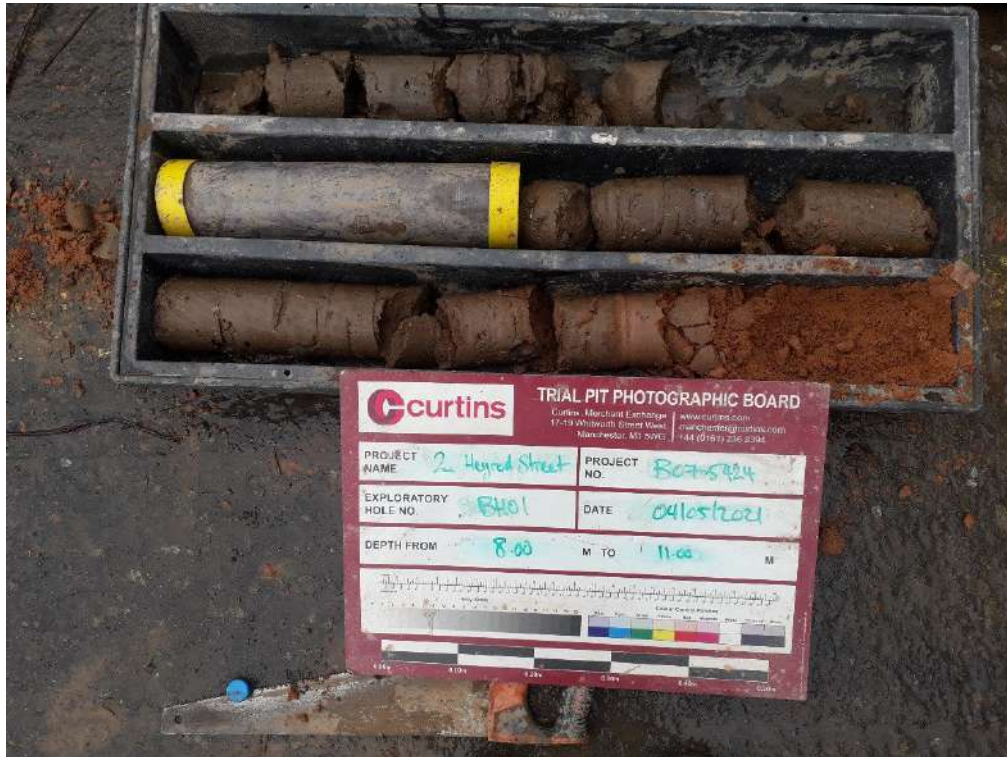
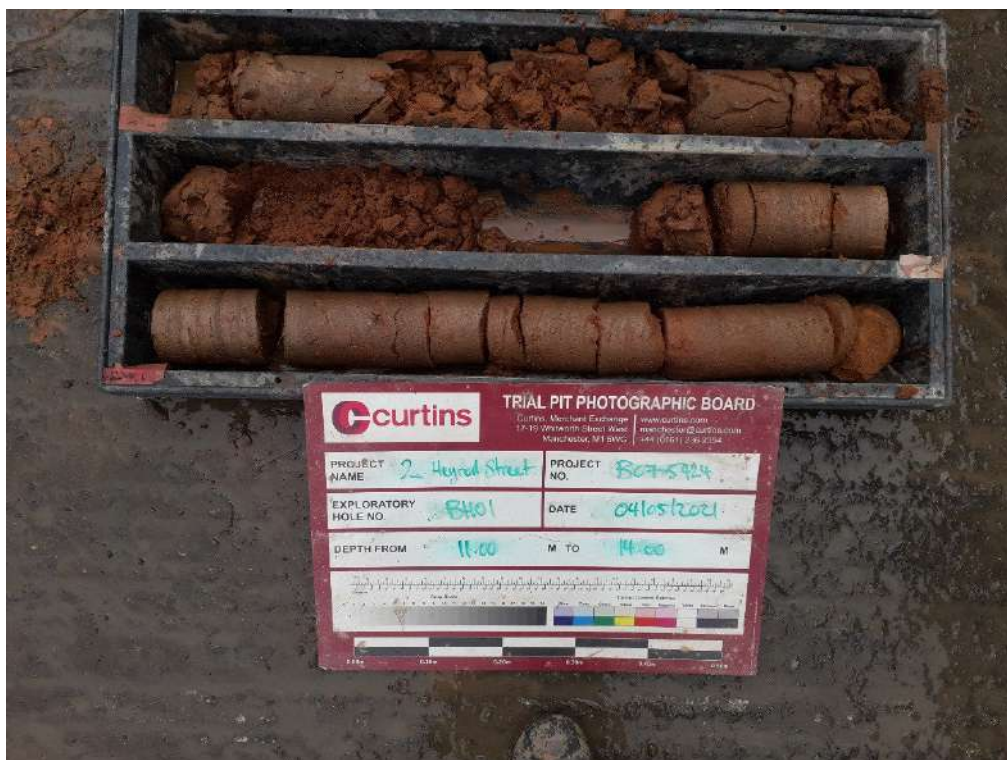
| <b>No.</b><br>2 | <b>Date:</b><br>04/05/2021 | <b>Description:</b><br>BH01 Logging Photographs 8.00m to 14.00m bgl. | |

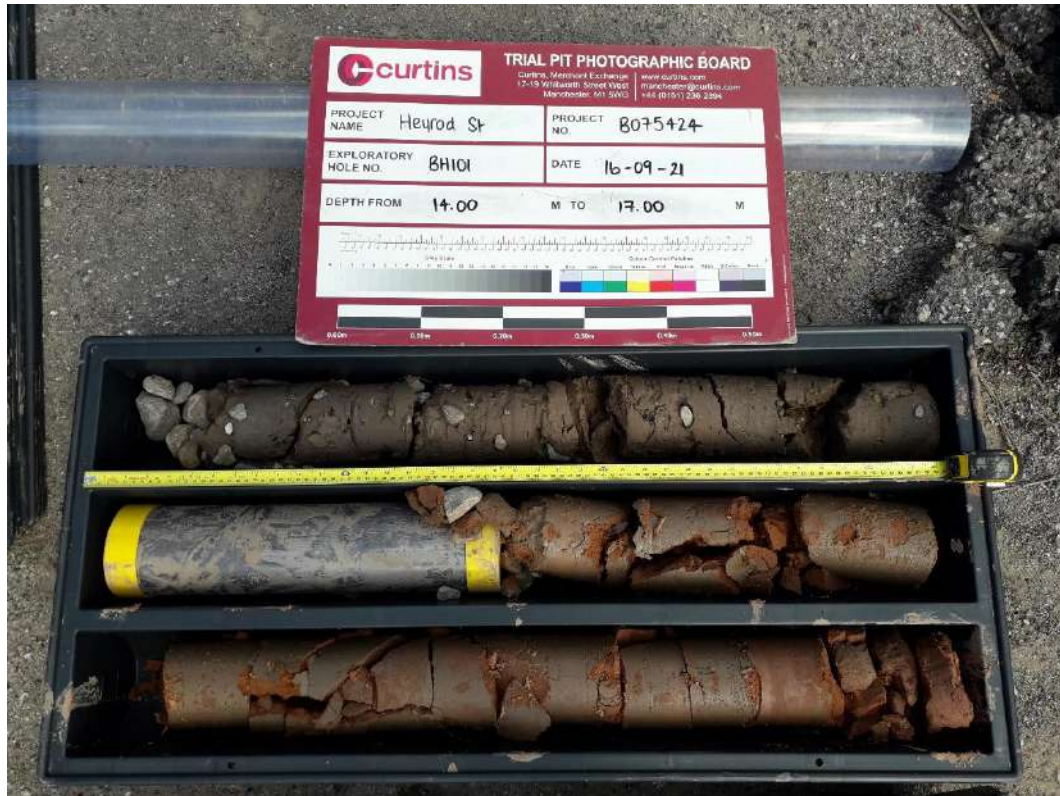
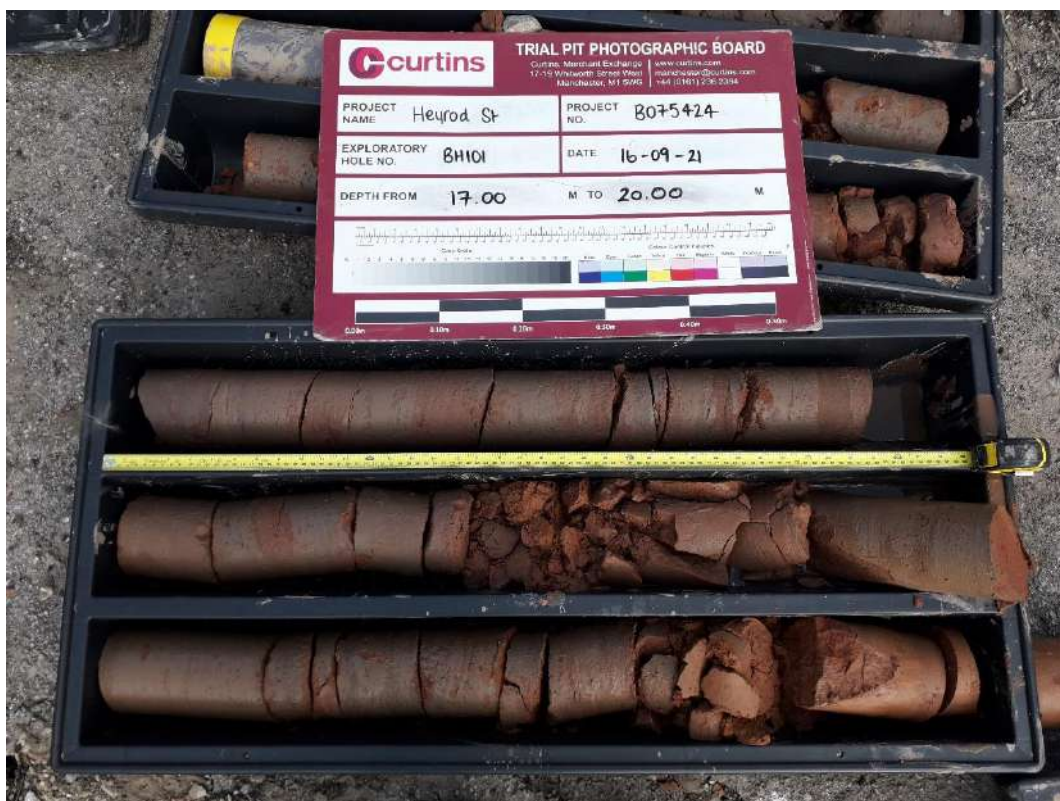
| <b>No.</b><br>1 | <b>Date:</b><br>16/09/2021 | <b>Description:</b><br>BH101 Rock Logging Photographs 14.00m to 20.00m bgl. | |

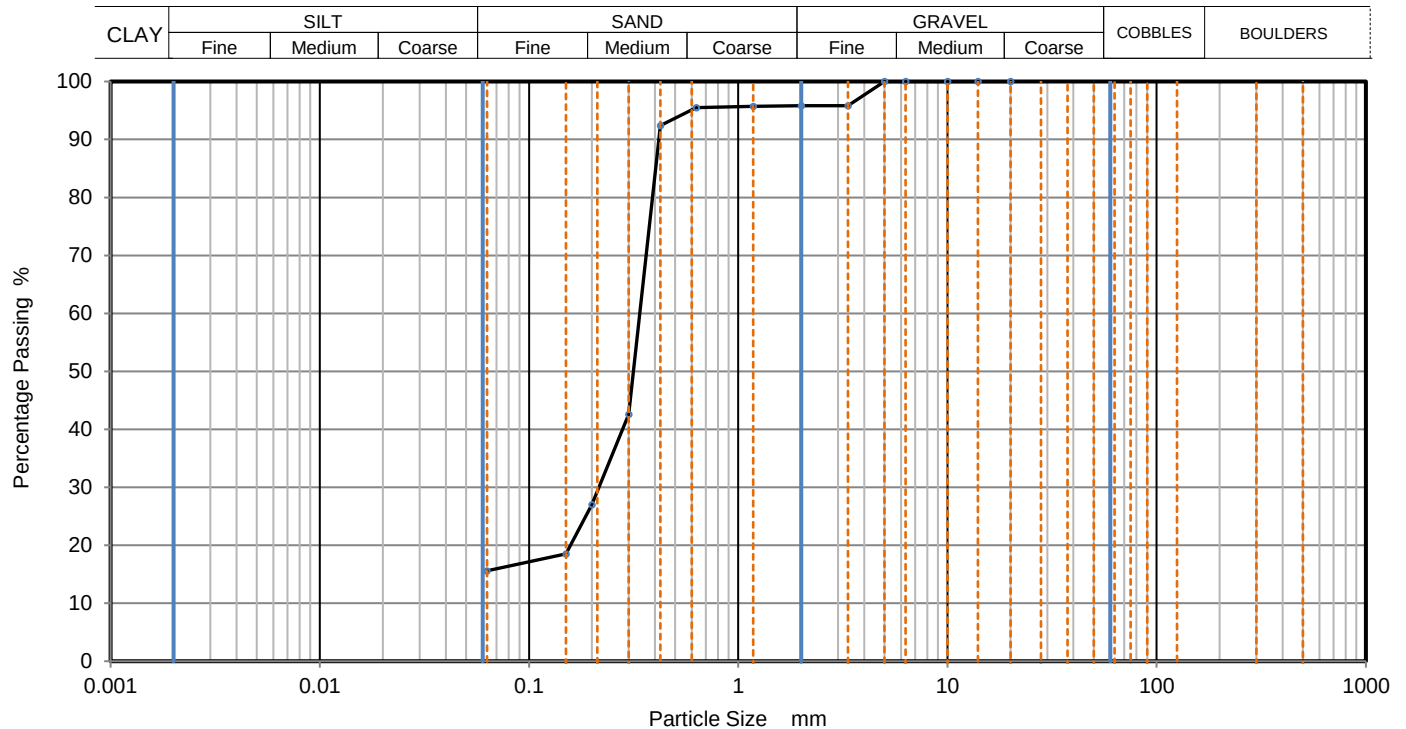
| Borehole / Trial Pit | Depth (m) | Sample | Testing Type | Description |
|---|---|---|---|---|
| BH01 | 11.00 | B3 | Wet Sieve | Brown silty SAND |

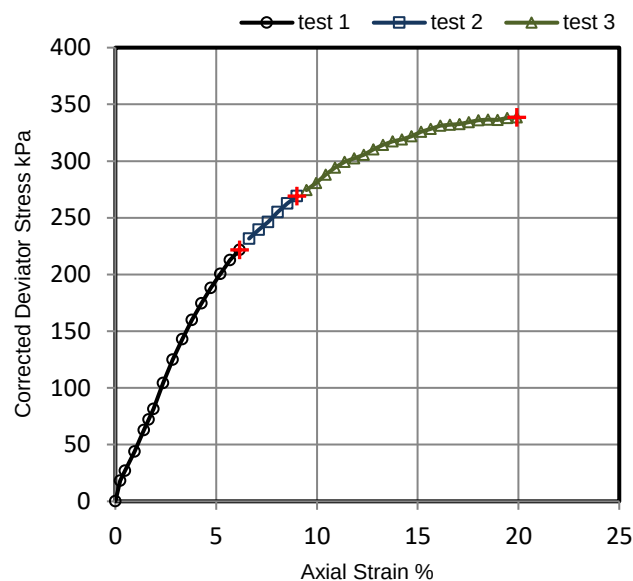
**Deviator Stress v Axial Strain**

$c_u$  73 kPa

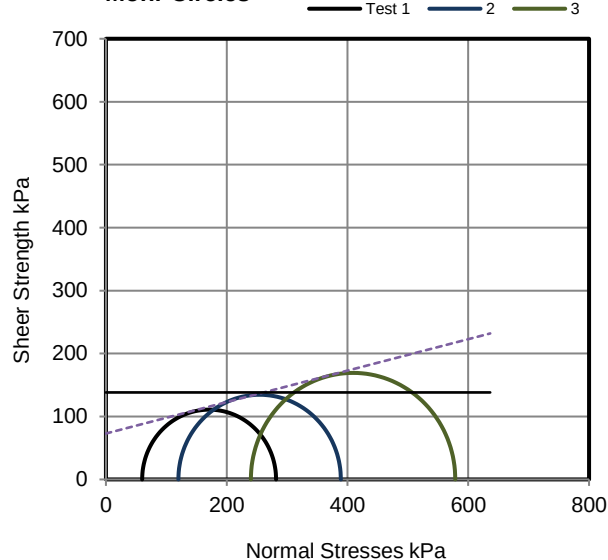
**Mohr Circles**

Mohr circles and their interpretation is not covered by BS1377. These are provided for information only.

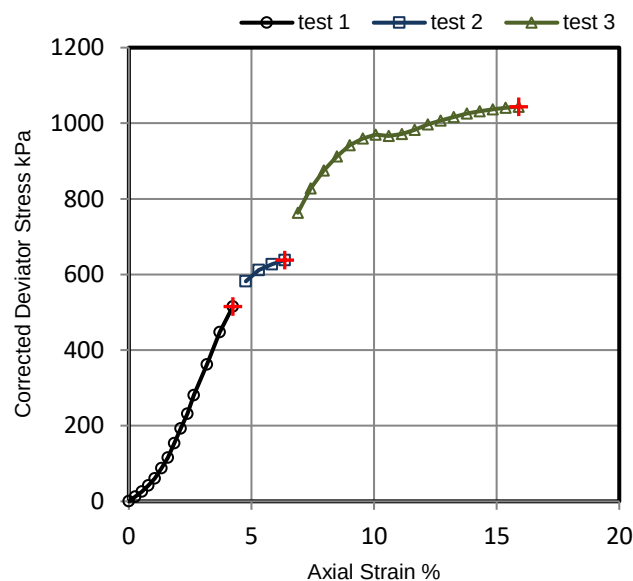
**Deviator Stress v Axial Strain**

$c_u$  96 kPa

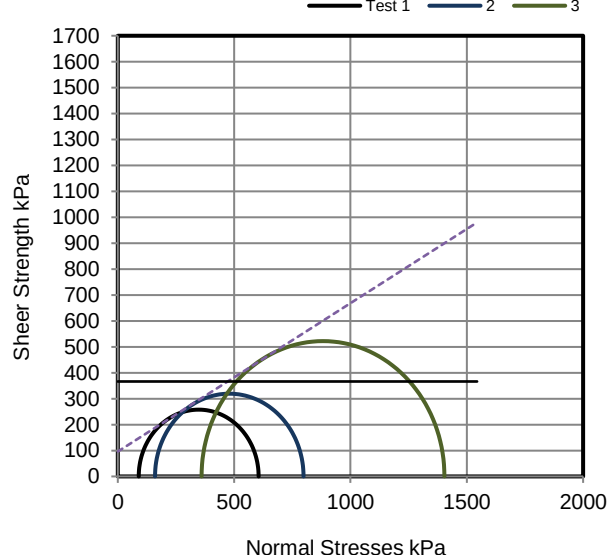
**Mohr Circles**

Mohr circles and their interpretation is not covered by BS1377. These are provided for information only.

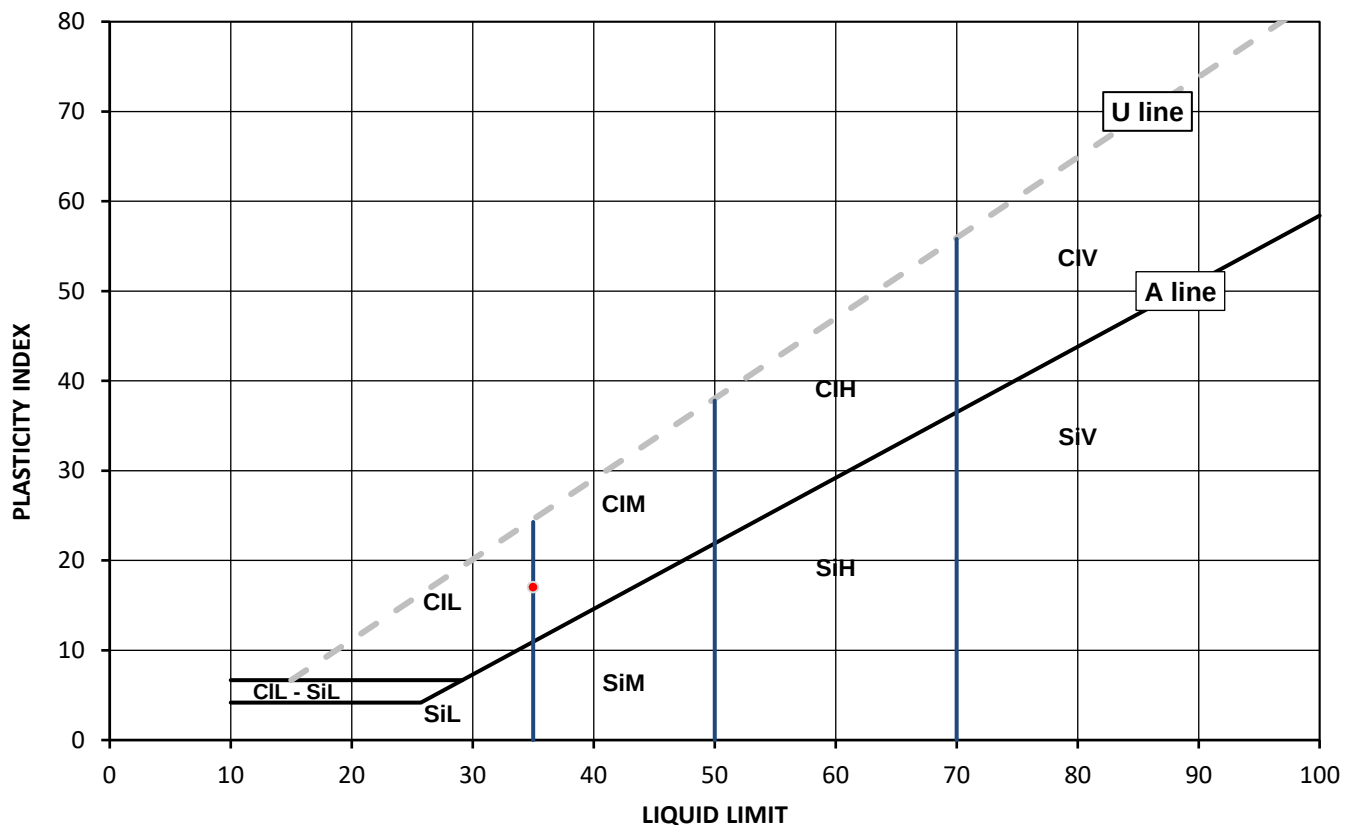
| As Received Moisture Content [ W ] % | Liquid Limit [ WL ] % | Plastic Limit [ Wp ] % | Plasticity Index [ Ip ] % | % Passing 425µm BS Test Sieve |
|---|---|---|---|---|
| 16 | 35 | 18 | 17 | 91 |

Legend, based on BS EN ISO 14688 2:2018 Geotechnical investigation and testing – Identification and classification of soil

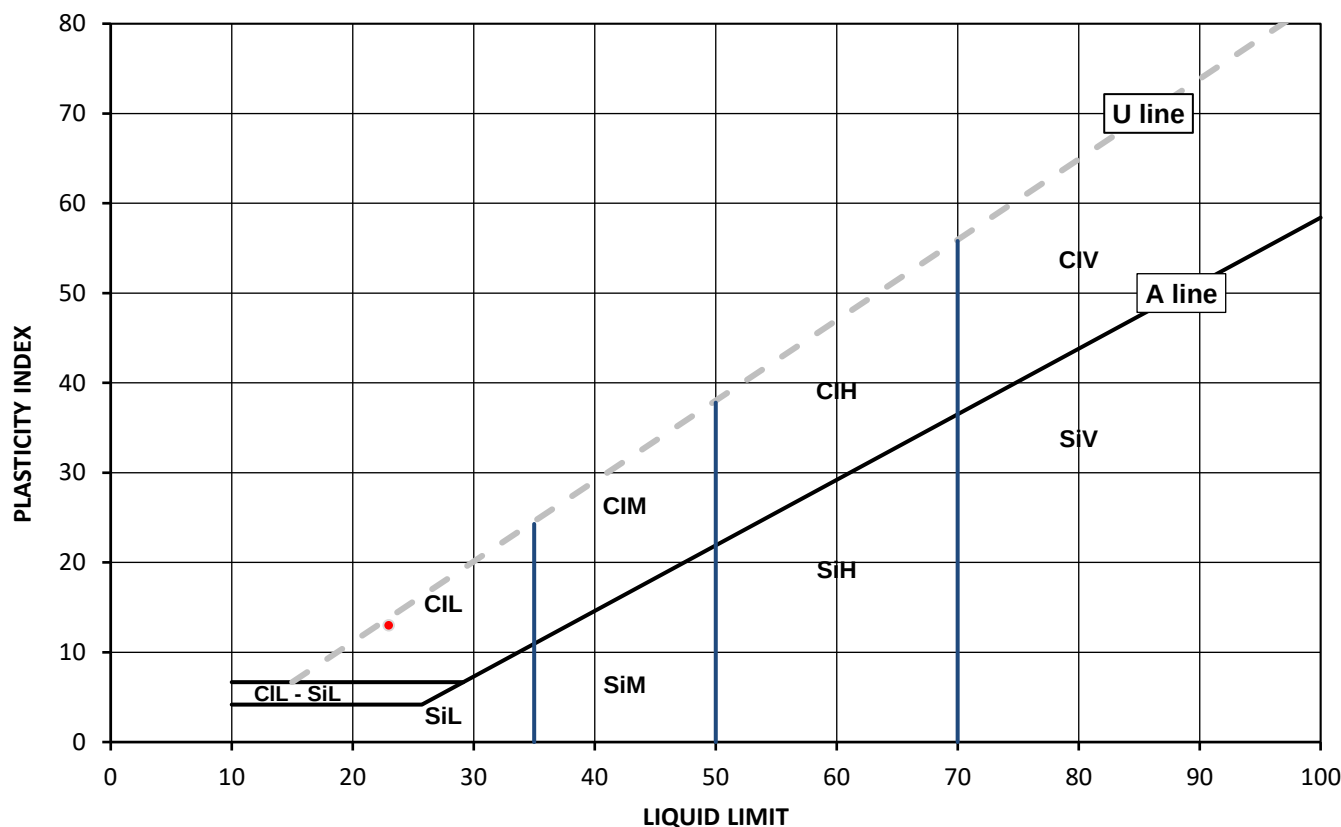
| As Received Moisture Content [ W ] % | Liquid Limit [ WL ] % | Plastic Limit [ Wp ] % | Plasticity Index [ Ip ] % | % Passing 425µm BS Test Sieve |
| 11 | 23 | 10 | 13 | 91 |

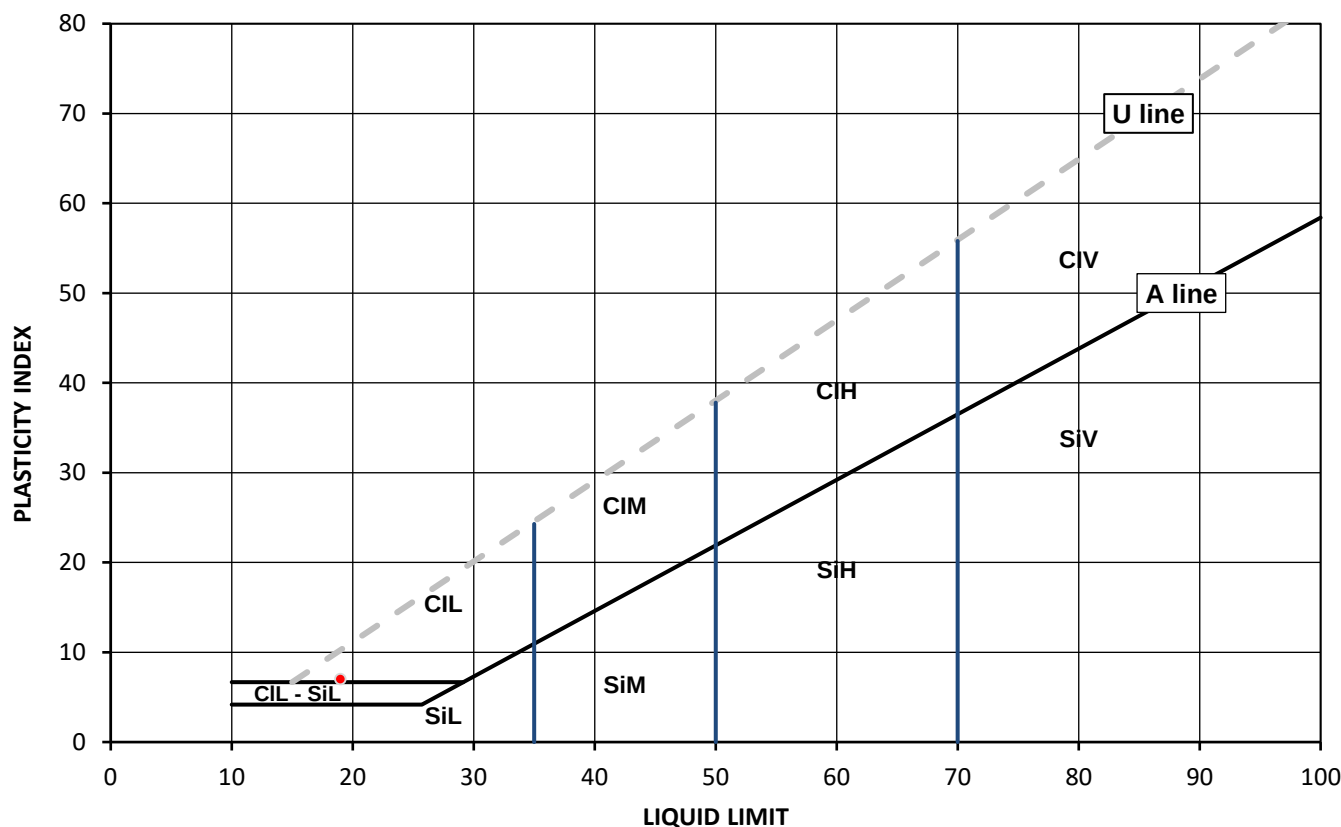
| As Received Moisture Content [ W ] % | Liquid Limit [ WL ] % | Plastic Limit [ Wp ] % | Plasticity Index [ Ip ] % | % Passing 425µm BS Test Sieve |
| 6.1 | 19 | 12 | 7 | 87 |

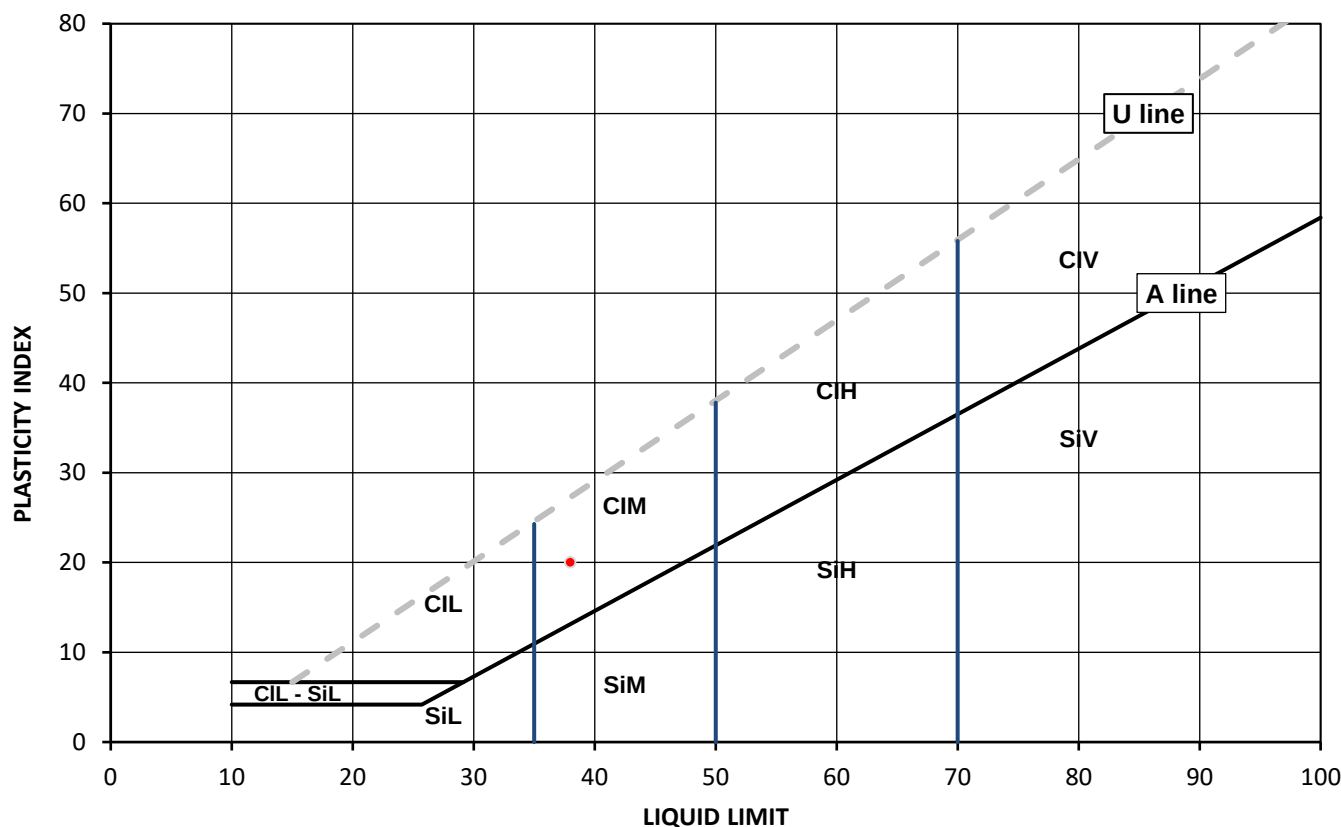
| As Received Moisture Content [ W ] % | Liquid Limit [ WL ] % | Plastic Limit [ Wp ] % | Plasticity Index [ Ip ] % | % Passing 425µm BS Test Sieve |
| 18 | 38 | 18 | 20 | 99 |

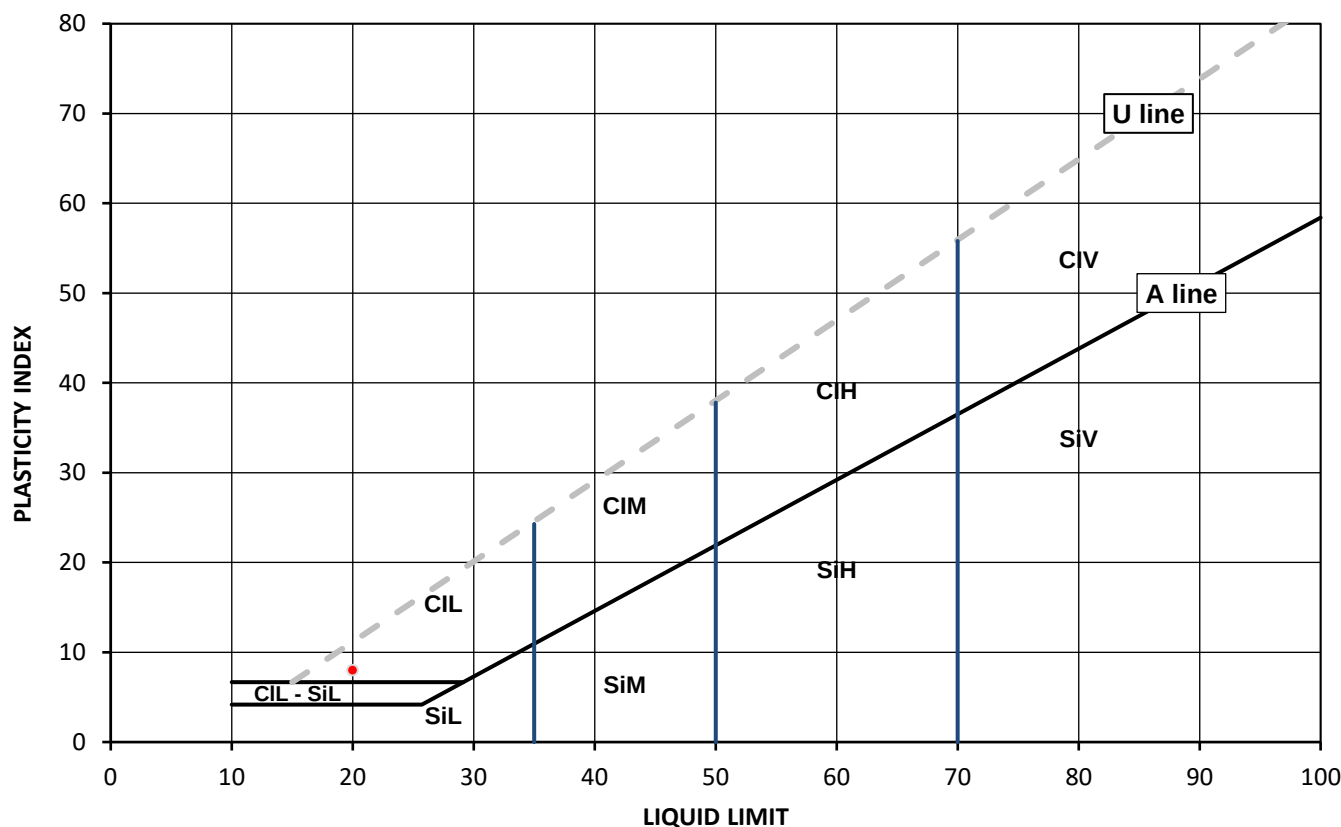
| As Received Moisture Content [ W ] % | Liquid Limit [ WL ] % | Plastic Limit [ Wp ] % | Plasticity Index [ Ip ] % | % Passing 425µm BS Test Sieve |
| 8.9 | 20 | 12 | 8 | 99 |

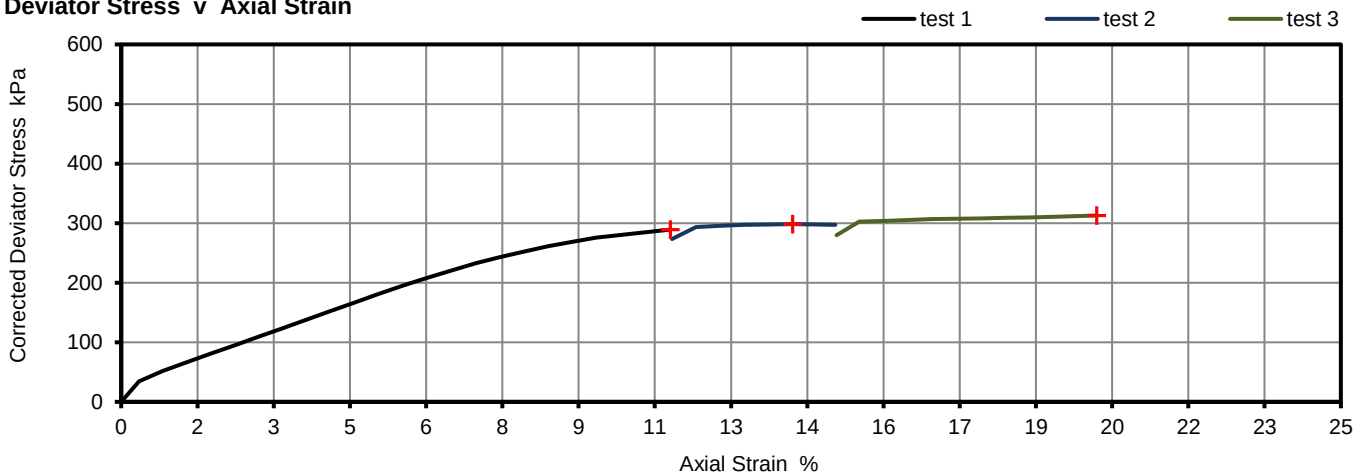
**Deviator Stress v Axial Strain**

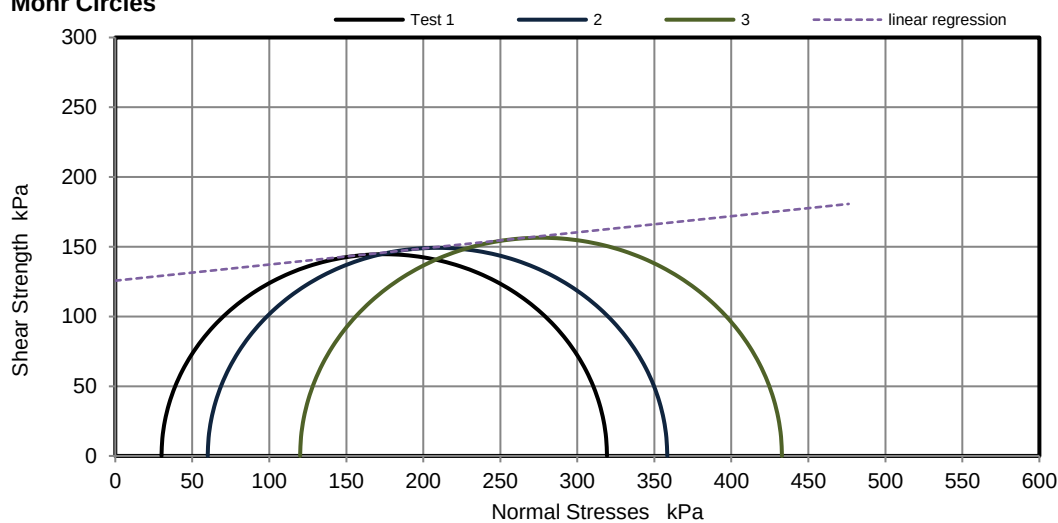
**Mohr Circles**

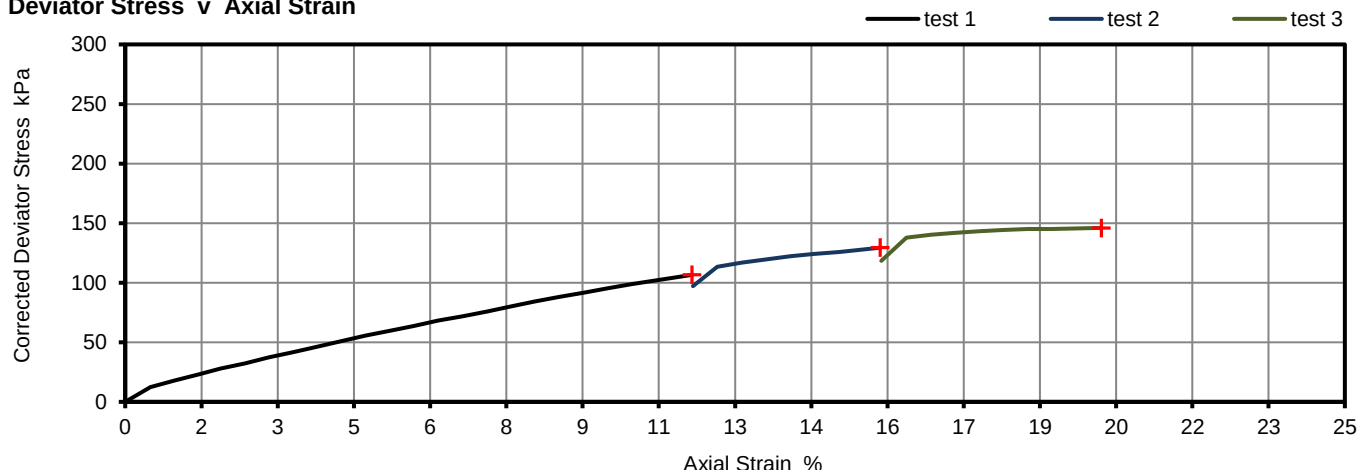
### Deviator Stress v Axial Strain
