# Heyrod Street

## Phase 2 Ground Investigation

Curtins Ref: 075424-CUR-00-XX-RP-GE-003

Issue Date: 29 October 2021

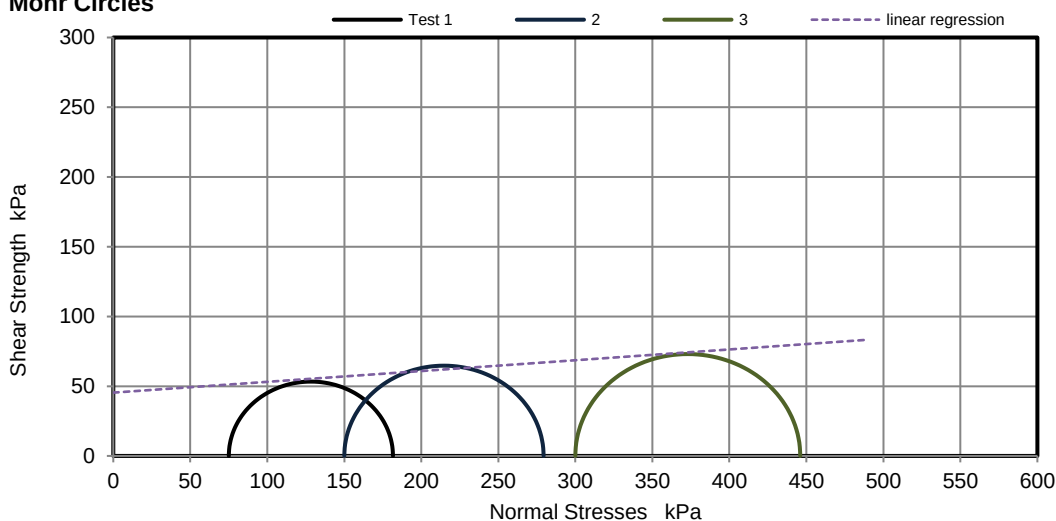
### Mohr Circles

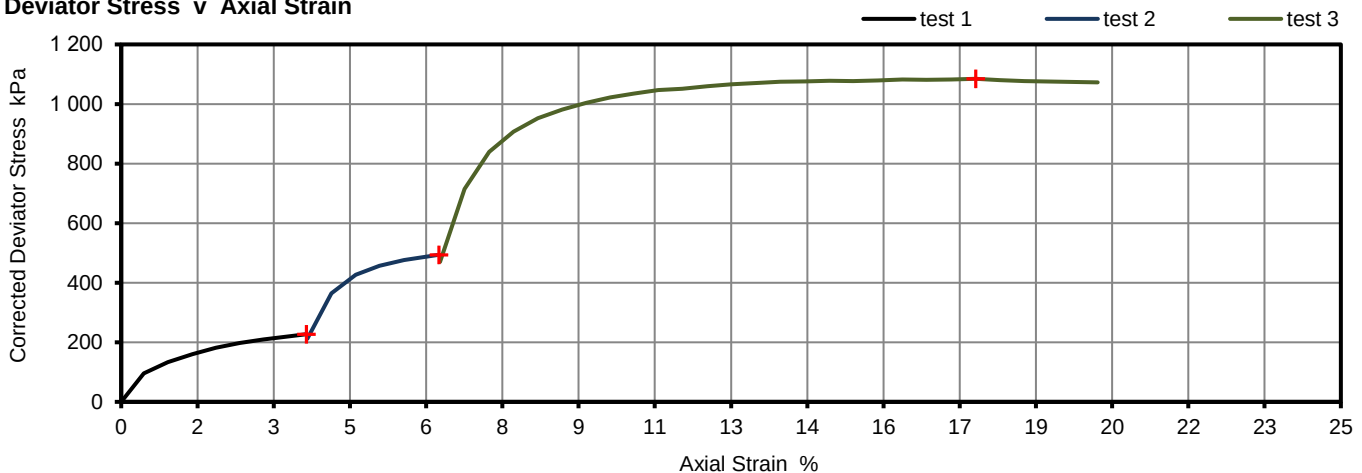
### Deviator Stress v Axial Strain

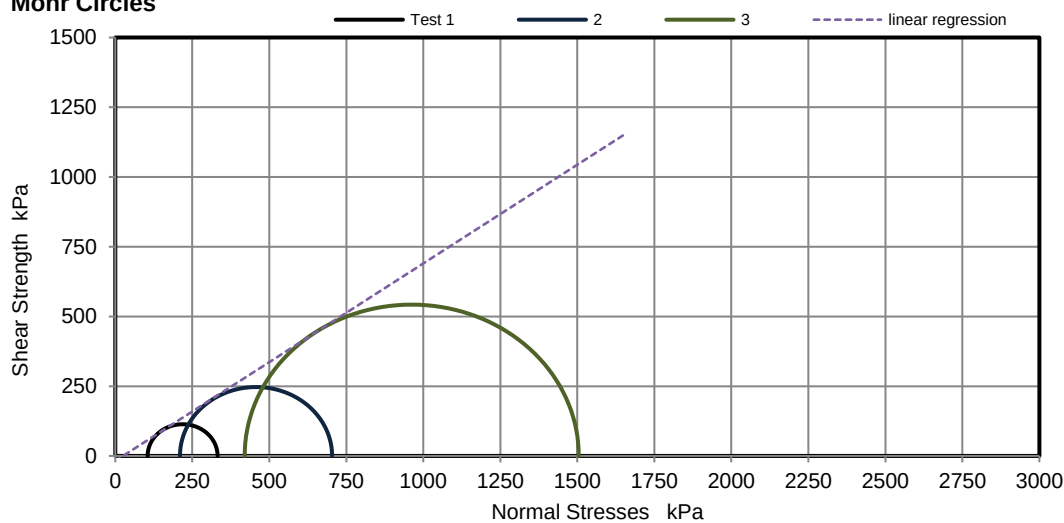
### Mohr Circles
