# **New Park House Phase 2 Ground Investigation**

## Phase 2 Ground Investigation

Curtins Ref: NMGNPH-CUR-VV-XX-RP-C-0002

Site Address: North Manchester General Hospital, Ellis Drive, Crumpsall, M8 5RL

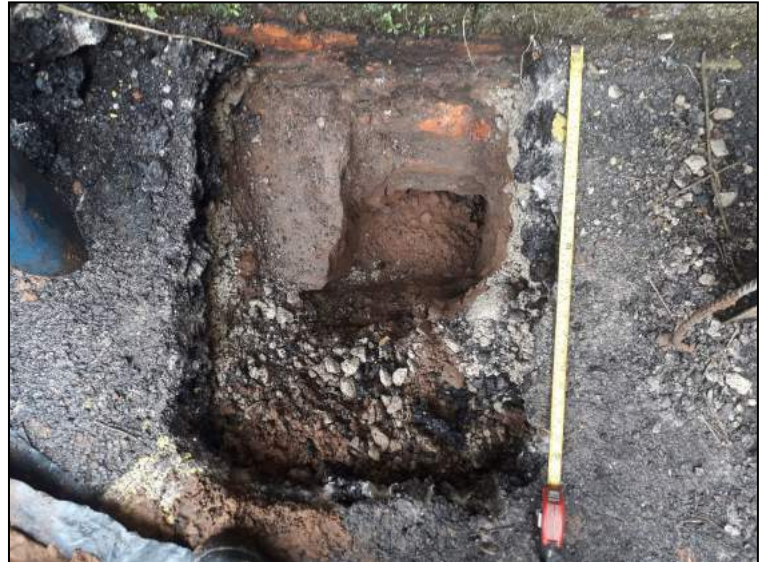
**HP01**

Not to scale.

Hand dug trial pits logs should be read in conjunction with cross section sketches for each location, detailing the foundations encountered, both of which are enclosed in Appendix B.

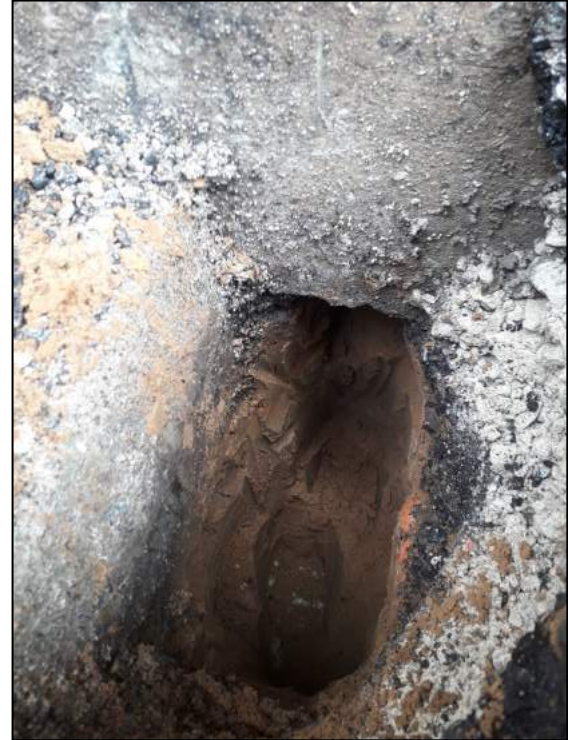
**HP02A**

Terminated at 0.70m bgl due to base of foundation being encountered

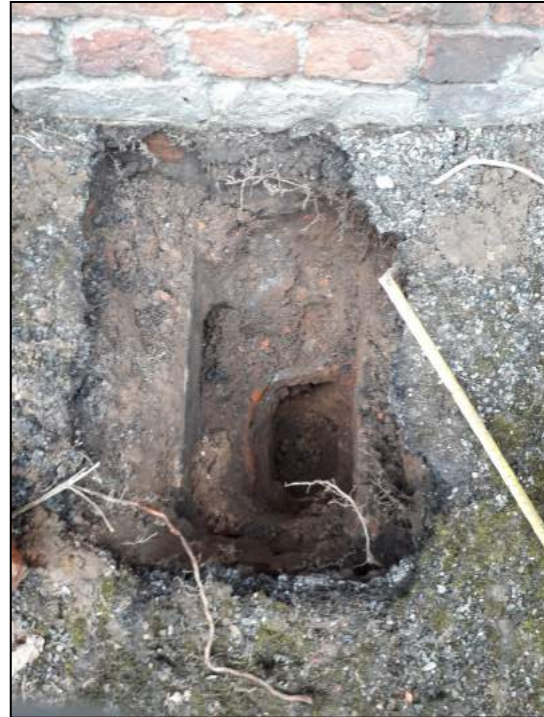
## HP05

Terminated at 0.70m bgl due to base of foundation being encountered
