70655/lt02

## **23 Crimsworth Avenue, Chorlton: Foundation and Slope Advice**

**FACTUAL REPORT ON  
GROUND INVESTIGATION  
AT  
23A CRIMSWORTH AVENUE,  
CHORLTON**

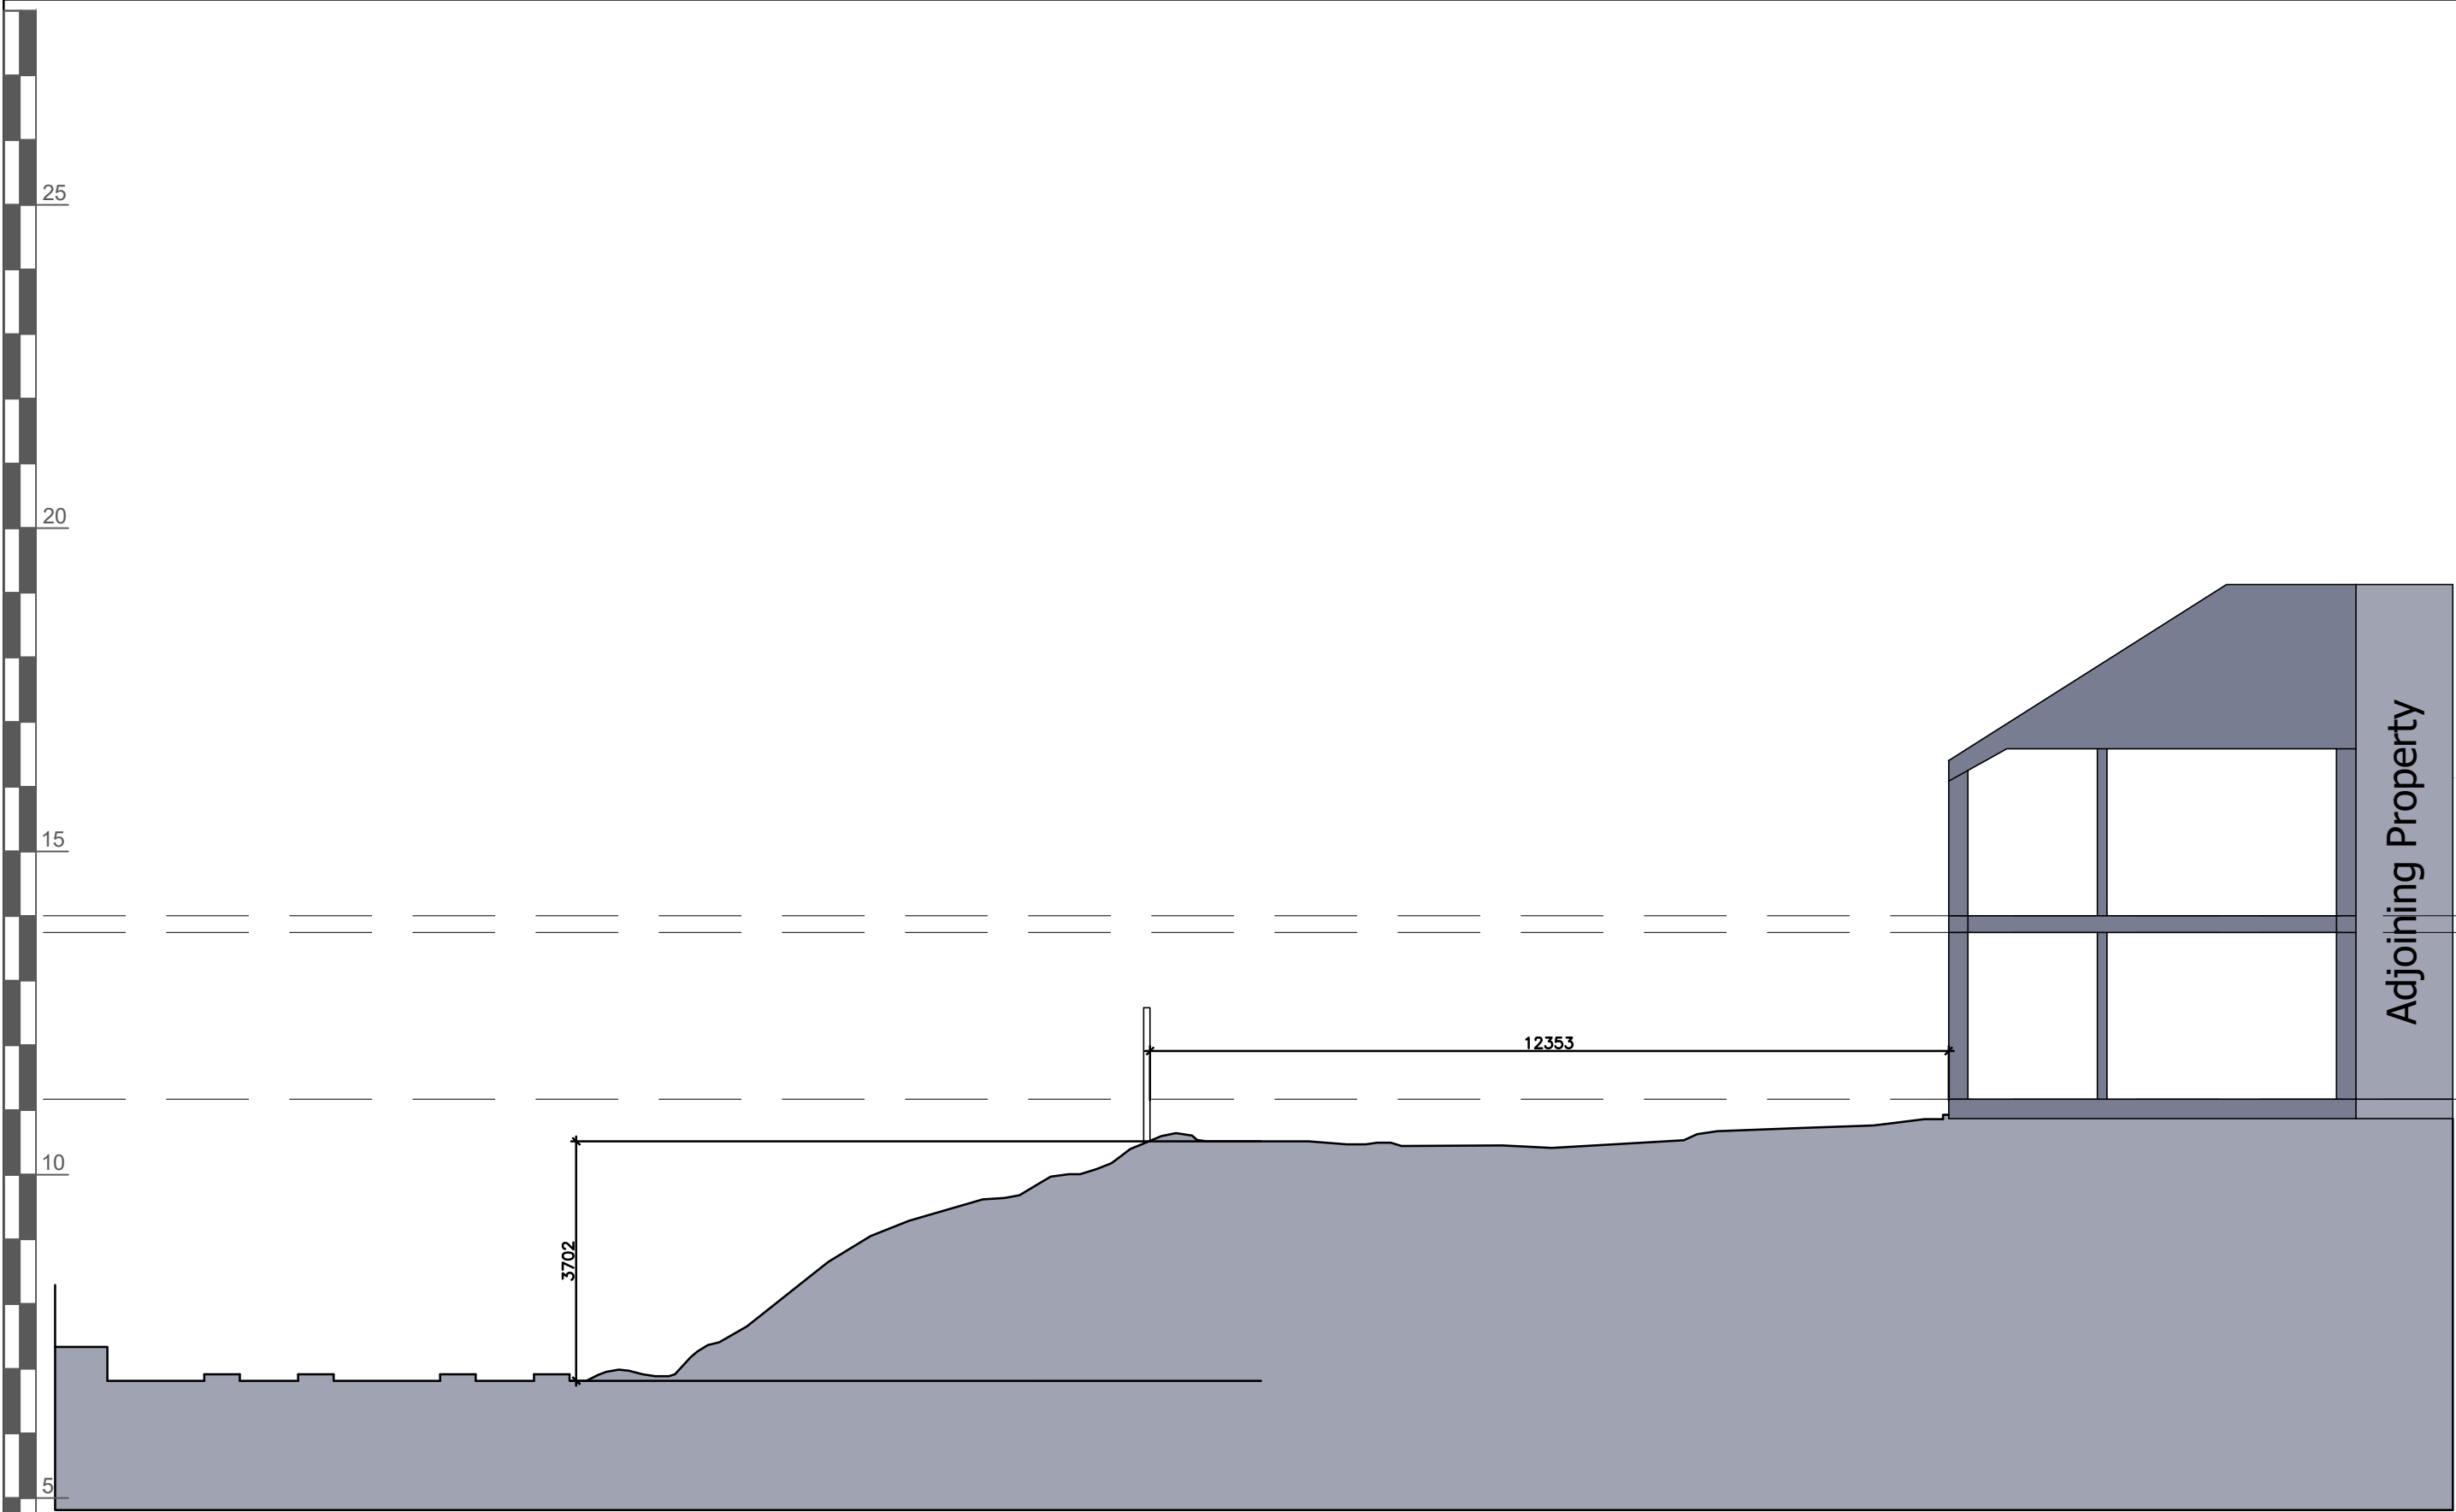
# SITE SECTION

**EXISTING SITE SECTION**  
July 2021 By CQ Scale 1:100@A3 [L]

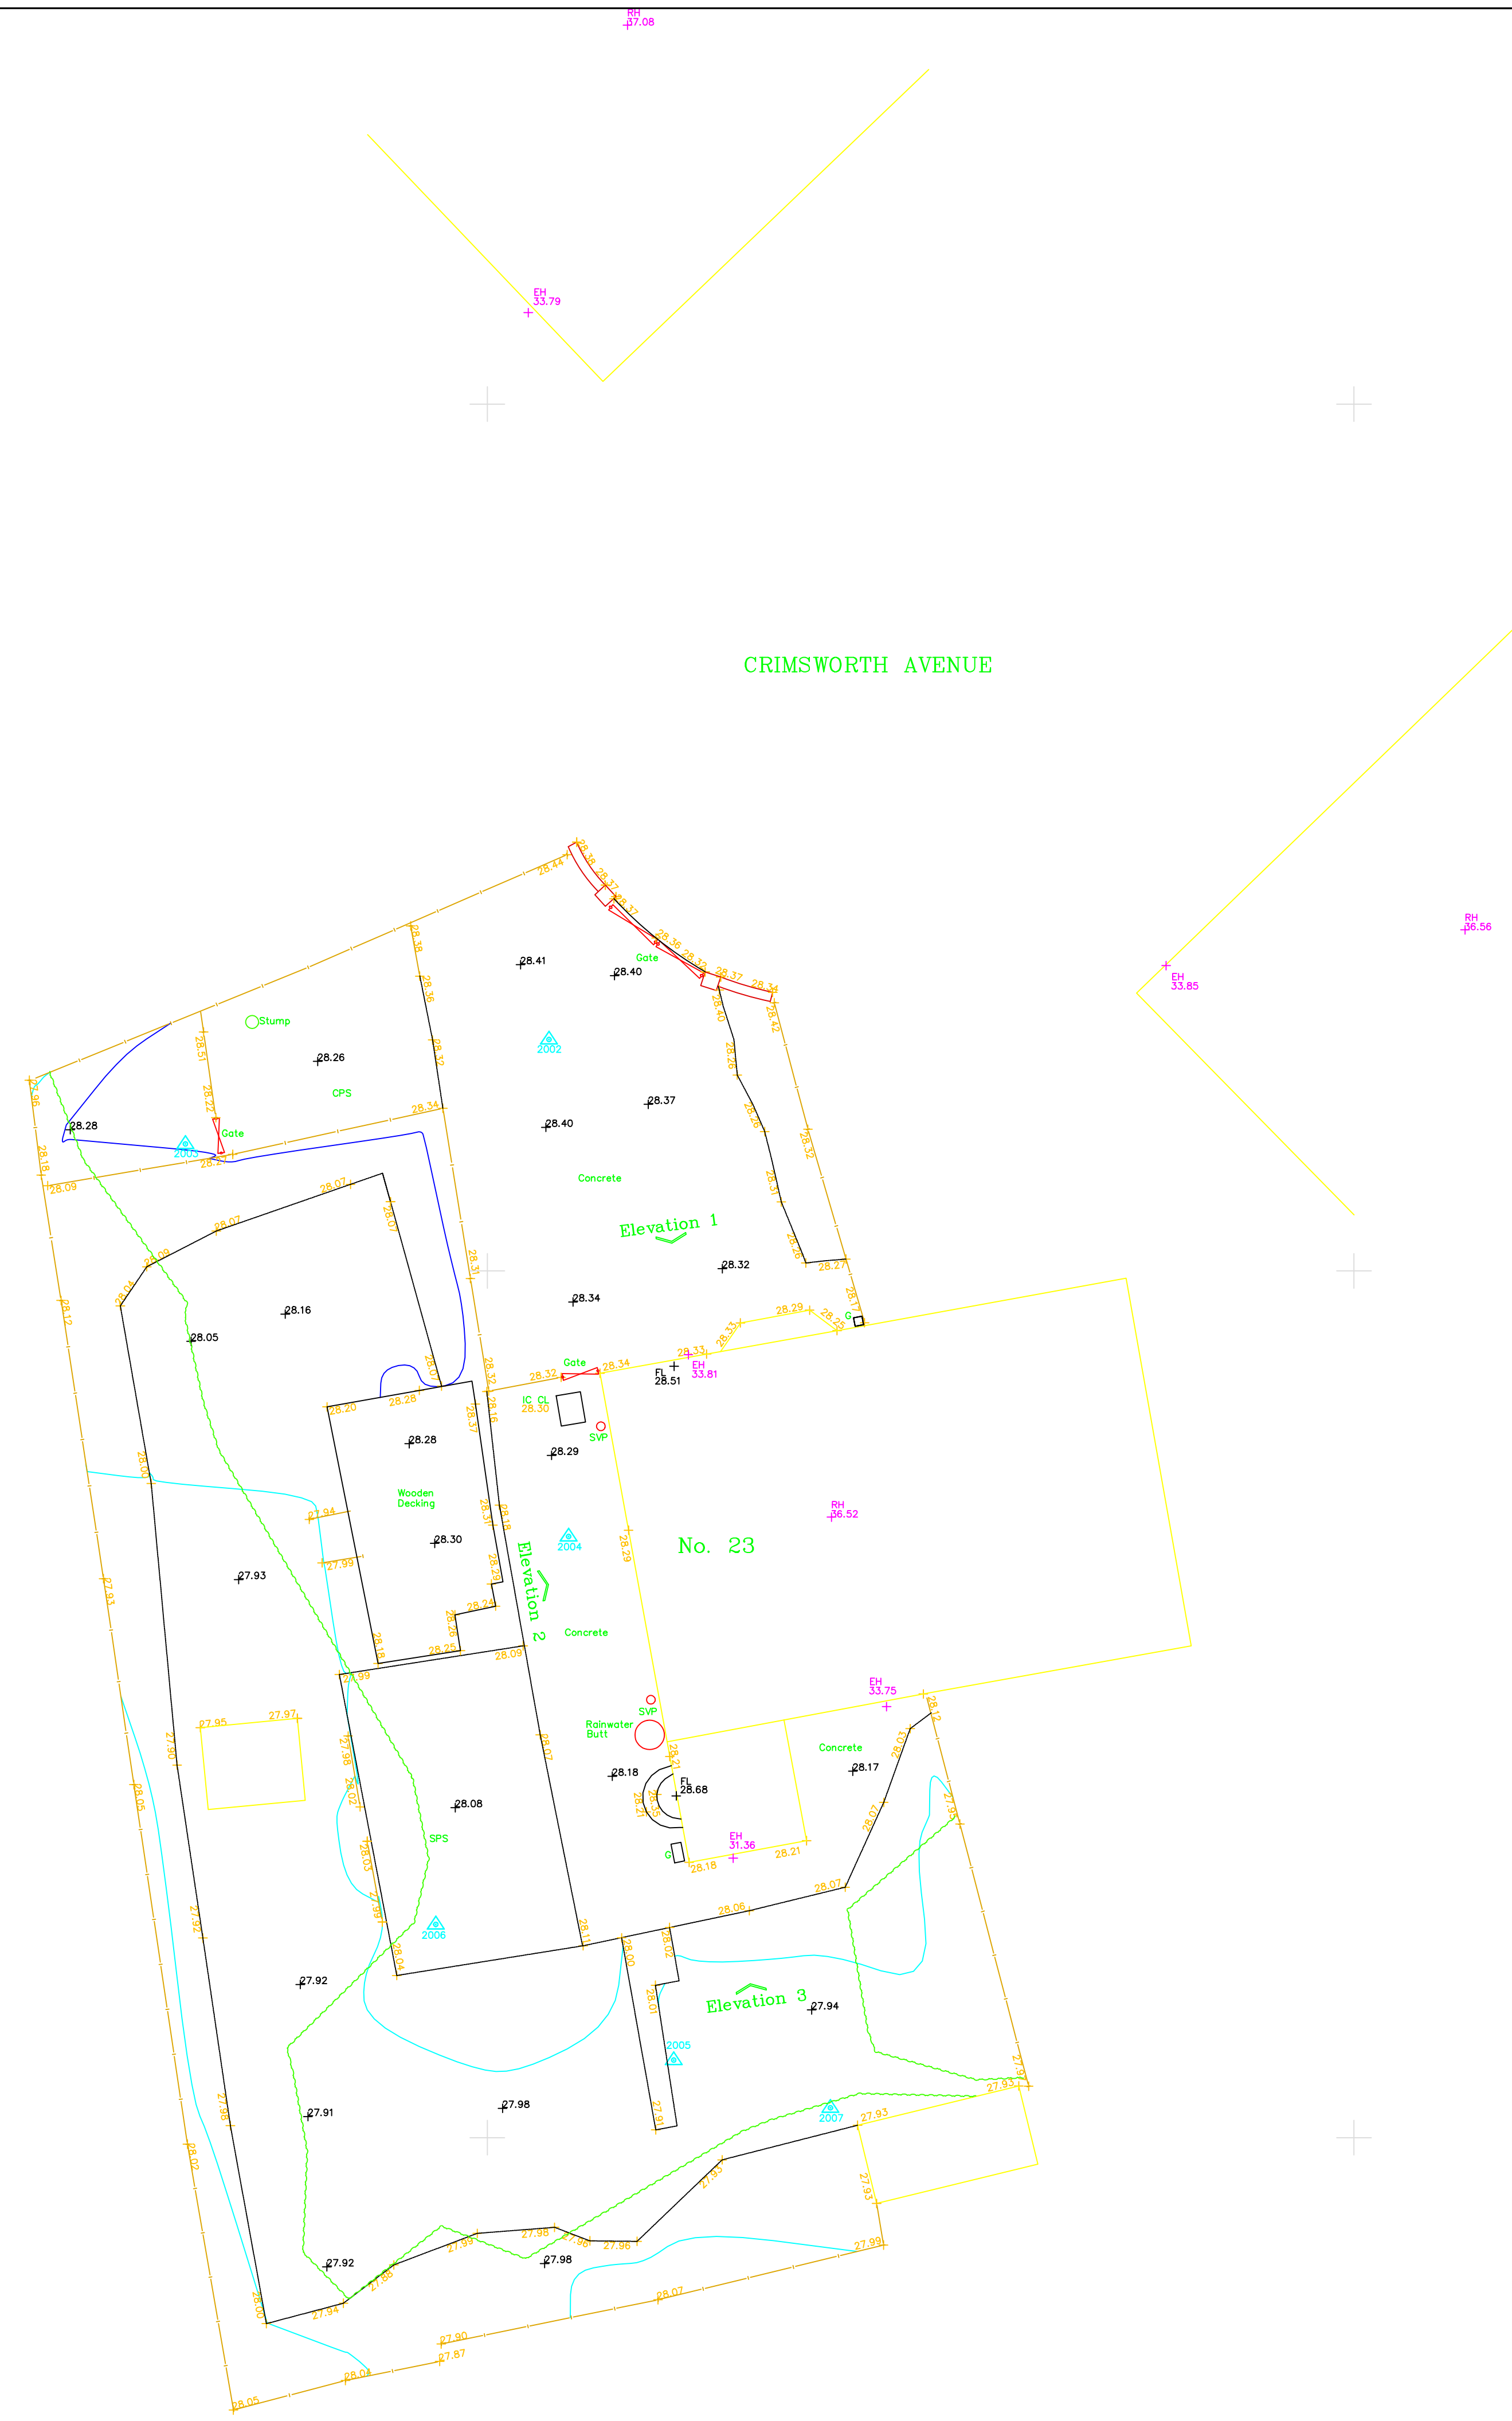
| Drawing Title | | |
|---|---|---|
| TOPOGRAPHICAL SURVEY | | |

Survey Information  
The survey has been orientated to Ordnance Survey National Grid and datum using one central control station. No Scale Factor has been applied to the coordinates meaning that the survey is arbitrary and not true Ordnance Survey Coordinates.

a topographical survey Drawing ref: 02492/01 produced by Geomatic Surveys Ltd, dated September 2020. The location is shown on Drawing No. AG3278-21-02 in Appendix A, which is based on this topographical survey drawing.

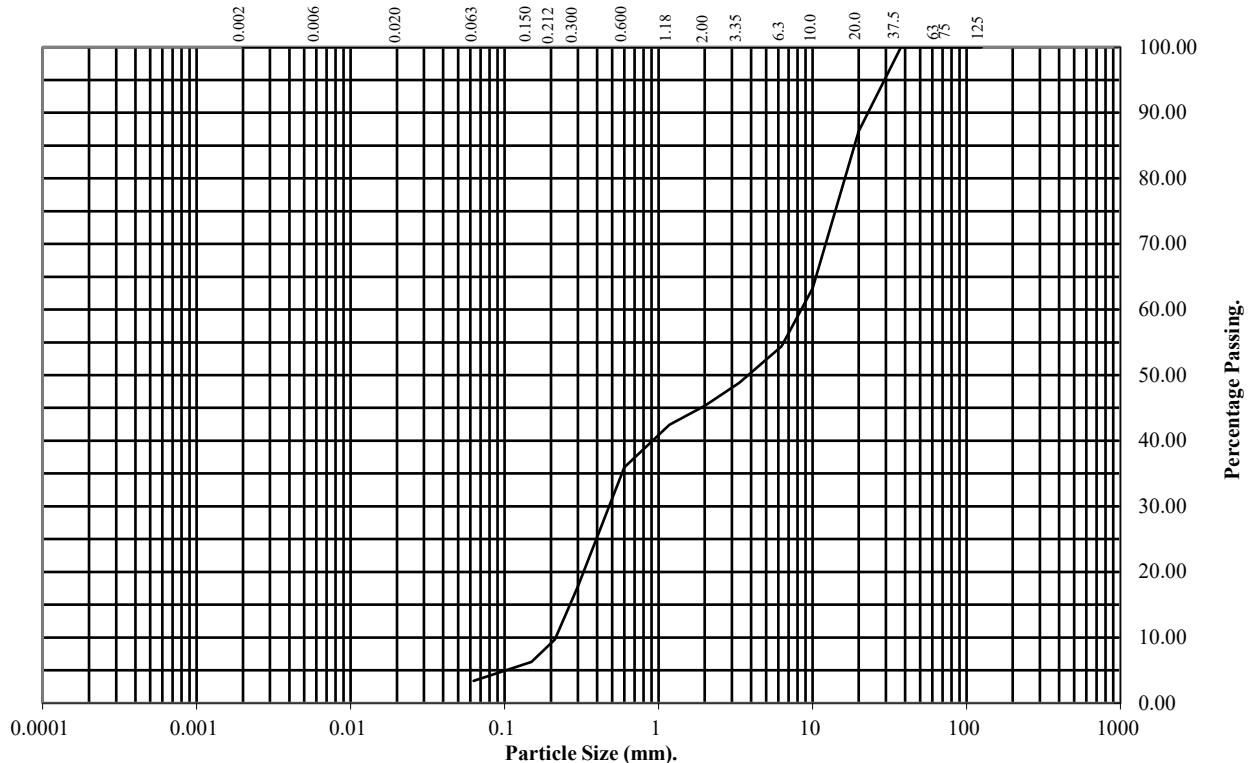
Sample Number: Base Depth(m): 2.45

Sample Type: B

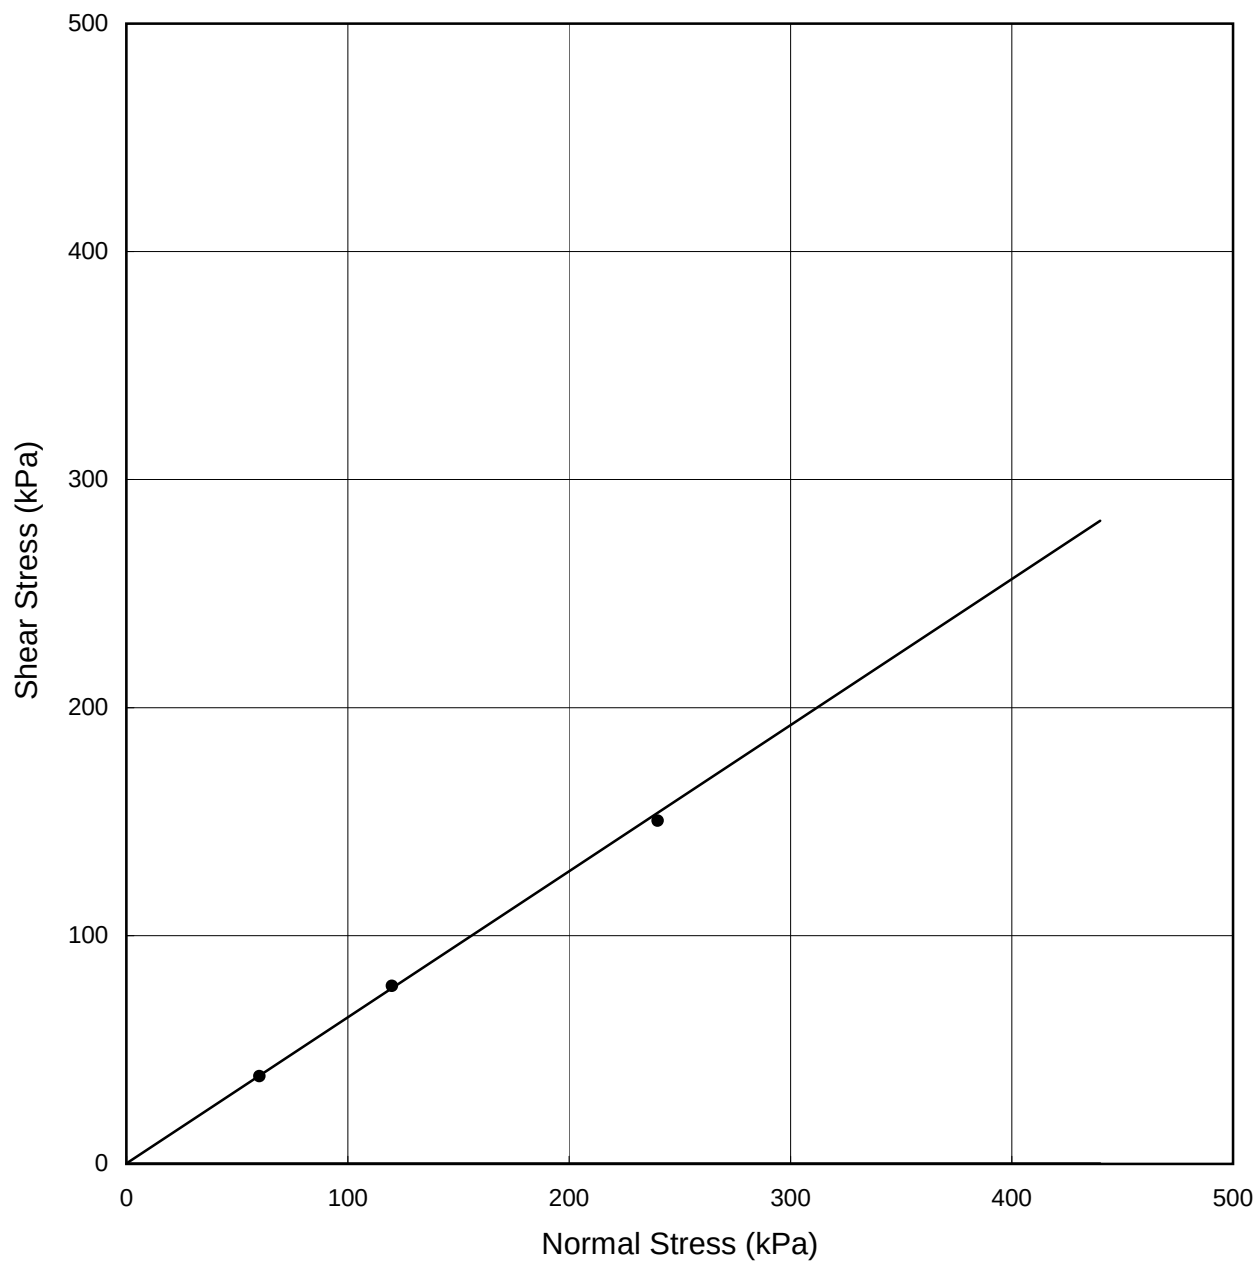
## Shear Stress v Normal Stress

## Shear Strength Parameters

$c' = 0$  kPa $\phi' = 32.5^\circ$

The effective shear strength parameters for the Glacial Till are conservative given its low plasticity index, which are suggestive of  $\phi' = 30^\circ$ .
