## Wythenshaw Hall – Bar and Tenant Hall areas Paint Analysis

### **Report on Findings** Report No HPMWH02

ISSUE 01– 25/10/2021

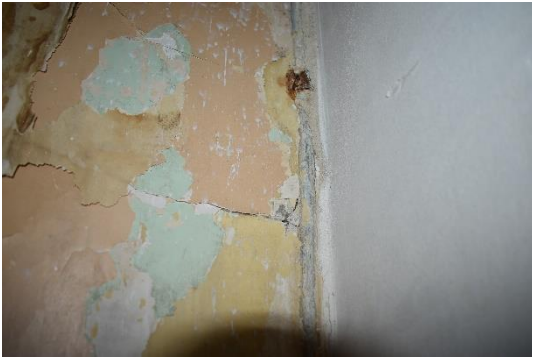
| Sample Ref:W1 | Location: Wythenshaw Hall |
|---|---|
| <p>Paint sample removed from:</p> <p>Location: W1 (Wall area)<br/>The sample was covered by wallpaper which was partly detached.</p> <p>13 decorative layers are visible in the sample.</p> | |

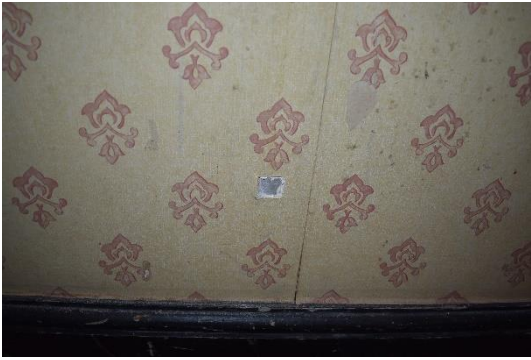
| Sample Ref:W2 | Location: Wythenshaw Hall |
|---|---|
| <p>Paint sample removed from:</p> <p>Location: W2 (Wall area)</p> <p>12 layers are present in the sample.</p> | |

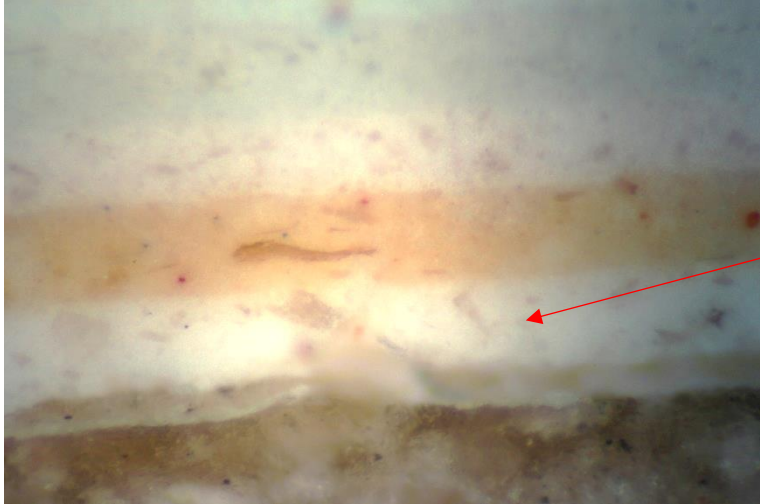
| Sample Ref:W2 | Location: Wythenshaw Hall |
|---|---|
| | <p>X400 -</p> <p>Earliest paint layers.</p> <p>Earliest paint scheme – white paint based on lead carbonate.</p> <p>(Note: the sample is similar to ample W1 however it is missing the earliest layers present in that sample).</p> |

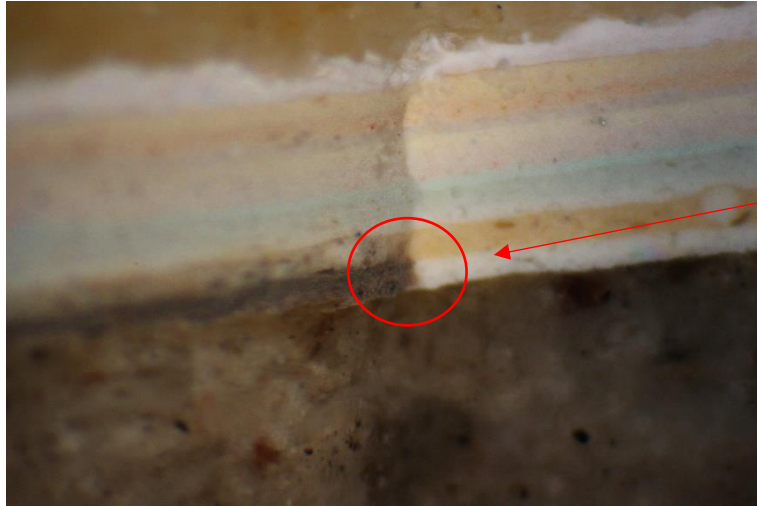
X100 – schemes tested for lead.

The earliest schemes test positive

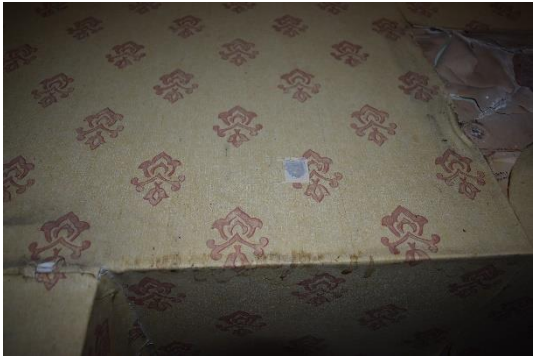
| Sample Ref:W3 | Location: Wythenshaw Hall |
|---|---|
| <p>Paint sample removed from:</p> <p>Location: W3 (Wall area) – above doorway.</p> <p>12 separate layers are visible in the sample.</p> | |

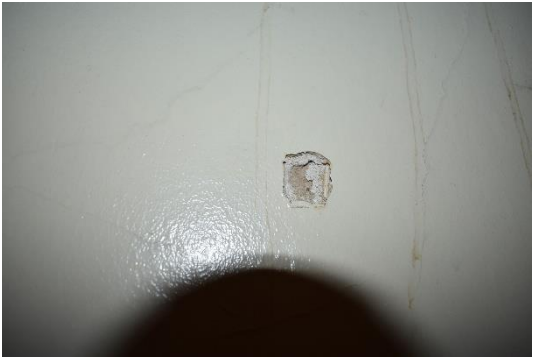
| Sample Ref:W4 | Location: Wythenshaw Hall |
|---|---|
| <p>Paint sample removed from:</p> <p>Location: W4 (Wall area) – mid wall height.</p> <p>21 separate paint layers are visible in the sample.</p> | |

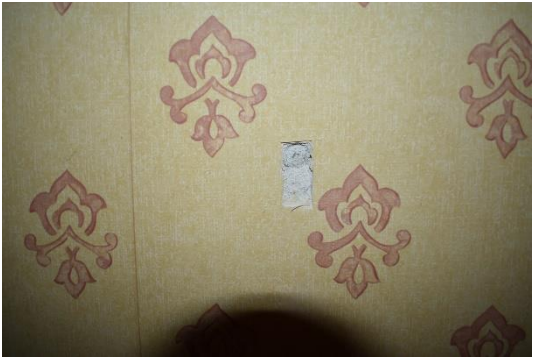
| Sample Ref:W5 | Location: Wythenshaw Hall |
|---|---|
| <p>Paint sample removed from:</p> <p>Location: W5 (Wall area) – mid wall height.</p> <p>20 separate decorative layers are present in the sample.</p> | |

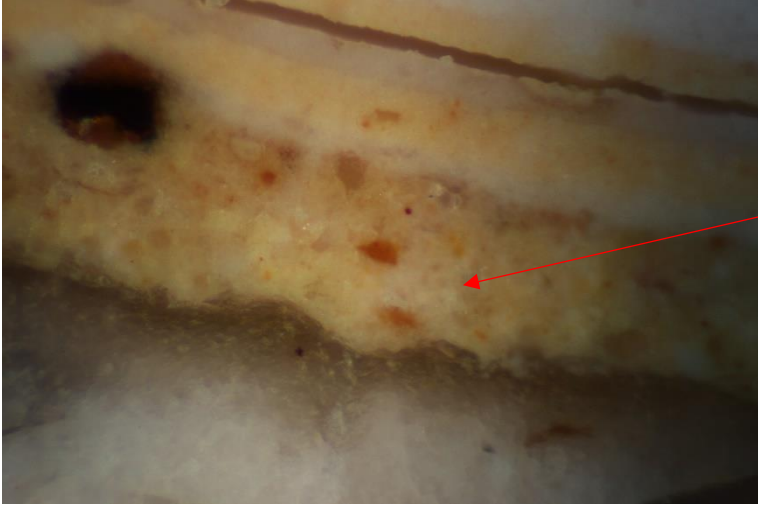
| Sample Ref:W5 | Location: Wythenshaw Hall |
|---|---|
| <br> | <p>X50 –</p> <p>Wallpaper – current decorative scheme.</p><br><p>X400 -</p> <p>Earliest paint layers.</p> <p>Beige coloured paintwork - based on lead carbonate and tinted with red and yellow ochres.</p> <p>This earliest layer is similar to layer 3 in sample W4 ie the earliest two layers are missing.</p> |

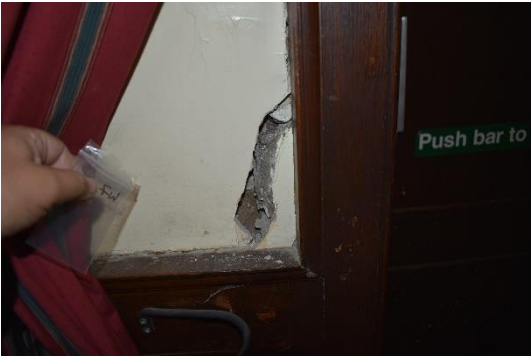
| Sample Ref:W6 | Location: Wythenshaw Hall |
|---|---|
| <p>Paint sample removed from:</p> <p>Location: W6 (Wall area) – mid wall to side of doorway.</p> <p>A total of 19 separate paint layers were present in the sample.</p> | |

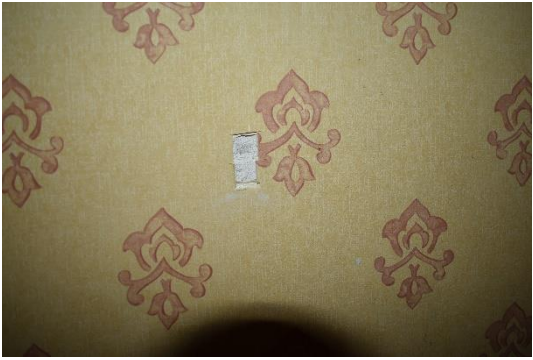
| Sample Ref:W7 | Location: Wythenshaw Hall |

| Sample Ref:W7 | Location: Wythenshaw Hall |
|---|---|
| <p>Paint sample removed from:</p> <p>Location: W7 (Wall area) – mid wall to side of window.</p> <p>20 decorative layers are present in the sample.</p> | |

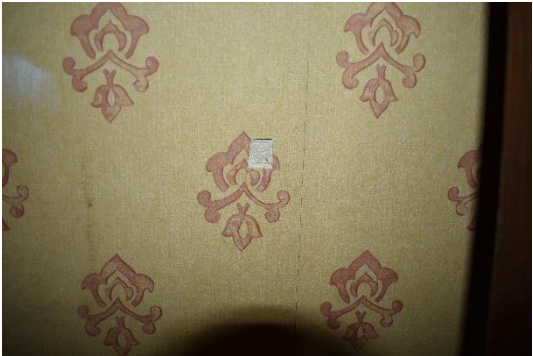
| Sample Ref:W8 | Location: Wythenshaw Hall |

| Sample Ref:W8 | Location: Wythenshaw Hall |
|---|---|
| <p>Paint sample removed from:</p> <p>Location: W8 (Wall area) – mid wall height behind bar.</p> <p>A total of 20 separate decorative layers are present in the sample.</p> | |

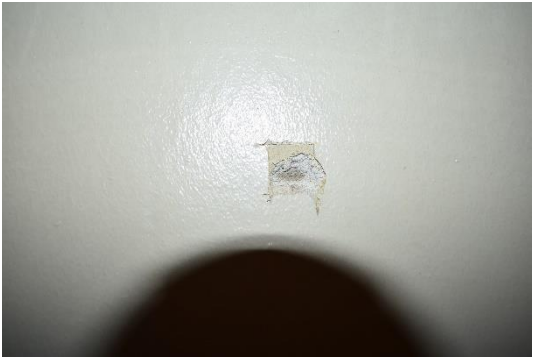
| Sample Ref:W9 | Location: Wythenshaw Hall |
|---|---|
| <p>Paint sample removed from:</p> <p>Location: W9 (Wall area) – upper wall height.</p> <p>19 separate decorative layers are present in the sample (no wallpaper in this location).</p> | |

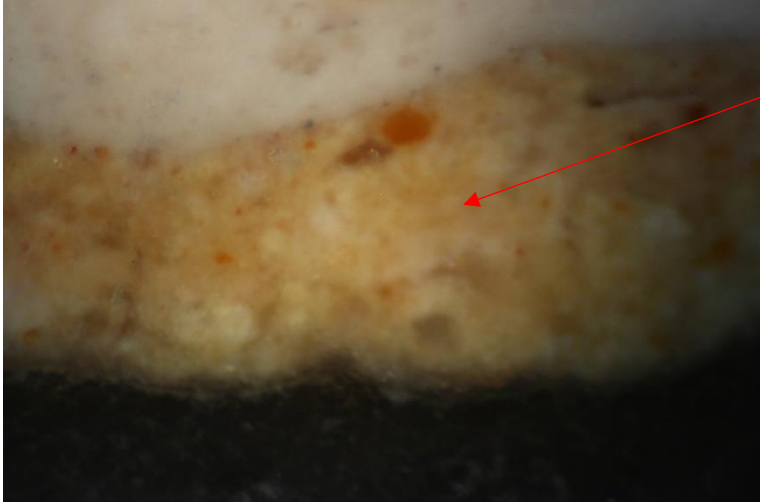
| Sample Ref:W9 | Location: Wythenshaw Hall |
|---|---|
| | <p>X400 -</p> <p>Earliest paint layers – a beige paint based on lead carbonate and coloured with yellow and red ochres.</p> |

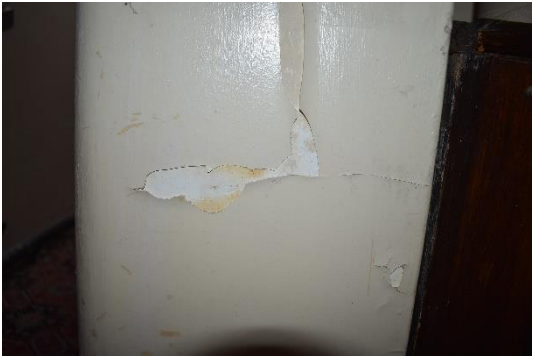
| Sample Ref:W10 | Location: Wythenshaw Hall |
|---|---|
| <p>Paint sample removed from:</p> <p>Location: W10 (Wall area) – mid wall height (return wall).</p> <p>20 separate paint layers are present in the sample.</p> | |

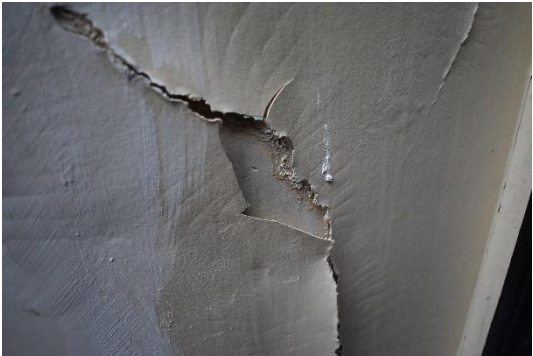
| Sample Ref:W11 | Location: Wythenshaw Hall |
|---|---|
| <p>Paint sample removed from:</p> <p>Location: W11 (Wall area) – low wall height (rear of door).</p> <p>19 separate paint layers are present in the sample</p> | |

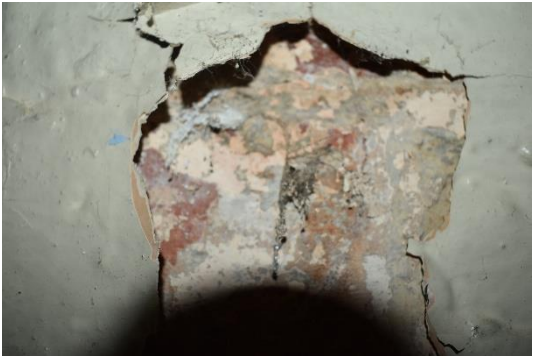
| Sample Ref:W12 | Location: Wythenshaw Hall |
|---|---|
| <p>Paint sample removed from: Hall Area</p> <p>Location: W12 (Wall area) – mid wall height (above timber dado).</p> <p>16 separate paint layers are present in the sample.</p> | |

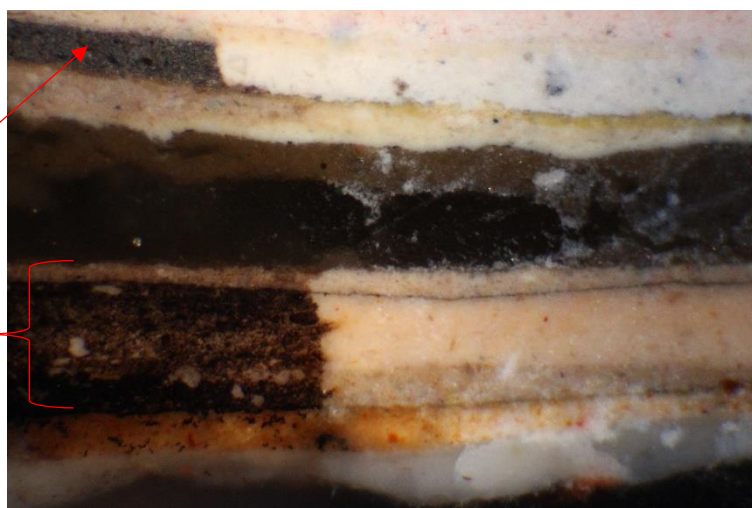
Layer 8 based on lead carbonate.

Layers 3 & 4 based on lead carbonate.

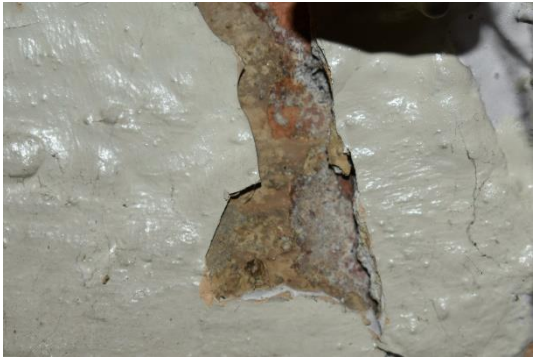
| Sample Ref:W13 | Location: Wythenshaw Hall |
|---|---|
| <p>Paint sample removed from:</p> <p>Location: W13 (Wall area) – mid wall height (to RHS of fire place).</p> <p>17 separate paint layers are present.</p> | |
