Phase II Geoenvironmental Site Assessment  
Renaissance, Manchester

Reference: 14-261-R2-1  
Date: 21<sup>st</sup> May 2021

## PHASE II GEOENVIRONMENTAL SITE ASSESSMENT

Renaissance  
Deansgate  
Manchester  
M3 2FE

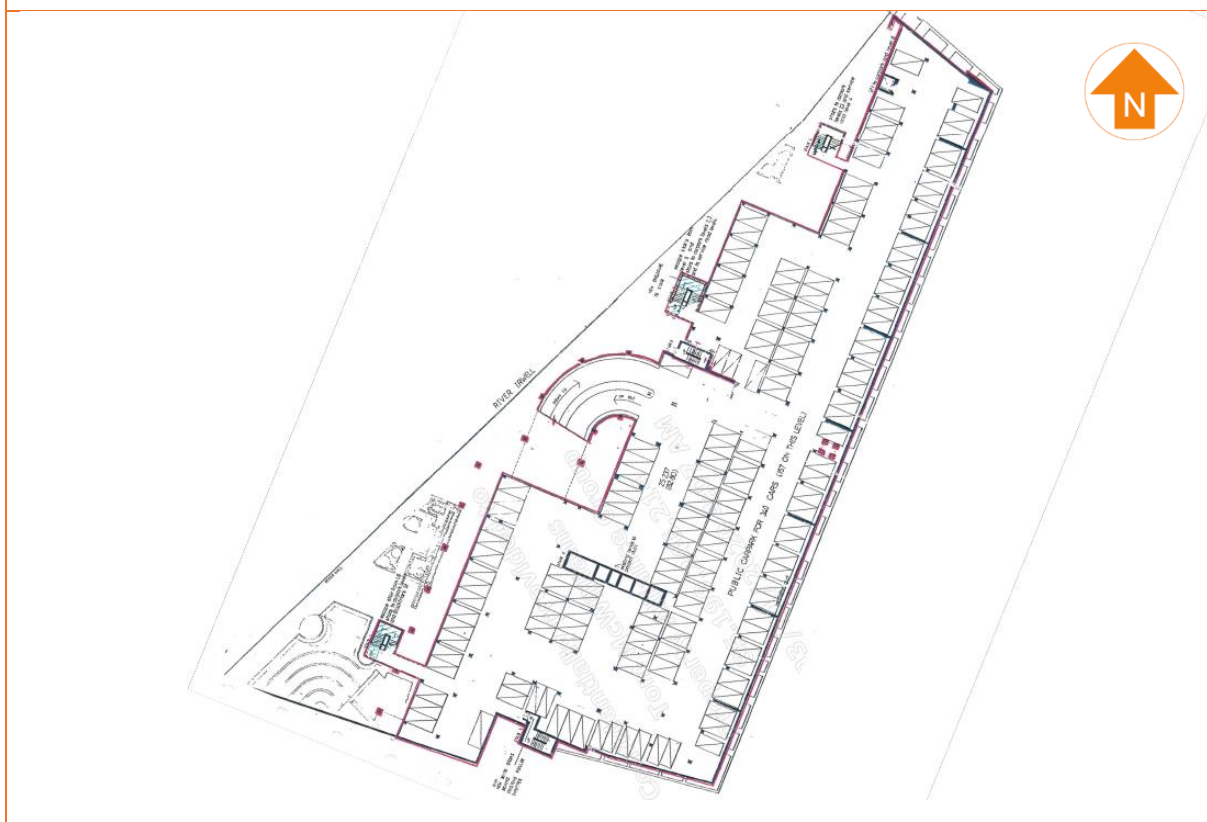
FIGURE 1.1      SNAPSHOT OF PROPOSED DEVELOPMENT

A snapshot of the proposed development layout is indicated in Figure 1.1.

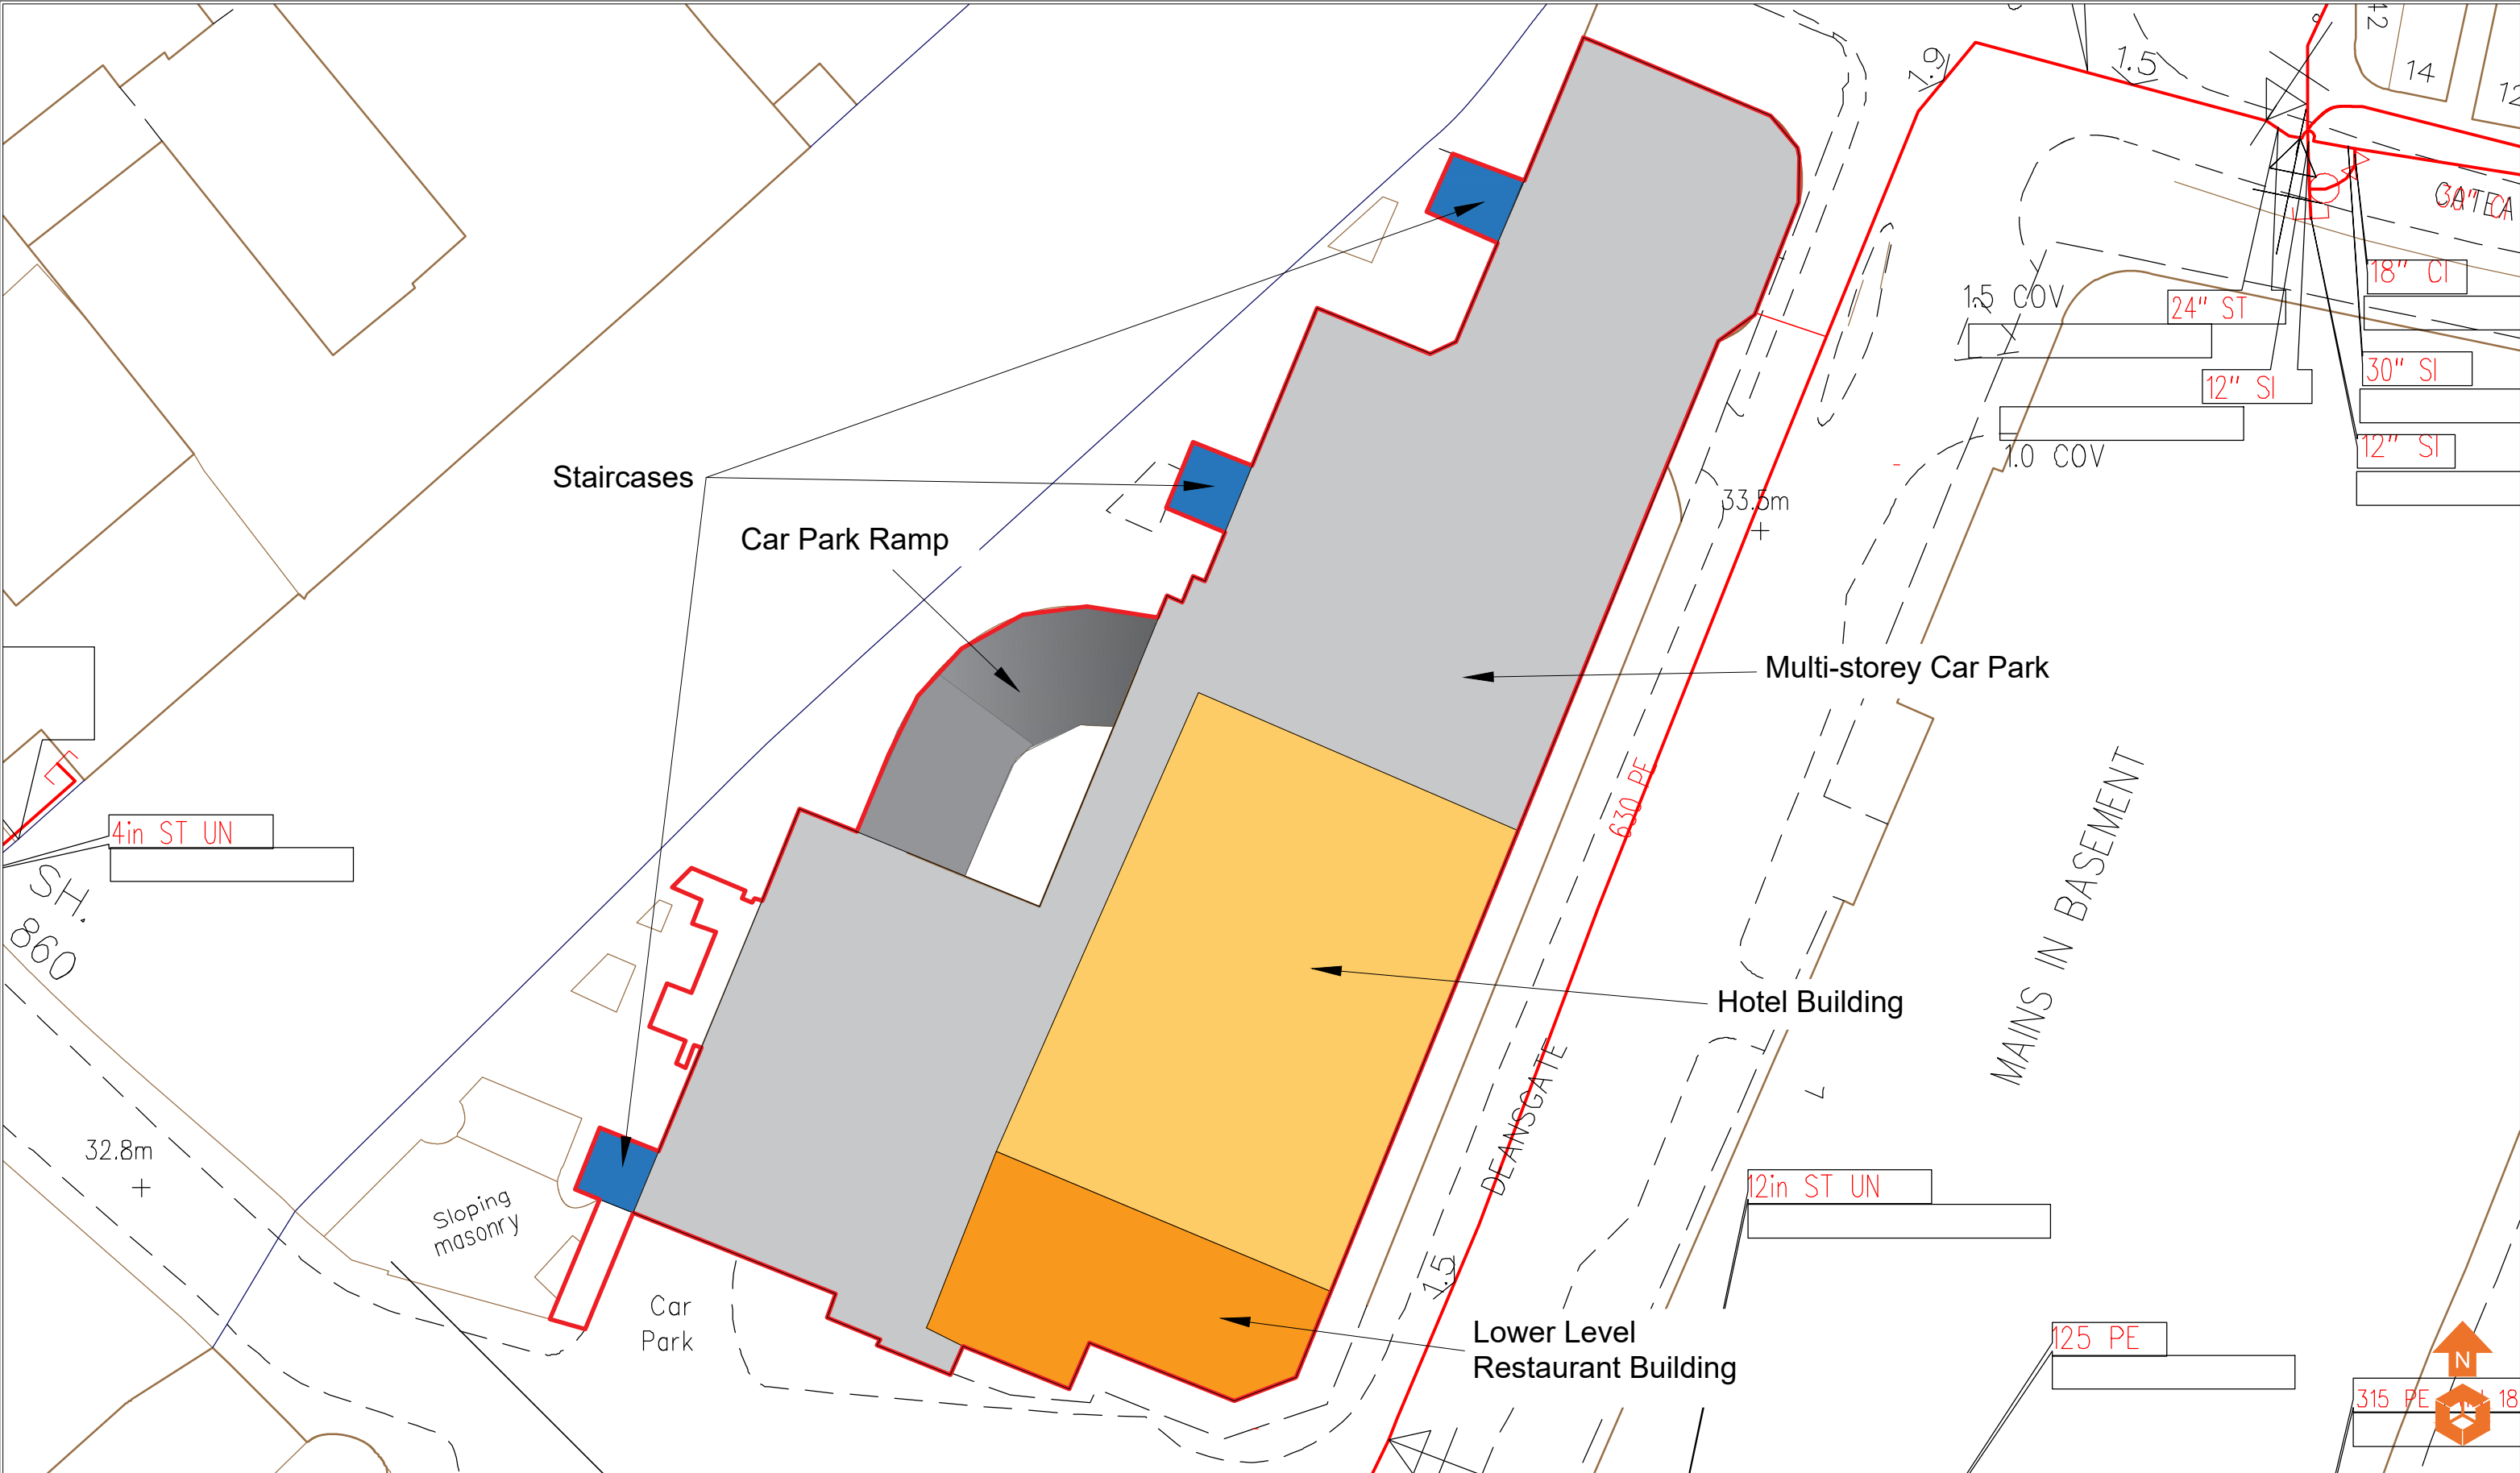
| <div>Site Features</div> <div><div></div>Multi-Storey Car Park</div> <div><div></div>Hotel</div> <div><div></div>Restaurant</div> <div><div></div>Staircases</div> <div><div></div>Car Park Ramp</div> | <div>Notes:</div> | | | | | <div>Client:</div> <div>Property Alliance Group Ltd</div> | <div>Job No:</div> <div>14-261</div> | <div>Date:</div> <div>28.07.2020</div> | <div><div><div></div></div><div>e3p</div><div>Environmental Engineering Partnerships Ltd<br/>City Heliport &amp; Business Centre<br/>Eccles, Manchester, M30 7RU<br/>Tel: 0161 707 9612<br/>E-mail: info@e3p.co.uk<br/>Website: www.e3p.co.uk</div></div> | |
| | <div>P1</div> <div>REVA</div> <div>28.07.2020</div> <div>LM</div> <div>EF</div> <div>Phase</div> <div>Issue</div> <div>Date</div> <div>Drawn</div> <div>Checked</div> | | | | | <div>Job Title:</div> <div>Renaissance Deansgate</div> | <div>Drawing Title:</div> <div>Site Features Plan</div> | | <div>The client must not amend any drawing, design or other intellectual property produced by E3P Ltd without permission in writing from E3P Ltd in advance of any amendments being made. In the event that such written permission is not obtained in advance of the amendments being made, E3P Ltd shall not be liable for any damage and/or losses occurring as a result of the amended drawing, design or intellectual property.</div> | |

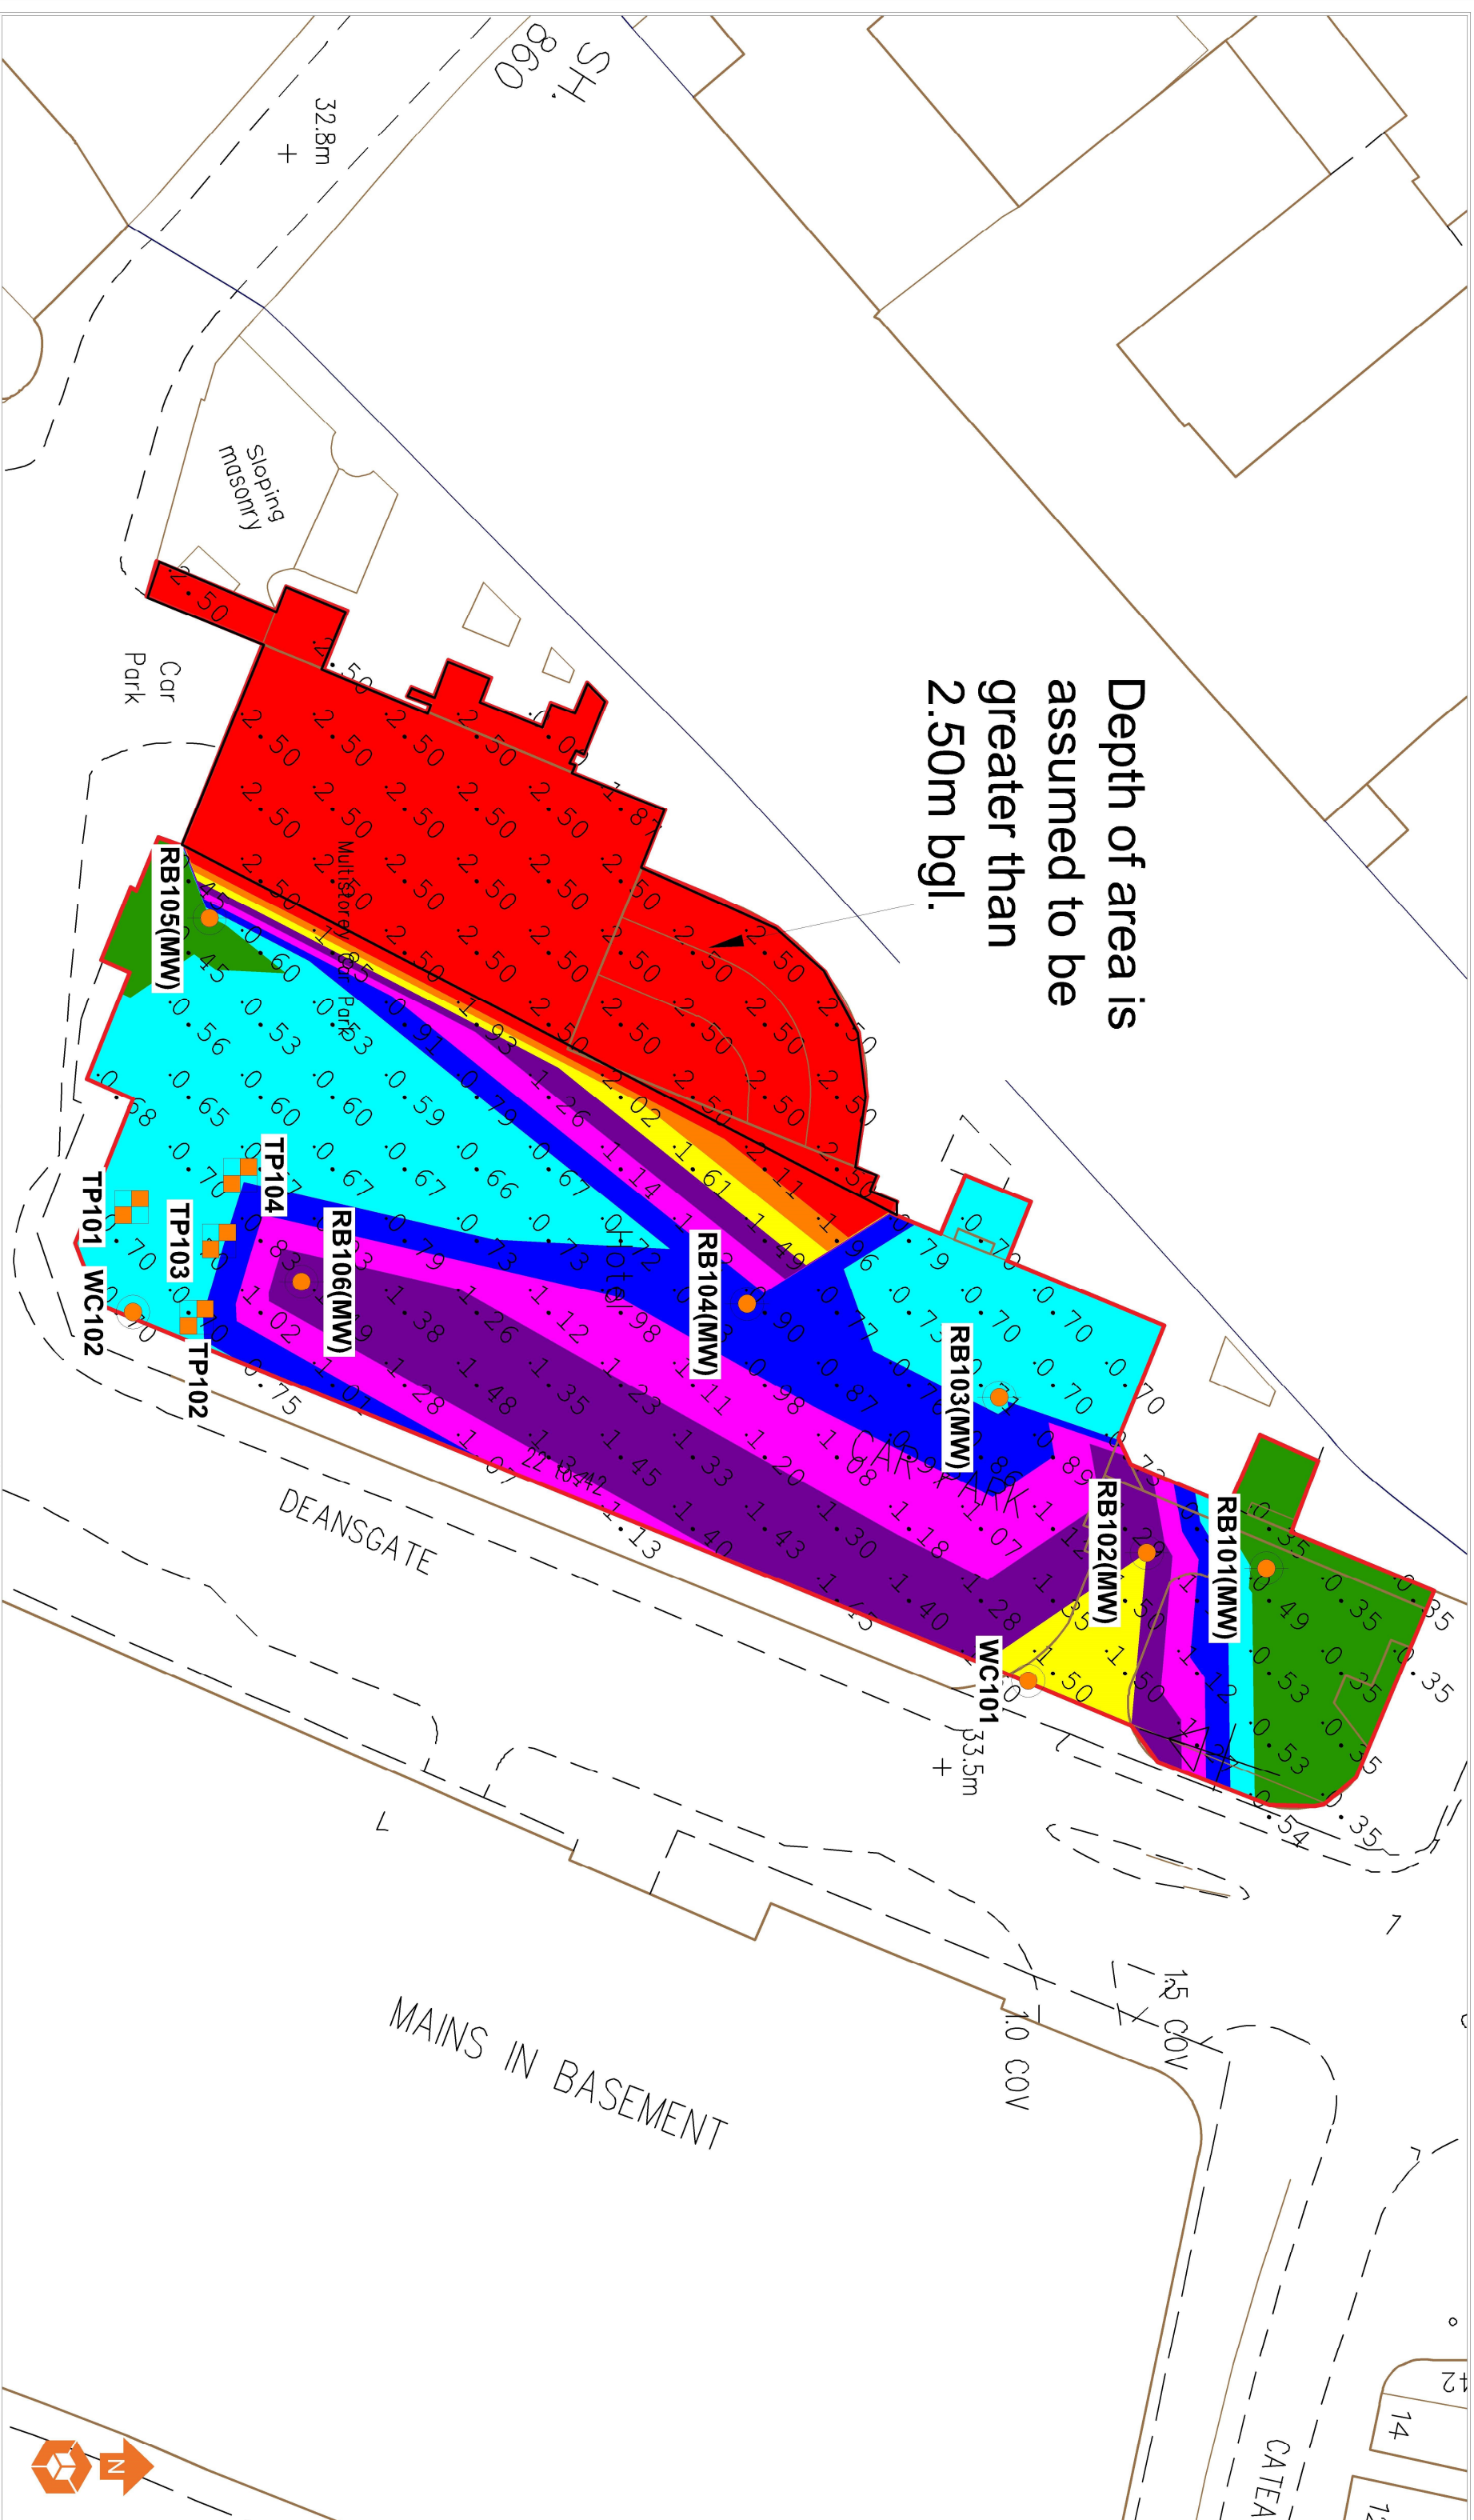
| <div>Location Symbols</div> <div><div> Approximate Core Through Well location</div><div> Approximate Trial Pit location</div><div> Approximate Rotary Borehole Location with Install</div></div> | <div>Made Ground Depth (m)</div> <div><div> Depth of Made Ground 0.00 - 0.24m</div><div> Depth of Made Ground 0.25 - 0.49m</div><div> Depth of Made Ground 0.50 - 0.74m</div><div> Depth of Made Ground 0.75 - 0.99m</div><div> Depth of Made Ground 1.00 - 1.24m</div><div> Depth of Made Ground 1.25 - 1.49m</div><div> Depth of Made Ground 1.50 - 1.74m</div><div> Depth of Made Ground 1.75 - 1.99m</div><div> Depth of Made Ground &gt;2.00m</div></div> | Notes: | Client: | Job No: | Date: | <div><div>Environmental Engineering<br/>Partnership Ltd<br/>Taylor Road, Trafford Park<br/>Urmston, Manchester, M41 7LQ<br/>Tel: 0161 707 9612<br/>E-mail: <a href="mailto:info@esp.co.uk">info@esp.co.uk</a><br/>Website: <a href="http://www.esp.co.uk">www.esp.co.uk</a></div></div> | | |

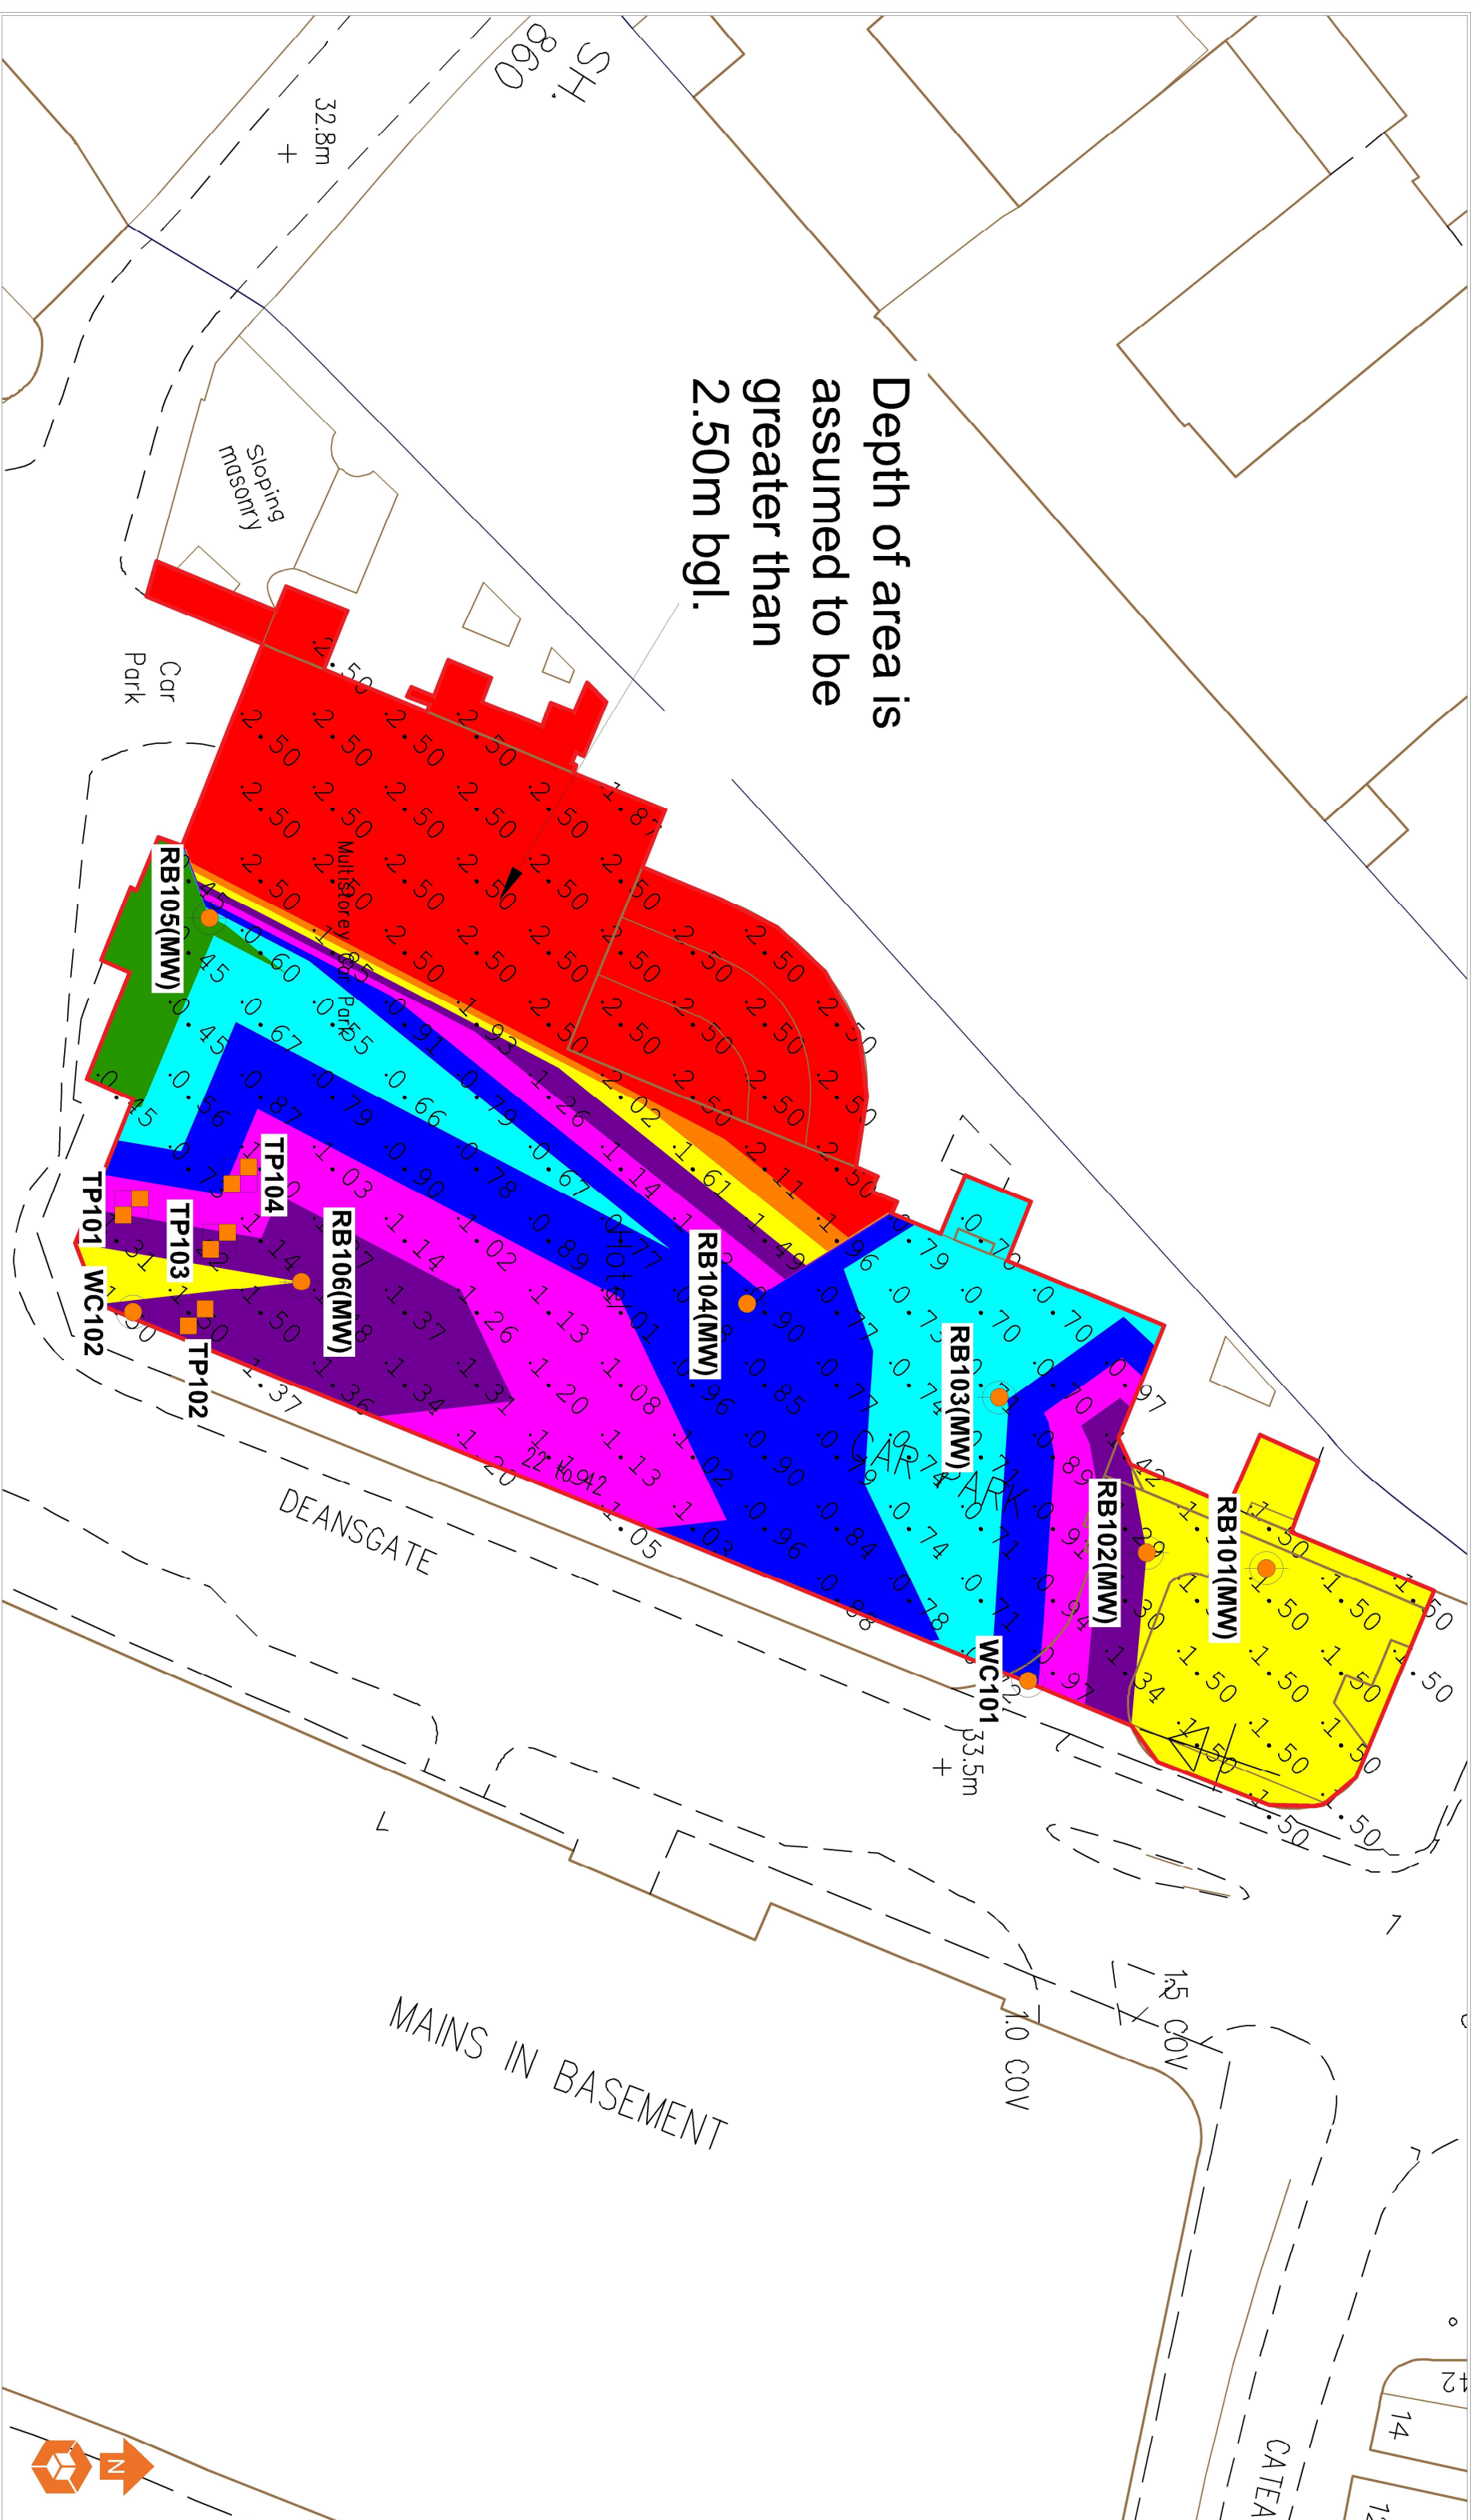
Depth of area is assumed to be greater than 2.50m bgl.

| <div>Location Symbols</div> <div><div>Approximate Core Through Well location</div><div>Approximate Trial Pit location</div><div>Approximate Rotary Borehole location with install</div></div> | | <div>Bedrock Depth (m)</div> <div><div>Depth of Bedrock 100 - 0.24m</div><div>Depth of Bedrock 125 - 0.48m</div><div>Depth of Bedrock 150 - 0.74m</div><div>Depth of Bedrock 175 - 0.99m</div><div>Depth of Bedrock 200 - 1.24m</div><div>Depth of Bedrock 225 - 1.48m</div><div>Depth of Bedrock 250 - 1.74m</div><div>Depth of Bedrock 275 - 1.99m</div><div>Depth of Bedrock 300m</div></div> | |

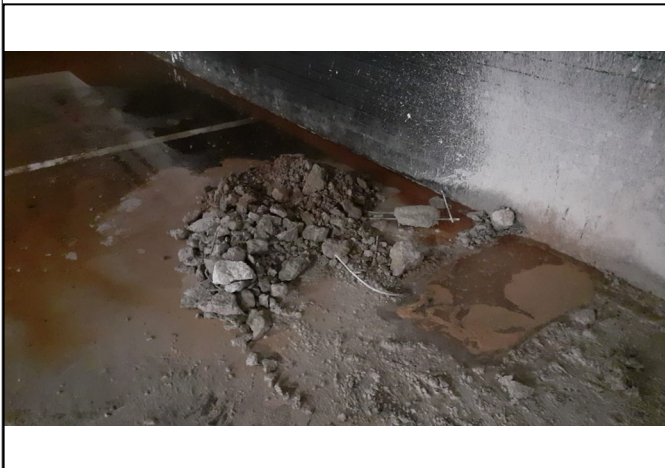
TP102 spoil

Remarks: 1. Foundation for wall observed at 0.40m bgl, placed upon possible beam structure observed at 0.70m bgl. 2. Depth of foundation could not be determined

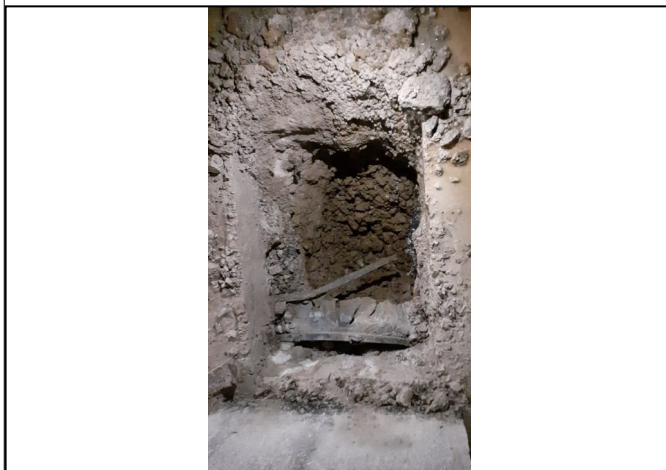
TP103

Remarks: 1. Foundation pad observed at 0.70m bgl 2. Foundation pad 0.70m in length from supporting pillar 3. Depth of pad could not be determined

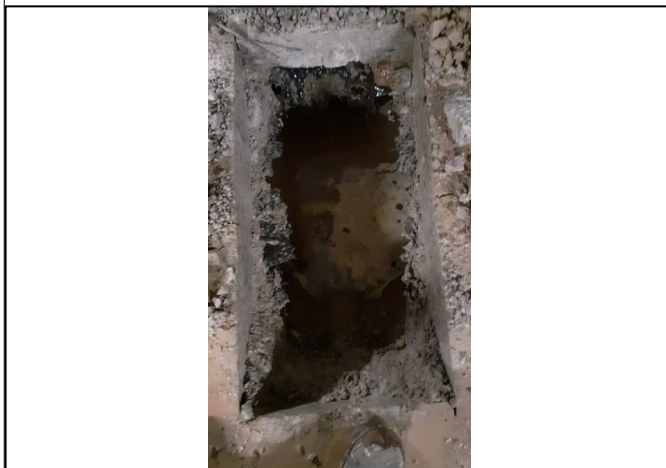
TP104

Remarks: 1. Foundation pad observed at 0.70m bgl 2. Foundation pad 0.70m in length from supporting pillar 3. Depth of pad could not be determined
