PHASE 4 VALIDATION  
**REPORT**

| job number<br><b>J3408/16/E/V</b> | date<br><b>16/07/21</b> |
| site address<br><b>29 Berry Brow,<br/>Clayton Bridge,<br/>Manchester.</b> | |

## Phase 4: Validation Report Of Remediation

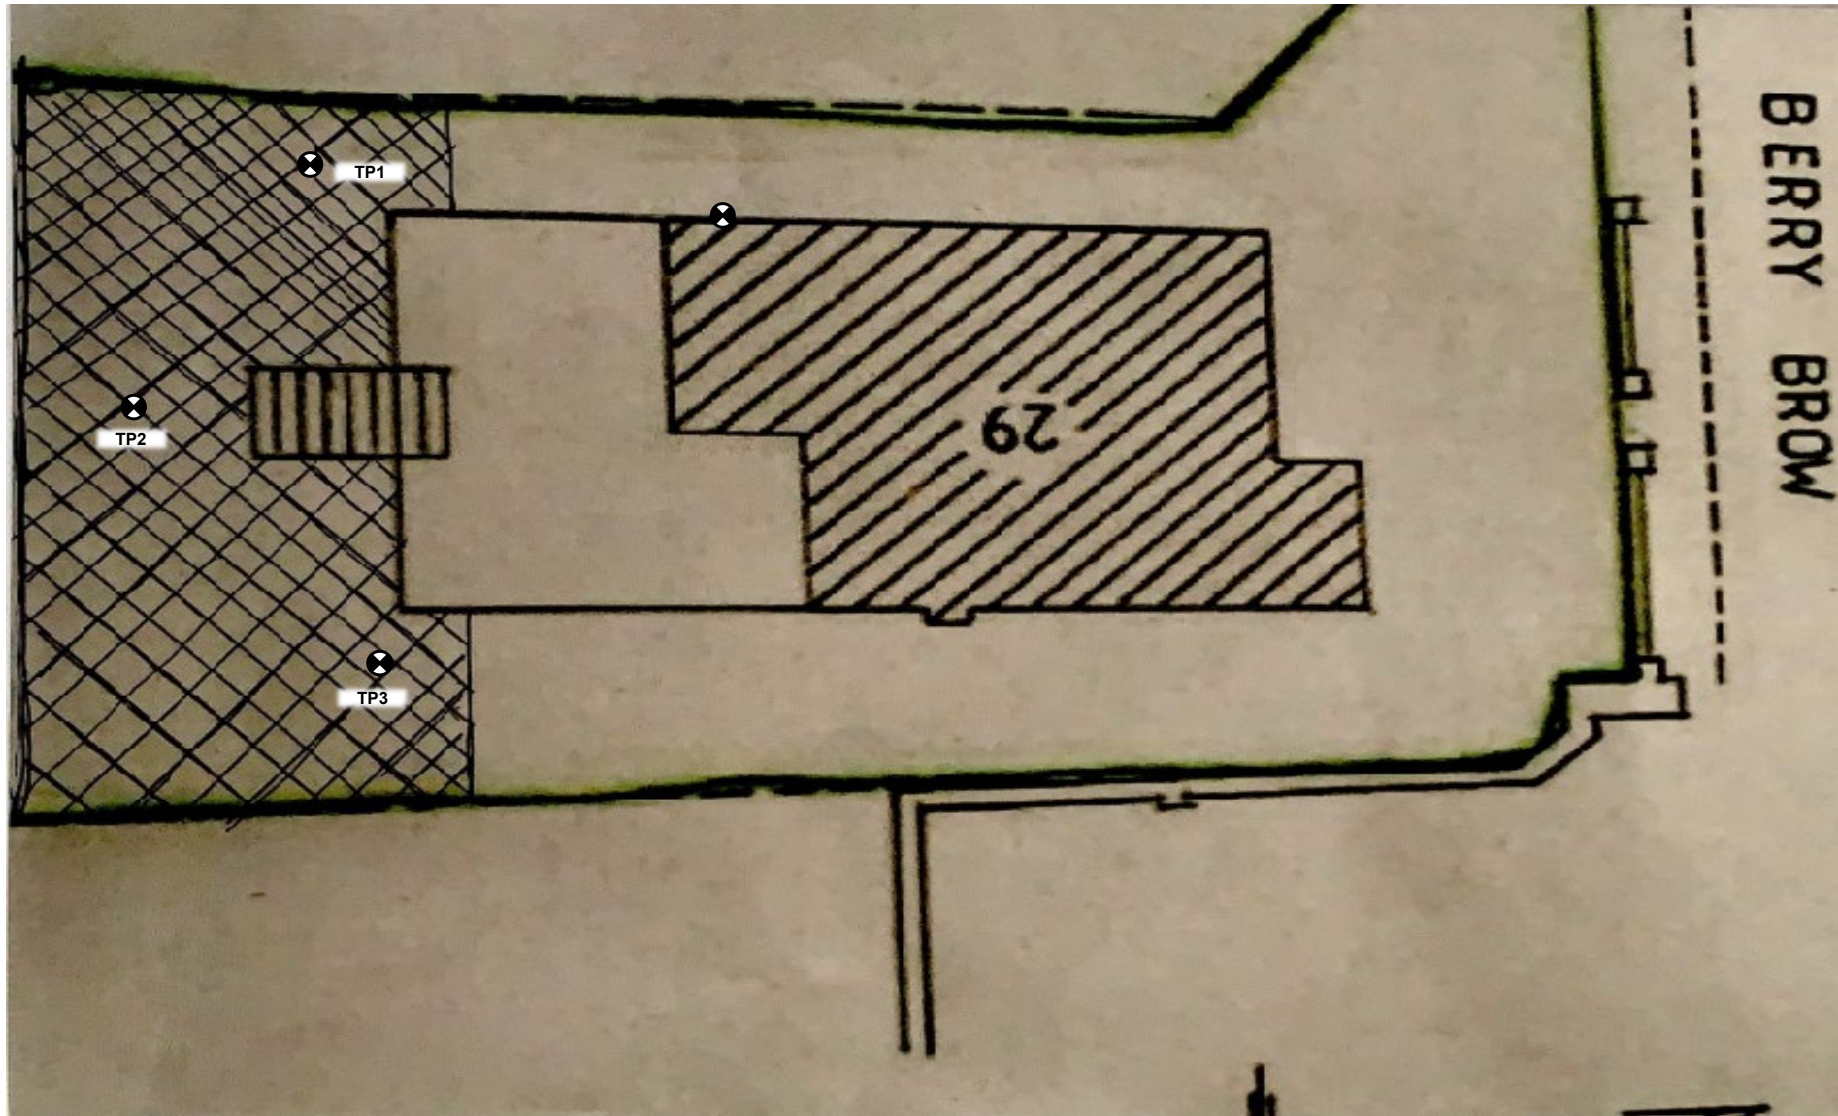
### Site Plan

Investigation positions approximated from site operative's notes.

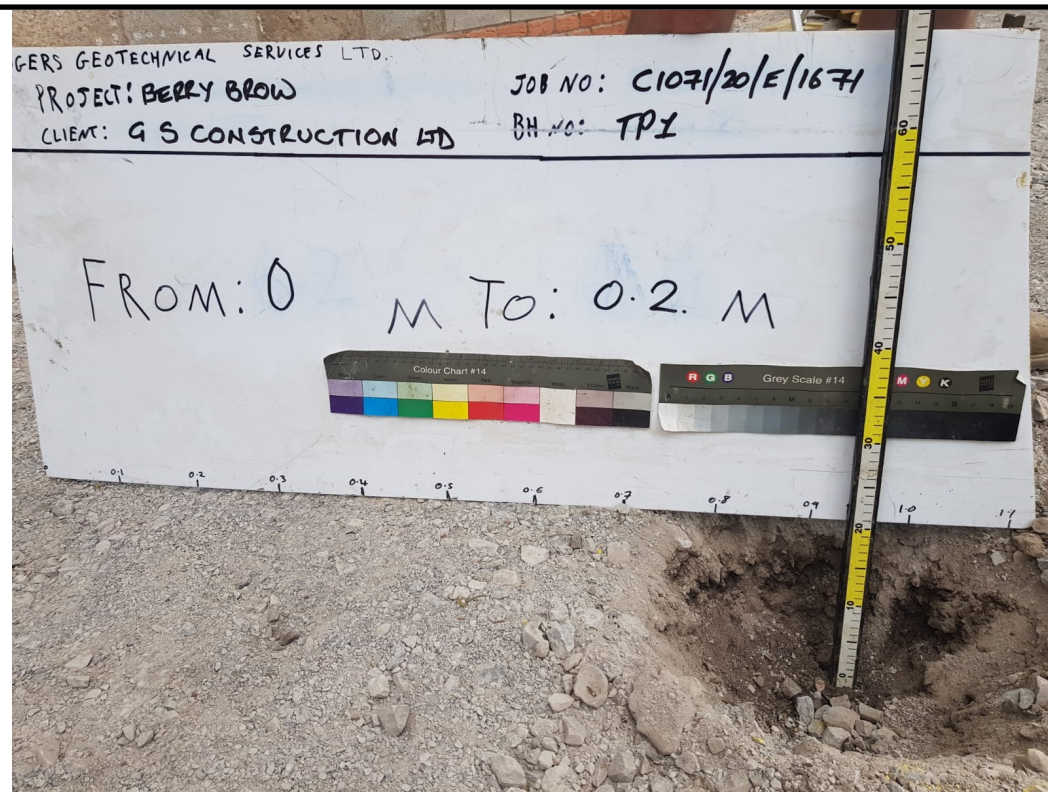
Photo 1: TP1

| Water<br>Strike | Samples and In Situ Testing | | | Depth<br>(m) | Level<br>(m) | Legend | Stratum Description | |
|---|---|---|---|---|---|---|---|---|
| | 0.00 - 0.20 | D | | 0.20 | | | MADE GROUND (Light grey silty sandy, sub-angular to sub-rounded, fine to medium GRAVEL of dolomitic limestone). [Capillary break].<br>End of pit at 0.20 m | 1 |

It is concluded that the imported material placed as a capillary break at the site has been obtained from a single supplier and comprises silty sandy gravel of limestone. This material has been well compacted and provides a physical barrier to the underlying contaminated soil as well as serving as a capillary break. This material has been observed to be between 0.12m and 0.2m in thickness, as can be seen from the photographs taken on site.

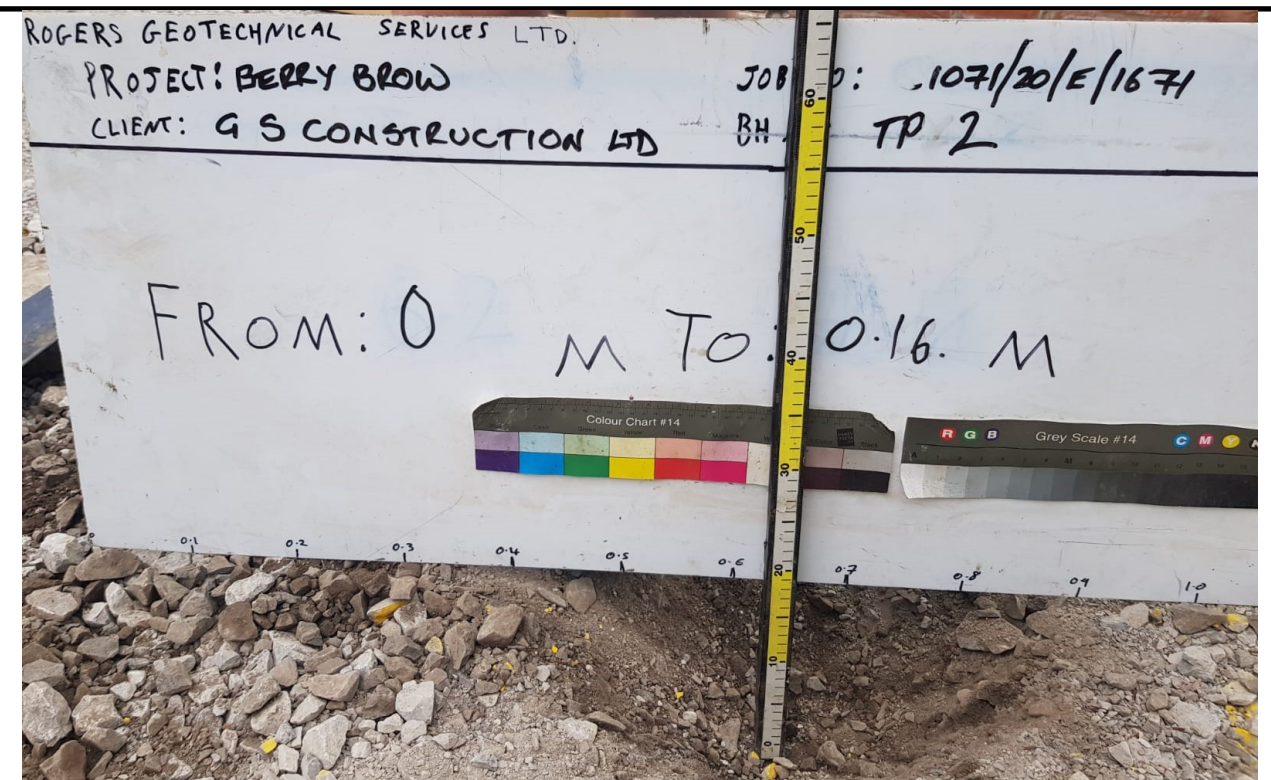
Photo 2: TP2

| Water<br>Strike | Samples and In Situ Testing | | | Depth<br>(m) | Level<br>(m) | Legend | Stratum Description | |
|---|---|---|---|---|---|---|---|---|
| | 0.00 - 0.16 | D | | 0.16 | | | MADE GROUND (Light grey silty sandy sub-angular to sub-rounded, fine to medium GRAVEL of dolomitic limestone). [Capillary break].<br>End of pit at 0.16 m | 1 |

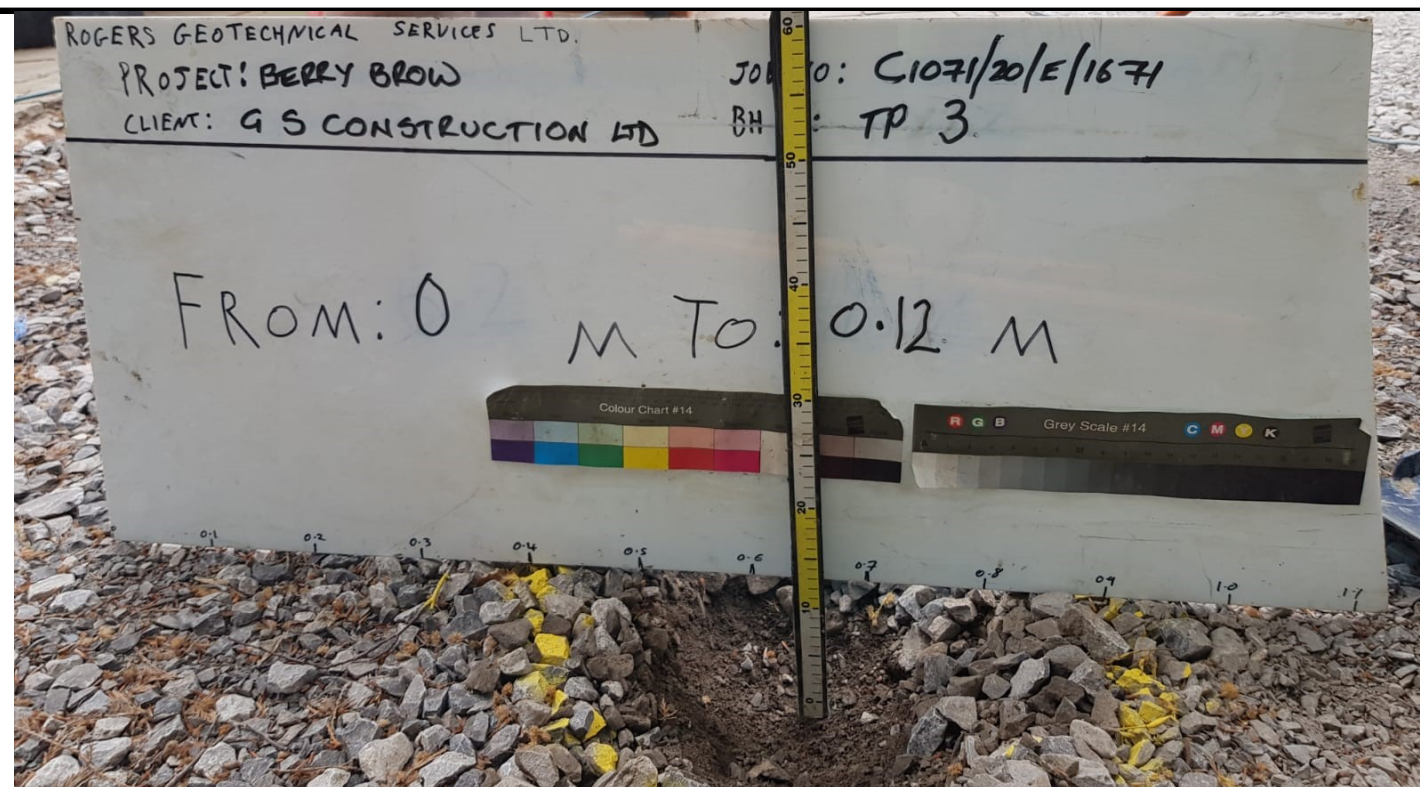
Photo 3: TP3

| Water<br>Strike | Samples and In Situ Testing | | | Depth<br>(m) | Level<br>(m) | Legend | Stratum Description | |
|---|---|---|---|---|---|---|---|---|
| | | | | 0.12 | | | MADE GROUND (Light grey silty sandy, sub-angular to sub-rounded, fine to medium GRAVEL of dolomitic limestone). [Capillary break].<br>End of pit at 0.12 m | 1 |
