**Stage 3, Tier 2 Verification Report  
(Pre-Construction Enabling Works)**

**Victoria Riverside  
Land South of Dantzic Street  
Strangeways  
Manchester  
M4 4EJ**

**(ref. TJ3752AR1v1.0)**

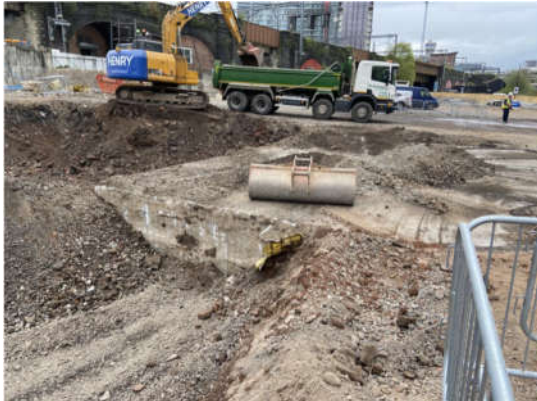
| Watching Brief | During the development, the client maintained a watching brief, a photographic record of which is presented in Appendix H, a selection of which are presented in the table below. | |
|---|---|---|
| April 2021 | | Excavations for the crane base. |

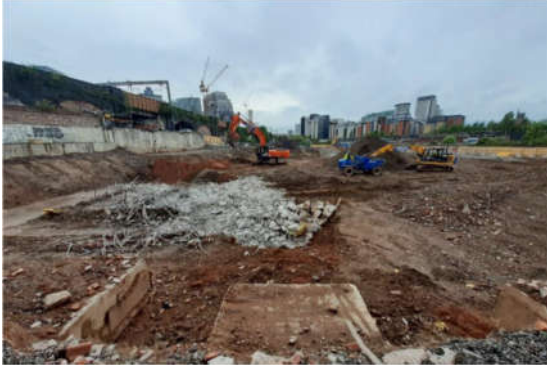
| Watching Brief | During the development, the client maintained a watching brief, a photographic record of which is presented in Appendix H, a selection of which are presented in the table below. | |
|---|---|---|
| May 2021 | | General view across the site. |

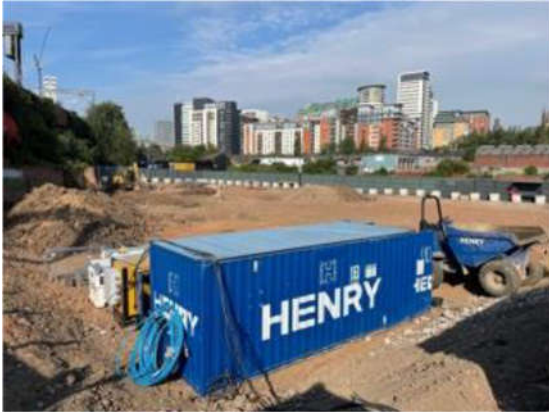
| Watching Brief | During the development, the client maintained a watching brief, a photographic record of which is presented in Appendix H, a selection of which are presented in the table below. | |
|---|---|---|
| June 2021 | | General view across the site. |

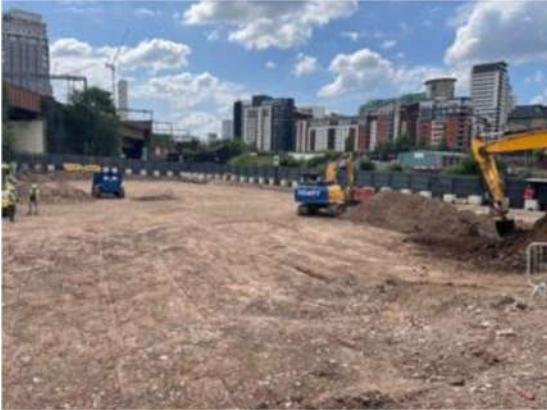
| Watching Brief | During the development, the client maintained a watching brief, a photographic record of which is presented in Appendix H, a selection of which are presented in the table below. | |
|---|---|---|
| July 2021 | | General view across the site. |
