# PHASE 2 GEO-ENVIRONMENTAL REPORT

| job number<br><b>C1742/21/E/2731</b> | date<br><b>16.07.21</b> |
| site address<br><b>Rushbrook Primary School</b><br><b>Shillingford Road</b><br><b>Gorton</b><br><b>Manchester M18 7TN</b> | |

## Report on a Phase 2 Geo-environmental Investigation

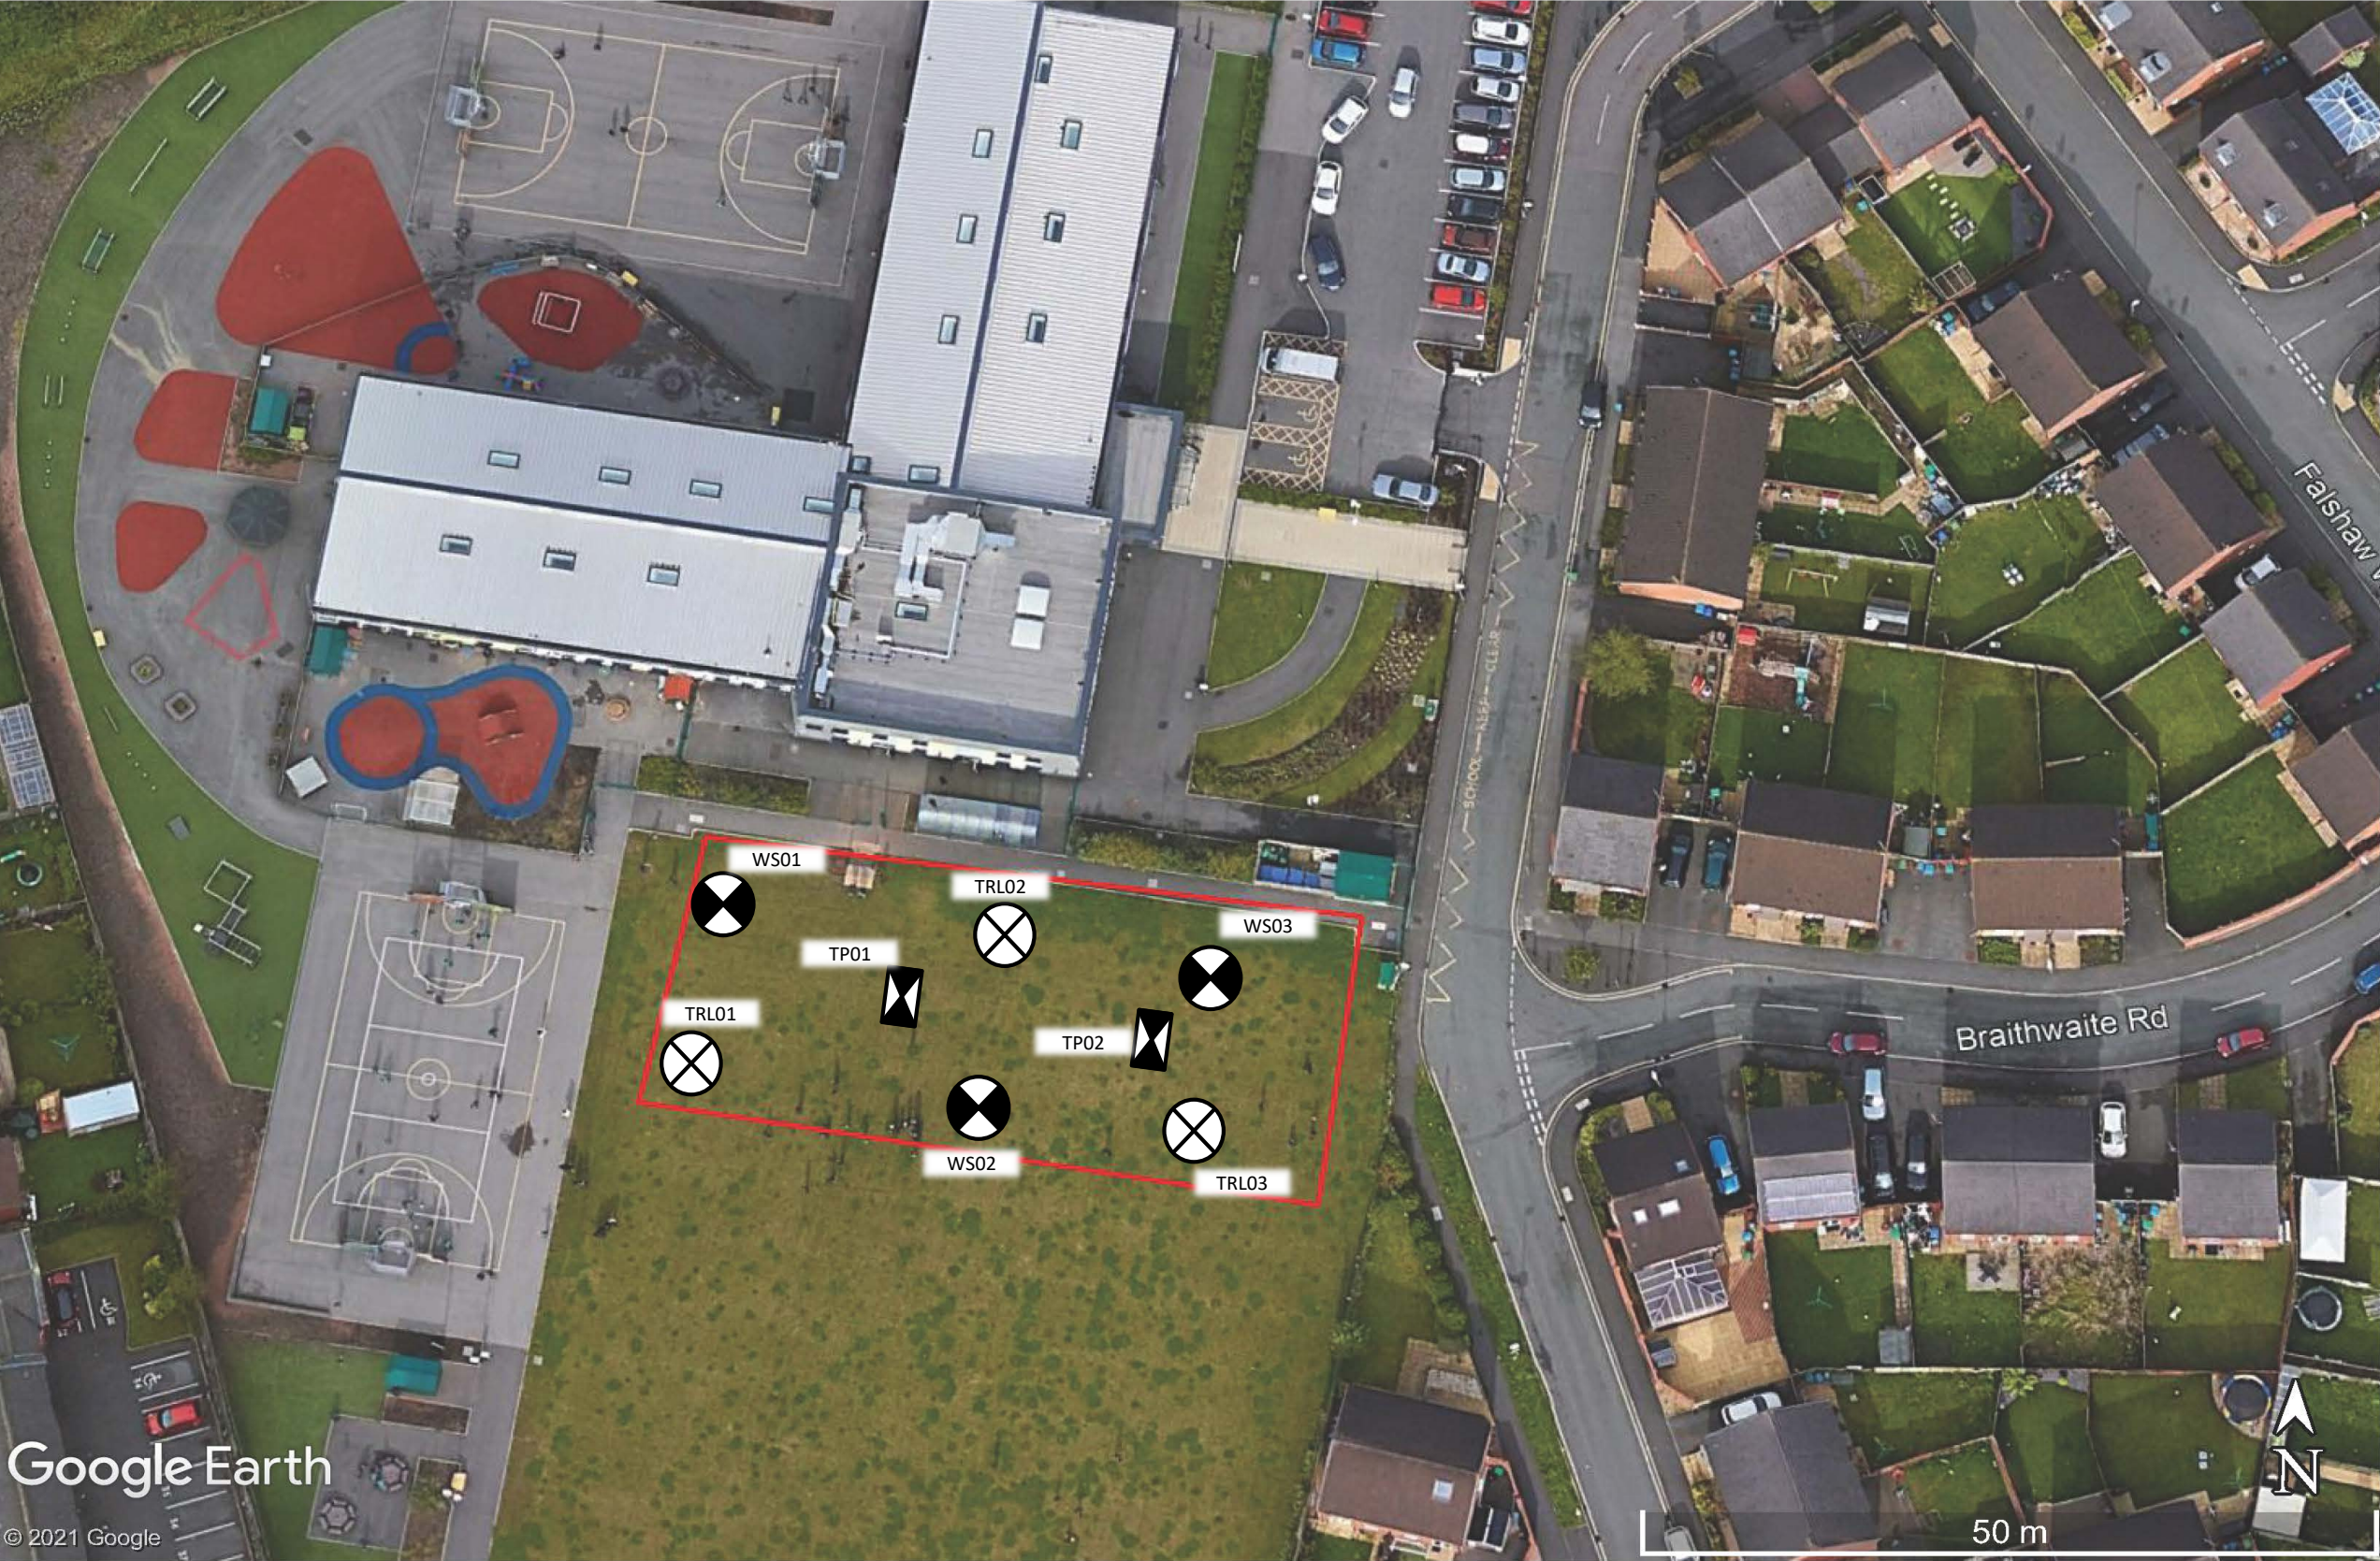
### Site Plan

**Notes:**  
Investigation positions approximated from site operative's notes.

The investigatory locations are shown on the site plan which is presented in Appendix 1 to this report. It should be appreciated that works were supervised by a UXO specialist. At each position, the ground was cleared at regular intervals with a magnetometer and CAT scan.

Two trialpits were excavated in order to undertake soakaway testing, the positions of which are shown in Appendix 1. The soakaway tests were undertaken at the base of the pit at depths rational to the construction of soakaways. The soils exposed in the trialpits were logged on site in general accordance with BS5930: 2015 +A1: 2020, and full descriptions are given on the trialpit records which are presented in Appendix 3, in addition to photographs of the trialpits. The results of the soakaway tests are presented in Appendix 4.
