# Arboricultural Impact Assessment (AIA)

**August 2021**

**Hough End Leisure Centre**

| <b>Title:</b> | Arboricultural Impact Assessment | | | |

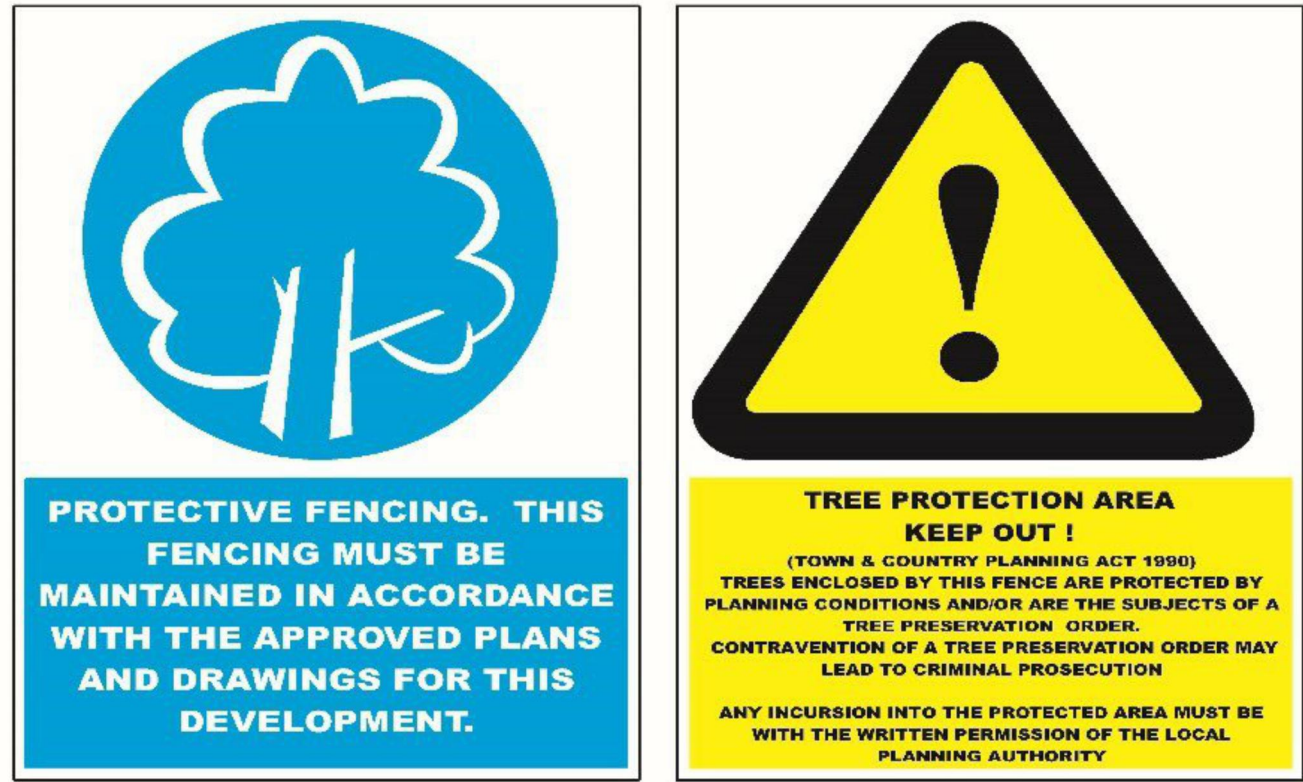
Insert 2: Tree protection notice

- 4.6.5. No fixing shall be made to any tree and all possible precautions shall be taken to prevent damage to the tree roots when locating uprights.
- 4.6.6. A 600mm x 300mm warning sign reading "TREE PROTECTION AREA KEEP OUT" shall be fixed to every 10m of protective fencing, as illustrated on the Tree Protection Plan (Insert 2).
