# TV RECEPTION SURVEY REPORT

Supplement March 2019  
Additional test points in the potential impact zone

**DATE OF SURVEY:** 5<sup>th</sup> March 2019  
**SCS JOB:** 153588

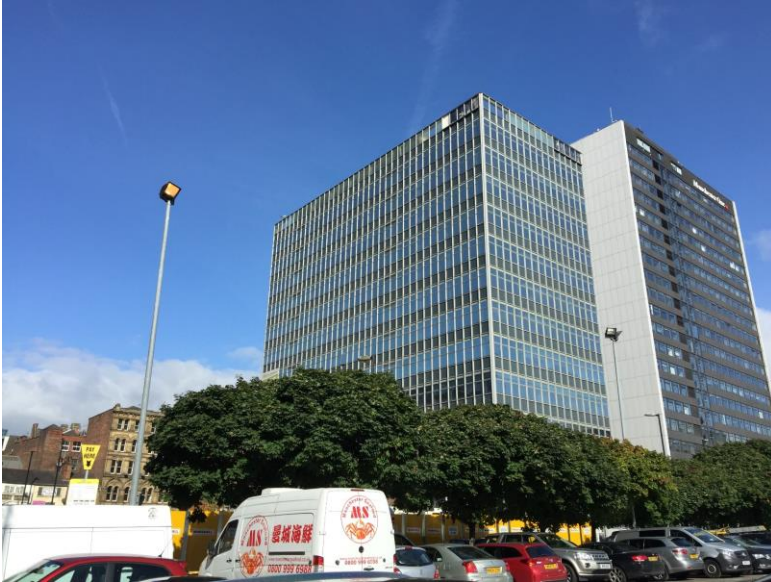
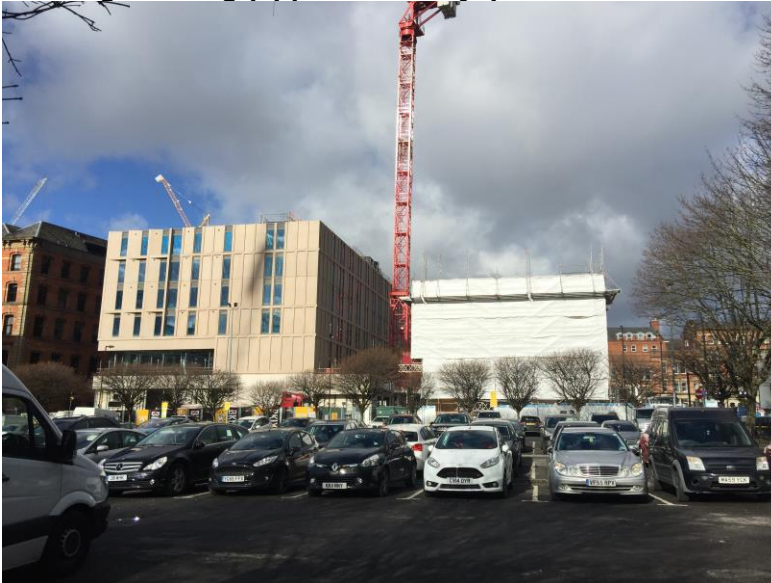
**PHOTO A: The developments location**

During the test results it was noted that the existing building at the development site has been partially demolished/removed and at the time of testing was approximately only consisting of 5 storey height, (this was originally consisting of a 12-storey building when test results were taken in October 2017) and when completed is to consist of a 16-storey building.

**Existing building (12 storeys) October 2017**

**Existing building (approx 5 storeys) March 2019**

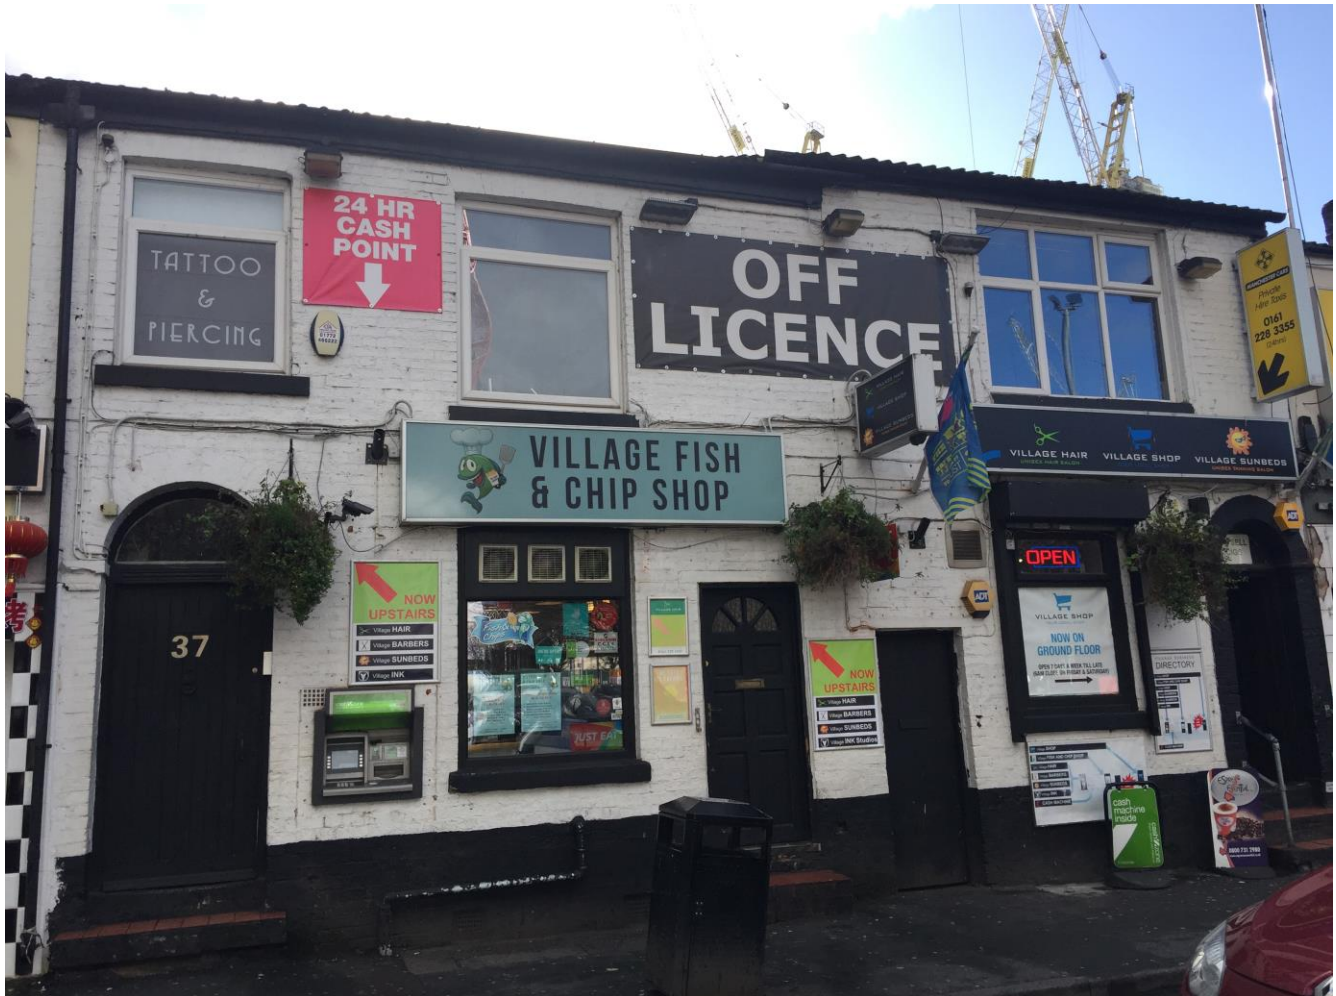
## VISIBLE TV AERIAL LOCATED IN THE AREA OF TEST POINT 1a

**Visible Existing Aerial Arrays:** High gain aerials on 2m and 3m masts, mounted at rooftop height on 2 storey properties, directed towards the Winter Hill Transmitter

**Visible Existing Obstructions:** Various multi-storey buildings in the general direction of the Winter Hill Transmitter

Television reception has low signal strengths and corruption is being received

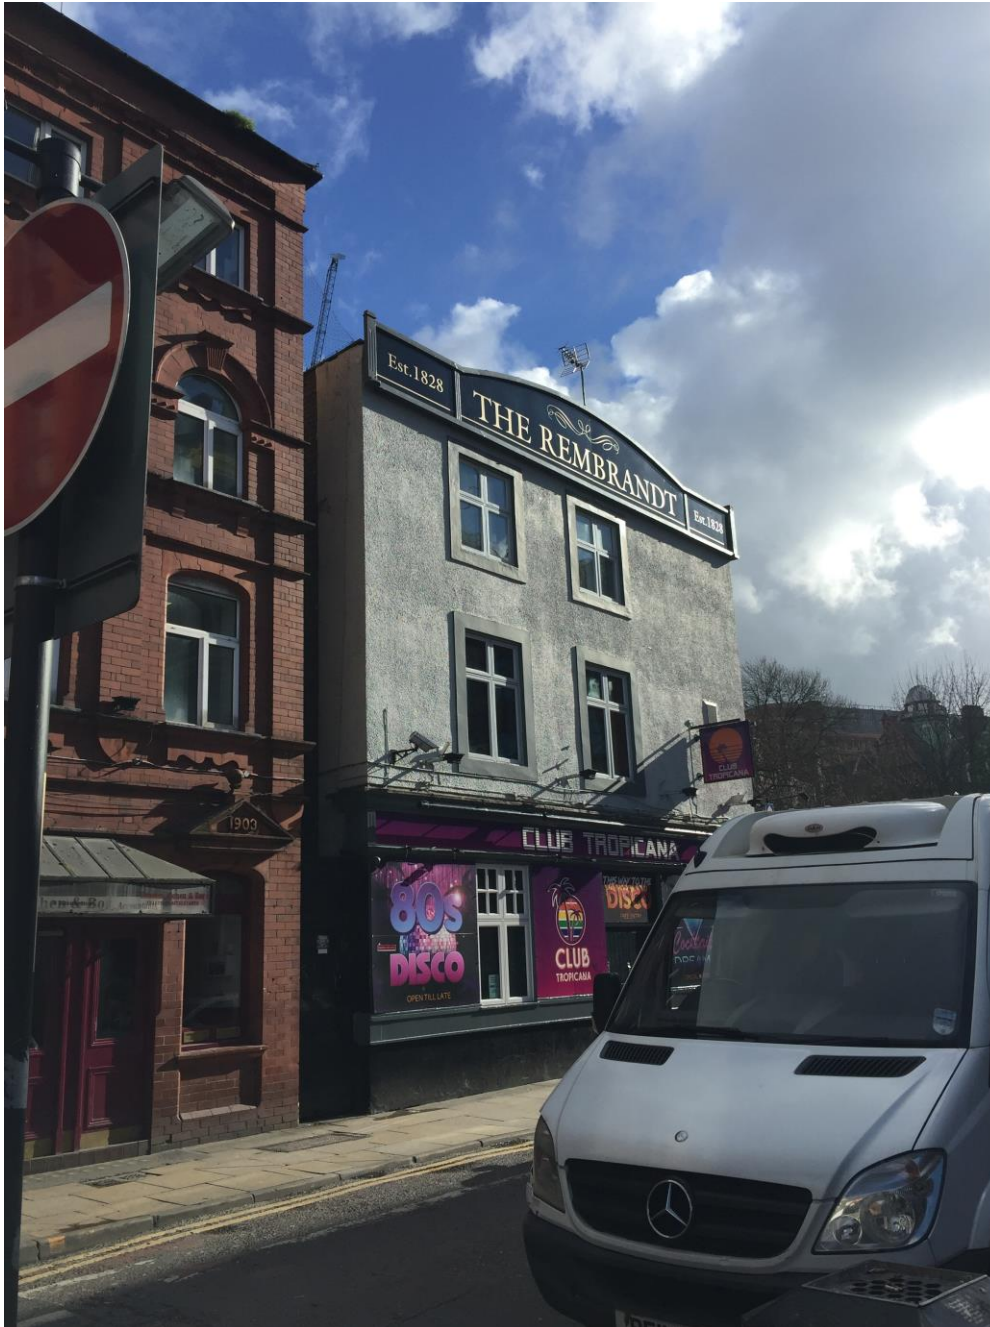
## VISIBLE TV AERIAL LOCATED IN THE AREA OF TEST POINT 2a

**Visible Existing Aerial Arrays:** high gain aerials on 2m and 3m masts, mounted at rooftop height on 3 storey properties, directed towards the Winter Hill Transmitter

**Visible Existing Obstructions:** Various multi-storey buildings/Trees in the general direction of the Winter Hill Transmitter

Television reception has low signal strengths and corruption is being received

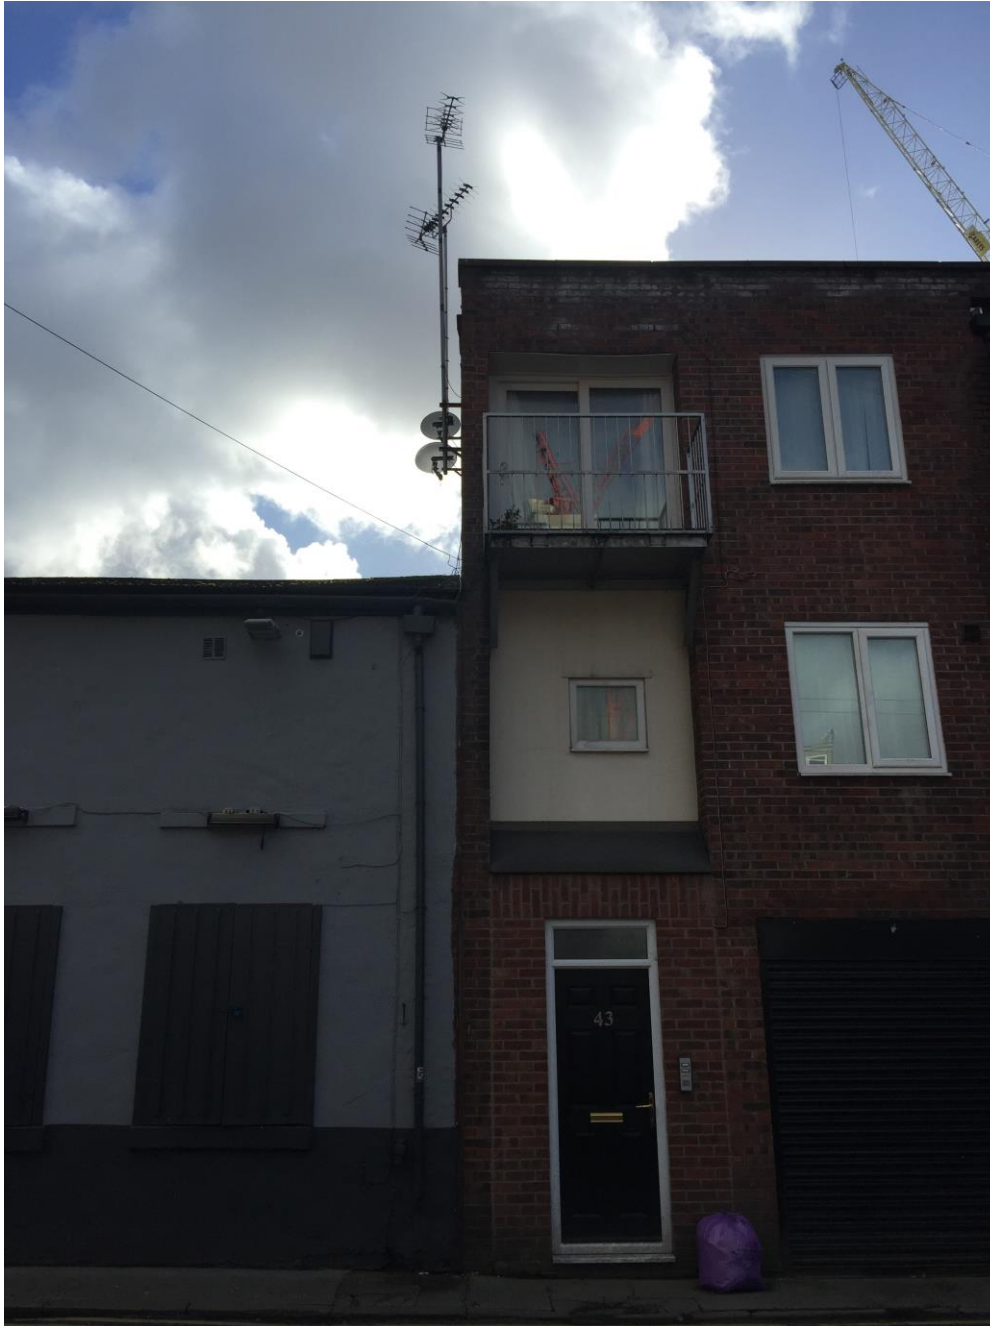
## VISIBLE TV AERIAL LOCATED IN THE AREA OF TEST POINT 3a

**Visible Existing Aerial Arrays:** high gain aerials on 2m and 3m masts, mounted at rooftop height on 3 storey properties, directed towards the Winter Hill Transmitter

**Visible Existing Obstructions:** Various multi-storey buildings in the general direction of the Winter Hill Transmitter

Television reception has low signal strengths and corruption is being received

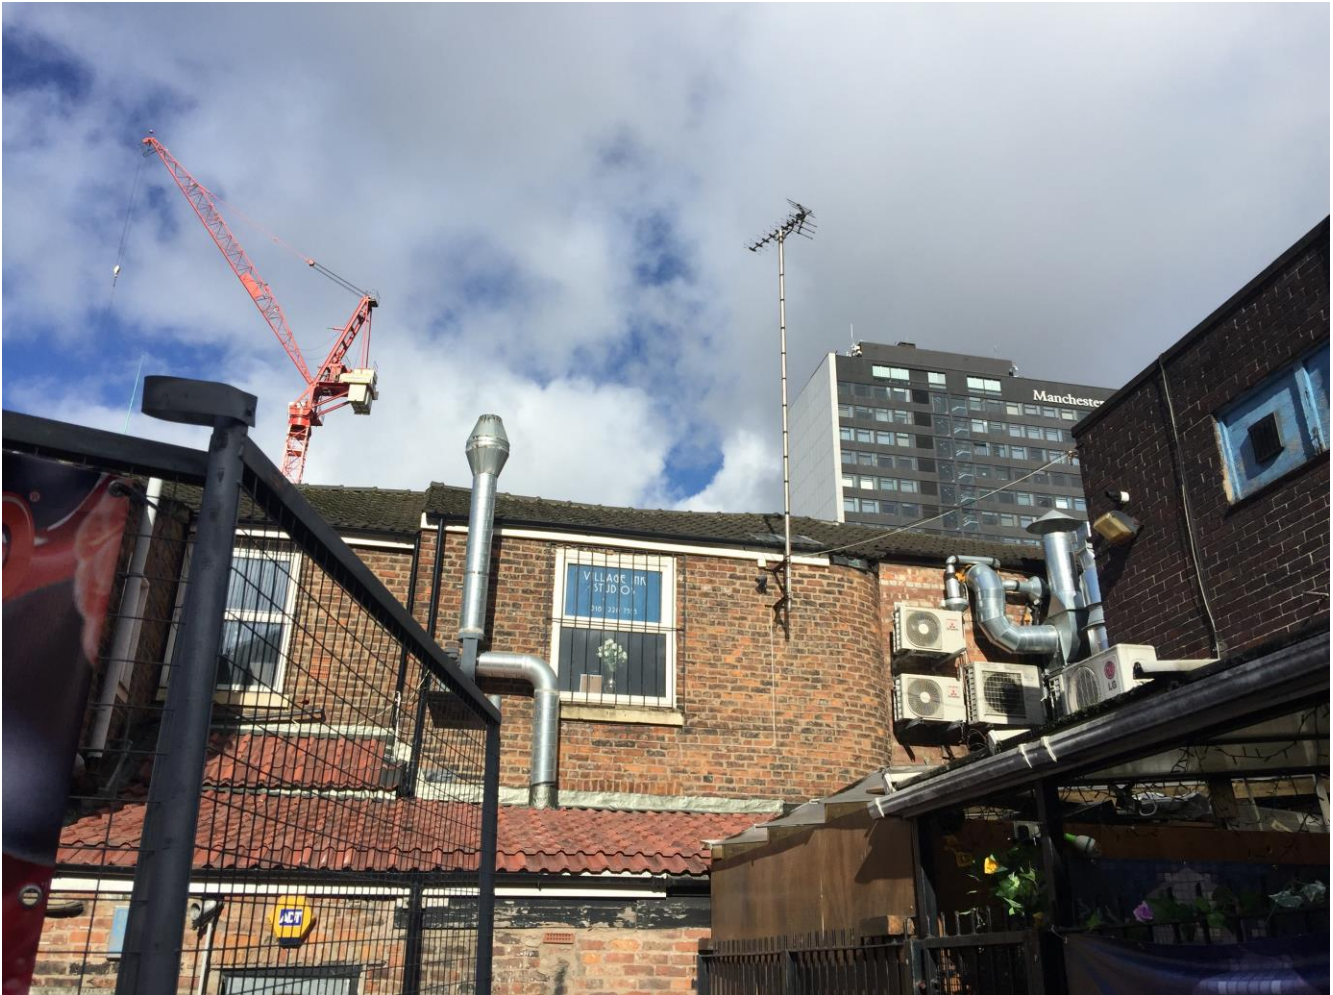
## VISIBLE TV AERIAL LOCATED IN THE AREA OF TEST POINT 4a

**Visible Existing Aerial Arrays:** high gain aerials on 3m masts, mounted at rooftop height on 2 storey properties, directed towards the Winter Hill Transmitter

**Visible Existing Obstructions:** Various multi-storey buildings/Land in the general direction of the Winter Hill Transmitter

Television reception is of an acceptable quality and strength

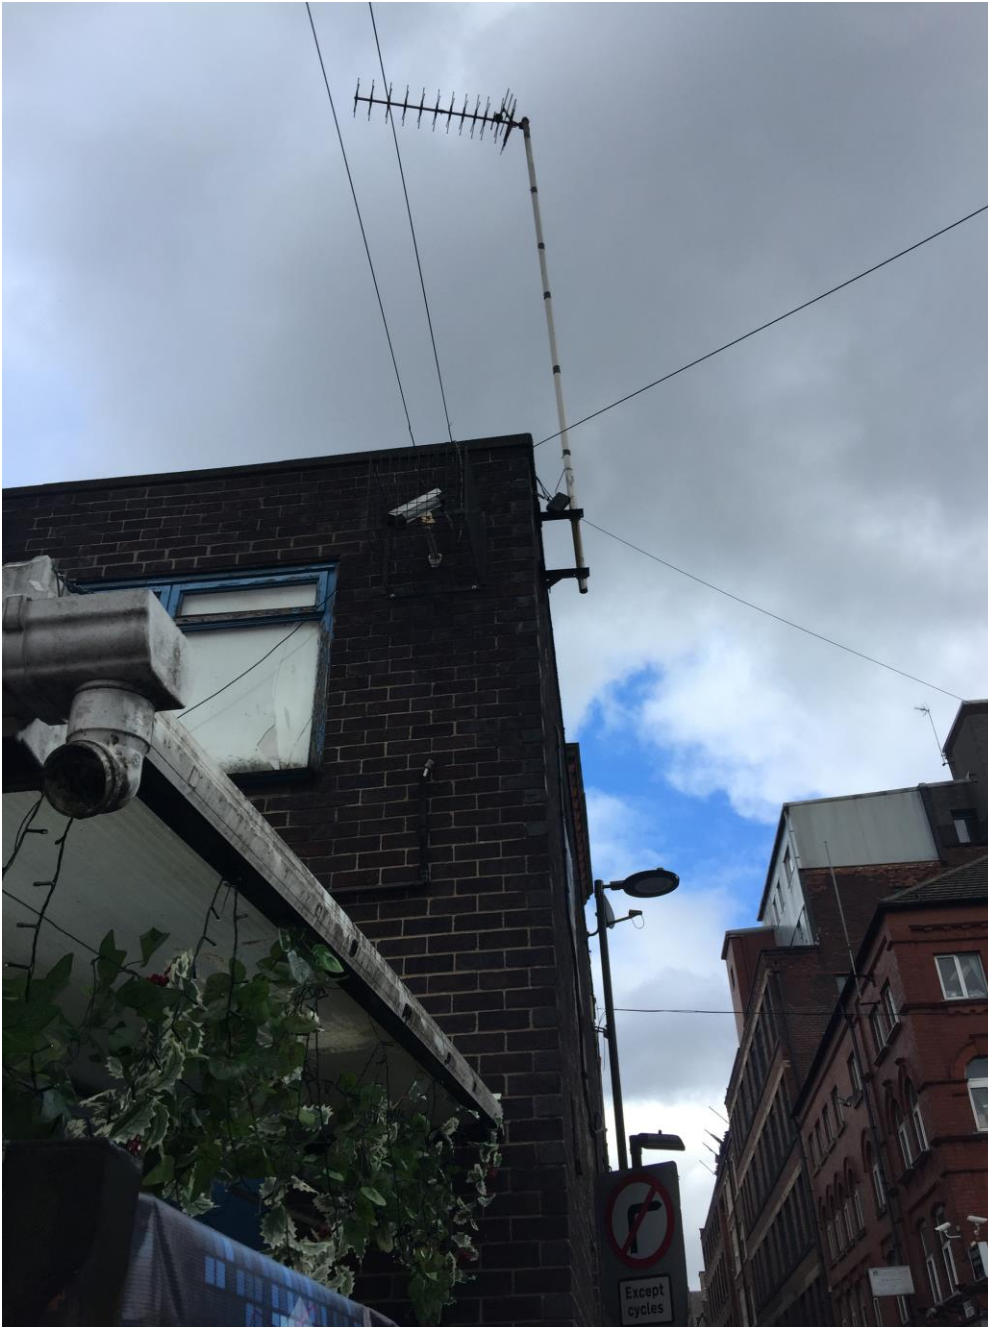
## VISIBLE TV AERIAL LOCATED IN THE AREA OF TEST POINT 5a

**Visible Existing Aerial Arrays:** high gain aerials on 3m masts, mounted at rooftop height on 2 storey properties, directed towards the Winter Hill Transmitter

**Visible Existing Obstructions:** Various multi-storey buildings in the general direction of the Winter Hill Transmitter

Television reception has low signal strengths and corruption is being received

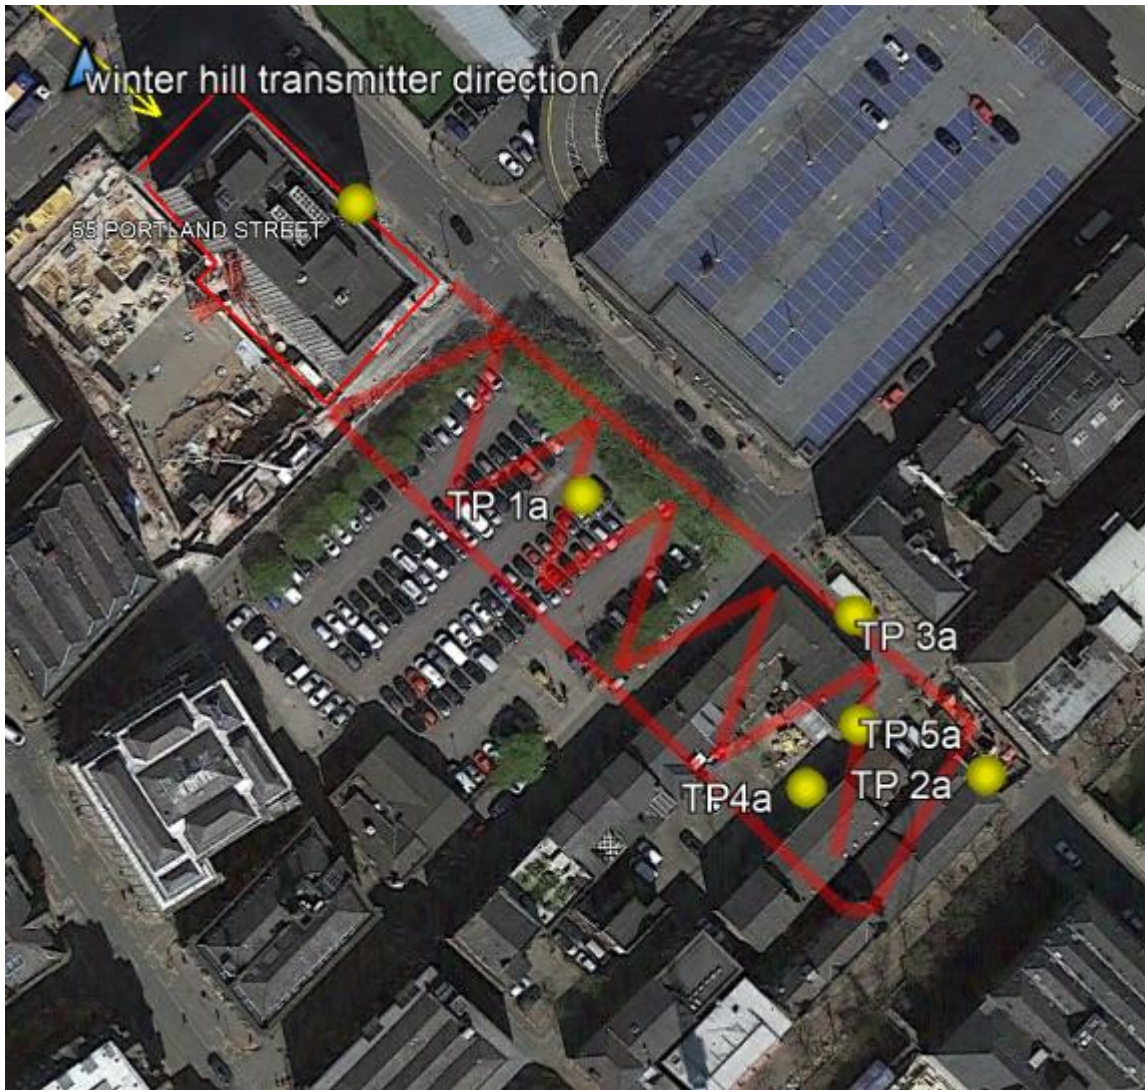
## POTENTIAL IMPACT ZONE – MAP 1

There will be a minimal increase in impact, and this zone although minor could slightly affect terrestrial television reception, this covers an area to the southeast of the development.

Most of the potential impact zone covers a Car Park area where we do not envisage any issues.

However, a portion of the potential impact zone covers a small area of bloom street/ and Richmond street and subsequently mitigation may be required. (please see Potential Impact 1)

Please refer to the Mitigation section of the Original report 2017 for possible remedies to rectifying terrestrial television reception issues.
