## Phase 1 GeoEnvironmental Desk Study

Penzance Street

Manchester

**Report No. A4353/21**

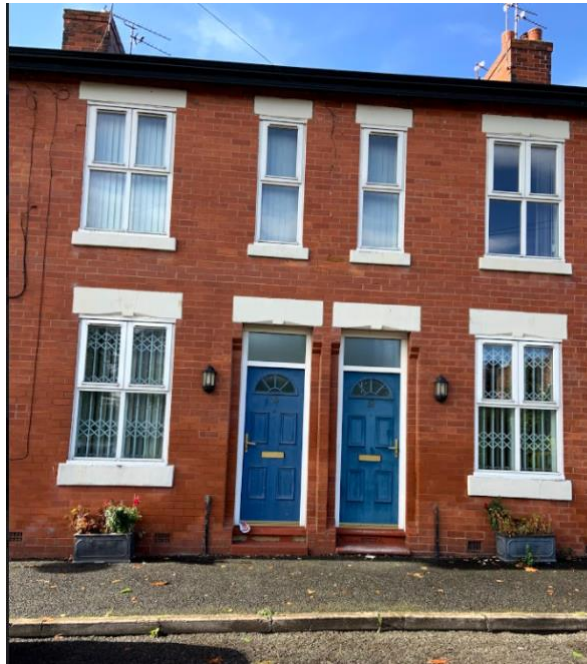
**Figure 3 Site Photograph**

- 2.1 The site is in Miles Platting, Manchester approximately 2.7km from Manchester City Centre. The approximate National Grid Reference for the centre of the site is SD 86447 99327 (X: 386447, Y: 399327) with the closest postcode being M40 7BD.
- 2.2 The site is a rectangular shaped parcel of land with current access via Highfield Park to the south of the site. The maximum dimensions of the proposed site are 8.8m north to south and 14.5m west to east. The site occupies an area of approximately 0.01 hectares.
- 2.3 The site is currently occupied by terraced houses with site access via Penzance Street.
- 2.4 The general surrounding area comprises predominantly of residential dwellings, with Sycamore Court retirement housing located to the southeast of the site.
- 2.5 A location plan is shown below as Figure 2, together with a recent site photograph as Figure 3 (overleaf).

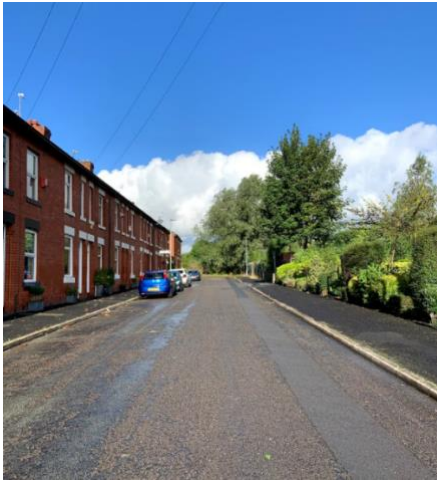
| <p><b>Plate 1 Viewing west, showing site access via Penzance Street. Note overhead cables and scar in the road (potential water supply.)</b></p> | <p><b>Plate 2 Viewing south showing front face of the site, comprised of two terraced houses.</b></p> |

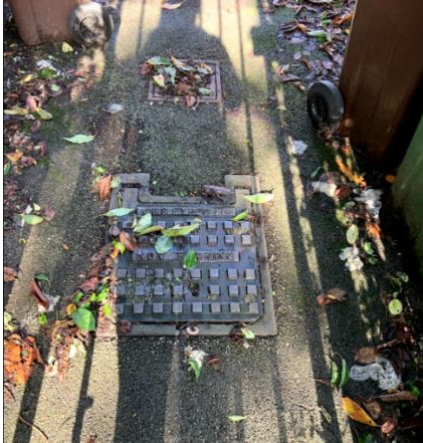
| <p><b>Plate 3 Viewing west showing unknown manholes located in alleyway on the southern boundary of the property.</b></p> | <p><b>Plate 4 Viewing east, showing Sycamore Court care home located on the eastern boundary of the site.</b></p> |

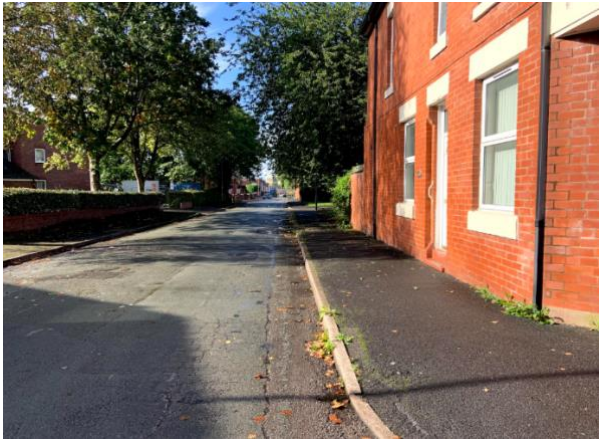
| <p><b>Plate 5 Viewing south, showing site access from Sandal Street, located east of the site. Note locked alleyway leading behind properties.</b></p> | <p><b>Plate 6 Viewing east, showing gasometer located within close proximity of the site.</b></p> |
