# London Road Fire Station, Manchester

## Phase 2 Intrusive Investigation

Curtins Ref: B061230/JB/8131

Issue Date: 27 January 2017

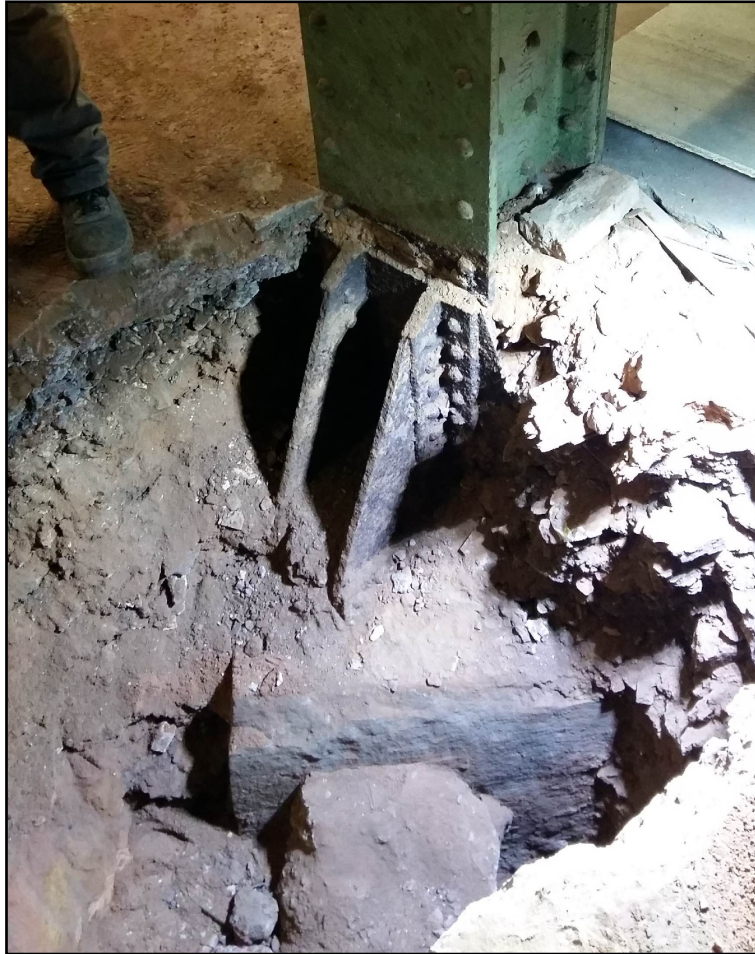
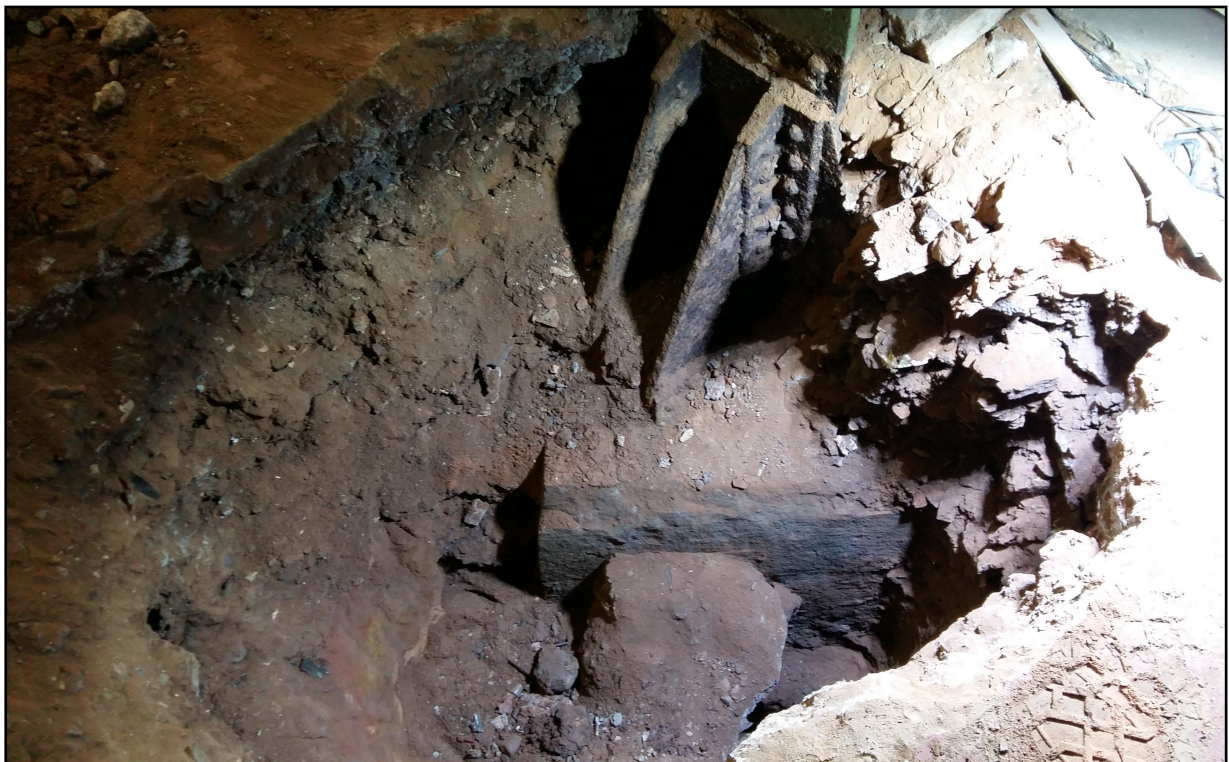
## Hand pit Photographs HP01

HP01 and HP03 encountered foundations which comprised iron columns on concrete pads; the top of the concrete pads were at 0.75m and 0.30m bgl respectively, and bases at 0.79m and 1.55m bgl respectively. A second layer of concrete in HP01 was encountered at 0.79m bgl. Overall the base of the foundations in HP01 and HP03 were at 1.90m in Made Ground and 1.37m bgl in Sand, respectively.

Additional investigations of existing foundations will need to be carried out to confirm the details of existing foundations, for structural design and to avoid clashes.
