## Planning Application for Change of Use & Extension At 120 Wilton Road, Crumpsall, Manchester

**120 WILTON ROAD  
CRUMPSALL**

**GROUND INVESTIGATION  
AND RISK ASSESSMENT  
REPORT**

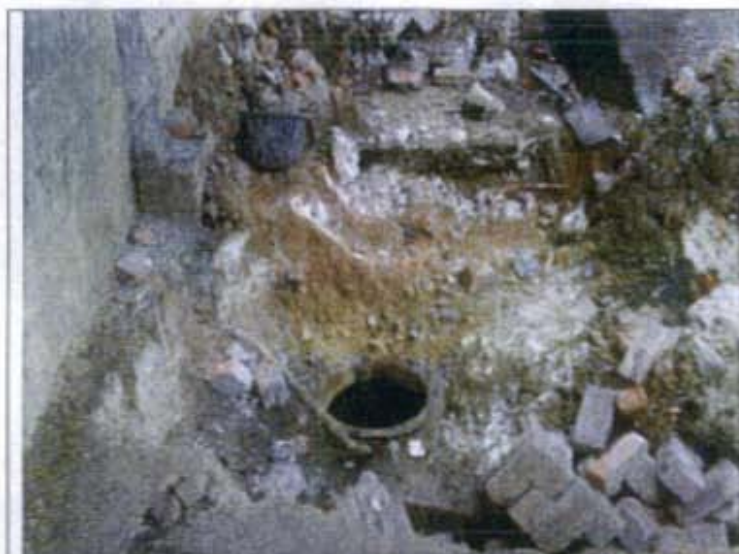
The initial site inspection indicated the tank was almost empty and approximately 1.5m in diameter by approximately 1.8m in length. The tank was encased in concrete and appeared to abut adjacent to the foundations of the retaining wall on the southern site boundary. A pipe was noted emerging from the wall however this was empty and without any discernable odour. A faint hydrocarbon smell, possibly heating oil, was noted in the fluid at the base of the tank.

**Photograph 1** Top of the tank

The tank was then sand blasted internally to bare metal. Tank-Care operatives noted that there was no re-entry of water through the tank welds following completion of sand blasting which generally indicates the tank is intact and not perforated.

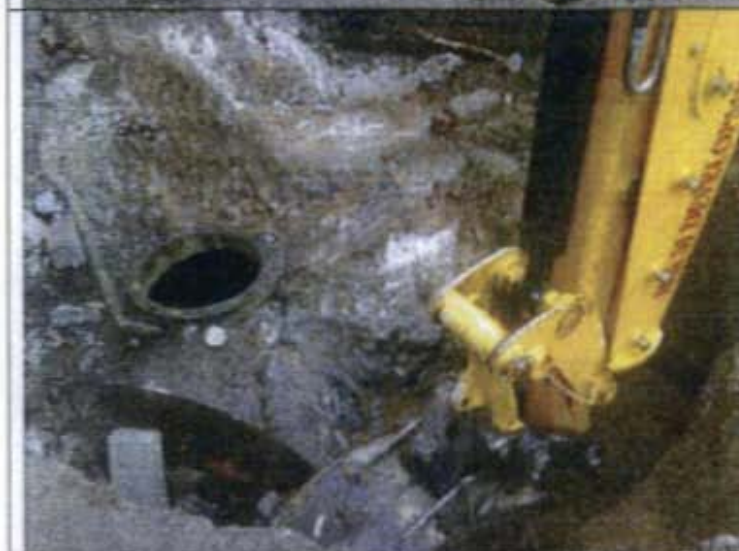
During the course of the site investigation the tank was found to be cased in concrete. No visual or olfactory evidence of hydrocarbon contamination was encountered around the tank. It should also be noted that TP103 was extended between the tank, WS3 and the existing building; however no evidence of pipework connecting the property to the tank was encountered.

**Photograph 2** Excavating around the tank to confirm extent

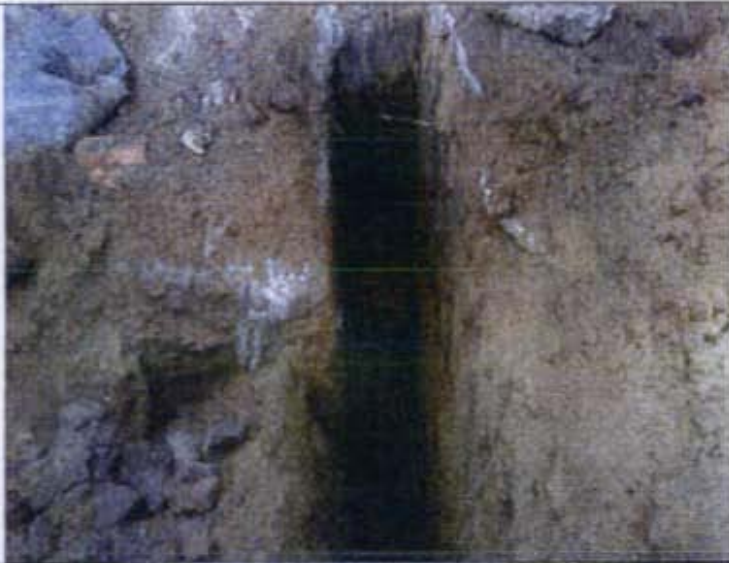
**Photograph 7** TP101 Concrete bunding can be seen at the rear face of excavation

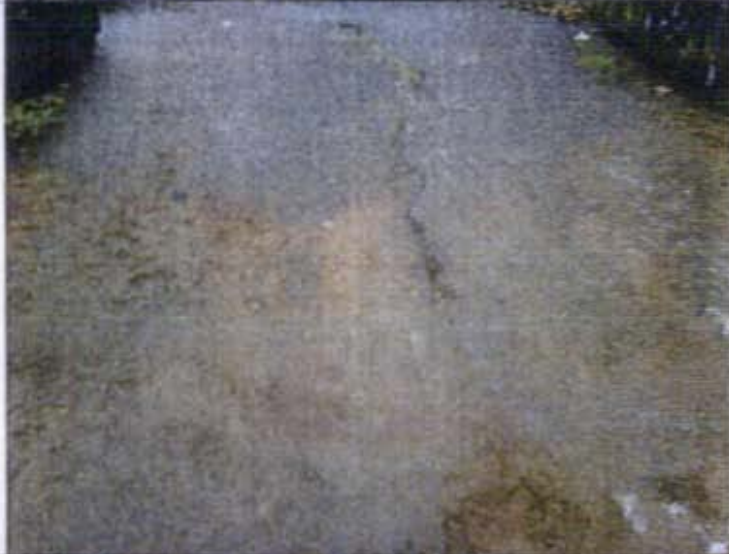
The location of WS3 with the recorded elevated concentration of Benzo(a)pyrene is considered to form part of the driveway of the new development and therefore any pollutant linkage will be broken by this hard standing capping layer.

**Photograph 8** Intact hardstanding looking east towards WS3
