Northenden Campus, Sale Road, M23 0DD

**ECOLOGICAL SURVEY AND ASSESSMENT  
(including a Licensed Bat Survey)**

May 2021

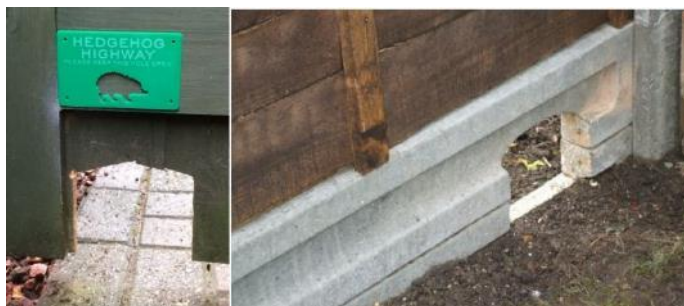
**Insert 1:** Wildlife access gaps

- i. Ensure the developed areas of the site are permeable to wildlife such as hedgehog (a Priority Species) by the installation of lifted gates and plot boundary fences and / or the accommodation of gaps to permit the passage of wildlife beneath, refer to **Insert 1**.

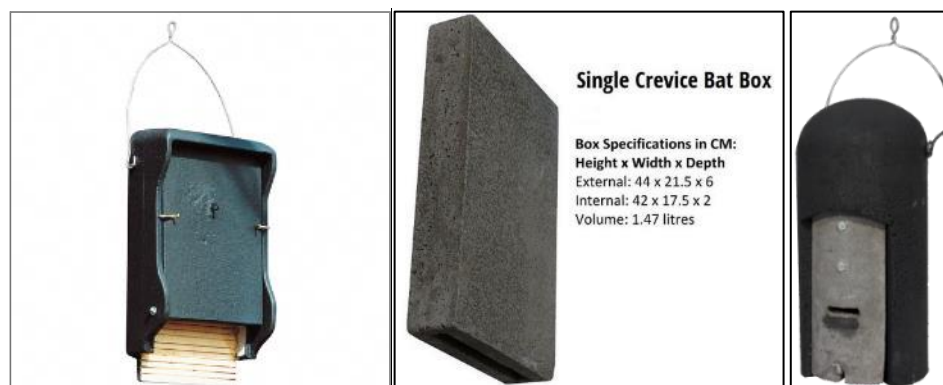
**Insert 3:** Schwegler 1FF, Greenwood Ecohabitat's single cavity and Schwegler 1FD bat boxes

- 5.6.3 In addition, it is recommended that ten bat boxes are installed on suitable retained mature trees within the site. An ecologist will advise on the siting of the bat boxes. Suitable bat boxes are the Schwegler 1FF, Greenwood Ecohabitat's single or double cavity boxes and Schwegler 1FD, see **Insert 3**, below.

- 5.6.4 Bat boxes should be installed to the following guidelines (Bat Conservation Trust, 2016):
- At least 4 metres above the ground (where safe installation is possible);
  - Sheltered from strong winds and exposed to the sun for part of the day (usually south or south-west). Ideally several bat boxes will be installed to provide a variety of different thermal options for bats. Grouping a number of boxes each with a different aspect can achieve this; while a number of boxes is preferable to one, a single box is still viable and may be used by roosting bats;
  - Located close to unlit linear features, such as lines of trees or hedgerows; and
  - Installed where the bat box entrance is not cluttered or impeded by branches, or accessible to predators (such as cats) by large branches underneath them.

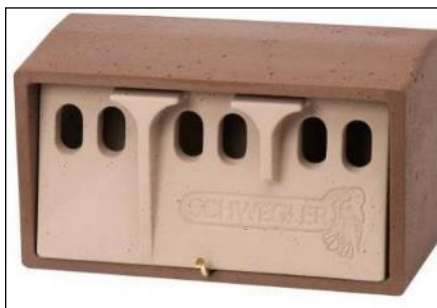
**Insert 4:** Schwegler 1SP House Sparrow Nesting Terrace

- 5.7.3 House sparrows are associated with suburban areas. Monitoring suggests a severe decline in the UK house sparrow population, estimated as halving in rural areas, and dropping by 60% in towns and cities since the mid-1970's (RSPB, 2018).
- 5.7.4 The installation of 15 house sparrow terrace nest boxes is recommended at the proposed new housing. The boxes will not be positioned over windows or doorways where droppings may become a nuisance. RSPB advice states that boxes should ideally be sited facing north to east, to avoid exposure to direct sunlight, which may cause overheating of chicks in the nest. An example of a suitable house sparrow bird box is given below at **Insert 4**.

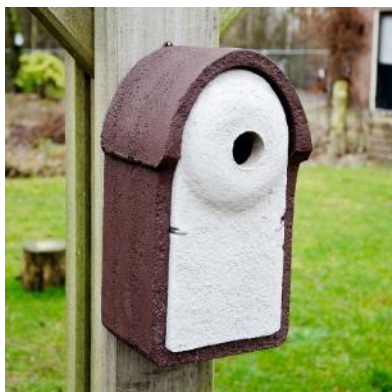
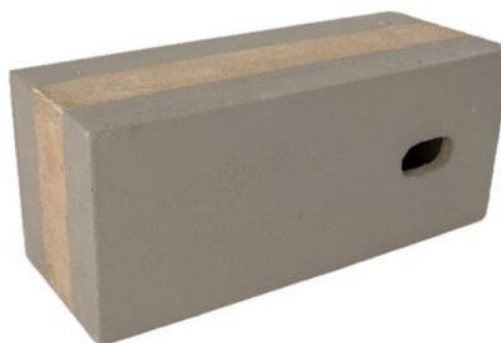
**Insert 5:** Vivara Pro WoodStone Starling Nest Box (left) and Vivara Pro Woodstone build-in swift nest box (right)

- 5.7.5 Starling and swift nest boxes should be installed at the properties (5 of each box type throughout the development). Starling boxes should be placed at least 3 metres from ground level, and swift boxes should be placed at least 4 metres from the ground beneath the eaves. An ecologist will advise on the siting of boxes once the proposals have been finalised. Examples of suitable boxes are given at **Insert 5**, below.

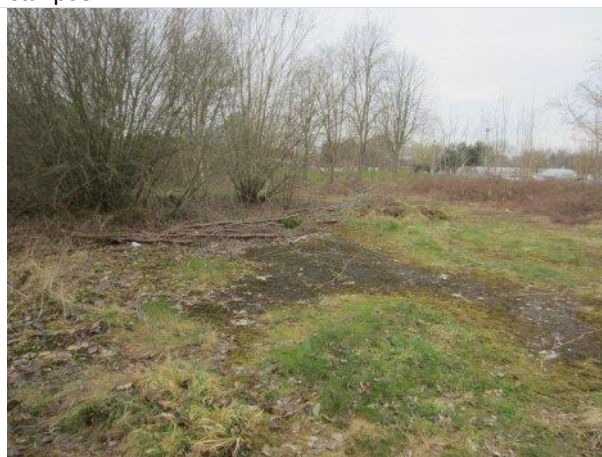
**Photo 6:** TN2: Self-seeded scrub and sparse ruderal vegetation over former car park

- 3.2.15 Refer to **Photo 6**. Approximately in the centre of the western margin of the site is an area of unmanaged self-seeded scrub that occupies an area of approximately 0.26 hectares and is the site of a former car park area.
- 3.2.16 Gaps in the hard-standing and former verges of the car park are colonised by self-seeded Goat Willow, Butterfly Bush (*Buddleia davidii*) and Silver Birch. Ivy is locally abundant with occasional plants of Herb-Robert (*Geranium robertianum*), Common Mouse-ear (*Cerastium fontanum*), Ash (*Fraxinus excelsior*) saplings, Common Ragwort (*Senecio jacobaea*) and Evening Primrose (*Oenothera biennis*).
- 3.2.17 A plant species list for scrub at the western boundary is appended at **Table 9.3**.

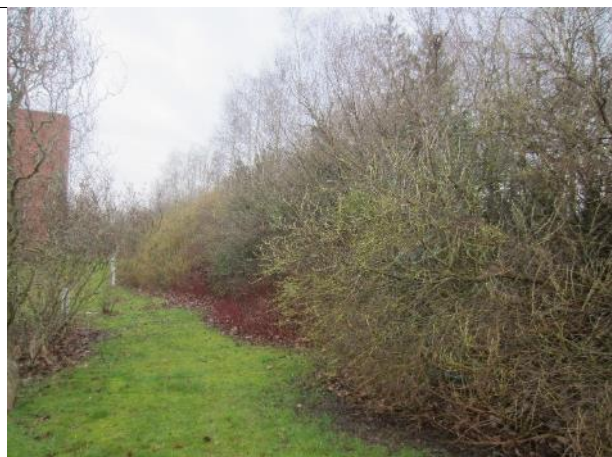
**Photo 7:** TN3: Young planted trees on raised mound at the eastern boundary (north)

- 3.2.18 Refer to **Photo 7**. At the north-eastern corner of the site is a steep sided raised bund of earth with planted trees and shrubs. The dense trees and shrubs are characterised by abundant Silver Birch and Hawthorn

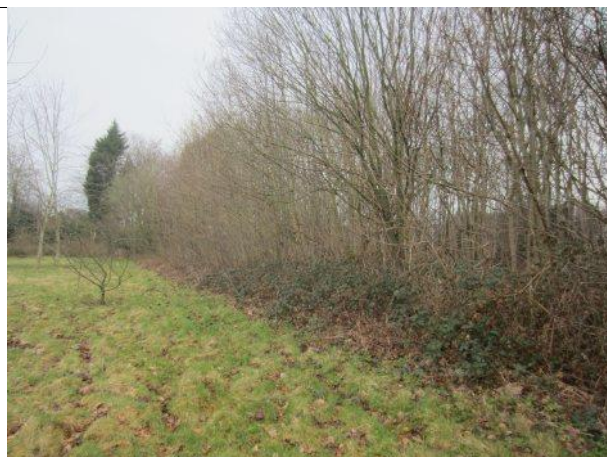
**Photo 8:** TN4: Young planted trees at the eastern boundary (south)

3.2.21 Refer to **Photo 8**. The southern section of the eastern site boundary is occupied by a low earth bund with a linear belt of plantation woodland of young trees and scrub that forms a barrier between the adjacent wooded belt along Princess Parkway (A5103) dual carriageway and the residential properties, and the site.

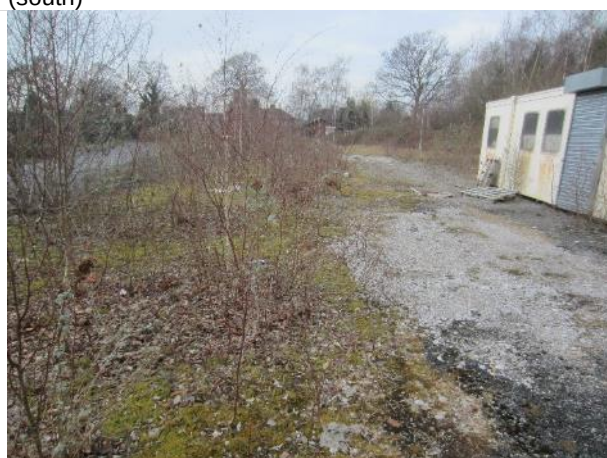
**Photo 10:** Sparse ruderal herbs over compacted ground at TN5

3.2.24 Refer to **Photo 10**. An area of compacted ground to the east of building B4 is colonised by sparse ruderal herbs characterised by typically early colonising species comprising frequent Red Fescue (*Festuca rubra*), Common Mugwort (*Artemisia vulgaris*), Yorkshire-fog (*Holcus lanatus*), Herb-Robert, Dove's-foot Crane's-bill (*Geranium mole*) and Perforate St. John's-wort (*Hypericum perforatum*). Butterfly Bush and Goat Willow and Grey Willow saplings are frequent.

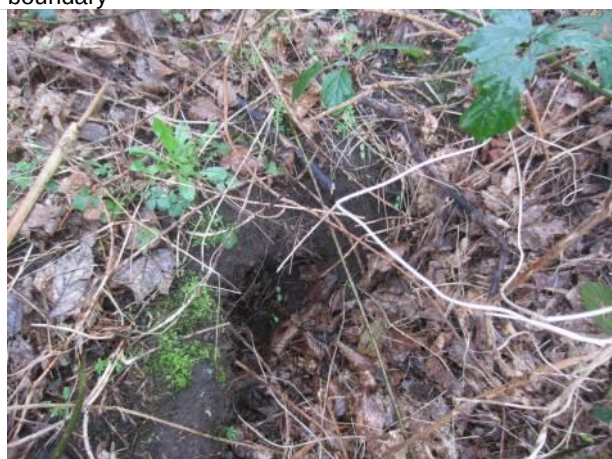
**Photo 11:** Mammal hole 1 at the north-western corner

3.3.2 Investigations of the holes by Ascerta in 2017 (including the use of a camera trap between 9<sup>th</sup> and 30<sup>th</sup> August 2017) did not detect evidence of use by badger (Ascerta, 2018), although updated surveys were recommended.

- 3.3.3 The two holes located in 2017 by Ascerta were re-located in March 2021 refer to **Photos 11** and **12**. No badger hairs were found at the entrances and no other field signs specific to badger (such as pit latrines were found). A smell of fox was present and this extended to the rear of building B4. Trampled pathways extend from the holes through the scrub to the off-site habitats to the north and west are present.

- 5.2.4 Based on the results of the 2017 and 2021 surveys at the site and the fact that the reported records of badger are on the opposite side of the M60 motorway and the River Mersey it is considered that the risk of badger colonising the site is very low. However, in accordance with the *Advice Note on the Lifespan of Ecological Reports and Surveys* (CIEEM, April 2019), if works have not commenced prior to Spring 2023, it is recommended that an updated survey for badger activity is carried out.

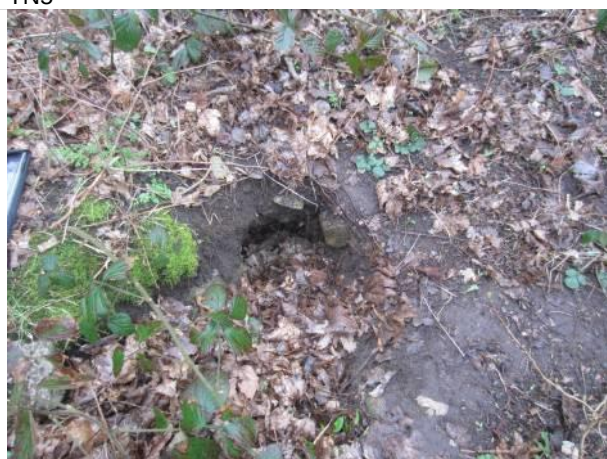
**Photo 12:** Mammal hole 2 at the north-western corner

- 3.3.5 The sticks propped up against the mammal holes during the Phase 1 survey (8<sup>th</sup> March 2021) remained in an upright position when observed on the 15<sup>th</sup> April and 19<sup>th</sup> April during the set-up and collection of the Bushnell Trophy Cam HD camera, indicating that the holes are not in use.

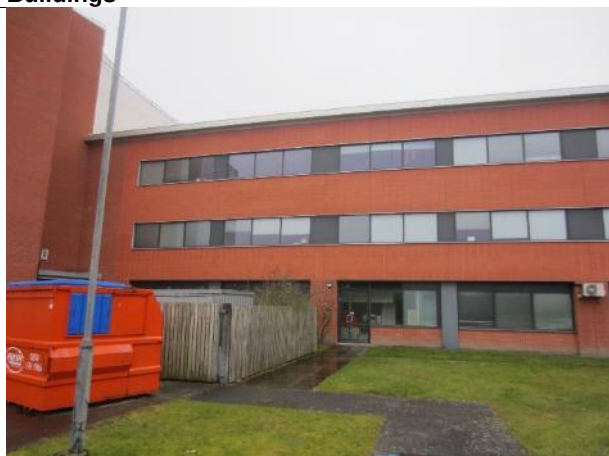
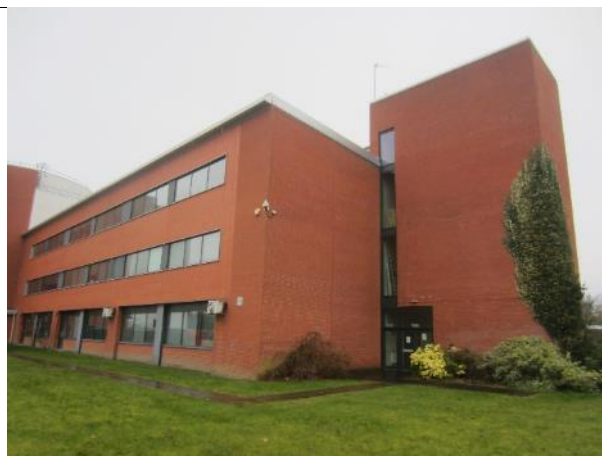
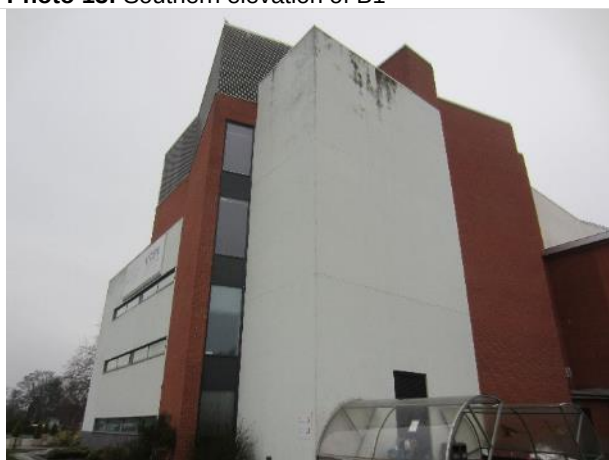
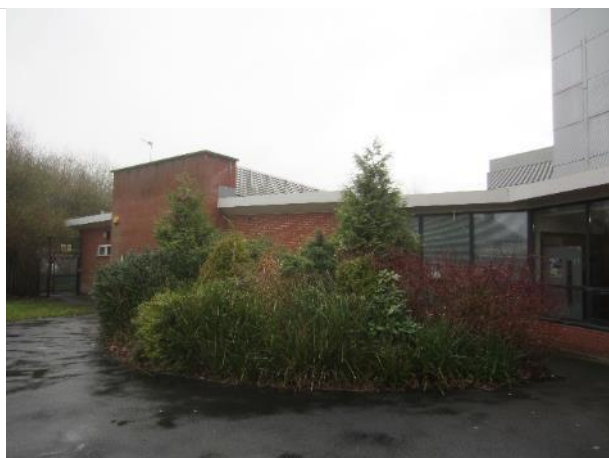
- 3.3.9 Refer to **Photos 13** to **17**. The main college building is a four storey building with elevation walls of cladding and a flat roof. The building is well-sealed and no potential roost features were found. Gaps between the bricks (perps) at the southern elevation above the fire exit door were inspected (refer to **Photo 16**); these gaps are shallow and do not lead to a cavity or a potential roost feature.
- 3.3.10 B1 and B2 are assessed to be of negligible suitability for use by roosting bats.

**Photo 13:** Southern elevation of B1

**Photo 14:** Southern and eastern elevations of B1

**Photo 15:** Western elevation of B1

**Photo 17:** Northern elevation of B2

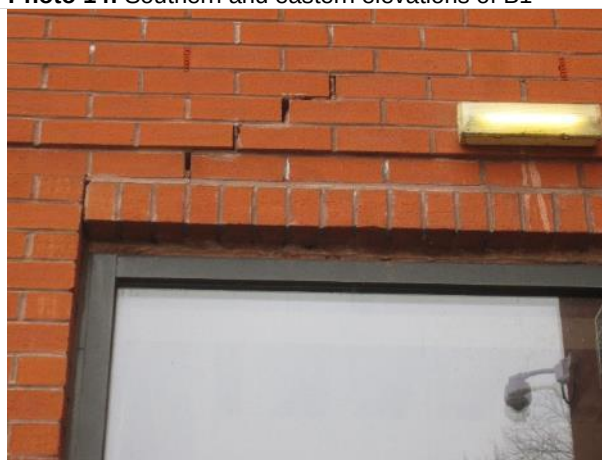
**Photo 16:** Gaps in brick work at southern elevation of B1; not a potential roost feature

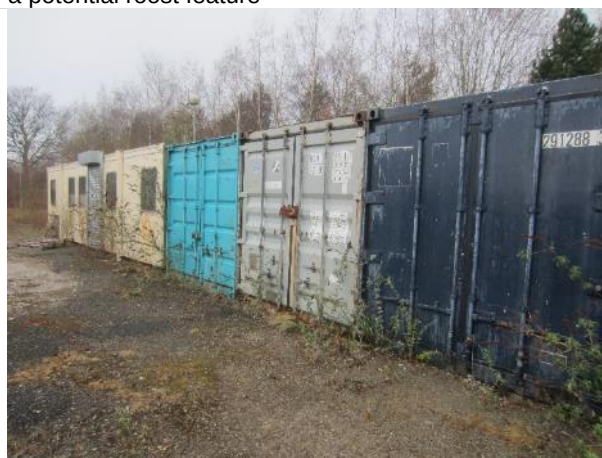
**Photo 18:** B3

- 3.3.11 Refer to **Photo 18**. B3 comprises a row of metal containers and a dilapidated portacabin. No potential roost features were found. B3 is assessed to be of negligible suitability for use by roosting bats.

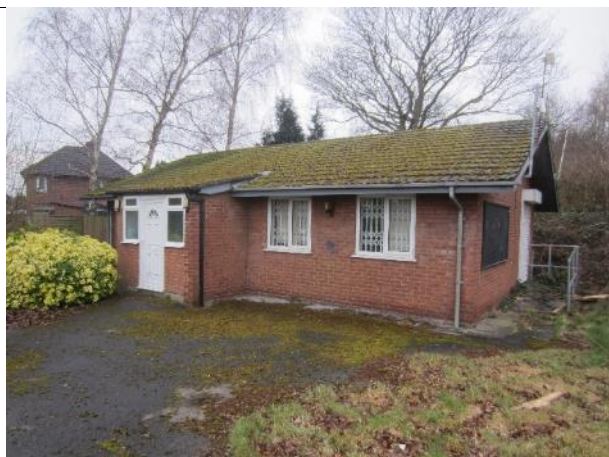
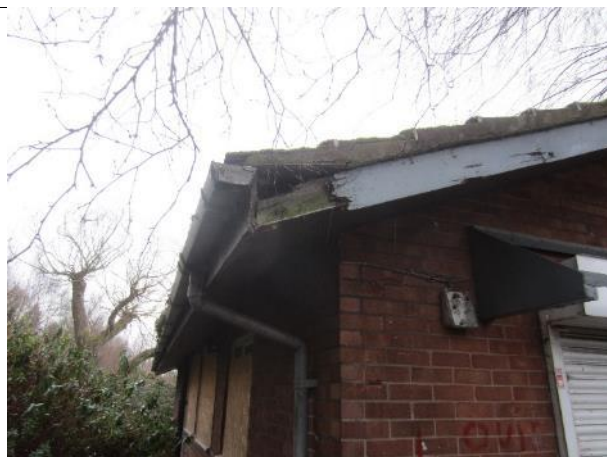
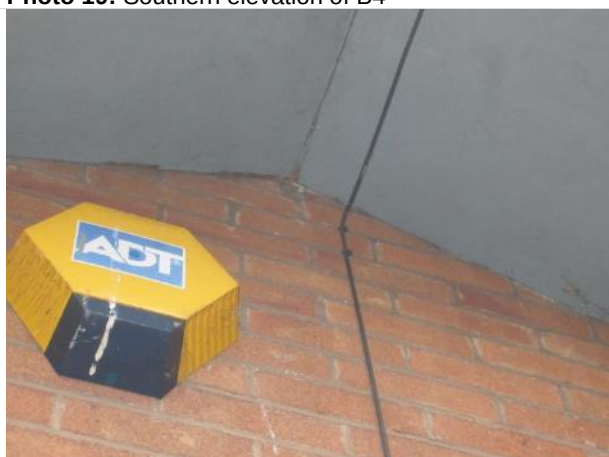
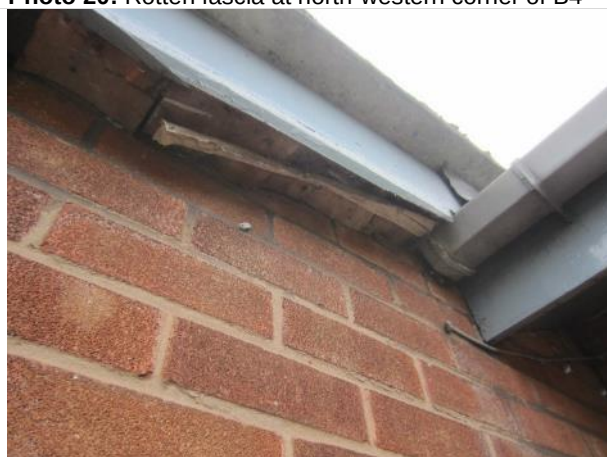
- 3.3.12 Refer to **Photos 19** to **24**. B4 is a brick bungalow with a pitched concrete tile covered roof. PVC window frames are present and timber signs are attached to the elevation walls; these are tightly sealed and provide no opportunities for bat access.
- 3.3.13 Opportunities for bat access were detected as follows:
- At a damaged / rotten soffit and fascia at the north-western corner of the building; and
  - At sections of lifted lead flashing on the roof.
- 3.3.14 One bat dropping was found adhering to the window on the southern elevation of the bungalow; the dropping is not beneath a potential roost feature (to indicate the presence of a roost) and is likely to have

**Photo 19:** Southern elevation of B4

**Photo 20:** Rotten fascia at north-western corner of B4

**Photo 21:** Sealed soffits at gable apex of B4

**Photo 22:** Rotten timber at eaves of B4

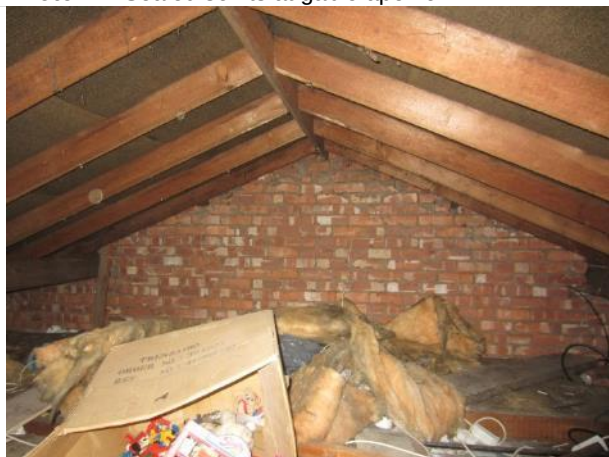
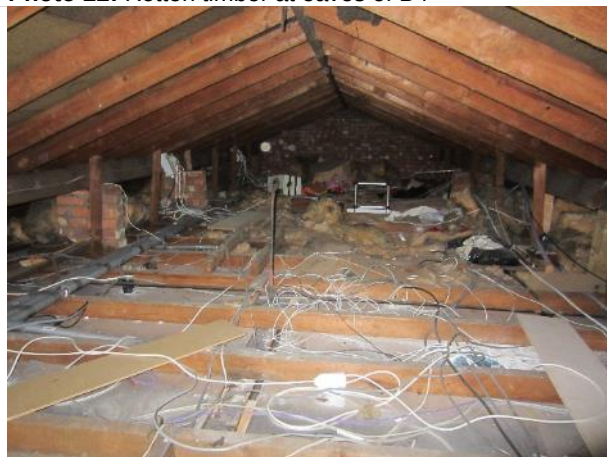
3.3.15 Inspection of the roof void confirmed the presence of a fibreglass insulation over the floor of the void and undertile felt beneath the roof tiles. No bats or bat droppings were found in the roof void. The void is illuminated by the vents above spot lights present in the rooms below.

**Photo 23:** Roof void at B4 (facing east)

**Photo 24:** Roof void at B4 (facing west)

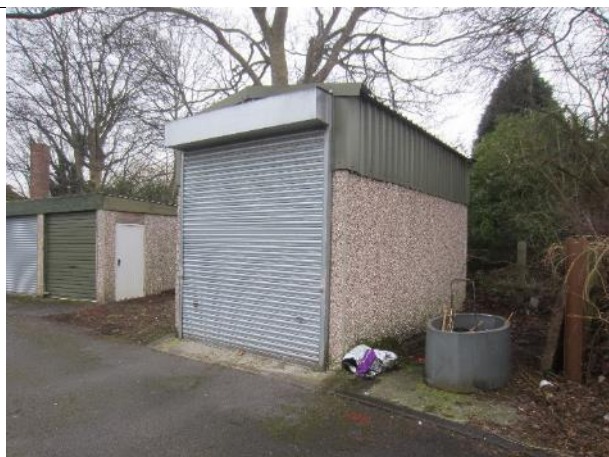
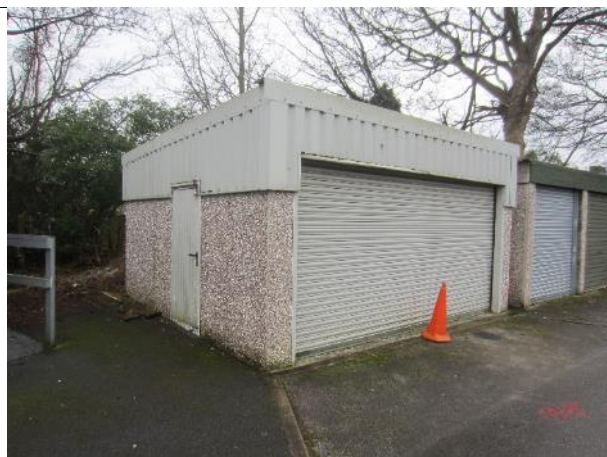
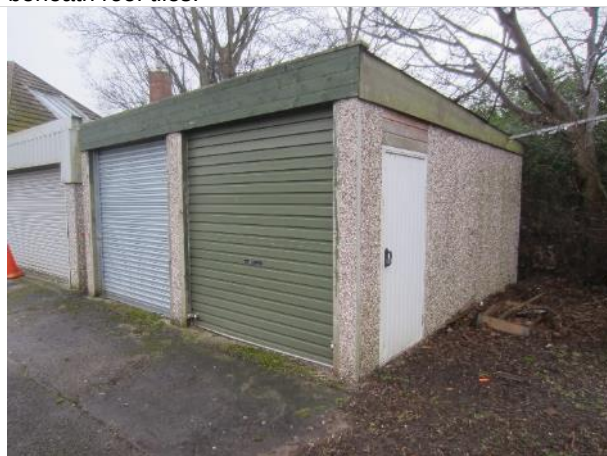
3.3.17 Refer to **Photos 25, 26 and 36**. B5, B6 and B10 are pre-fabricated single storey garages with a flat roof and corrugated metal sheeting on the elevation walls. The buildings are well-sealed and no potential roost features were found. B5, B6 and B10 are assessed to be of negligible suitability for use by roosting bats.

**Photo 25: B5**

**Photo 26: B6**

**Photo 36:** B10

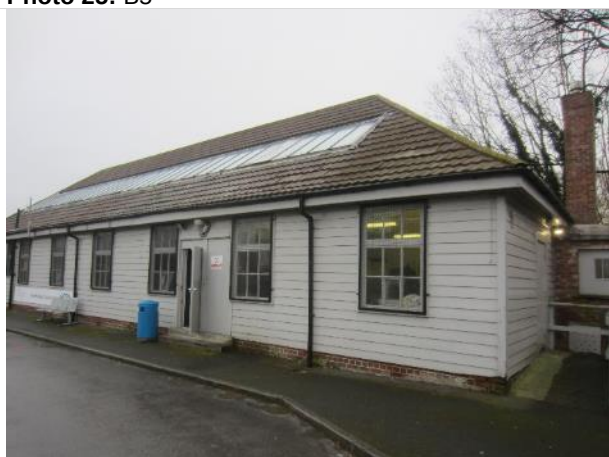
**Photo 27: North-eastern elevation of B7**

3.3.18 Refer to **Photos 27 to 31**. B7 is a single storey brick building with horizontal timber plank cladding on the elevation walls and a hipped concrete tile covered roof with glass skylights. No roof void is present and the underside of the roof tiles is clad with timber sarking.

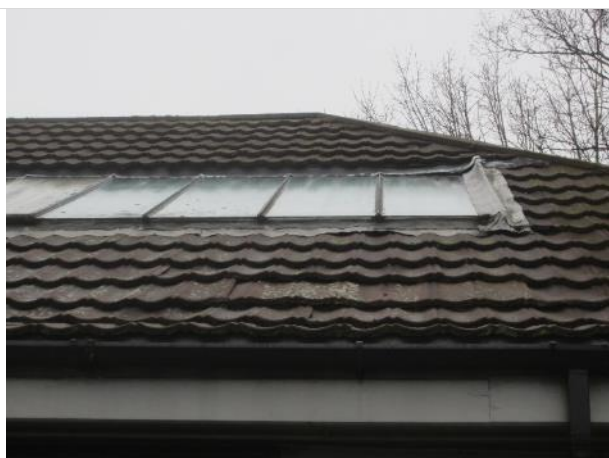
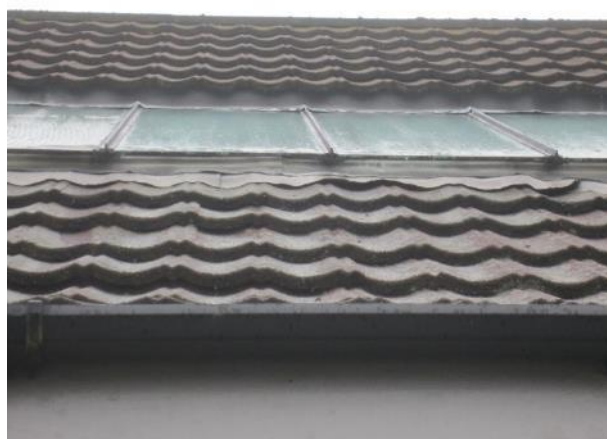
**Photo 29: Skylights and flashing at B7**

**Photo 30: Skylights and lifted flashing at B7**

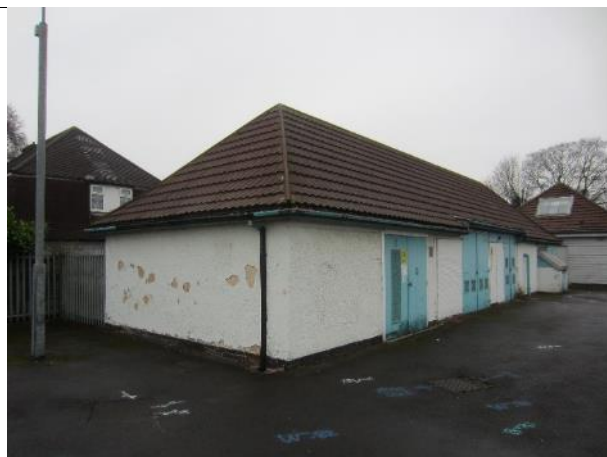
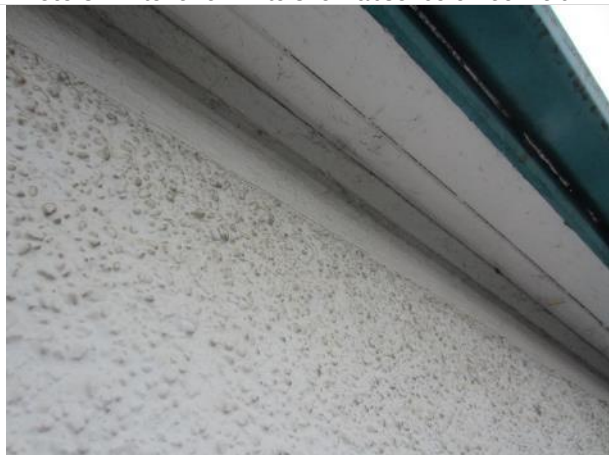
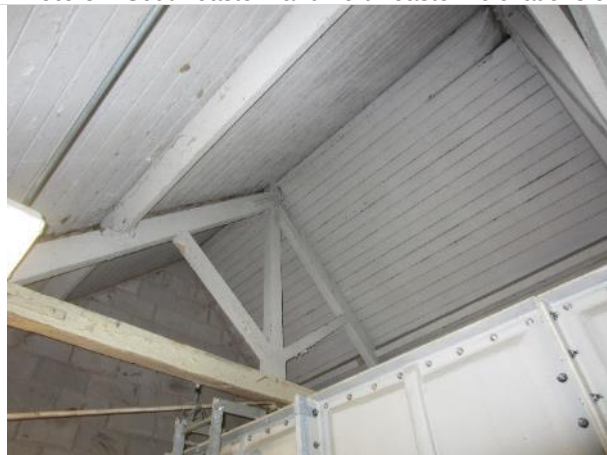
3.3.22 Refer to **Photos 32 to 36**. B8 is a single storey sub-station building with painted brick elevation walls and a hipped concrete tile covered roof. The elevation walls of the building and the soffits around the roof line are well-sealed; no potential roost features were found in these positions.

**Photo 32:** South-eastern and north-eastern elevations of B8

**Photo 33:** Sealed soffits at B8

**Photo 34:** Interior of part of B8 showing timber sarking beneath roof tiles.

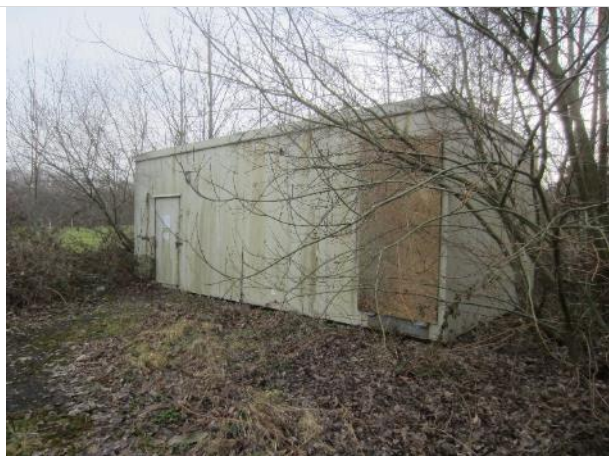
**Photo 35:** B9

3.3.26 Refer to **Photo 35**. B9 is a metal cabin with no potential roost features. B9 is assessed to be of negligible suitability for use by roosting bats.

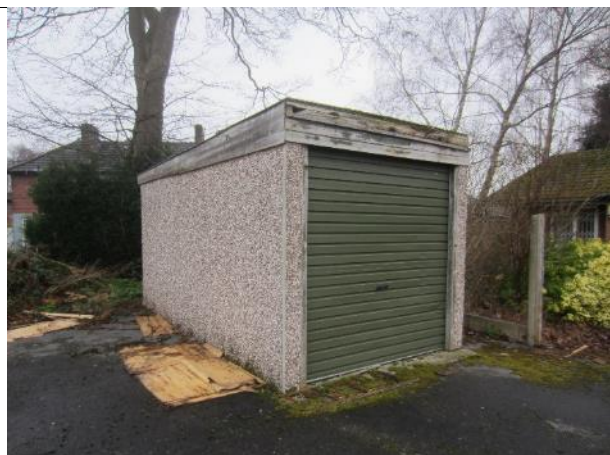
**Photo 37: B11**

3.3.27 Refer to **Photo 37**. B11 is a pre-fabricated garage with a flat timber board covered roof and timber fascia at the eaves. Inspection of the gap between the timber fascia did not detect any bats or droppings and confirmed that the fascia are wet and rotten.

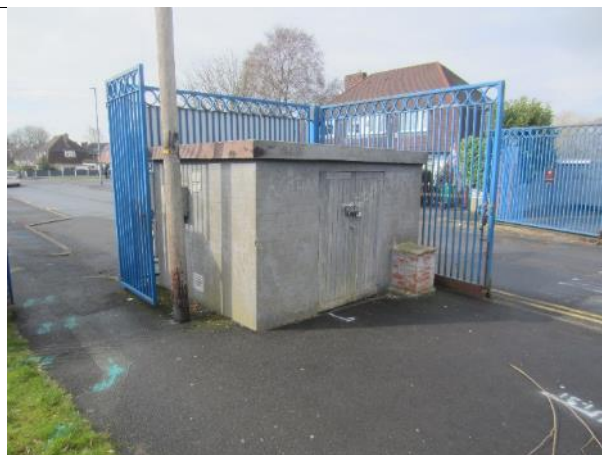
**Photo 38: B12**

- 3.3.29 Refer to **Photo 38**. B12 is a low (1.5 metres high) store with a flat concrete slab roof and with no potential roost features. B12 is assessed to be of negligible suitability for use by roosting bats.

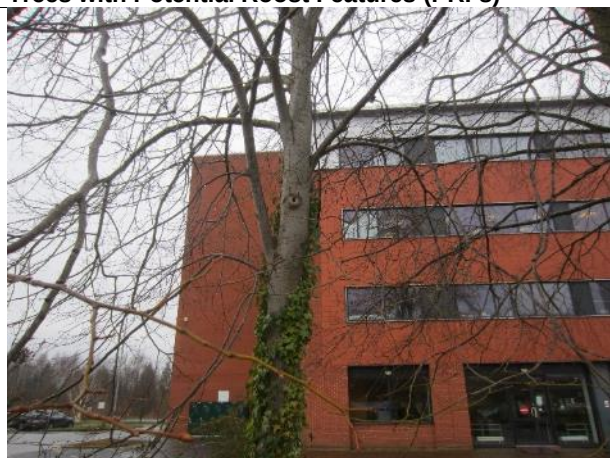
**Photo 39: T14 with blind knothole (negligible)**

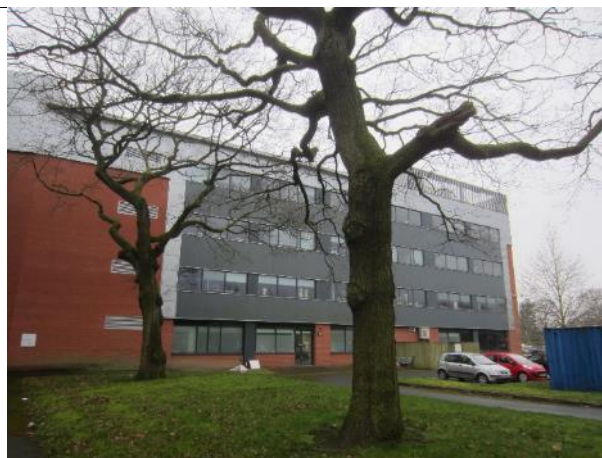
**Photo 40: Trees T1 and T2 (Two Oaks with low suitability)**

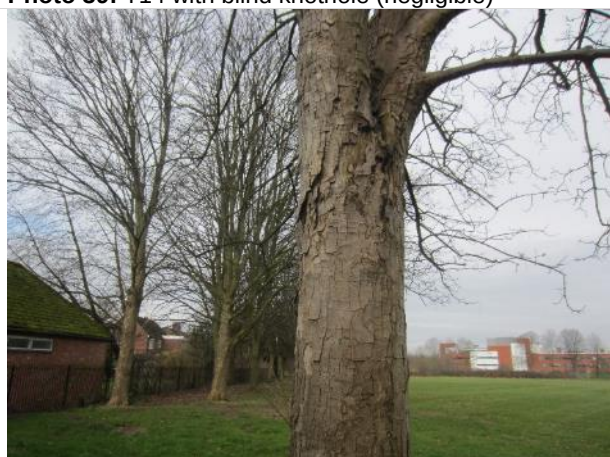
**Photo 41: Tree within G10 (Norway Maple with lifted bark – low suitability)**

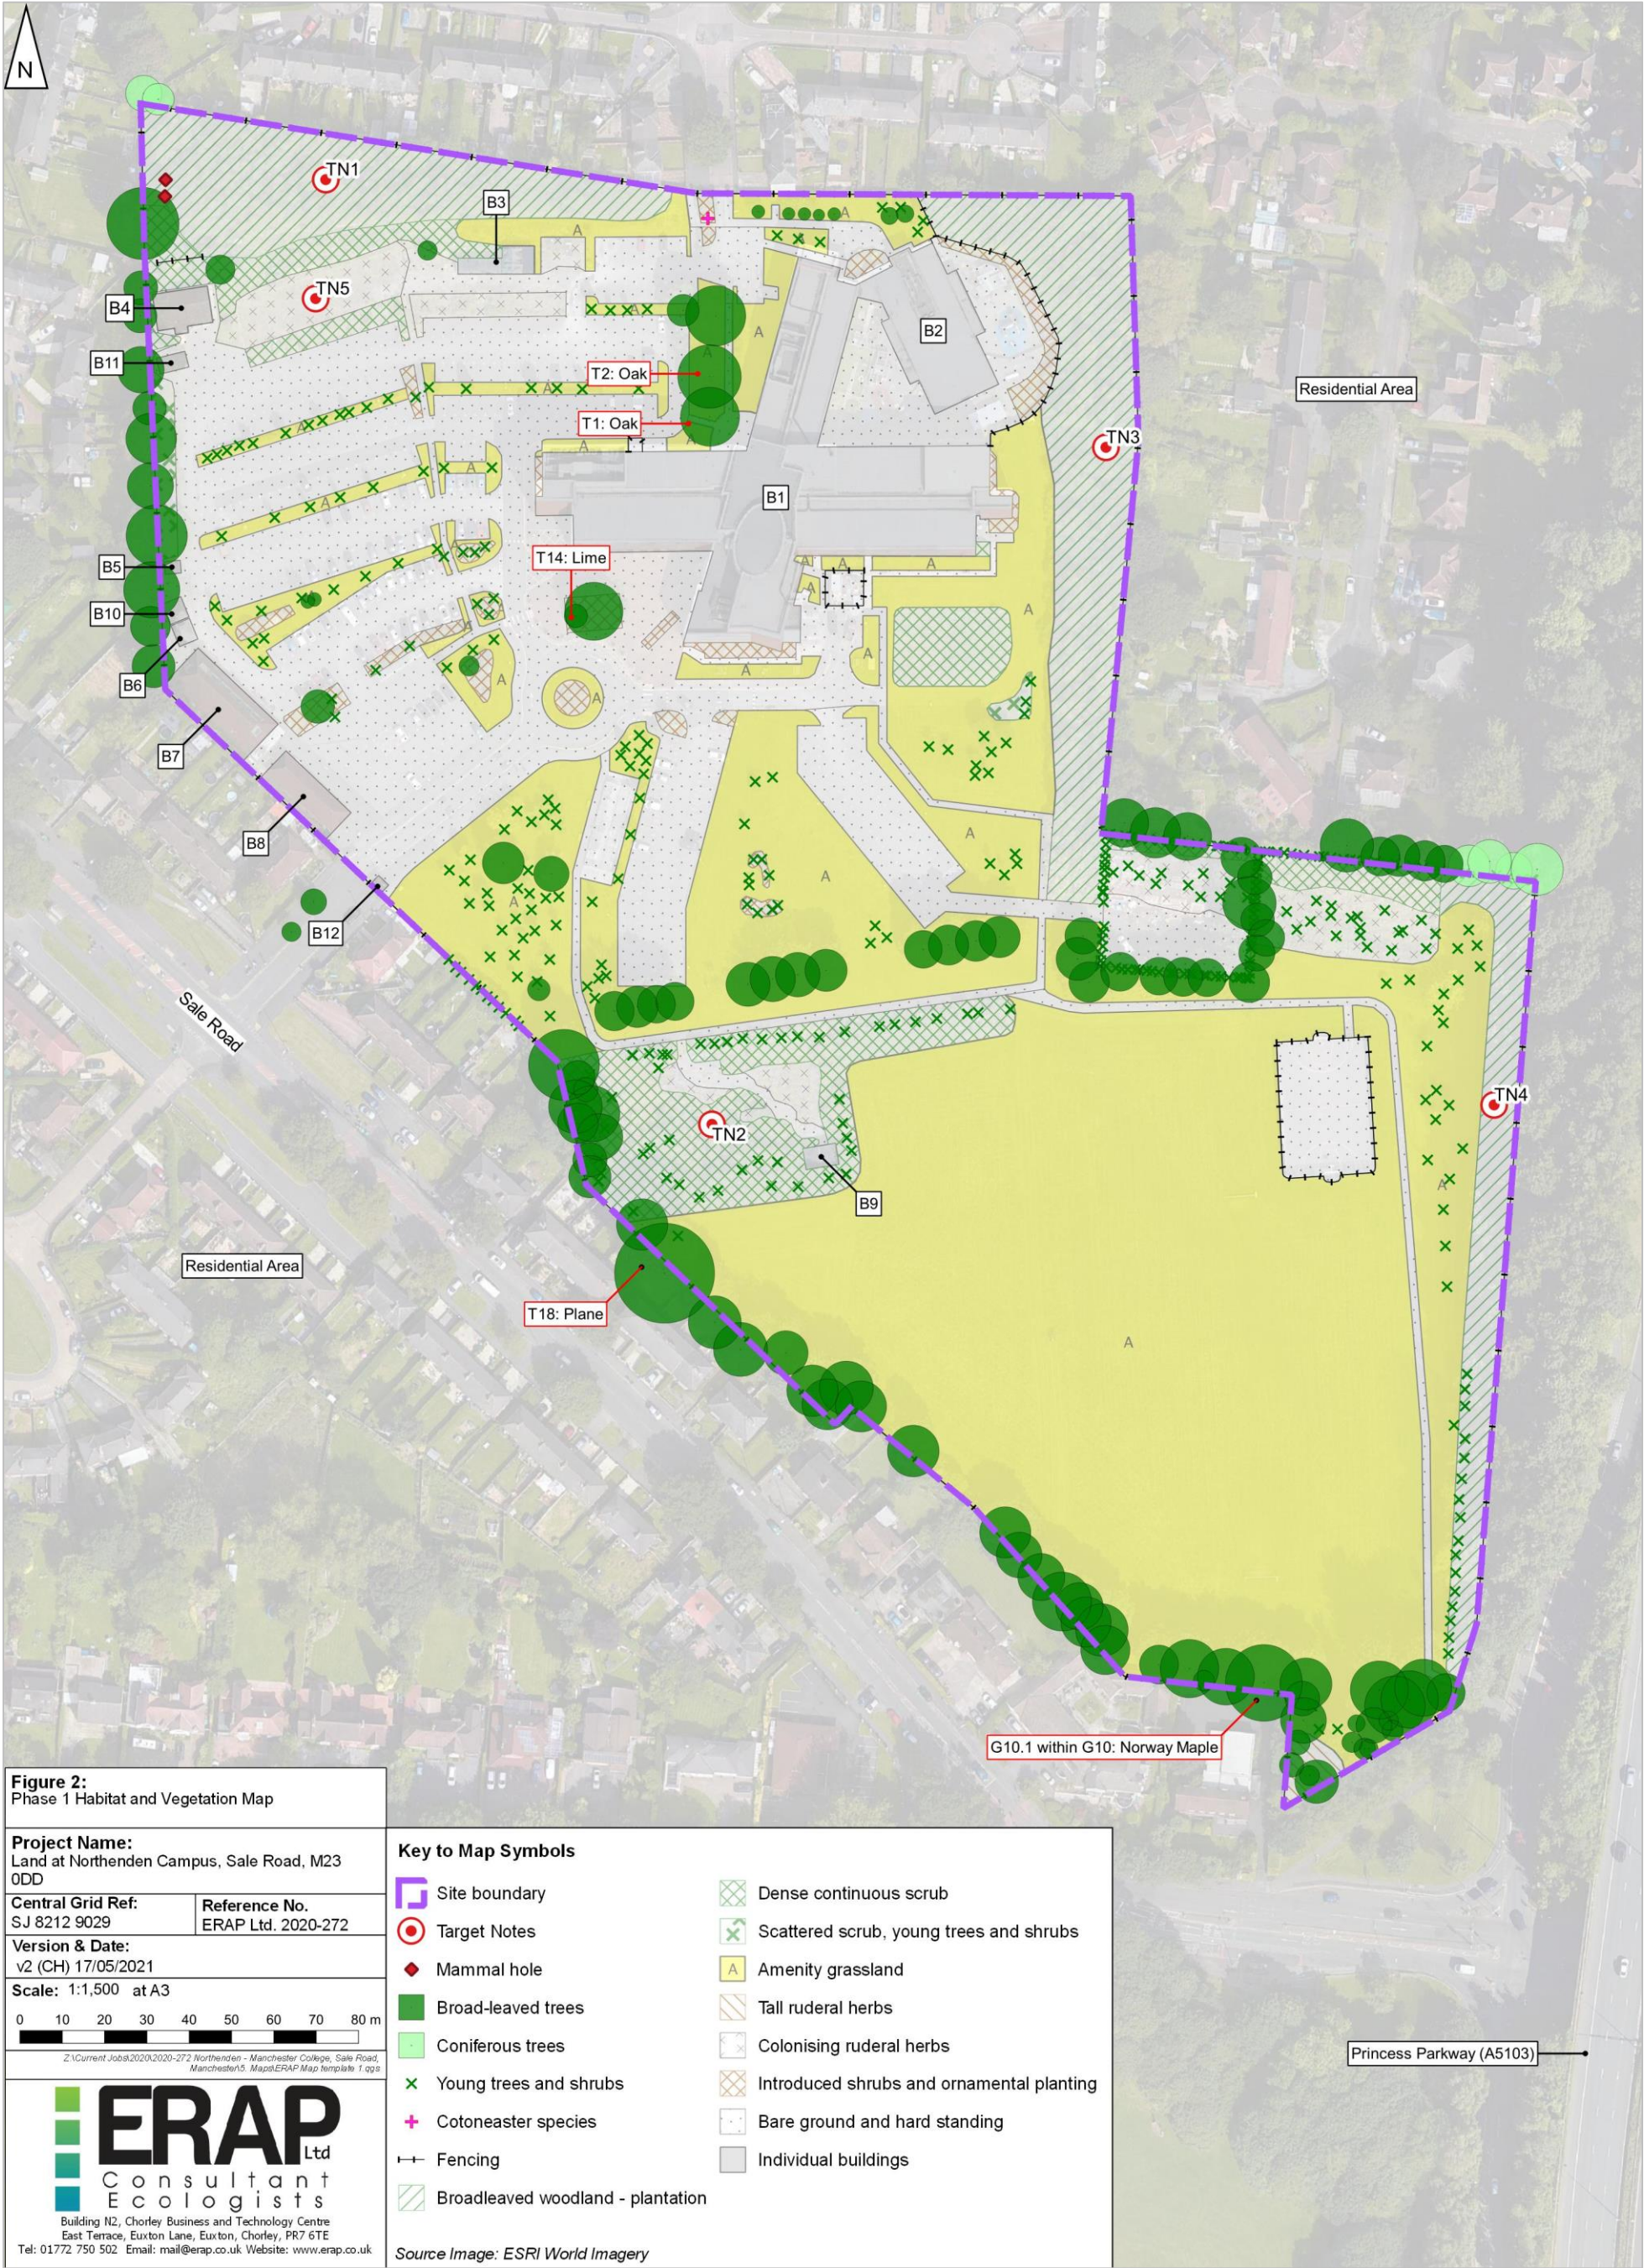
Figure 2: Phase 1 Habitat and Vegetation Map

- 2.2.2 A habitat and vegetation map was prepared for the site and the immediate surrounding area, refer to **Figure 2**. The mapping is based on the Joint Nature Conservation Committee Phase 1 Habitat Survey methodology (JNCC, 2010) with minor adjustments to illustrate and examine the habitats with greater precision.

3.2.28 As illustrated on **Figure 2**, a stand of Wall Cotoneaster was detected at the northern site boundary. Wall Cotoneaster is listed on Schedule 9 of the *Wildlife and Countryside Act 1981* (as amended); it is an offence to spread this species Cotoneaster to spread in the wild. This is considered further at **Section 4.3** below.

- 3.3.30 Five trees (T1 to T5 on **Figure 2**) at the site support features suitable for use by roosting bats, and are summarised below.
