# Desk Study & Phase I Risk Assessment.

Proposed Development at  
South View House, Nutbank Lane, Manchester M9 6BH.

Date: May 2021  
Report No: 2122-0001-DS

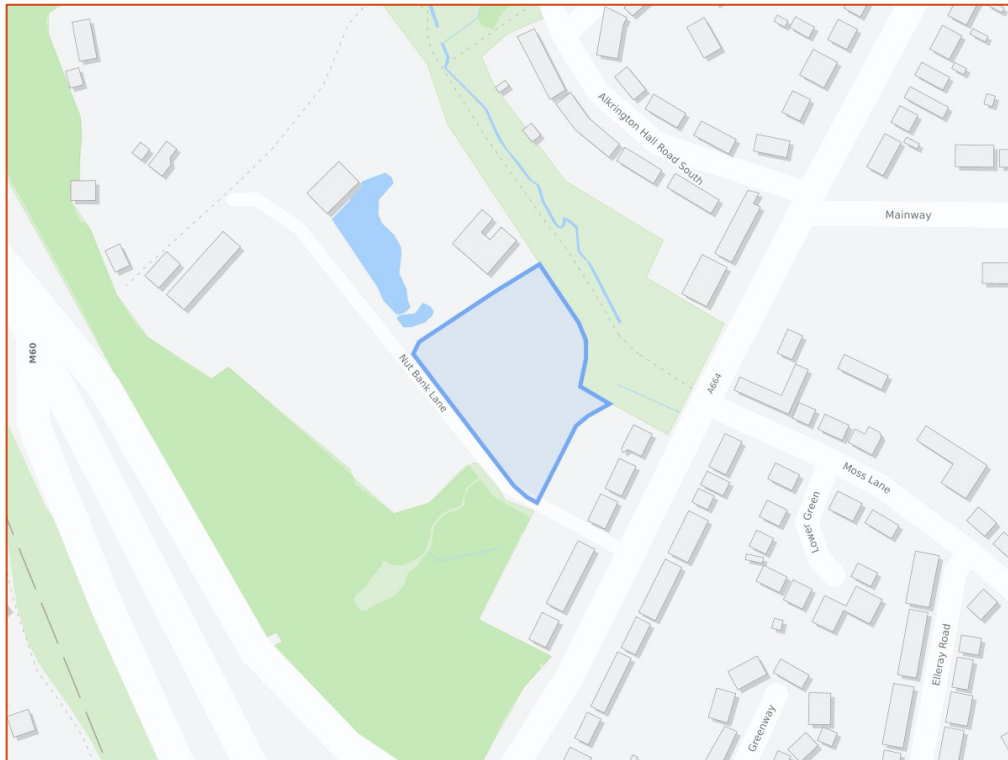
*Figure 1 Site Location Plan.*

The study site is located on the north-eastern side of Nutbank Lane, approximately 50m to the west of the A664 Manchester New Road.

The site is approximately trapezoidal in shape and covers an area of around 0.62ha.

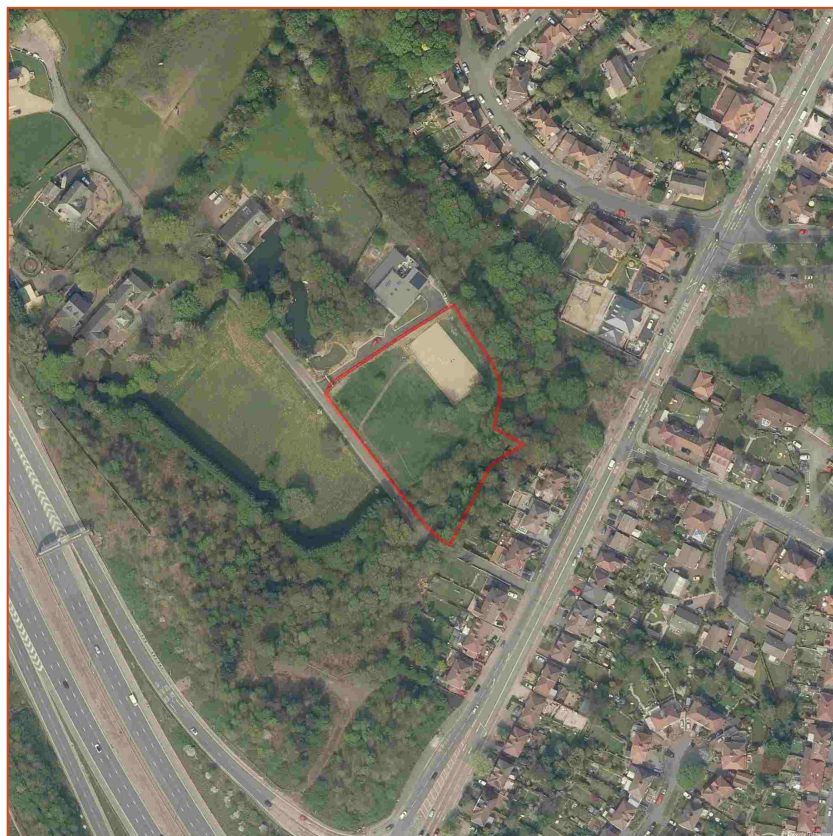
*Figure 2. Aerial Photograph.*

The site currently comprises a field/paddock and menage area.

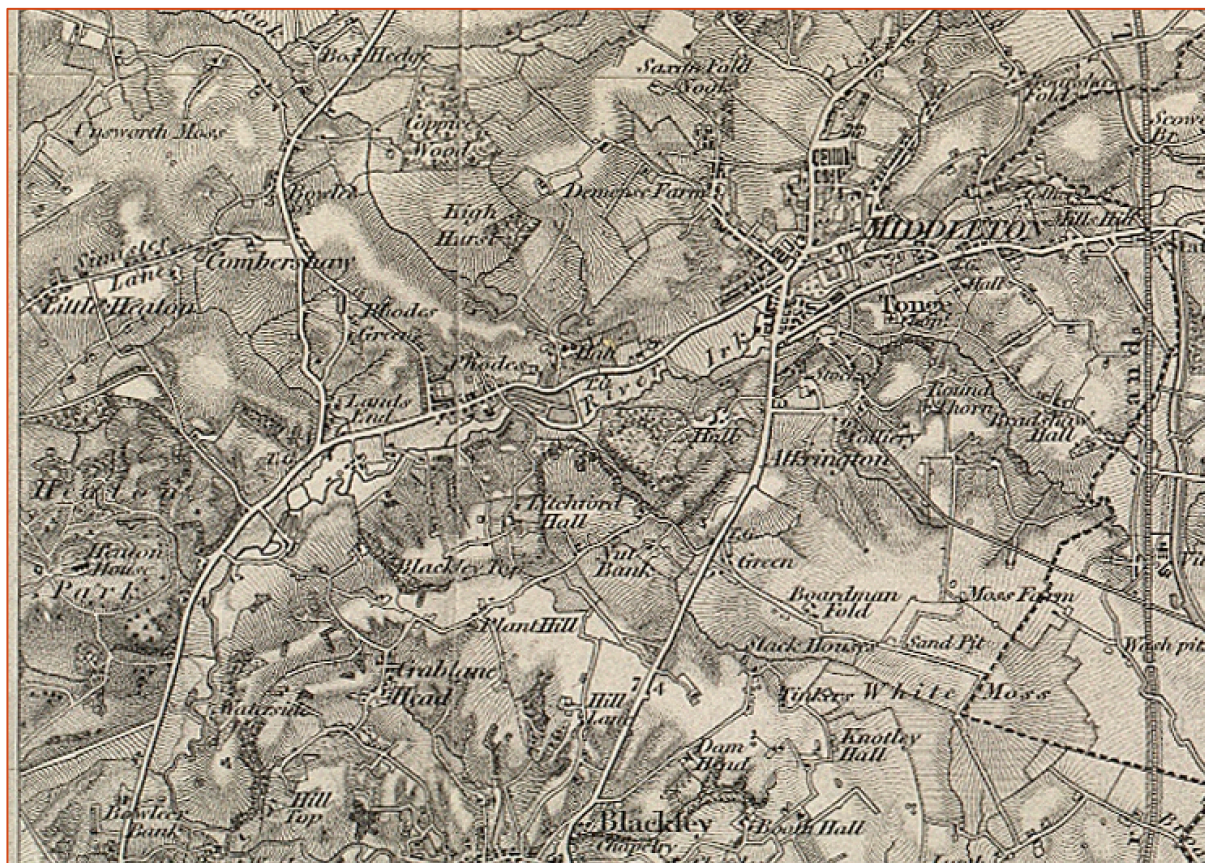
Figure 3, Ordnance Survey First Series, Sheet 88, 1843.

**The First Series Ordnance Surveys (Sheet 88) of 1843 at 1:63,560 Scale** shows the property of Nut Bank, which lies to the north-west of the site, and Nutbank Lane can also clearly be seen leading from the Manchester New Road to the property. No buildings are shown in the area of the site.

To the north-east a Colliery is identified in Alkrington, while a Sand Pit lies to the south-east. To the north and north-west of the site runs the River Irk, and a tributary of the Irk crosses the site from the south and flows around the northern boundary to join the main river to the north-west.

The earliest located map of the area, from 1843, shows the site lying undeveloped to the south-east of the property of Nut Bank. A stream, later identified as Boardman Brook, crosses the site from the south and flows around the northern boundary towards the River Irk in the north-west.
