# LONGSIGHT YOUTH CENTRE MANCHESTER

## Nocturnal Bat Survey Report

*September 2021*

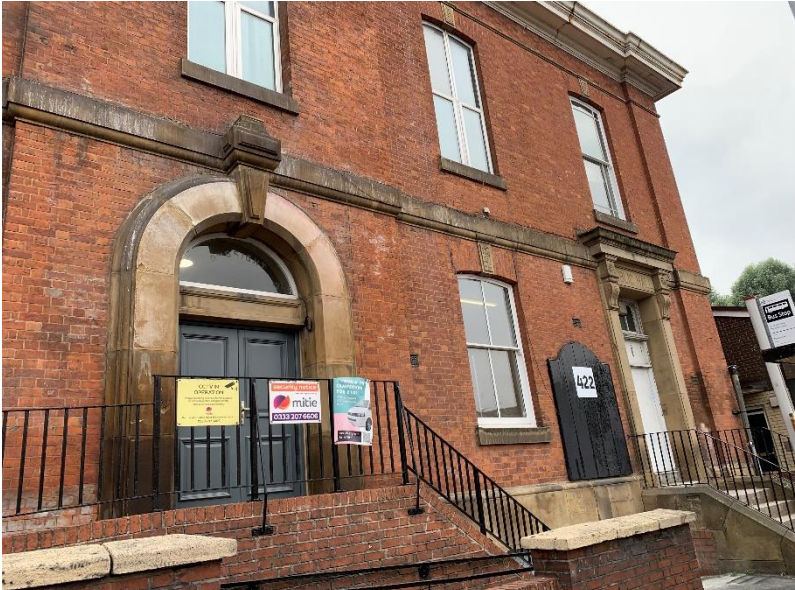
| Feature | Photograph |
|---|---|
| Longsight Youth Centre eastern elevation. | |

- 3.2.4. On the eastern elevation the brick work appeared intact with no features present. On the extension, boarded windows were present.
- 3.2.5. Internally the main building appeared largely well sealed with some areas of works already having been completed with newly replastered and painted rooms. No opportunities for roosting bats were observed internally within the main building.

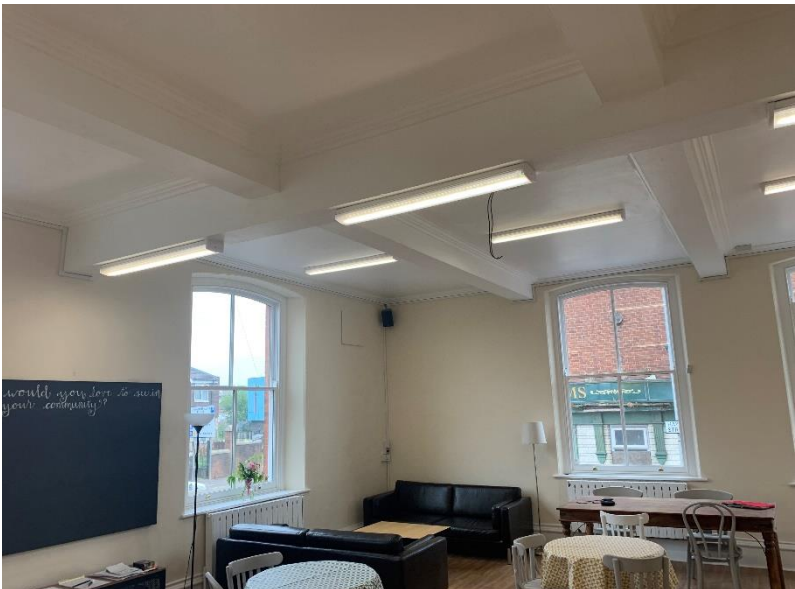
| Feature | Photograph |
|---|---|
| Internally, the main building was painted and plastered with no opportunities for roosting bats identified. | |

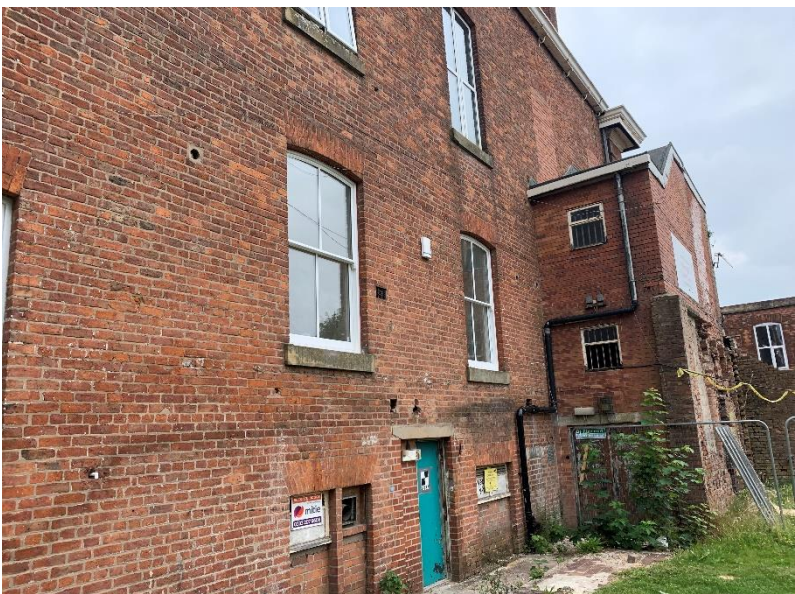
| Feature | Photograph |
|---|---|
| Western elevation of Youth Centre. Some crevices in the brick work were present. | |

- 3.2.2. On the western elevation, some crevices in the brick work were noted as well as the eaves in this section being in a poor state of repair with sections fully lifted away from the brick wall which could provide opportunities for crevice dwelling bats.

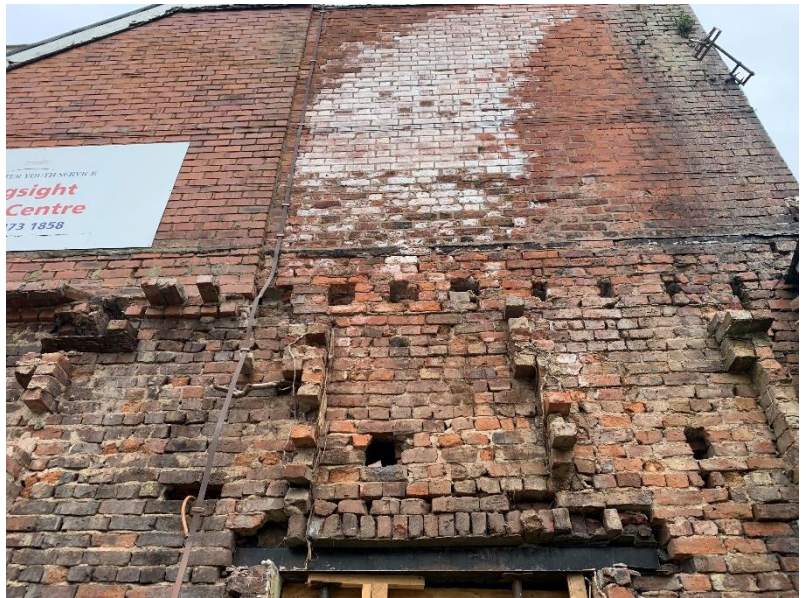
Southern elevation hosting several gaps and crevices in brickwork which could provide opportunities for roosting bats.

- 3.2.3. To the southern elevation, works appear to have started on the walls with the brick wall having been taken down exposing gaps between the wall and extension which appear to facilitate access into the building.

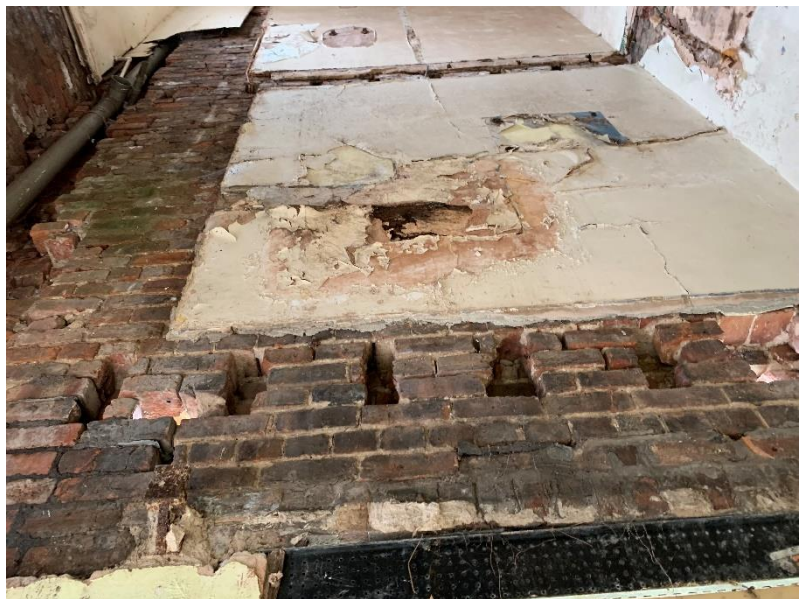
Internally, the extension hosted several features which could provide opportunities for roosting bats, including gaps in brickwork.

- 3.2.6. Internally within the extension, several features were present which could provide roosting value for bats by way of missing bricks and mortar and boarded windows and doors which created gaps to facilitate internal access. Upper floors had already been removed, and internally the extension was found to be light inside. Breeding feral pigeon were recorded within this area. No bat droppings or signs of bats were identified; however, rat droppings were located.

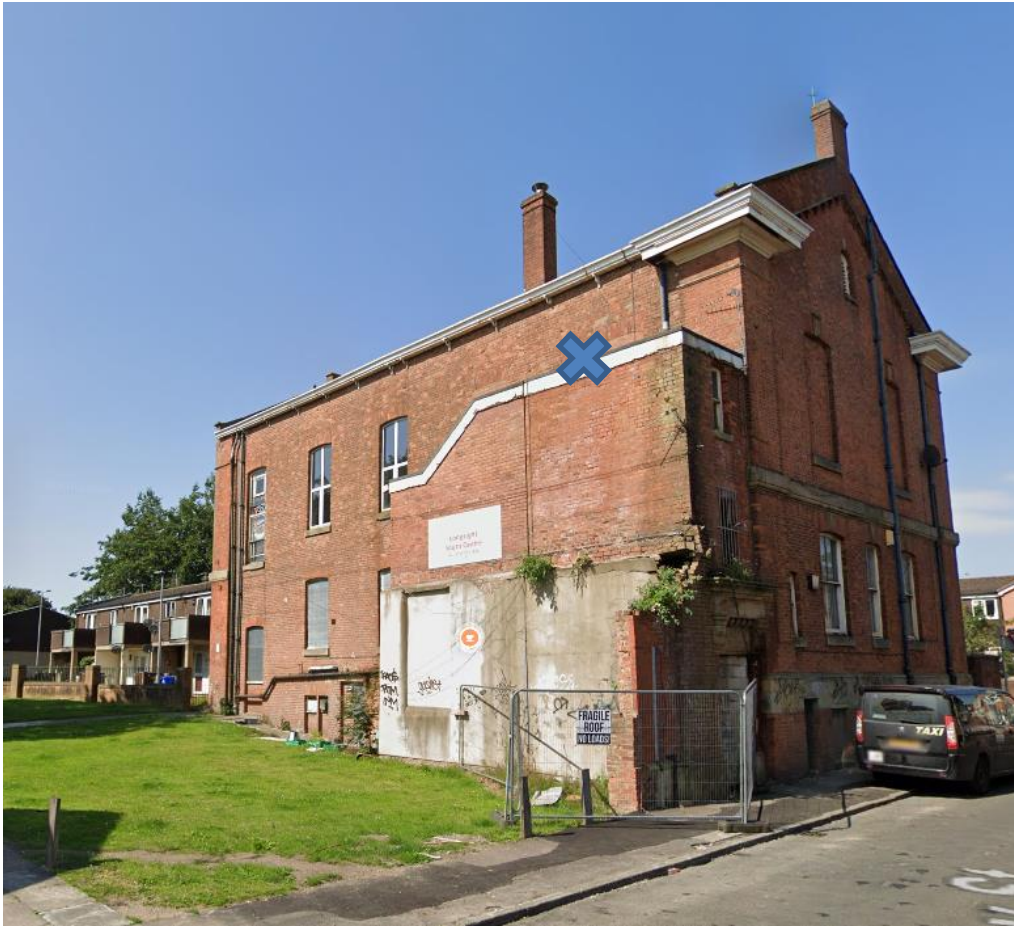
Figure 3.1 Approximate Location of Bat Roost

- 3.3.1. No roosting behaviour was observed during the dusk emergence survey. Very low numbers of bats were recorded during the survey, being common pipistrelle only.
- 3.3.2. During the dawn re-entry survey, very low numbers of bats were recorded, all being common pipistrelle. A single re-entry into the building was recorded at 05.56 at the rear of the building at the approximate location shown on Figure 3.1 below. The bat was observed re-entering underneath the wooden soffit board at the staircase.

- 3.4.1. The surveys found a single common pipistrelle day/ transitional roost used by a single individual. This is categorised as a roost of “low conservation significance” (English Nature, 2004). No other roosting behaviour was recorded in relation to the building.
- 3.4.2. Very low numbers of common pipistrelle were recorded using both surveys. The site and surrounding roads were found to be well lit from street lighting and as such only light tolerant species were recorded.

- 4.1.3. It is recommended that the proposed development proceed under a Natural England Low Impact Bat Licence. Alternative roost provision in the form of multipurpose bat boxes will be required, and these could be installed within the boundary treeline to be retained. The licence would be applied for once planning permission has been granted and all relevant wildlife conditions discharged. Please refer to the draft Method Statement provided below.

- 4.2.1. A Bat Mitigation Class Licence (BMCL) is to be used for the site which is applicable for the destruction of up to three “low conservation status roosts” which include feeding, day, night and transitional roosts. The site will be registered under a BMCL of a suitably qualified ecologist. The following Working Methods will be followed under the supervision of a licenced bat ecologist to reduce the risk of killing/ injuring bats.

- 4.2.2. Pre commencement works are as follows:
  - Before demolition can commence, two general purpose bat boxes will be installed in a suitable location. Boxes must be positioned on a southwest or south east facing aspect, a minimum of 4m from the ground and must remain in situ for a minimum of 5 years. Please refer to Figure 1 for the proposed locations of the bat boxes.
