CARMODY GROARKE

Power Hall and  
Decarbonisation

Science and Industry  
Museum

26th July 2021  
Gutter Design Principles

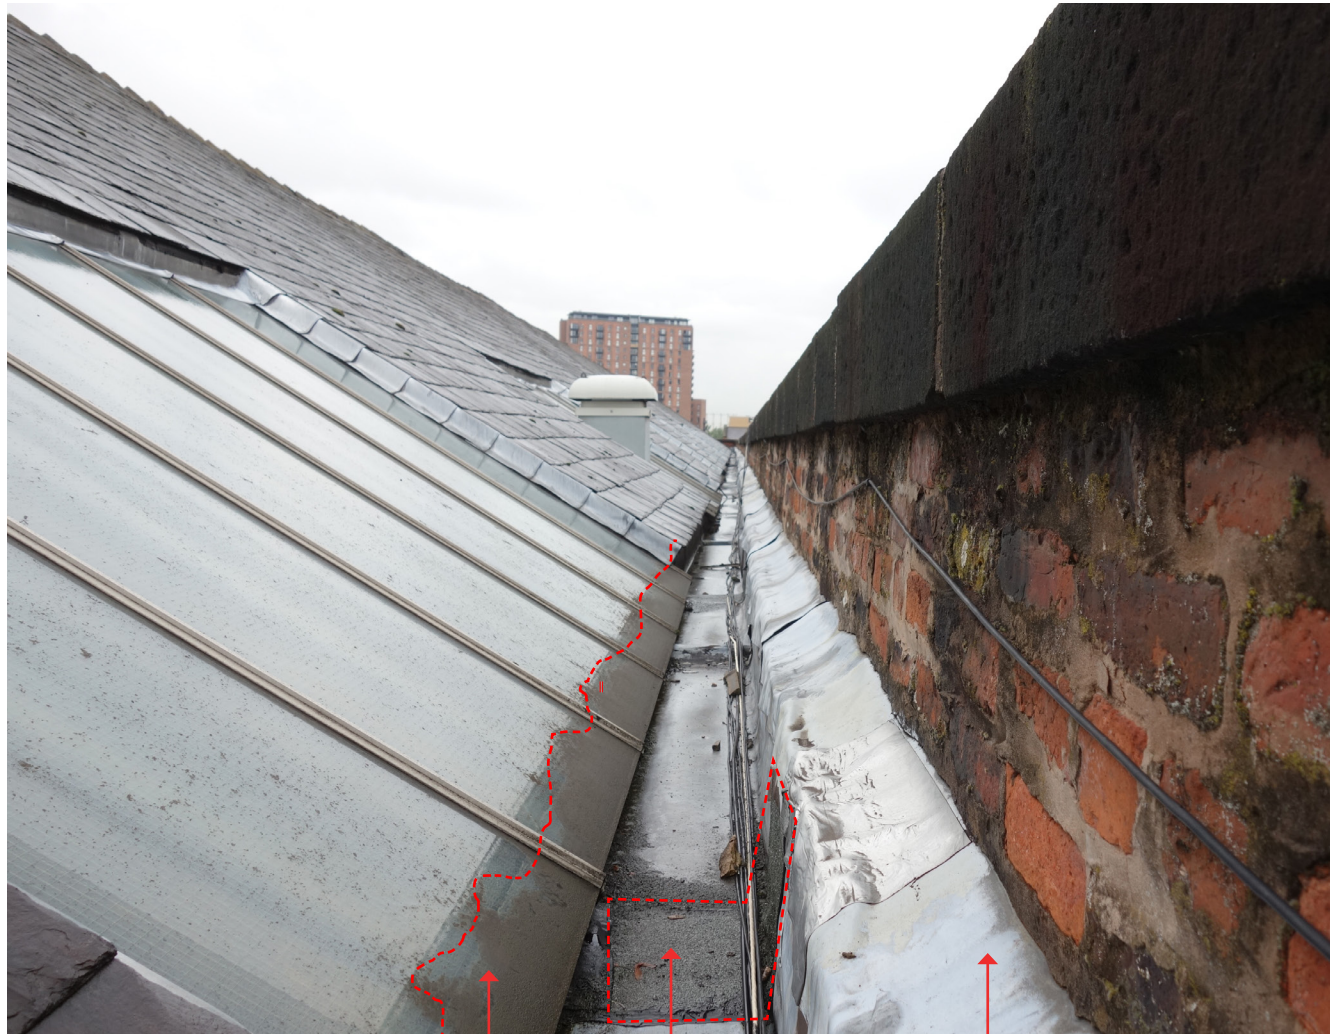
1

Tide mark from past water levels  
Patch repairs with roofing felt  
Lead Flashing

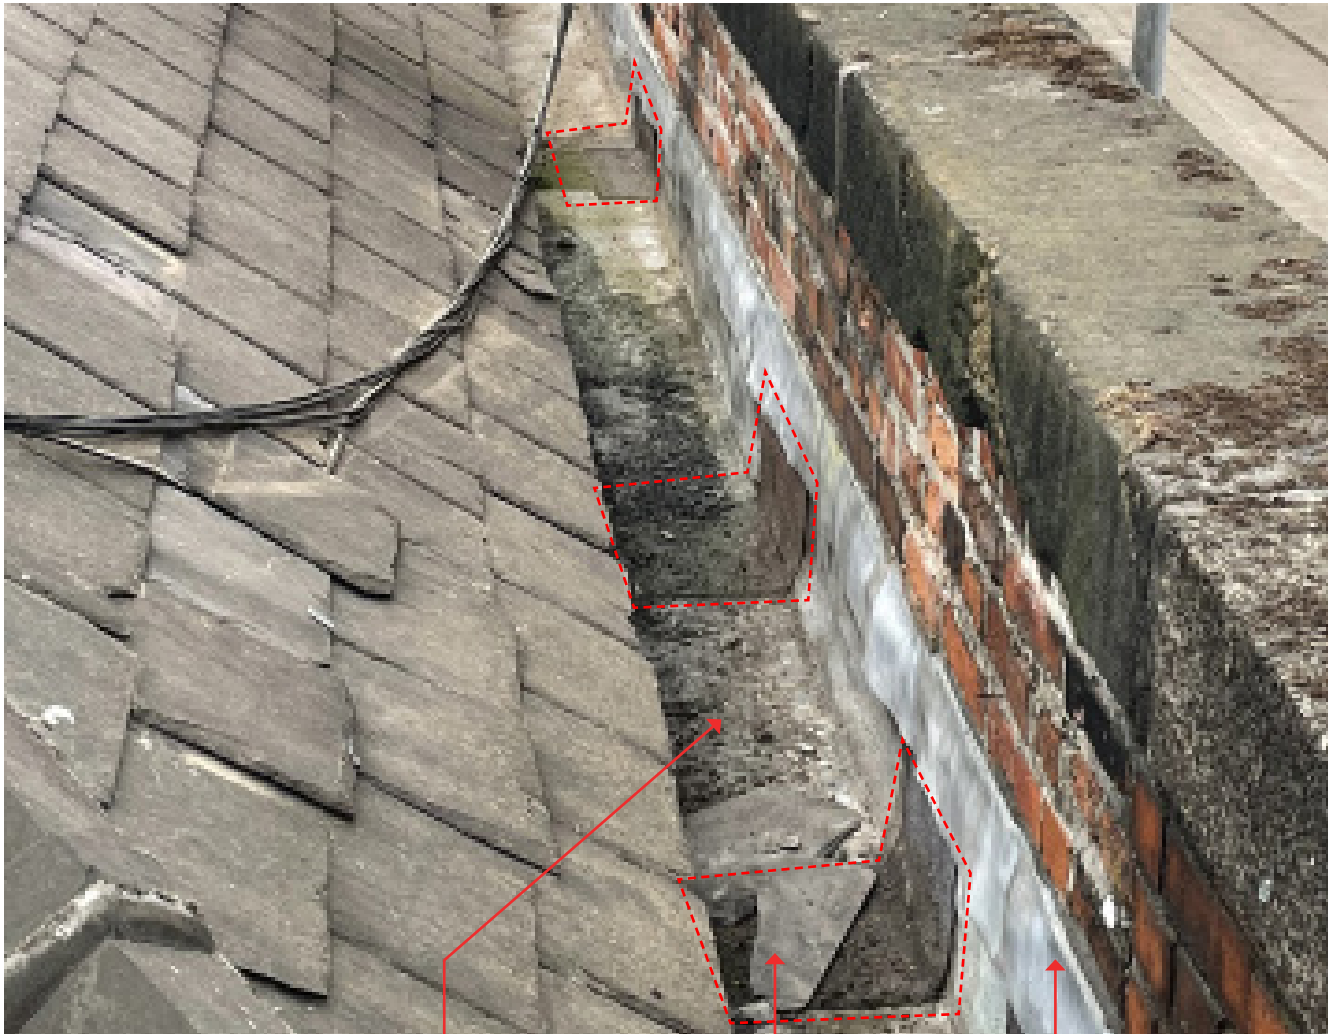
2

Lead gutter  
Patch repairs with roofing felt  
Lead Flashing

Parapet gutter

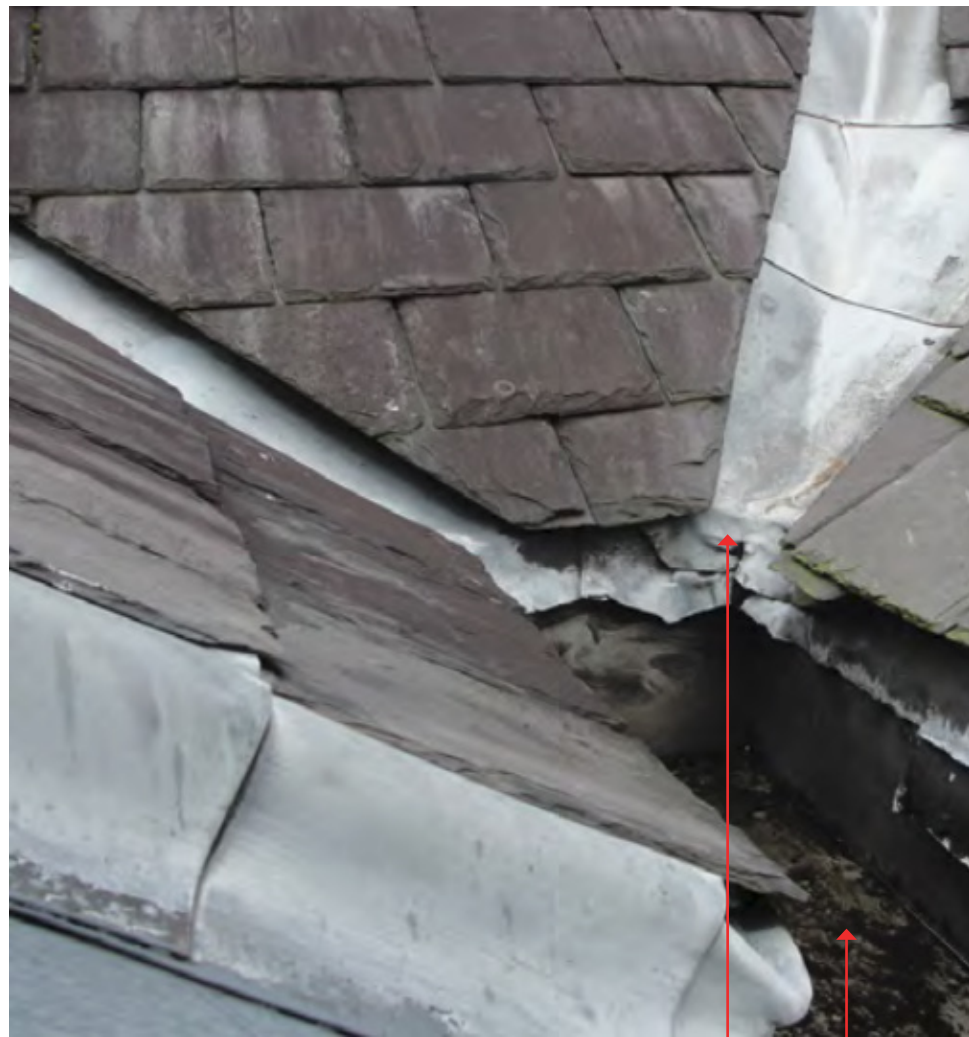
1

Lead Flashing  
Aluminium Gutter

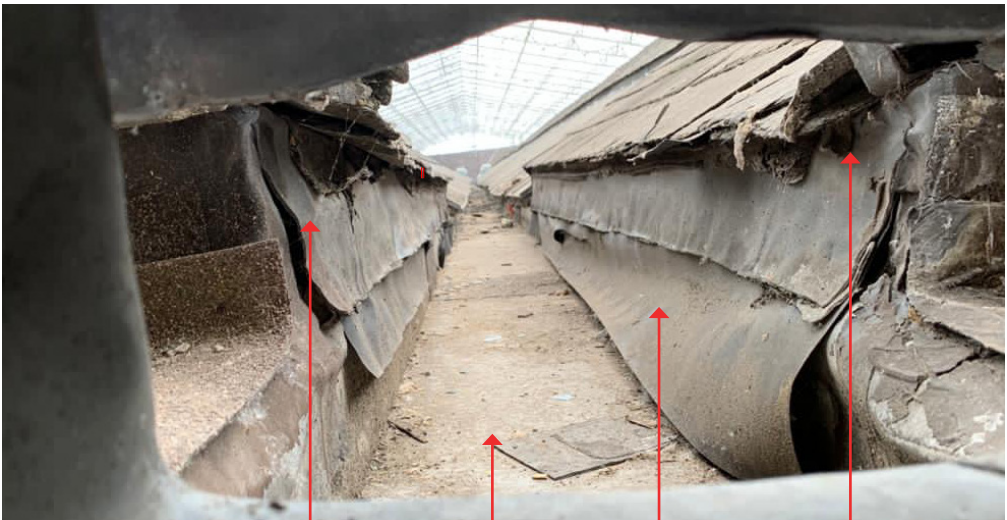
2

Lead Flashing  
Aluminium gutter  
Roofing felt  
Lead Flashing

Valley gutter

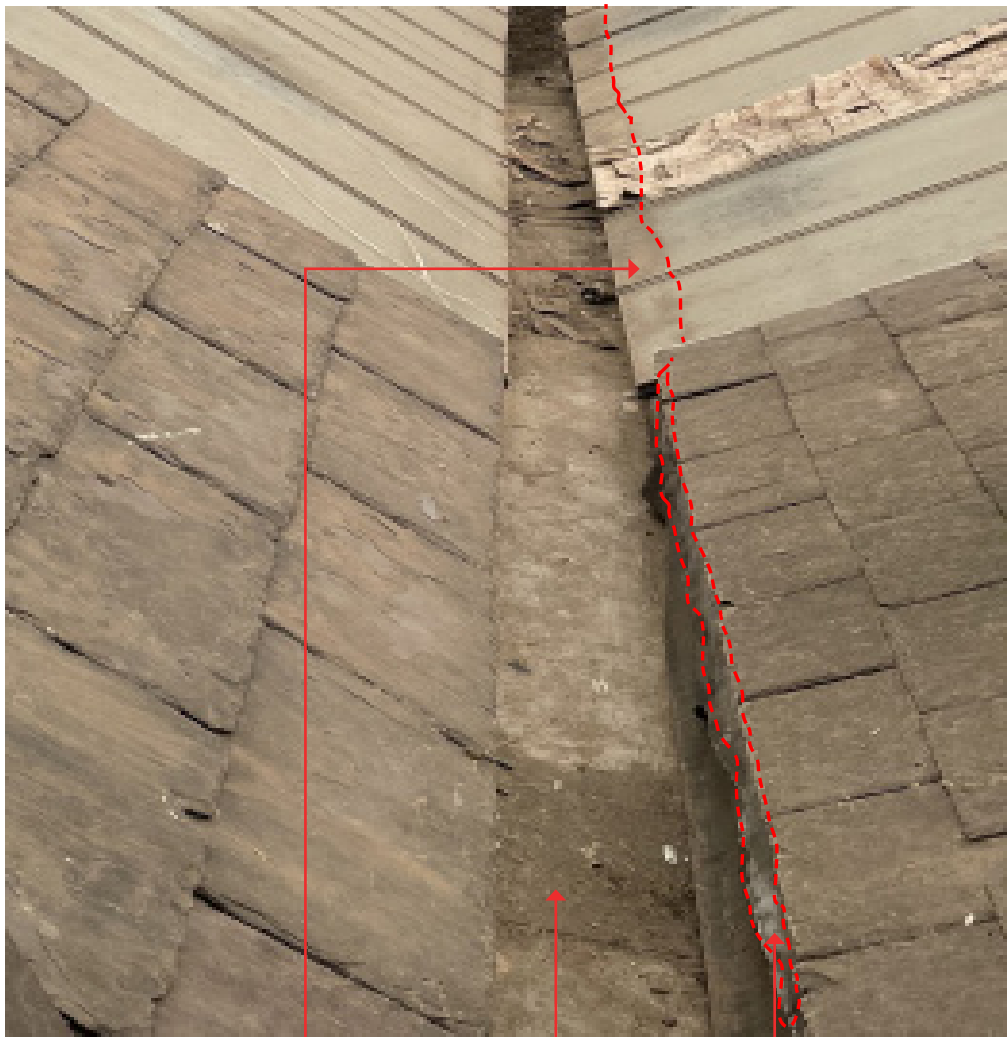
3

Tide mark from  
past water levels  
Aluminium  
gutter  
Lead Flashing

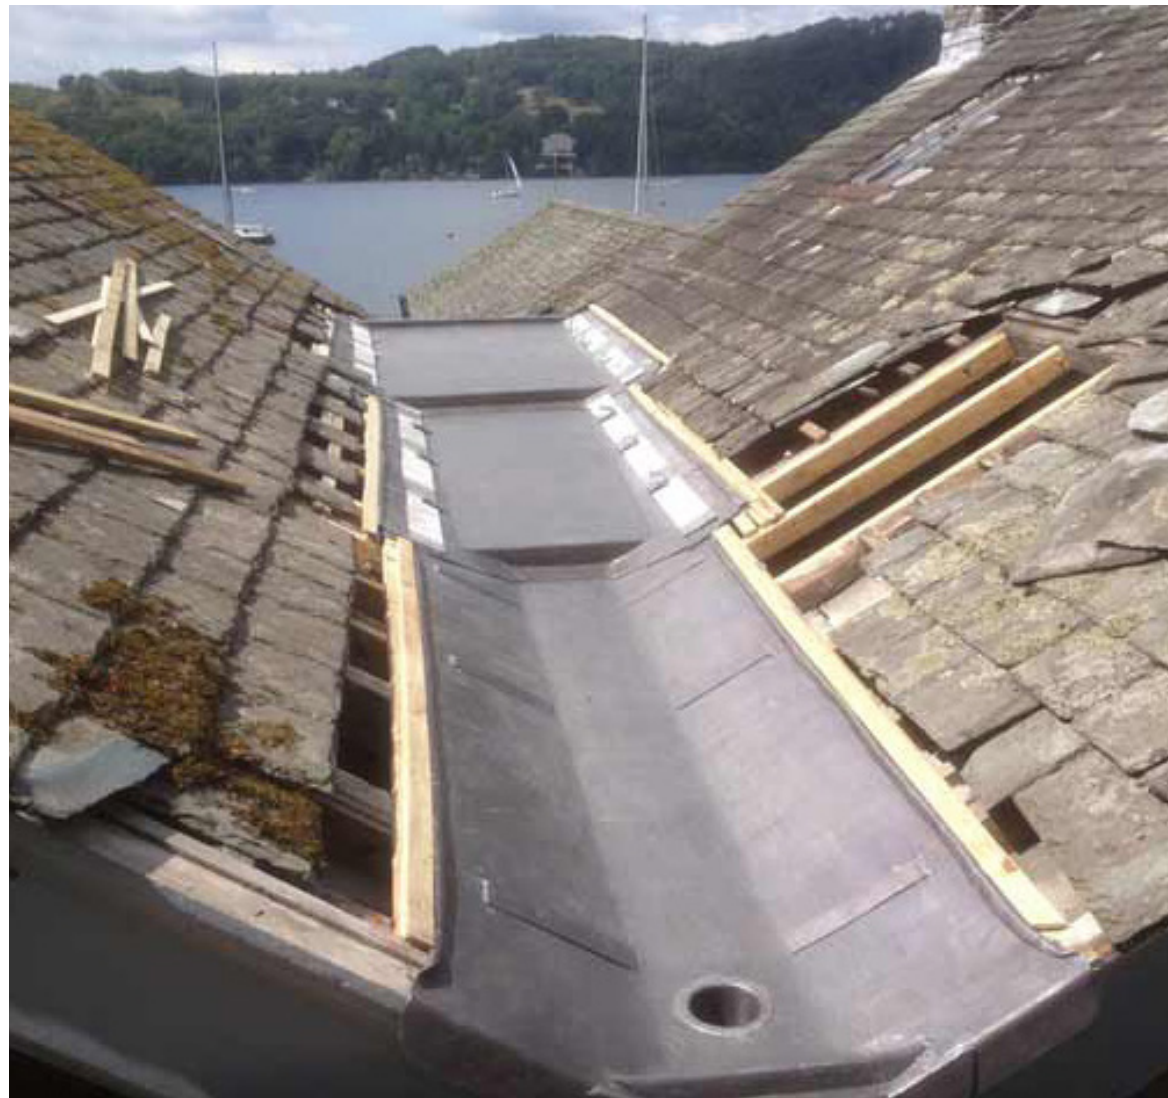
Drip Design Lead Gutter Lining

Lead gutters require a minimum 1/80 fall across their length, in addition to 60mm drips at least every 3m to make robust joint connections between pieces. (source: Rolled Lead Sheet: The Complete Manual)

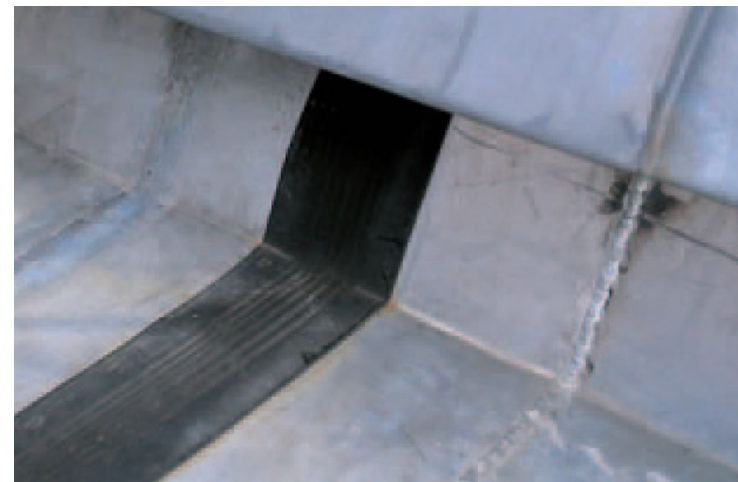
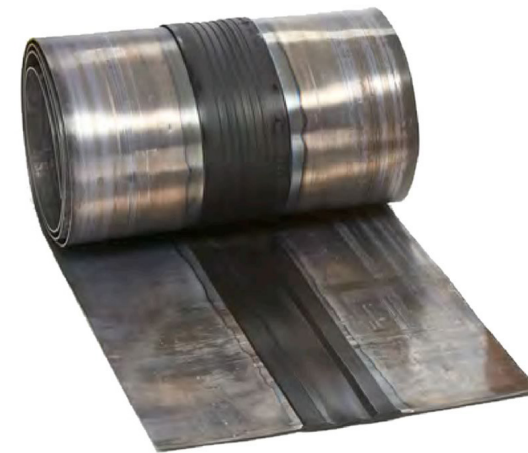
T-Pren expansion joints

Neoprene expansion joints do not have the robustness of traditional drips - T-Pren offer a guarantee of 10 years and suggest a service life of circa 25 years, but experience in practice suggests that the joints would need to be replaced after 15 years to mitigate the risk of failure causing water ingress. It is for this reason that both the Lead Association and RIBA recommend avoiding these joints wherever possible.

T-pren are not aware of their system being used on gutters as long as those on the Power Hall (the longest lead gutter they advised that uses T-pren joints in lead is 76m on Dunblane Cathedral).

Having a significant number of these joints greatly increases the risk of failure and locating the exact failure point would be difficult given the number of joints. This option is not feasible due to the maintenance and cost liabilities and as it is not a tried and test solution on a roof of this size.
