**REMEDIATION STRATEGY  
FOR LAND AT  
SNELL STREET  
MANCHESTER**

**July 2021**

**Ref: M0142 AD (GSI1450) RS AF A 080721**

| Quality Assurance | |
|---|---|
| Report Type | Remediation Strategy |

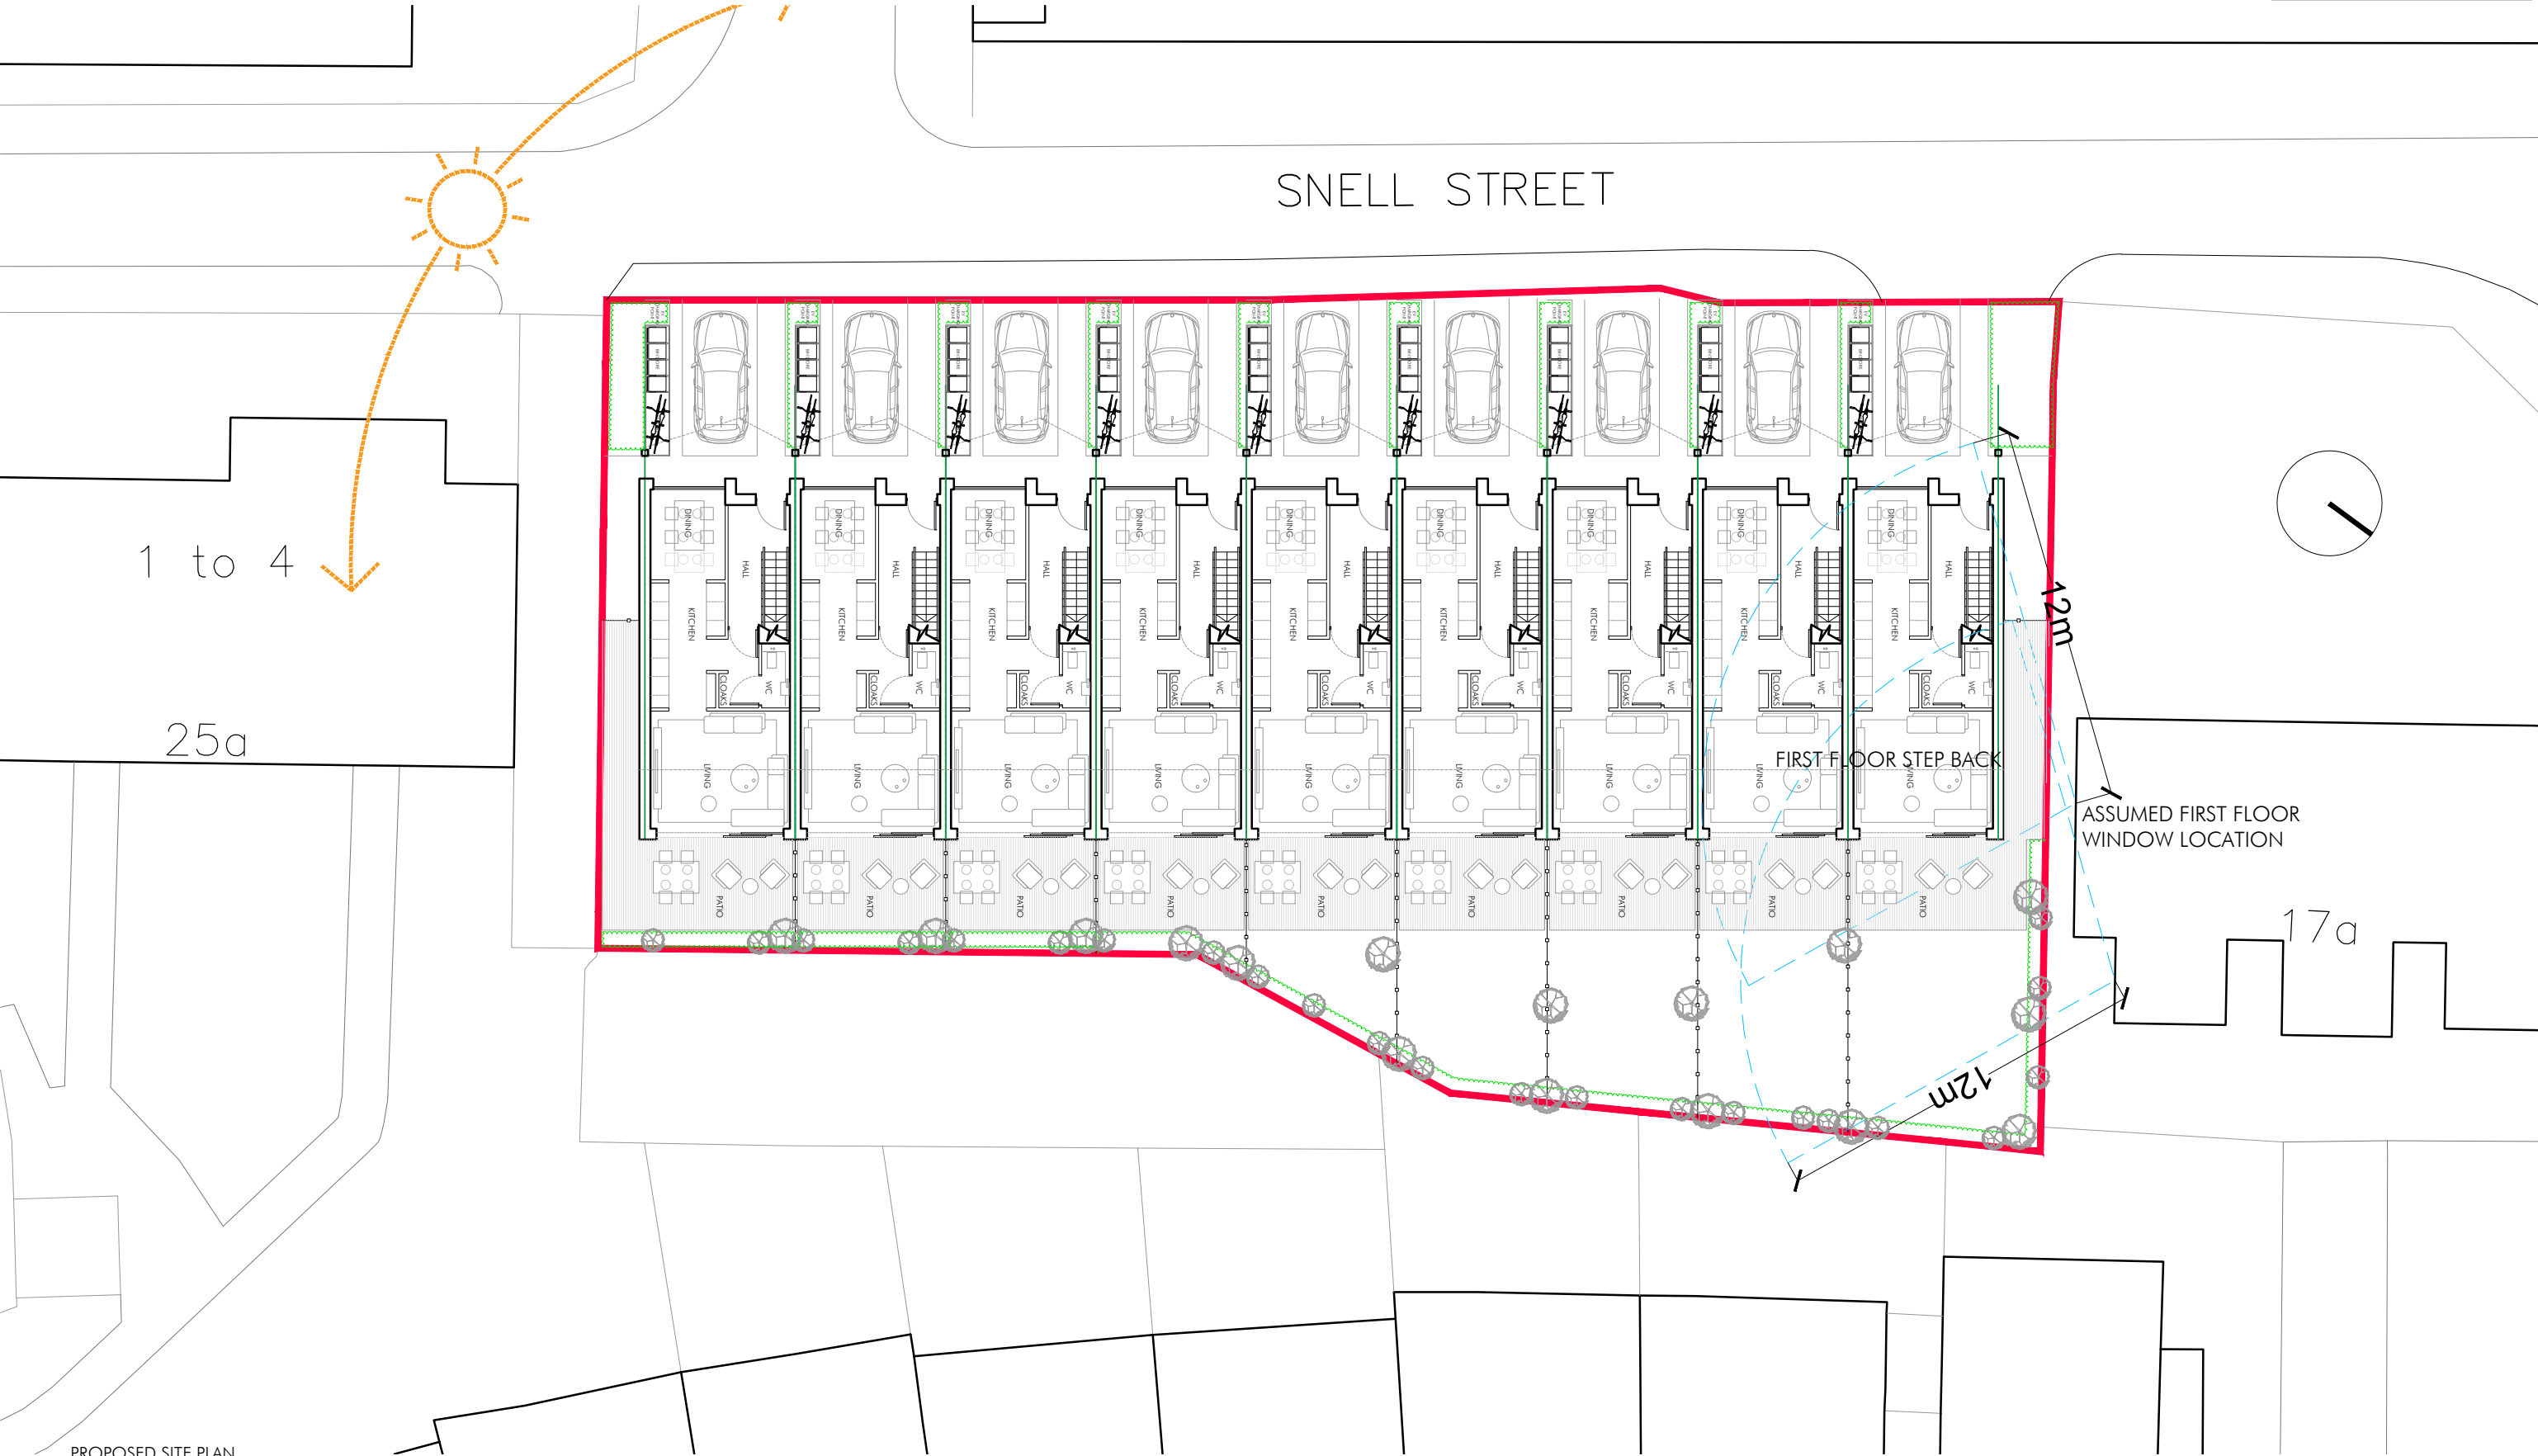
PROPOSED SITE PLAN  
DWG: 20096 (FE) 001 \*  
DATE: 05.10.20  
SCALE: 1:200 @ A3  
DRAWN: AG

PROPOSED SITE PLAN  
9 UNITS - TOTAL 13,167 SQFT
