# Television Baseline Survey Report

Jersey Wharf

Manchester Life Development Company 3 Limited

December 2021

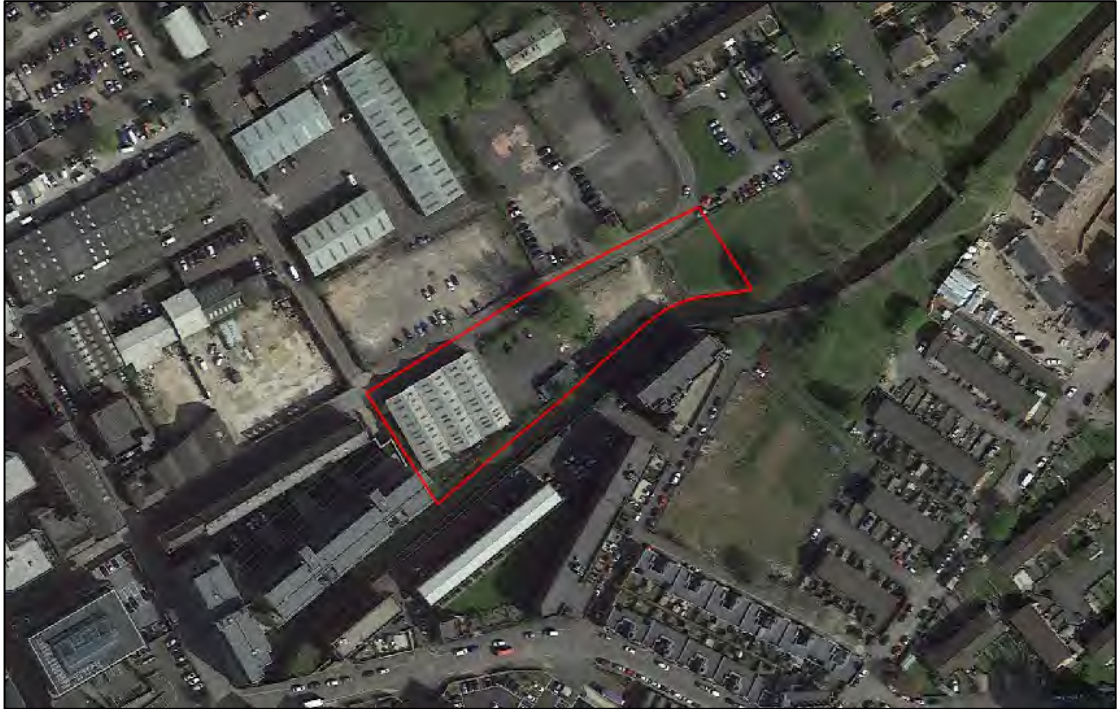
Figure 2 Proposed development boundary overlaid on aerial imagery

The development boundary (red line) for the proposed development overlaid on aerial imagery is shown in Figure 2<sup>3</sup> below.

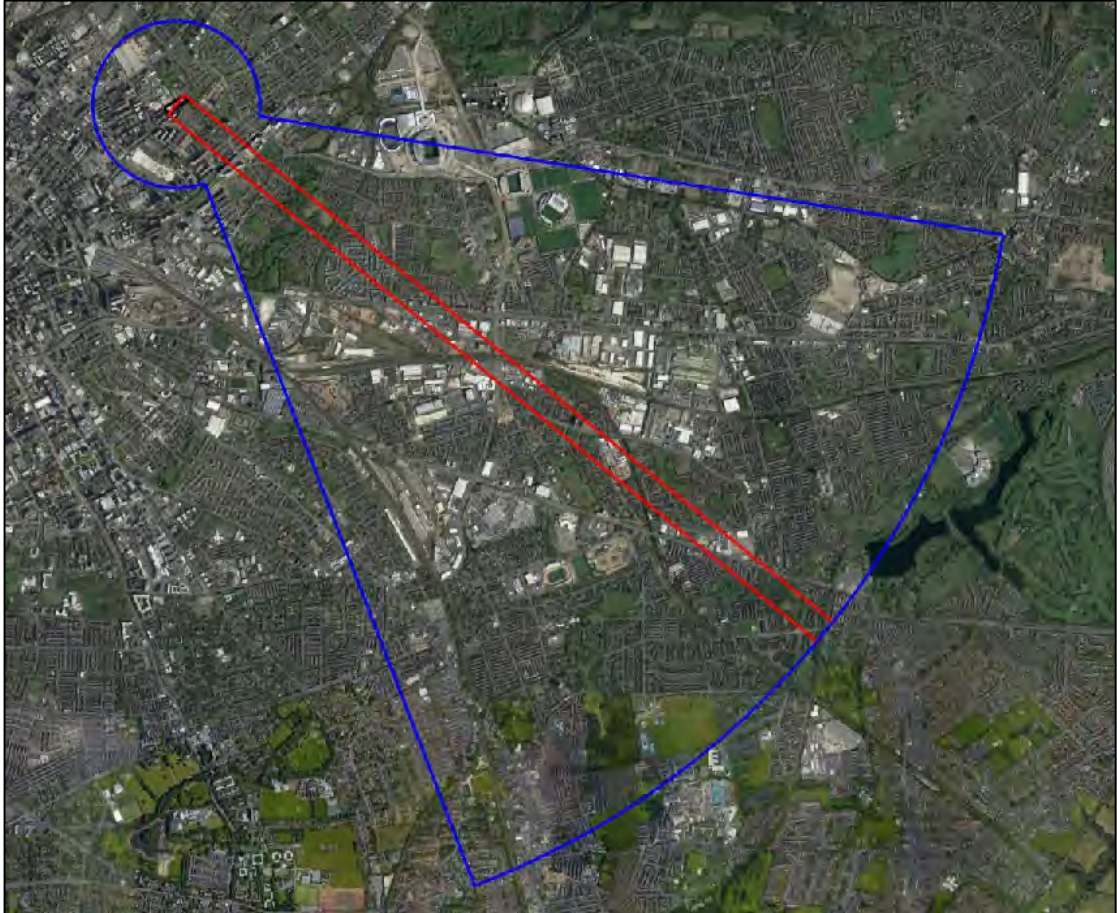
Figure 6 *Interference zones map*

Figure 6<sup>3</sup> below shows the interference zones overlaid onto an aerial image of the area.

The shadow zone passes over urban and commercial buildings. Areas closest to the proposed development are at the highest risk of experiencing television interference. This is typically limited to 1km based on Pager Power's assessment experience. Dwellings and apartment blocks are located within 1km of the proposed development shadow zone.

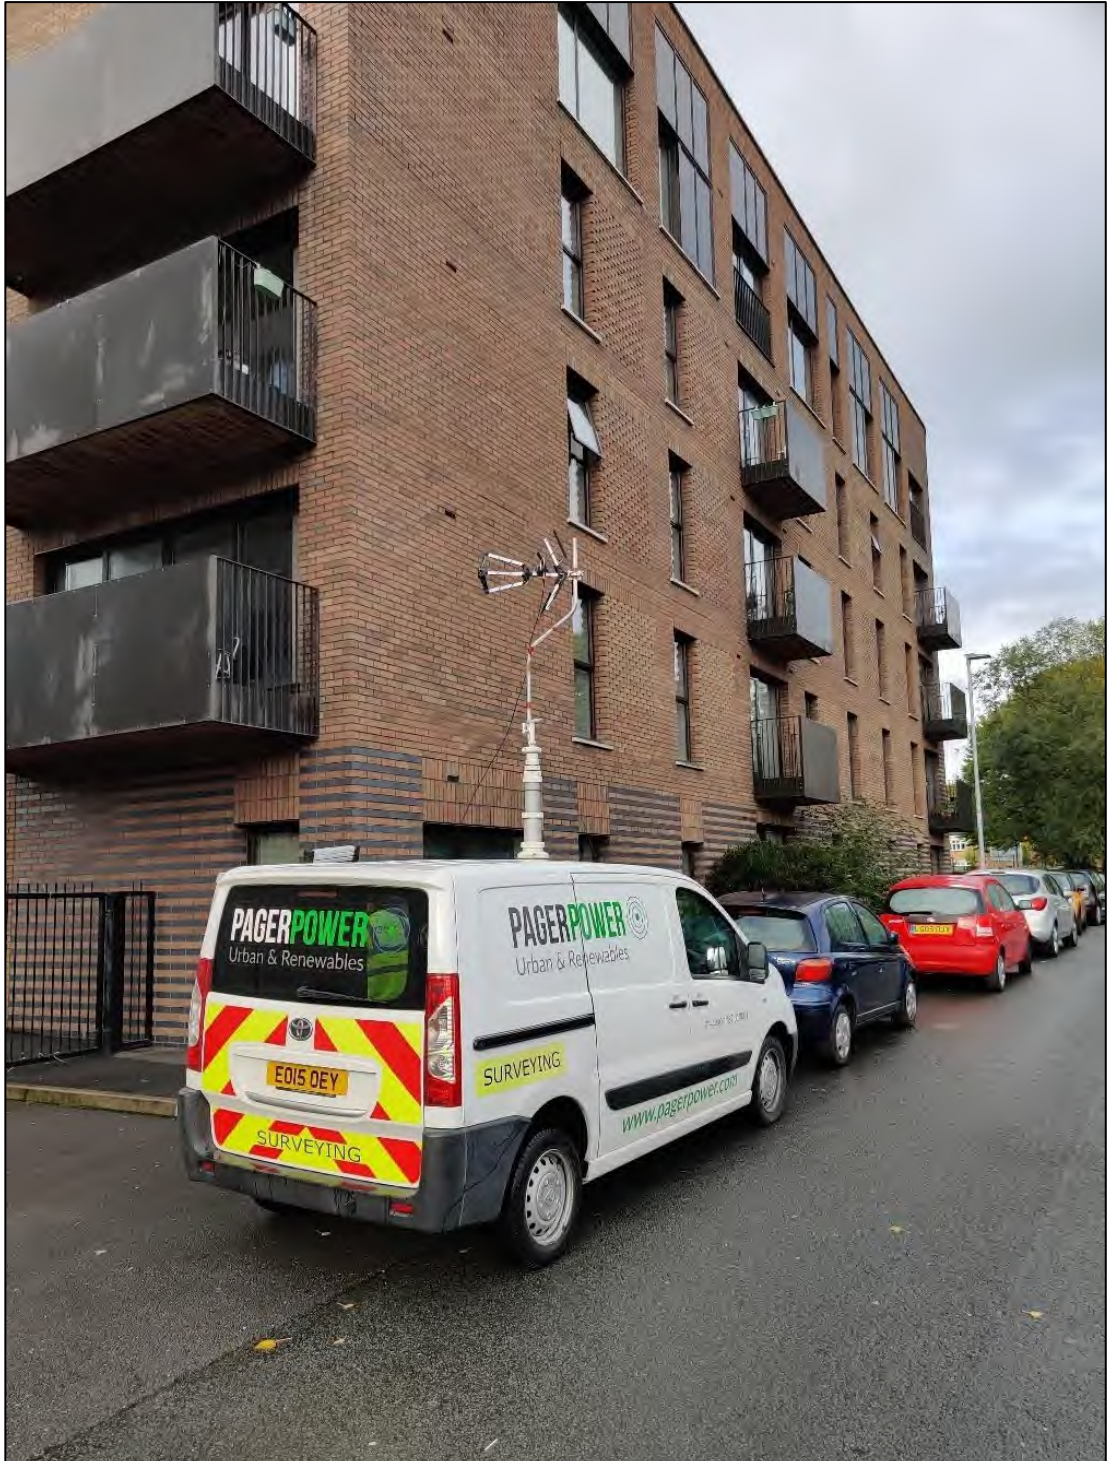
### Location 1

Notes: Multiple HP<sup>14</sup> UHF<sup>15</sup> aerial directed towards the Winter Hill transmitter was observed.  
Satellite dishes observed.

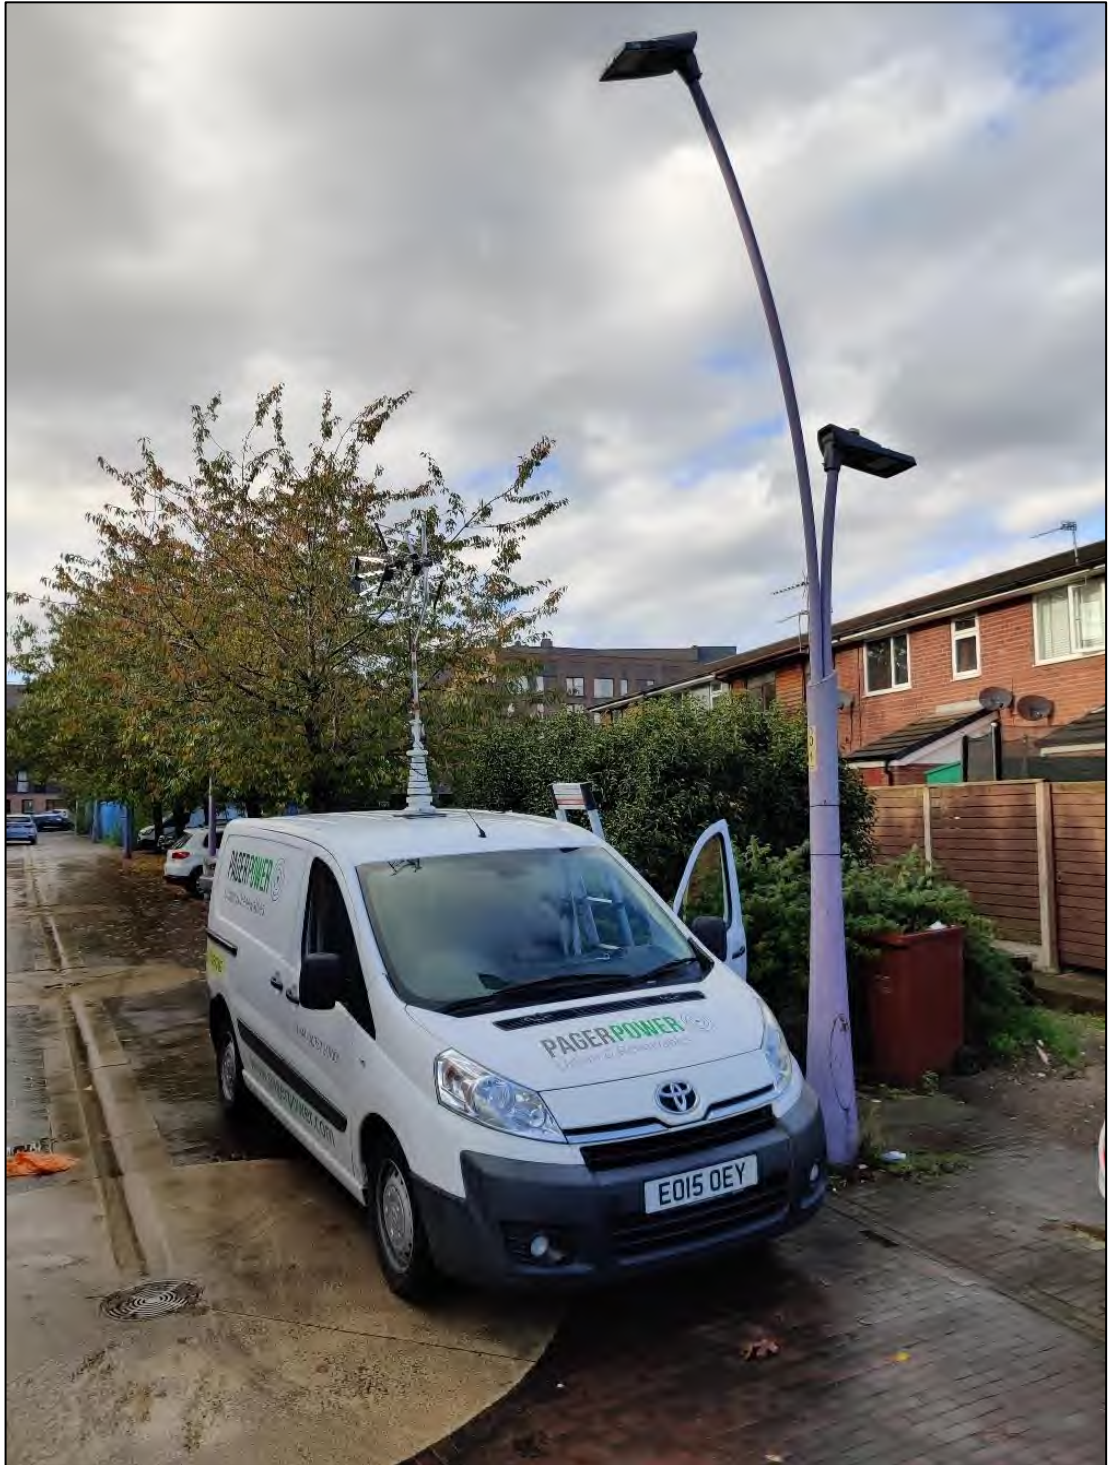
Location 2

Notes: Multiple HP UHF aerial directed towards the Winter Hill transmitter was observed.  
Multiple satellite dishes were observed.

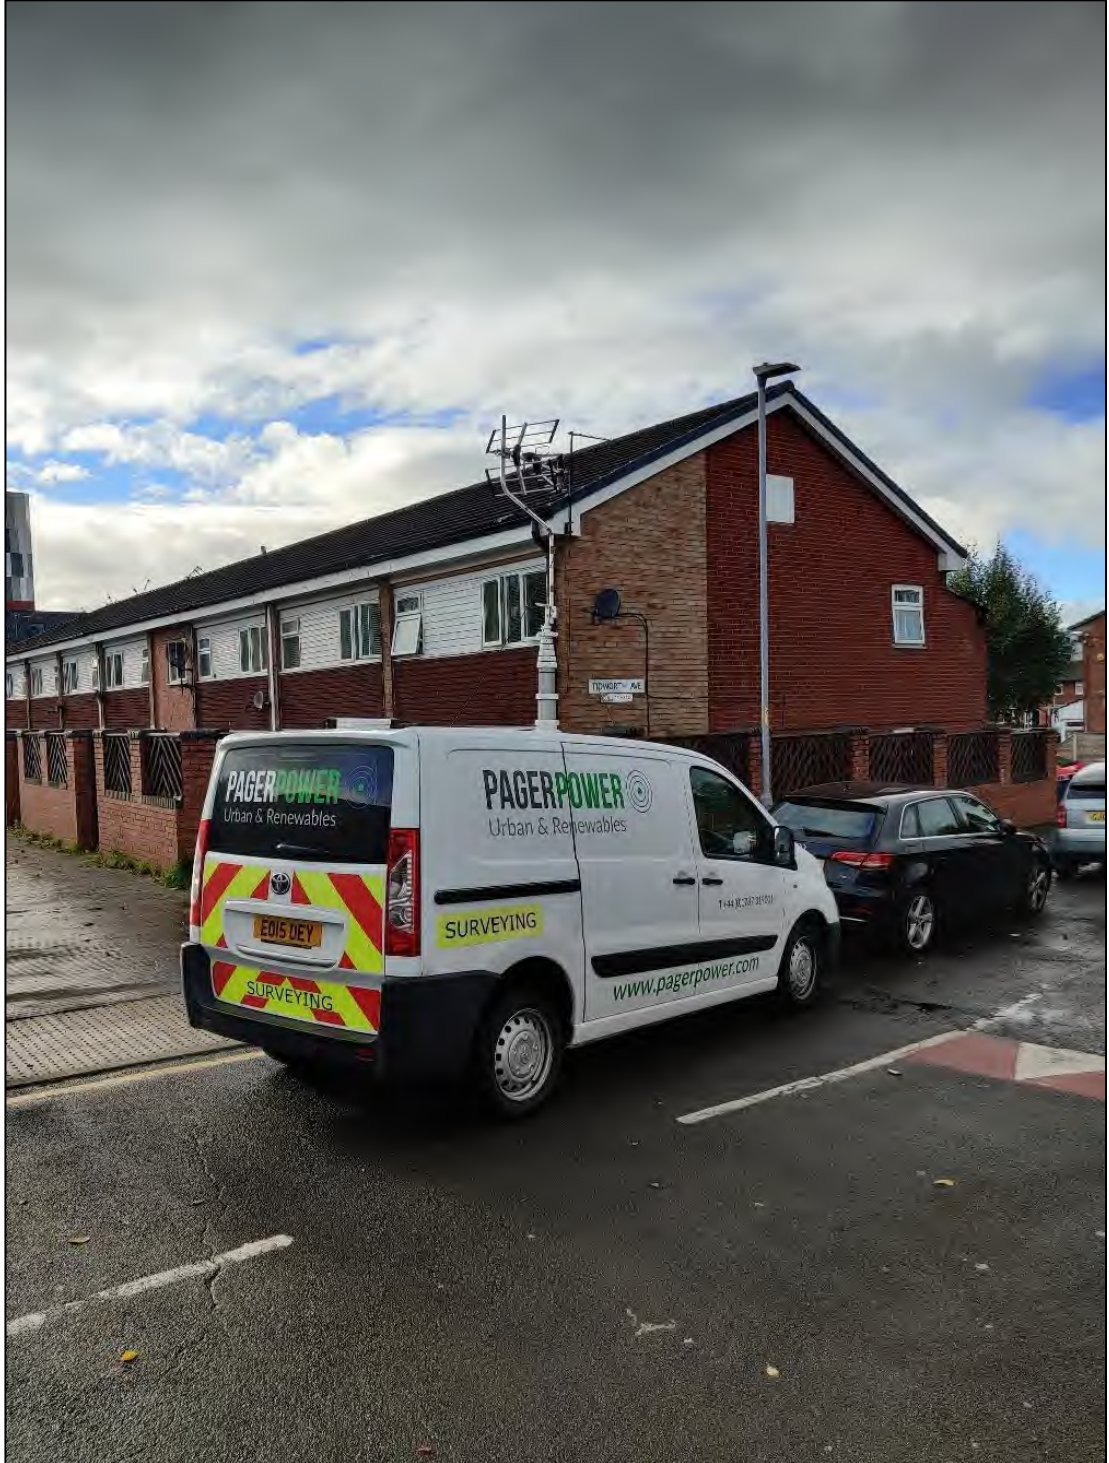
Location 3

Notes: Multiple HP UHF aerial directed towards the Winter Hill transmitter was observed.  
Multiple satellite dishes were observed.

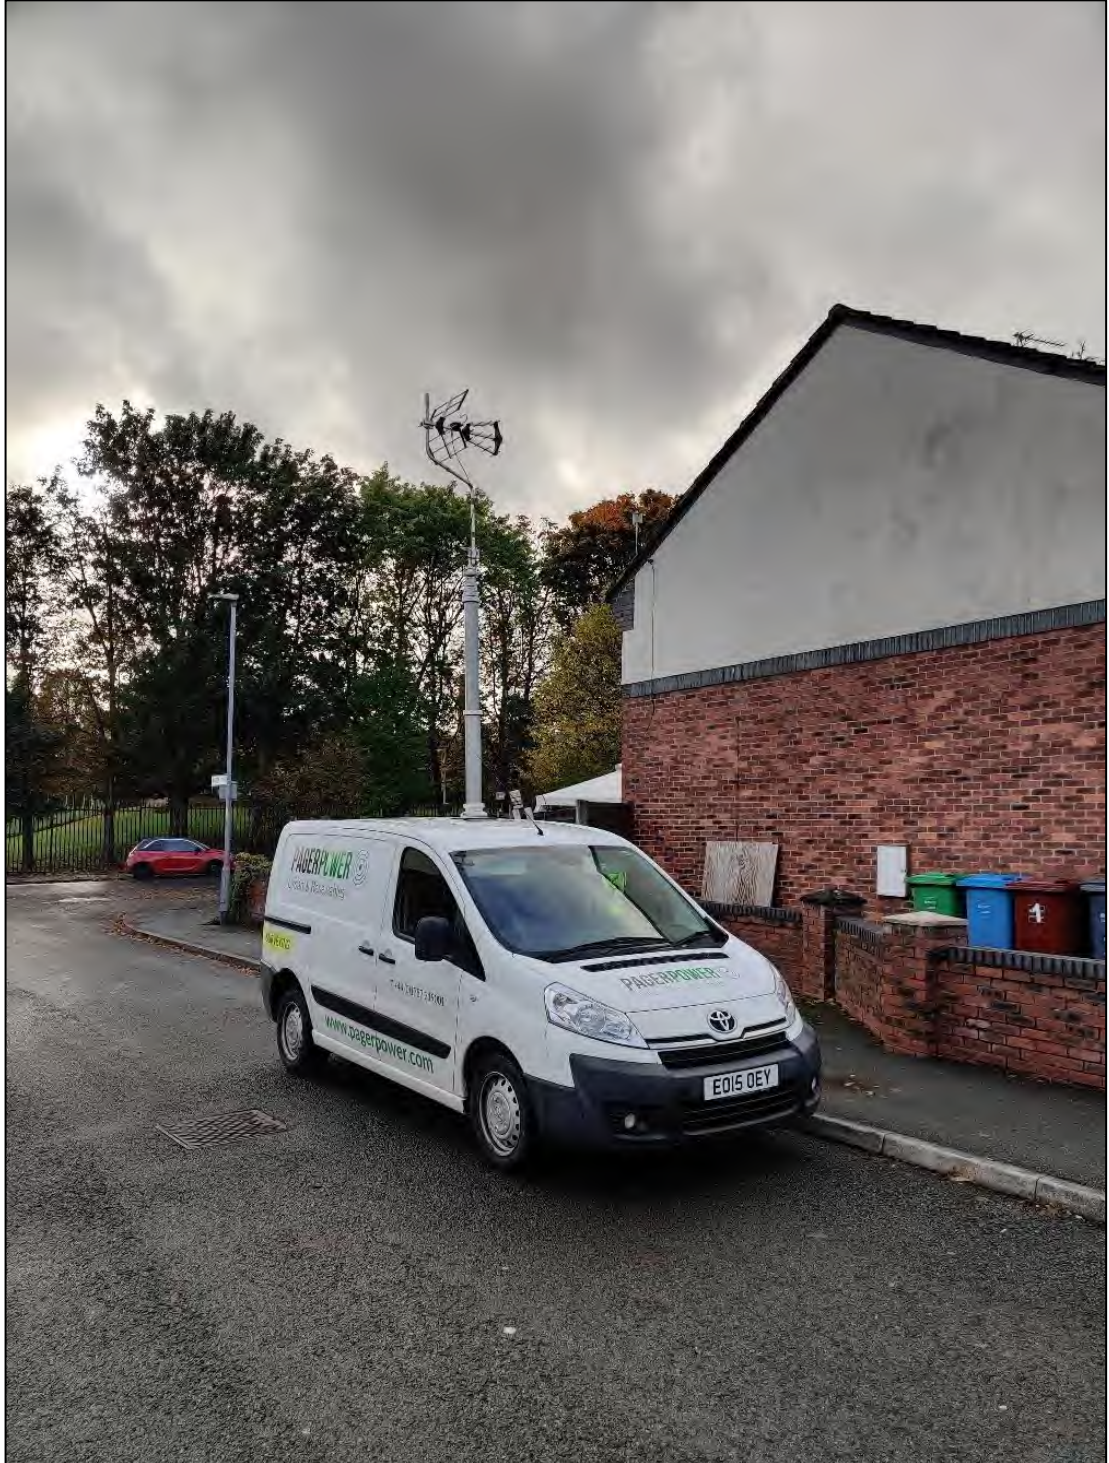
Location 4

Notes: Multiple HP UHF aerial directed towards the Winter Hill transmitter was observed.  
Multiple satellite dishes were observed.

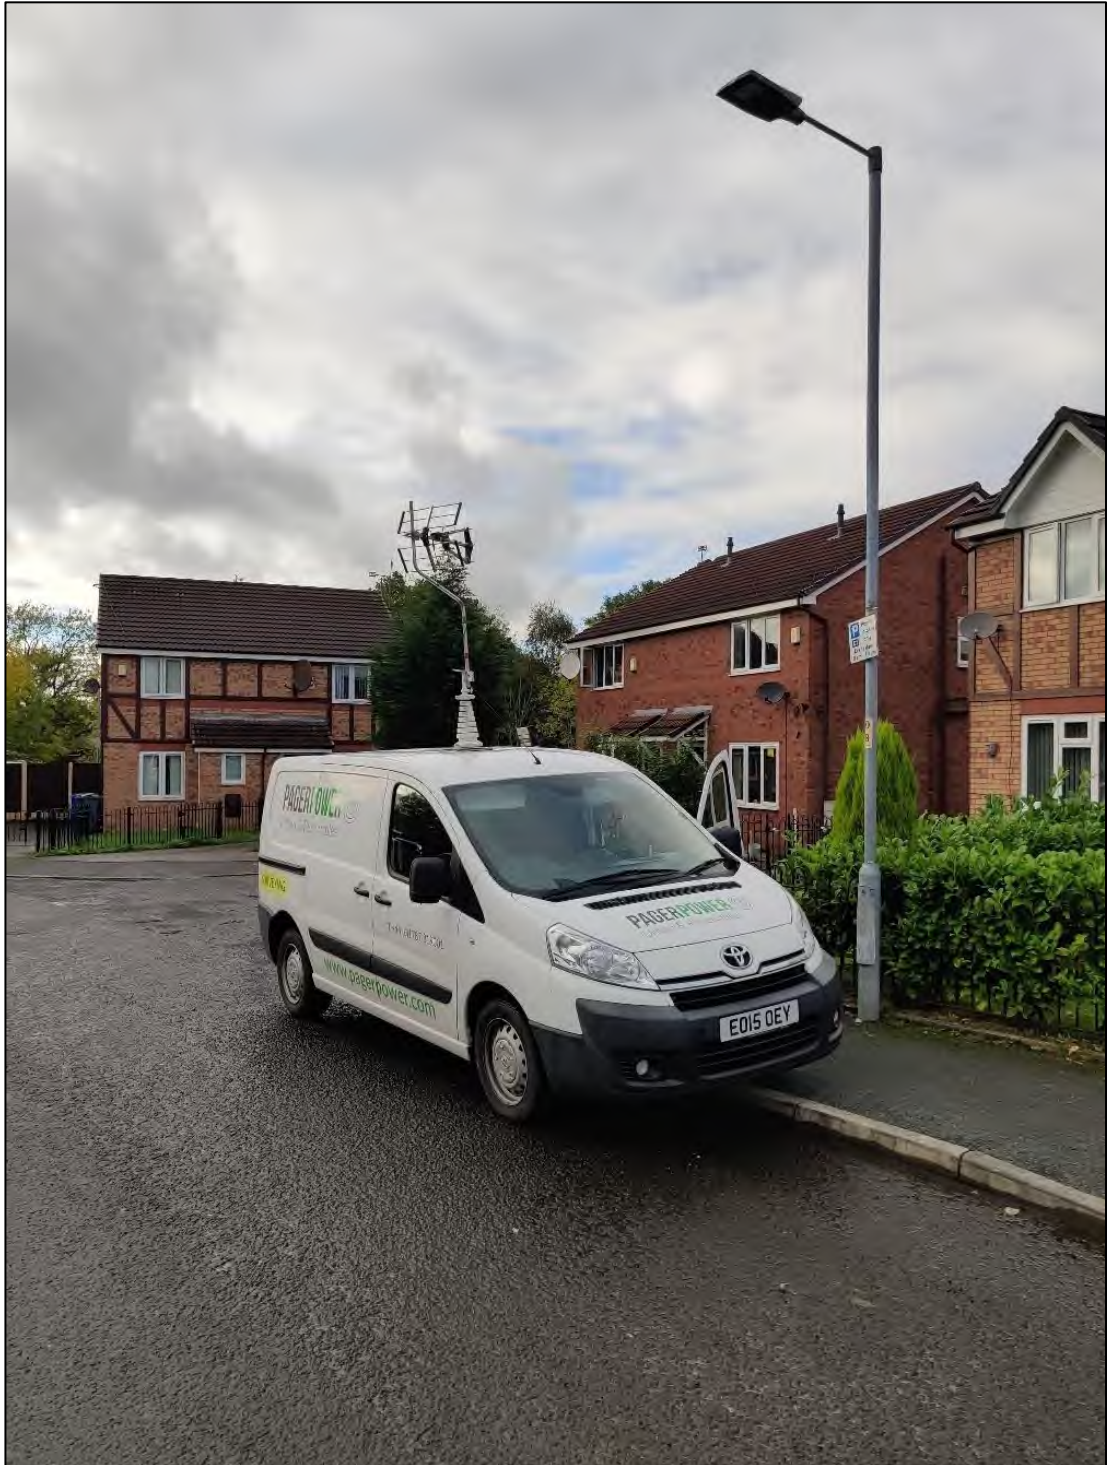
Location 5

Notes: Multiple HP UHF aerial directed towards the Winter Hill transmitter was observed.  
Multiple satellite dishes were observed.

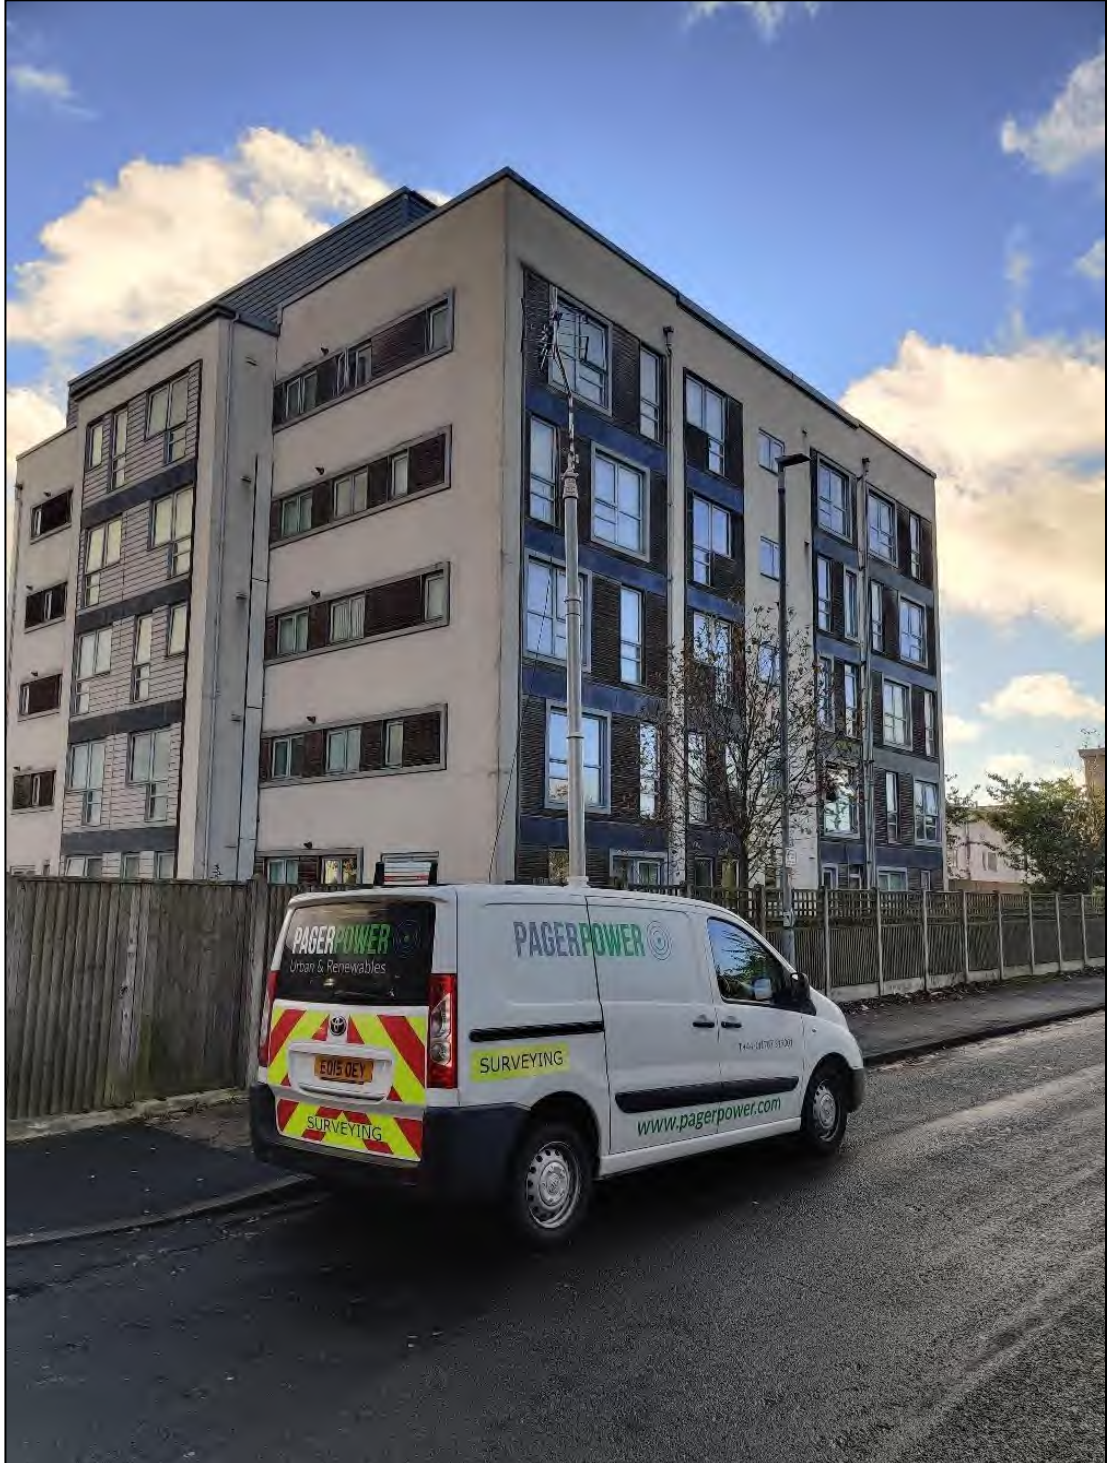
Location 6

Notes: Multiple HP UHF aerial directed towards the Winter Hill transmitter was observed.  
Multiple satellite dishes were observed.

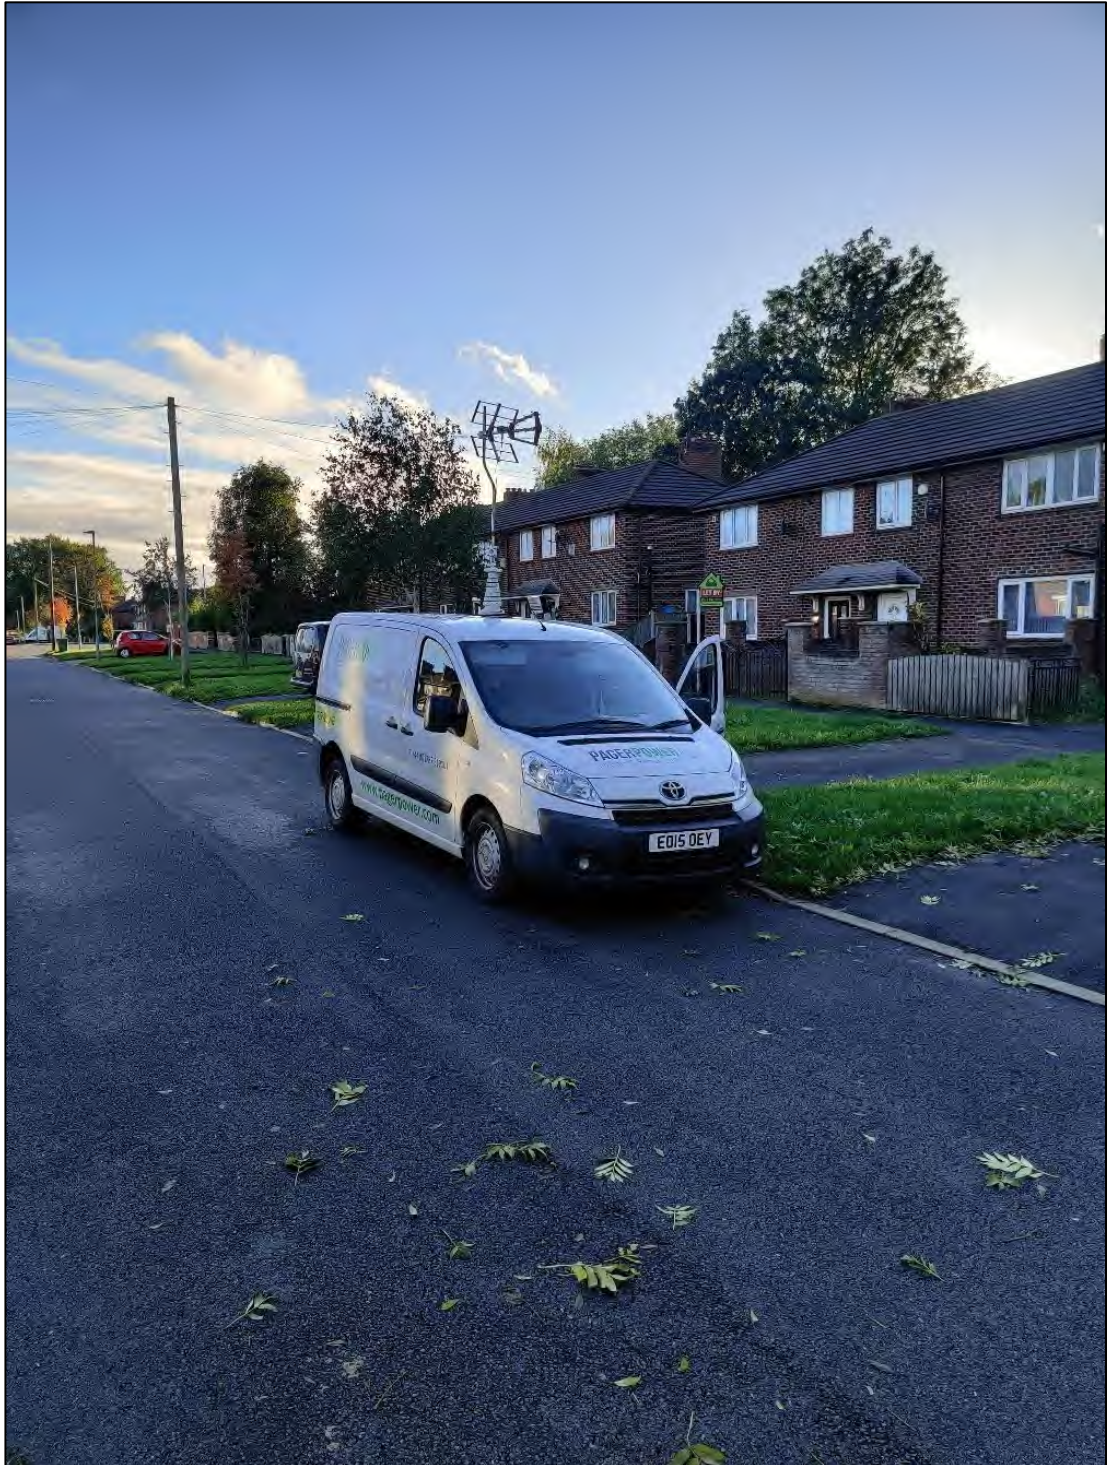
Location 7

Notes: Multiple HP UHF aerial directed towards the Winter Hill transmitter was observed.  
Multiple satellite dishes were observed.
