**PHASE 2 GEO-ENVIRONMENTAL SITE  
ASSESSMENT REPORT**

**60 – 62 CLARENCE ROAD,  
LOGSIGHT,  
MANCHESTER,  
M13 0YE**

**ENVIROSOLUTION LTD**

**Date: 22<sup>nd</sup> July 2021**

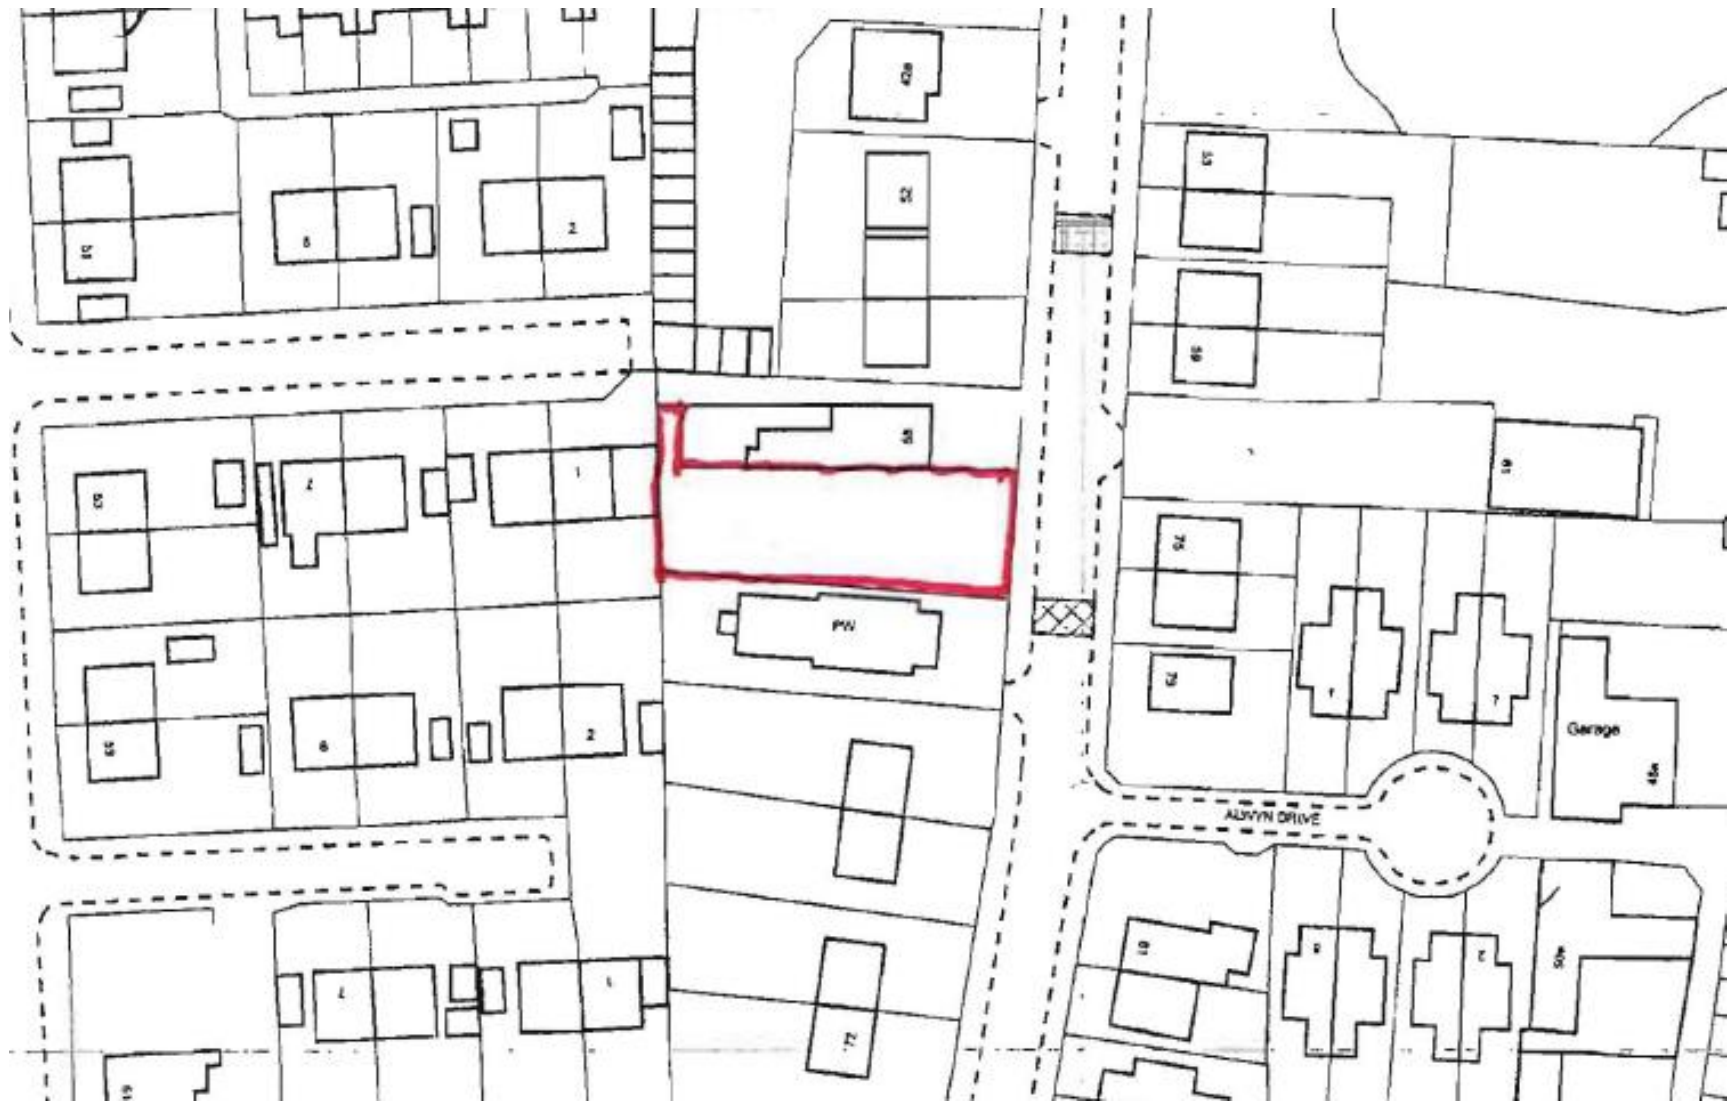
Figure 2

The site is currently a vacant plot of land. Relic foundation trenches are visible in the central area of the site.

Existing Site Plan

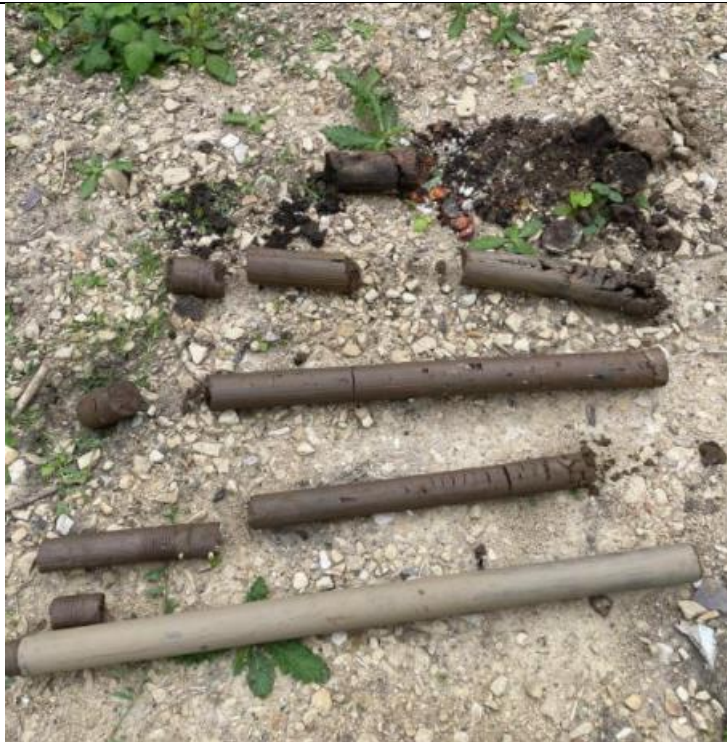
The Made Ground generally consists of brown reworked clayey soil with brick fragments and whole brick.

**WS1 soil core**

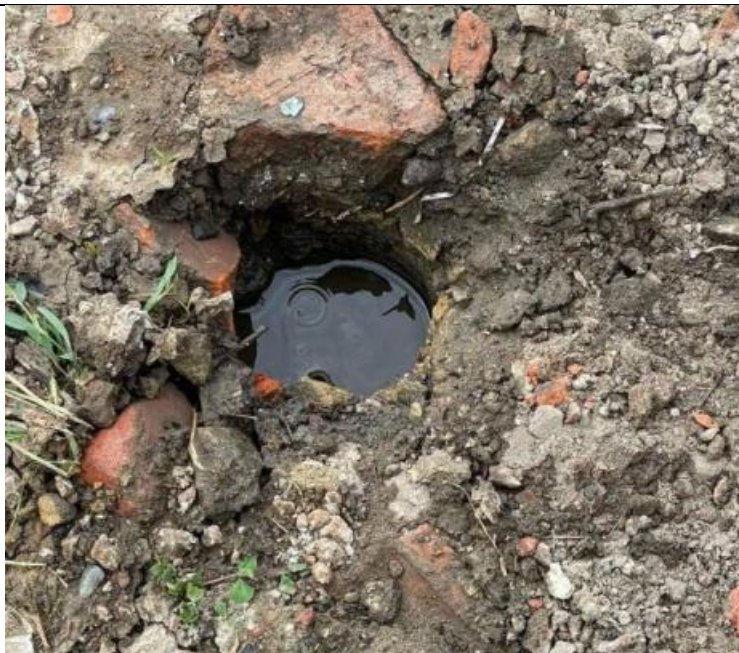
The results show that all infiltration tests failed as it was not possible to determine the infiltration rate using the standard methodology set out in BRE 365. The water failed to drain and remained at a stable level throughout the testing.

**Infiltration Test**

Given that the infiltration tests conducted at the site failed, it is therefore not recommended that soakaway drainage systems are installed at this site.

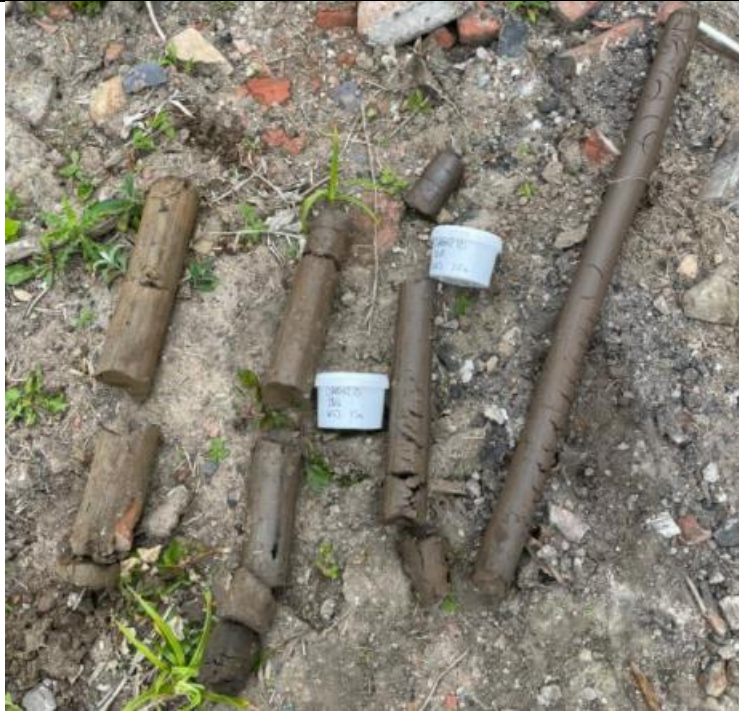
Soil core from WS3

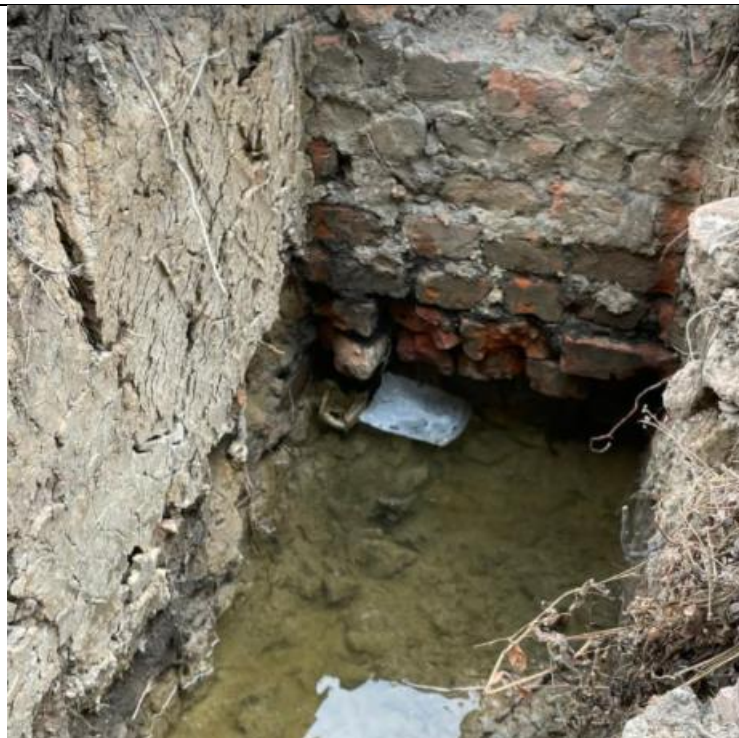
Relic wall and standing water

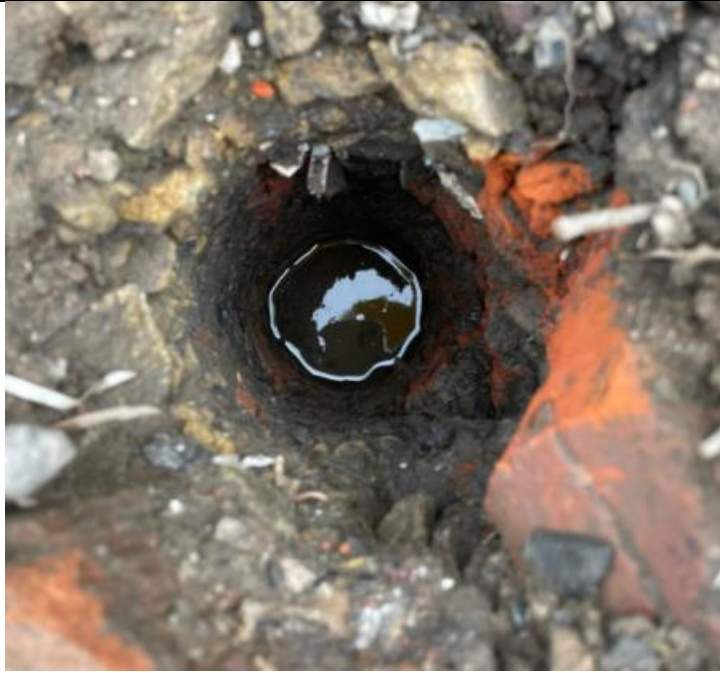
**Infiltration test**
