## HEATON PARK HORTICULTURAL CENTRE BOUNDARY WALL RE-BUILDING - EXISTING PHOTOGRAPHS

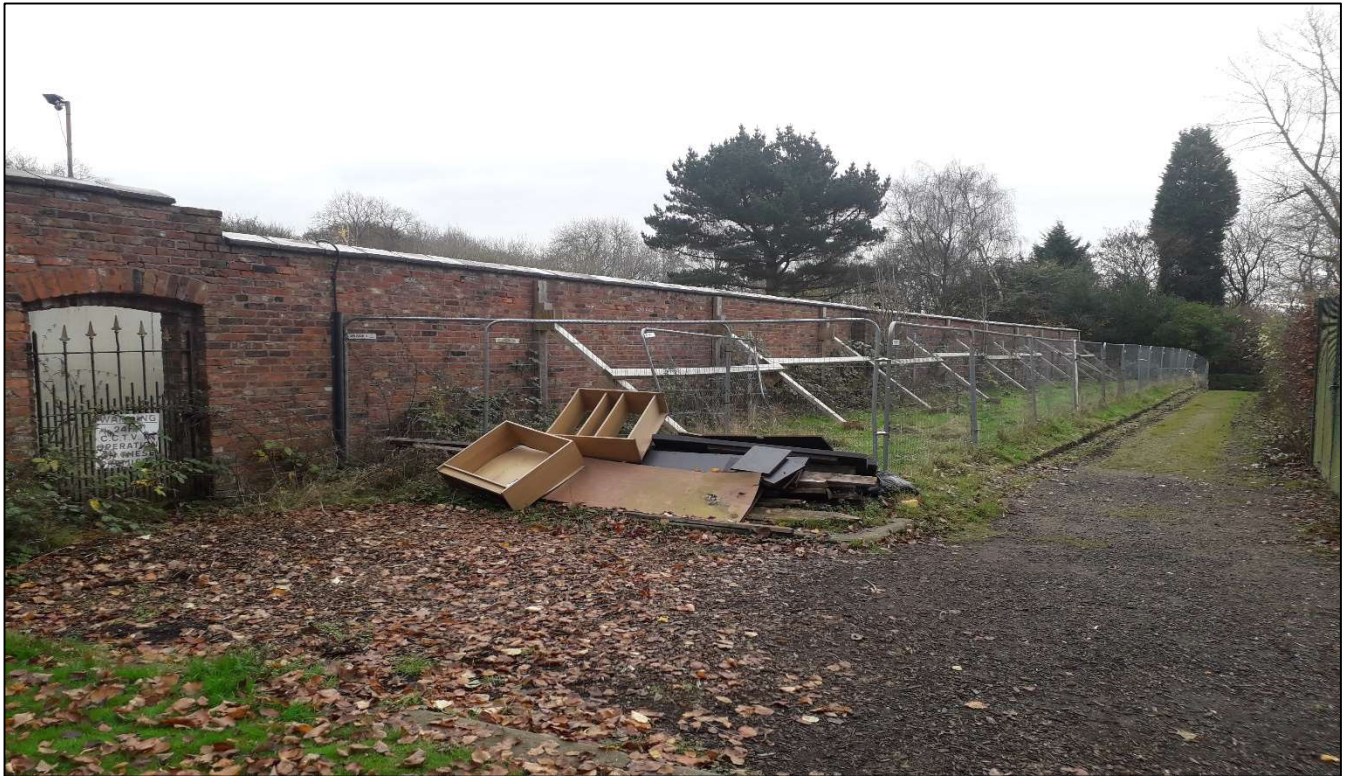
**Photo No.1** – View along the West Elevation Boundary Wall to the Horticultural Centre. Due to the walls instability, the area adjacent to it has been cordoned off and temporary raking shores erected.

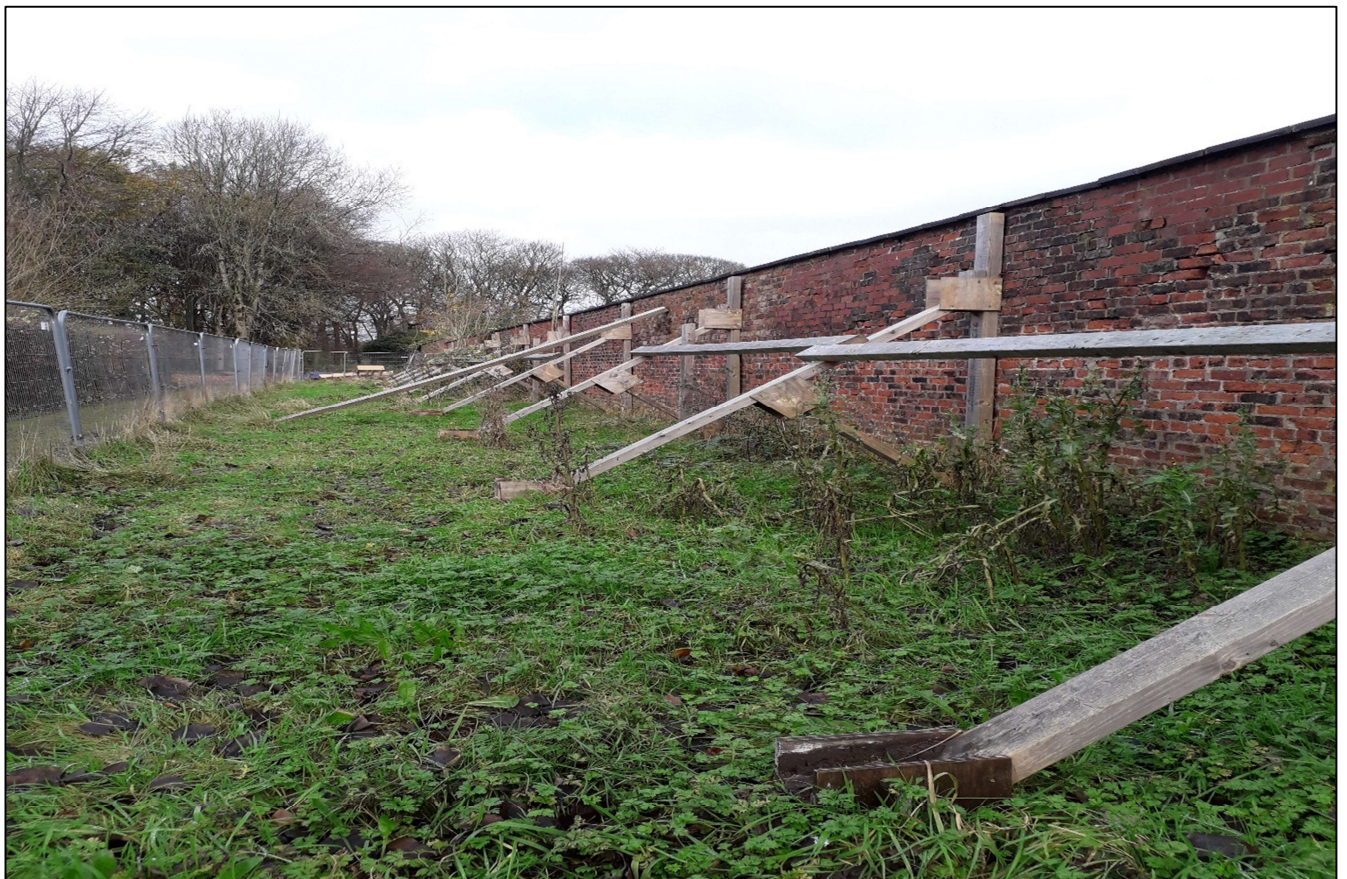
**Photo No.2** – View along the West Elevation Boundary Wall to the Horticultural Centre.

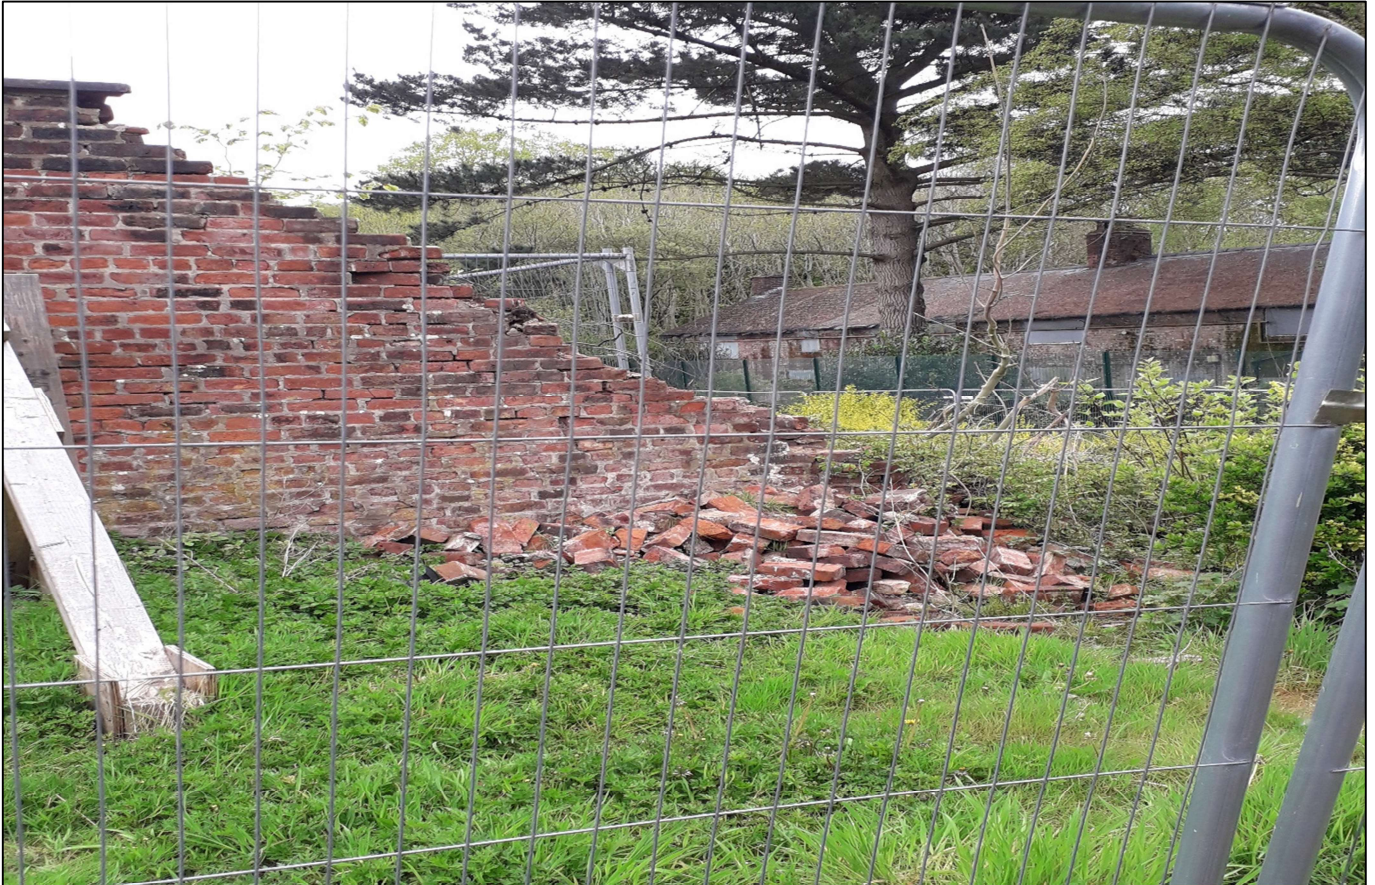
**Photo No.3** – View of collapsed section of the West Elevation Boundary Wall where it meets the Southern Boundary to the Horticultural Centre.

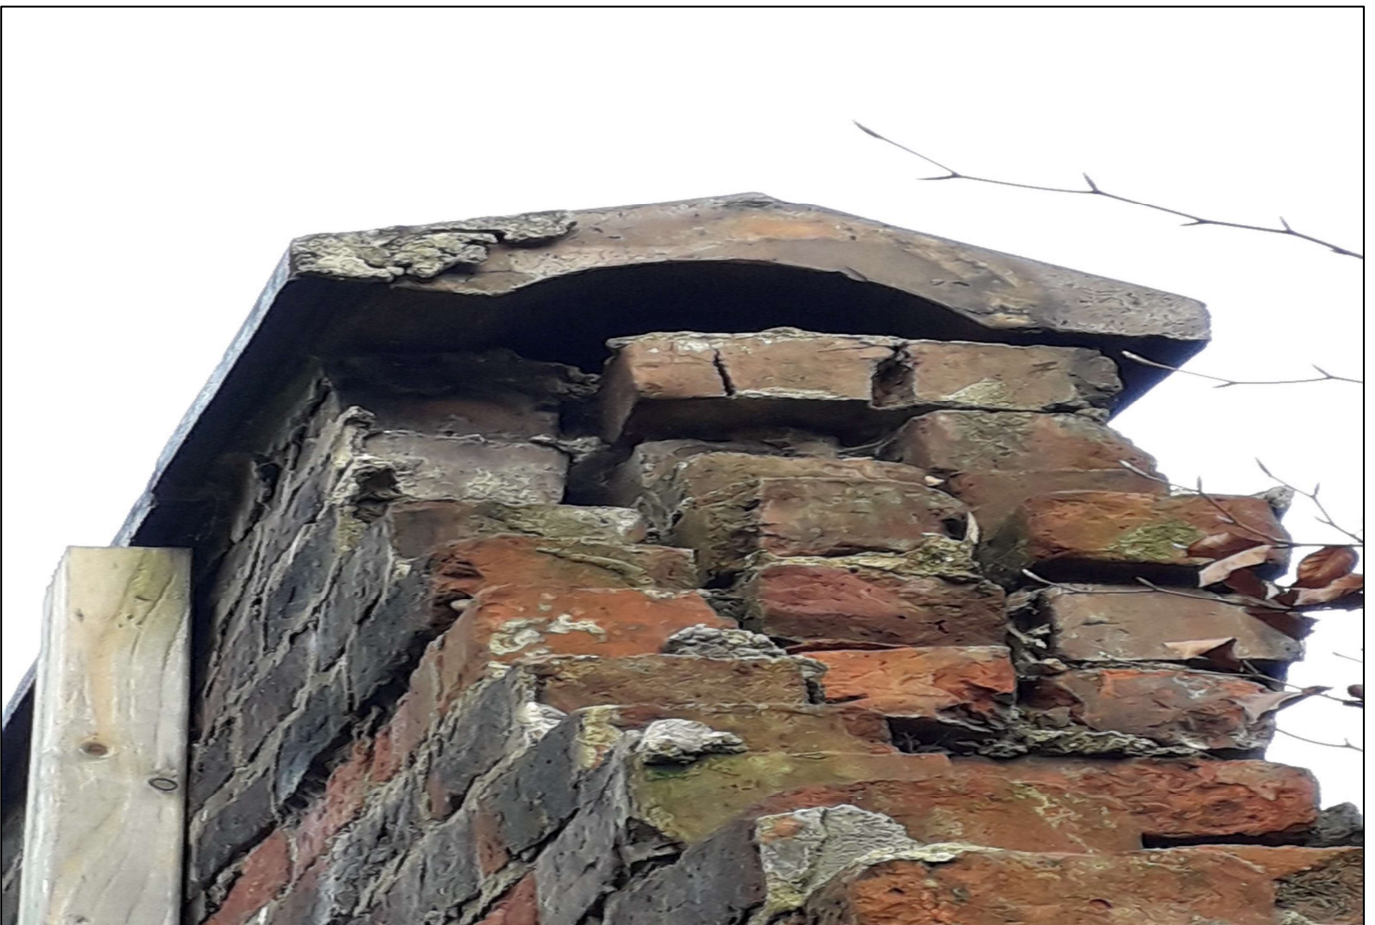
**Photo No.4** – View showing cross section of boundary wall where collapse has occurred.

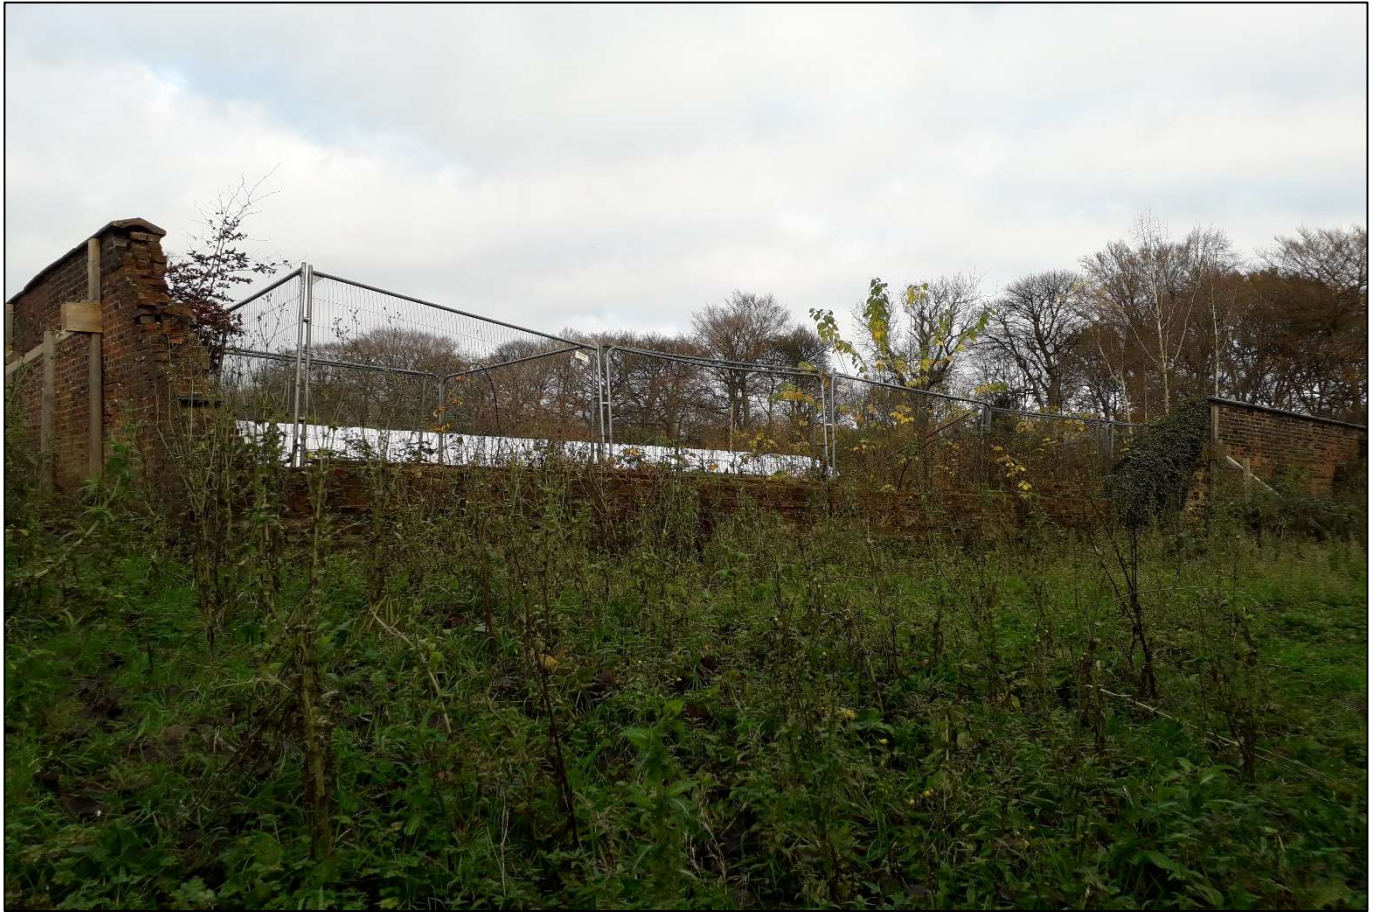
**Photo No.5** – View along South Elevation Boundary Wall to Horticultural Centre – Section of wall has collapsed completely.

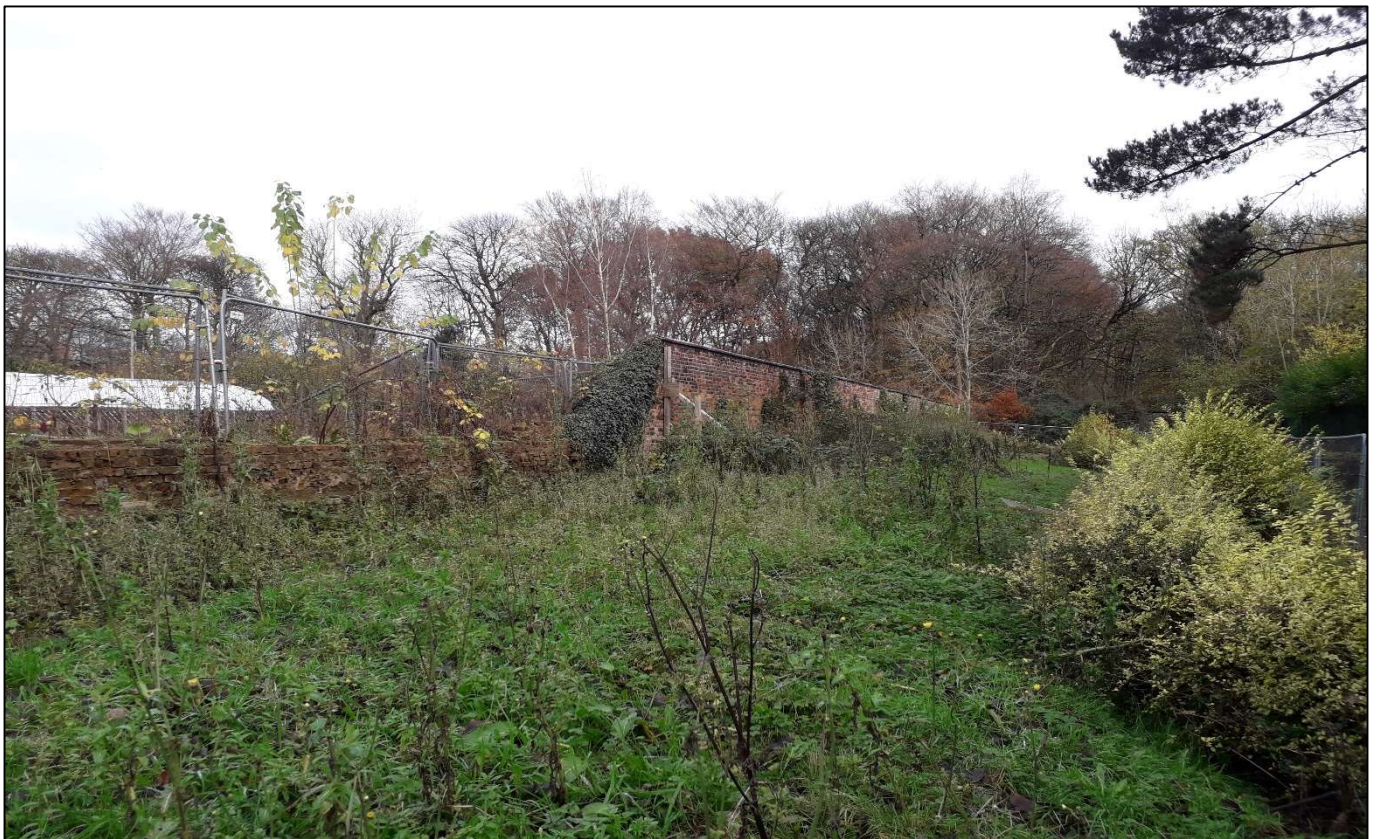
**Photo No.6** – View along South Elevation Boundary Wall to Horticultural Centre – Section of wall has collapsed completely.

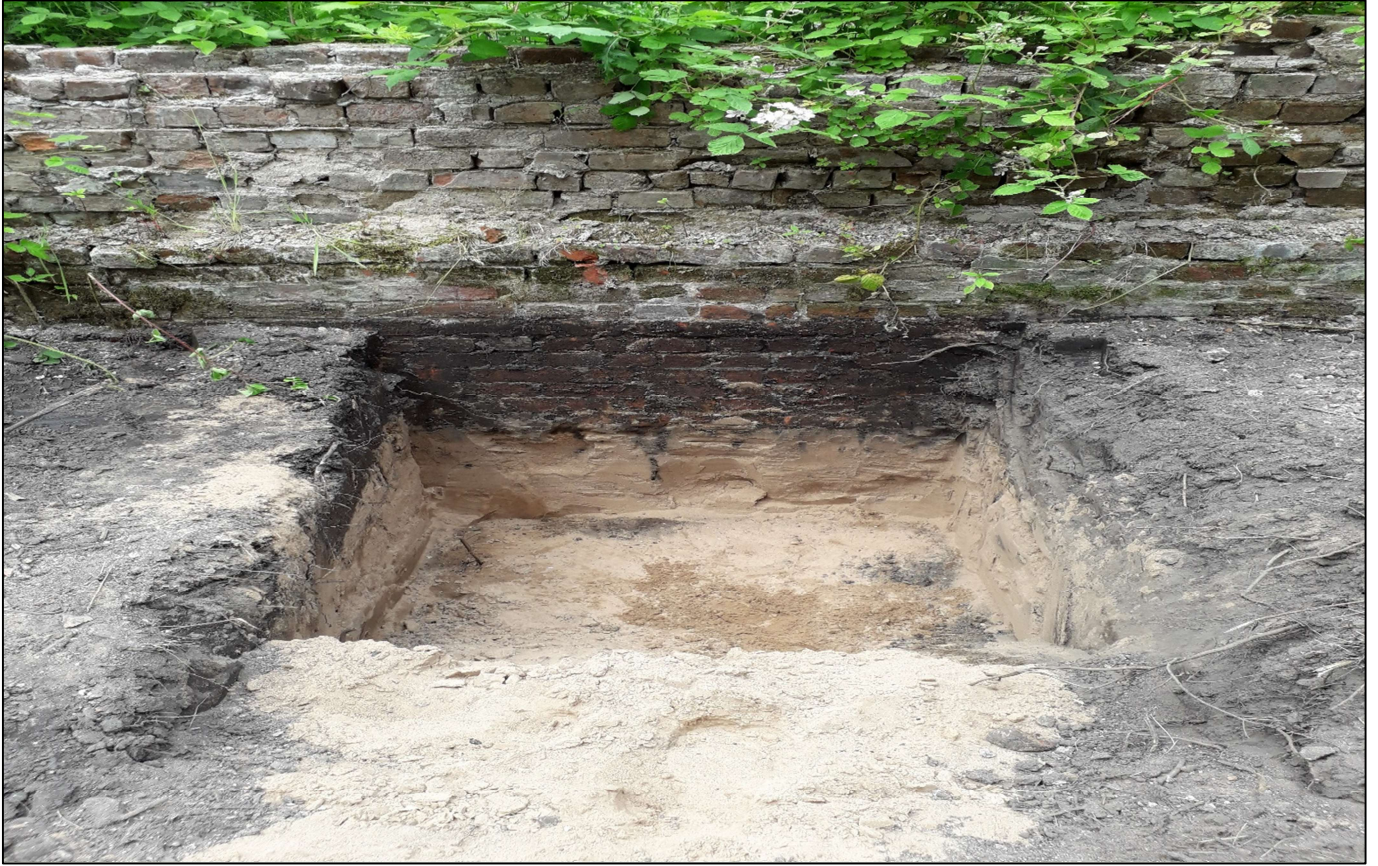
**Photo No.7** – View of trail hole at base of collapsed section of South Elevation Boundary Wall to Horticultural Centre. Wall was originally built with no foundation in sandy sub-strata.

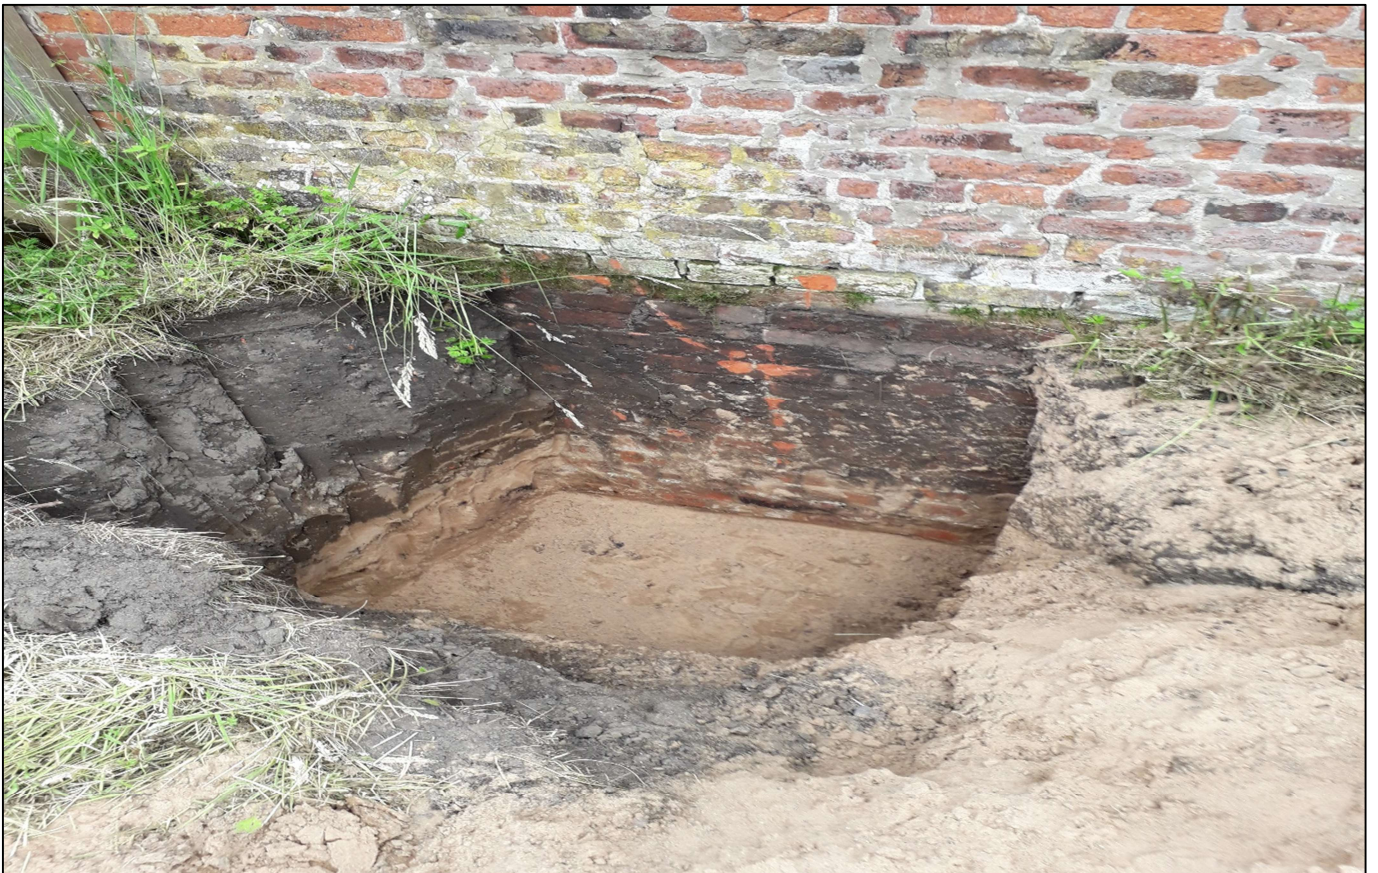
**Photo No.8** – View of trail hole at base of West Elevation Boundary Wall to Horticultural Centre. Wall was originally built with no foundation in sandy sub-strata.
