# Inspection Request

| Contract Name: Lampwick | Contract Number: E952 |

## Appendix H

### *Progress photographs*

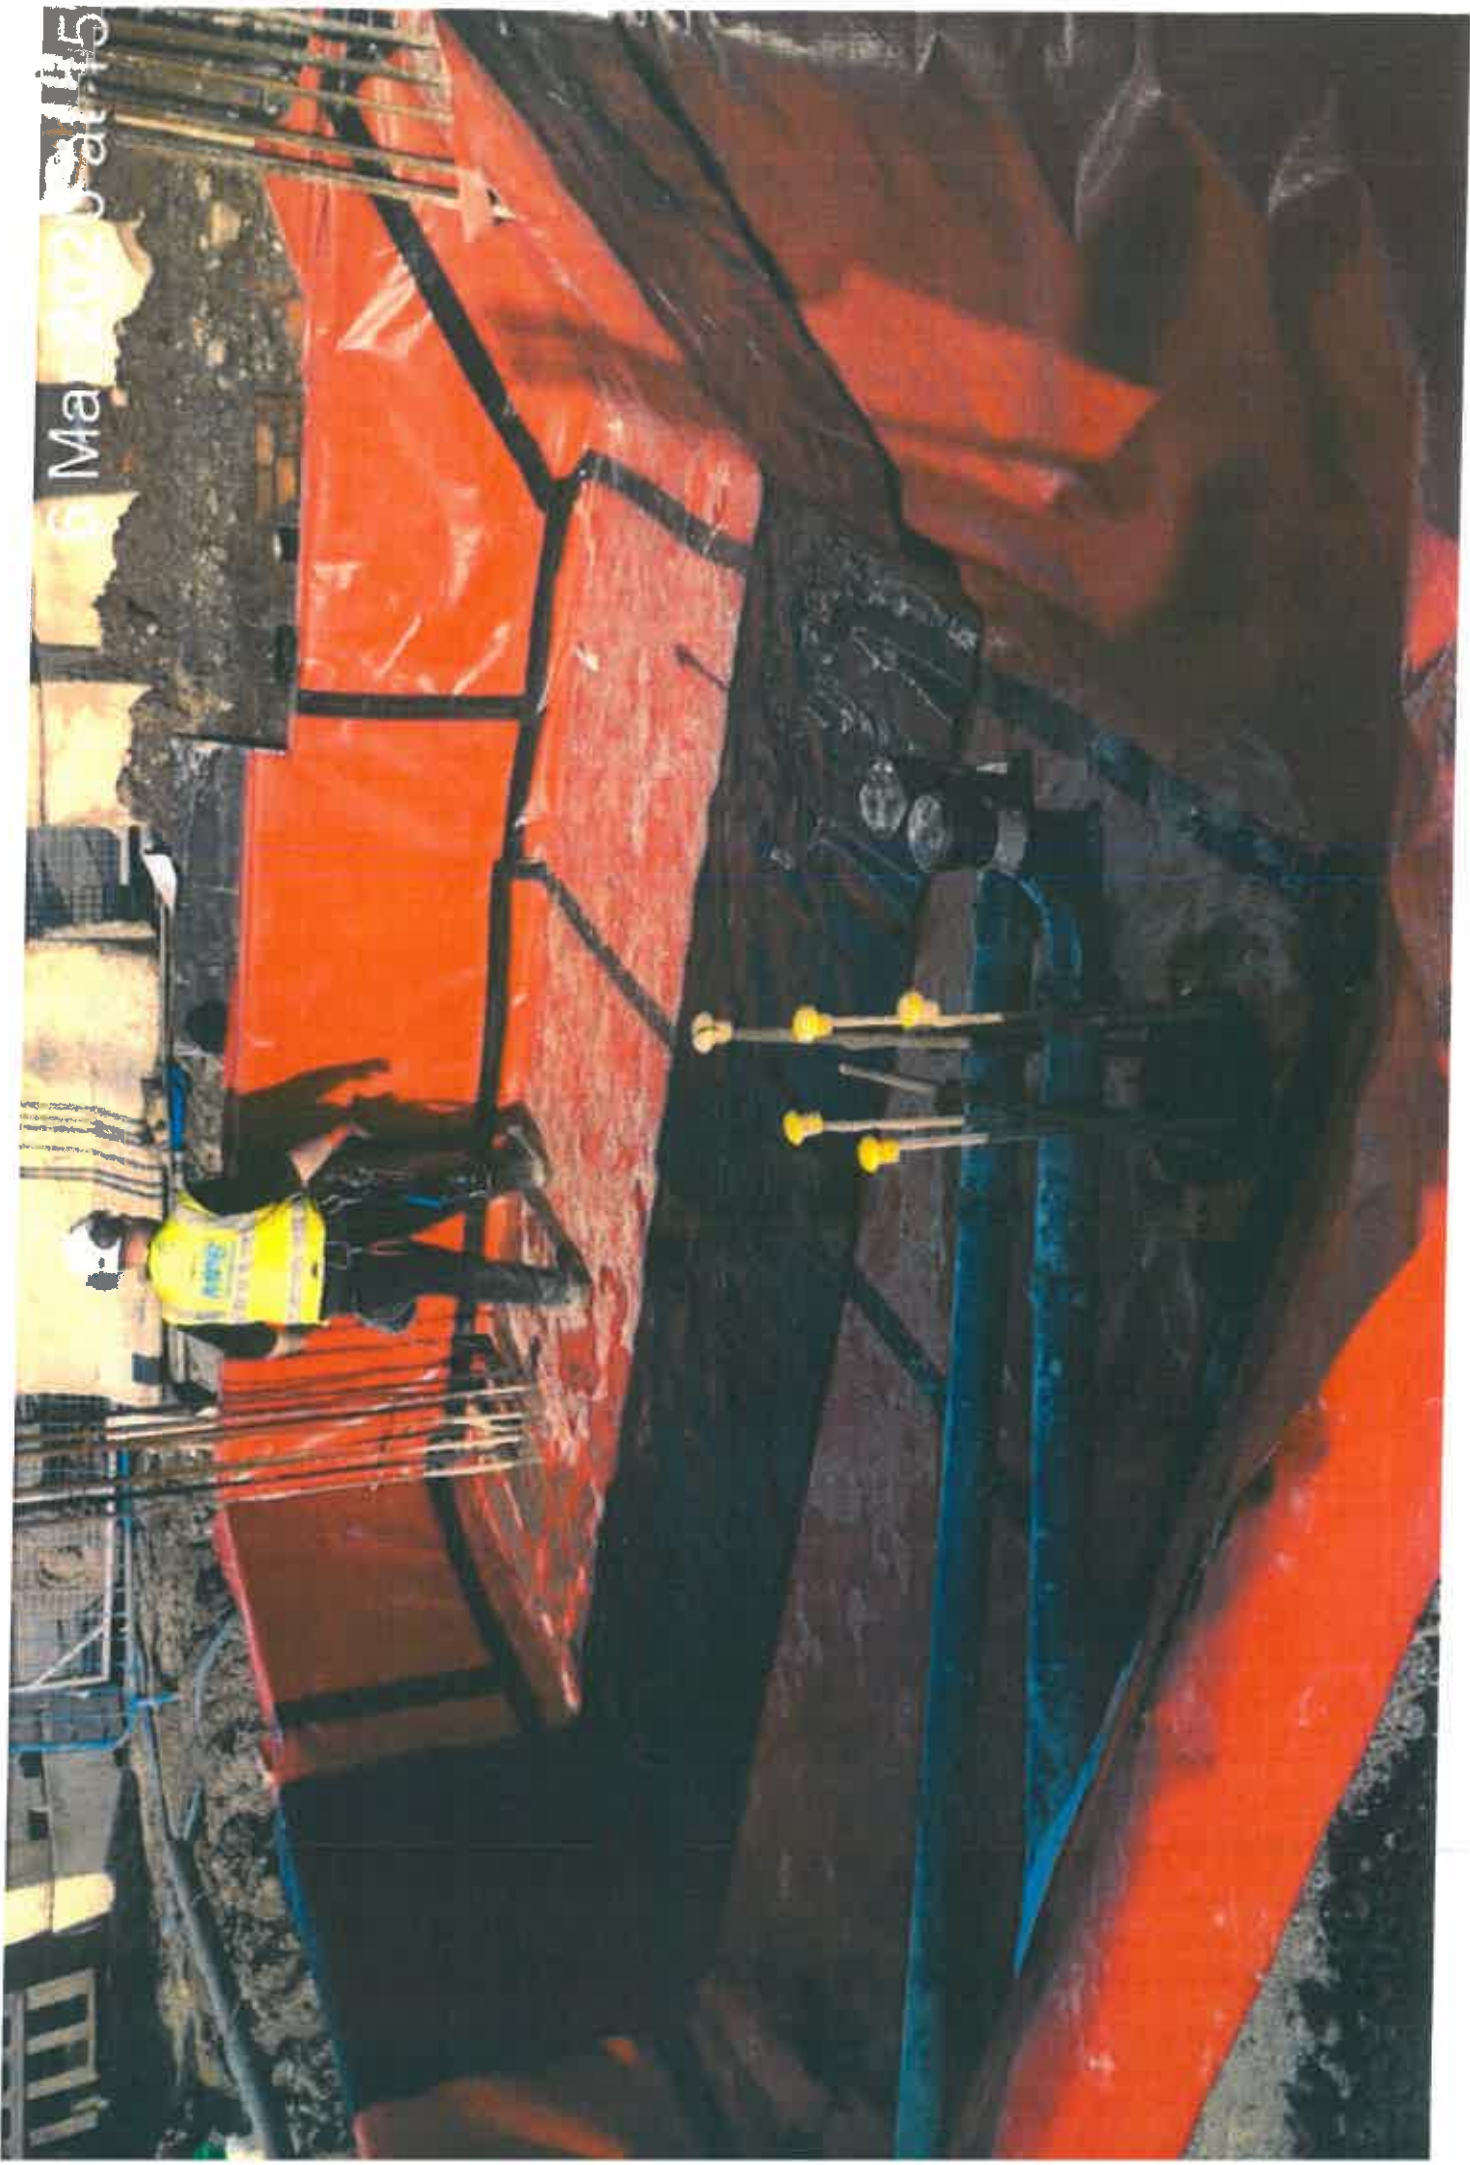
RIW inspection  
6/3/20

| Work Element: Zone 03 Service pit<br>GLS19 J-K | |
| Location: See drawing i have attached for location<br>Zone 3 | |

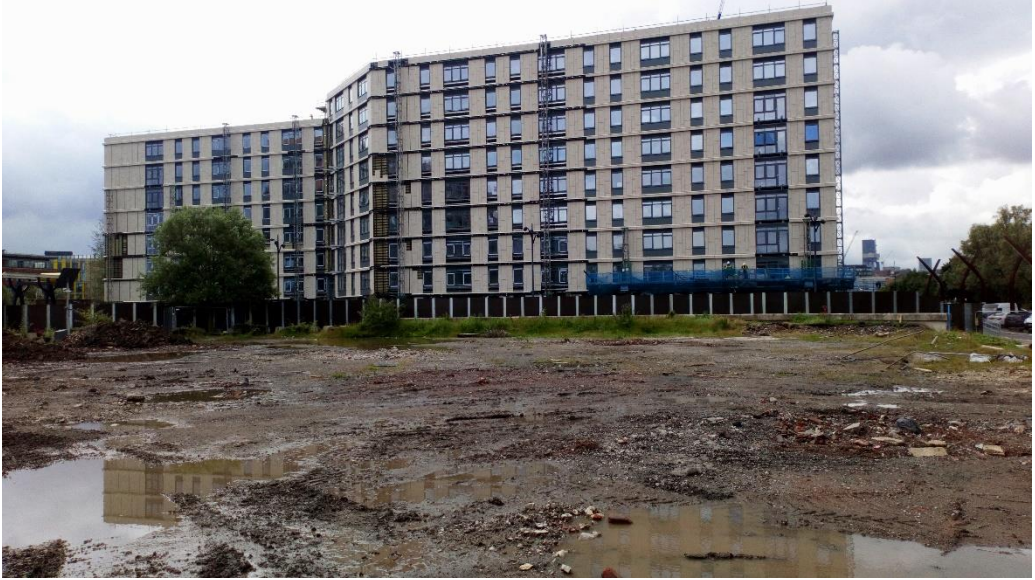
| <b>Photograph 1</b> | |

| <p><b>Direction:</b> Looking south west across the site.</p> <p><b>Description:</b> Surface level following site strip of the 6f2 material.</p> | |

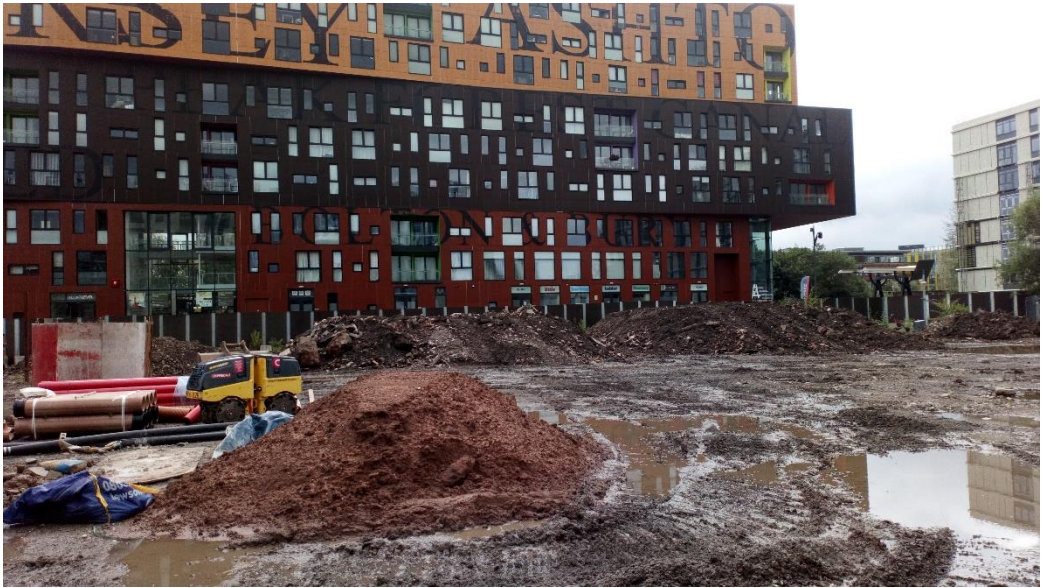
| <b>Photograph 2</b> | |

| <p><b>Direction:</b> Looking south east across the site.</p> <p><b>Description:</b> In the foreground is a small stockpile of imported red building sand. In the background are stockpiles of the 6f2 material following the site strip.</p> | |

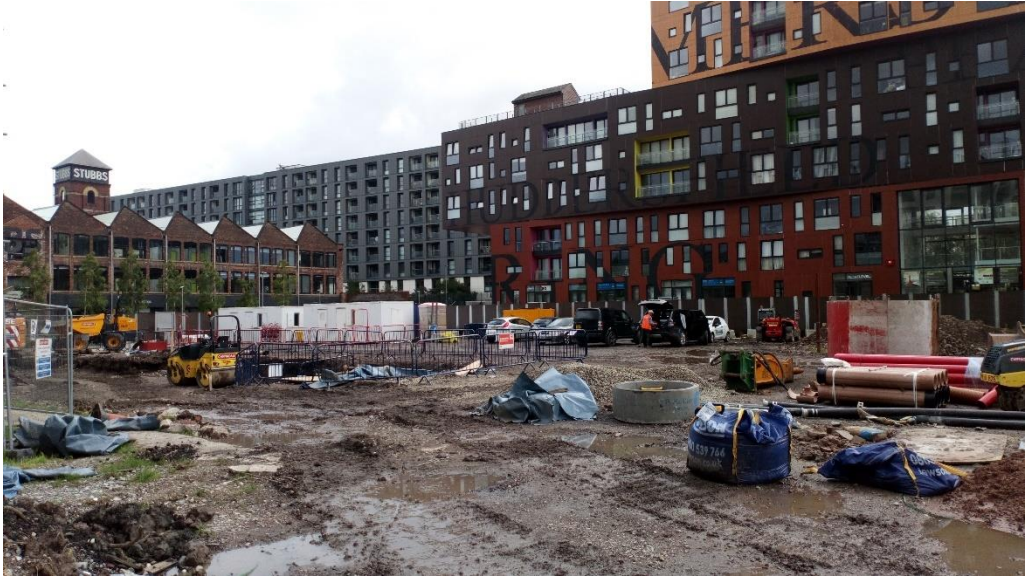
| <b>Photograph 3</b> | |

| <p><b>Direction:</b> Looking east across the site.</p> <p><b>Description:</b> Initial site compound, car parking area and welfare facilities.</p> | |

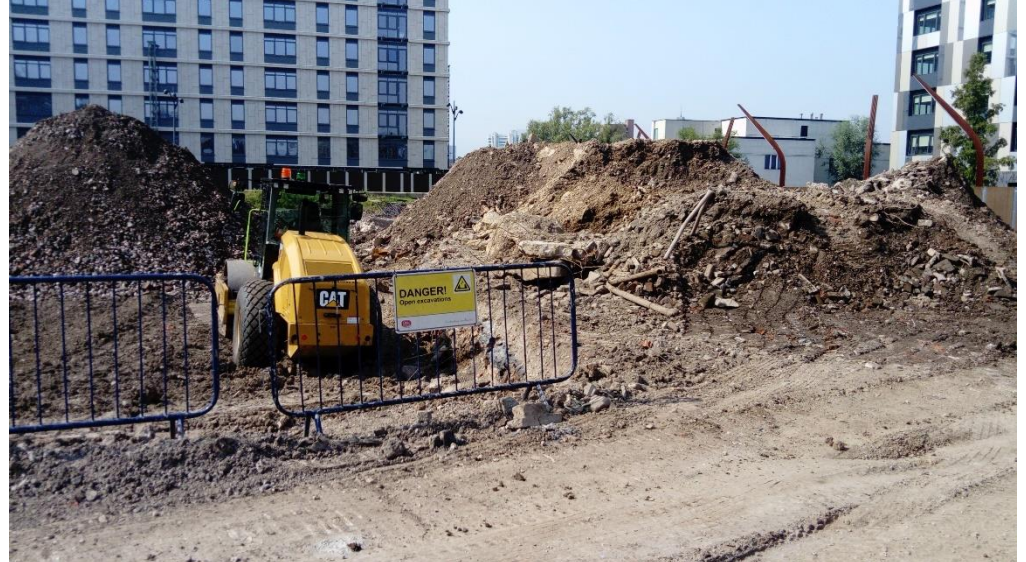
| <b>Photograph 4</b> | |

| <p><b>Direction:</b> Looking west across the site.</p> <p><b>Description:</b> Stockpiled material in Zone 2 and 3 arising from the road excavation.</p> | |

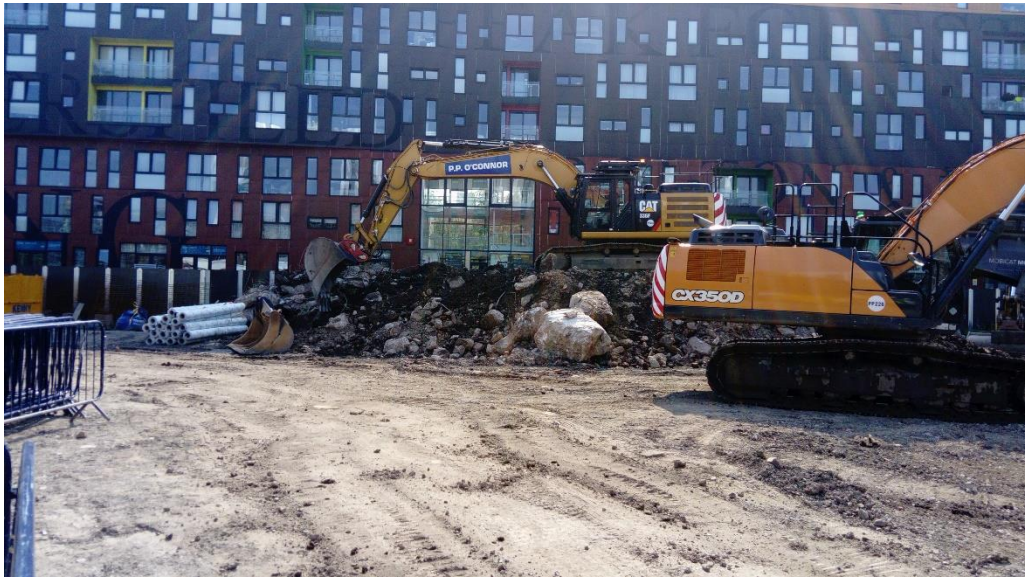
| <b>Photograph 5</b> | |

| <p><b>Direction:</b> Looking south east across the site.</p> <p><b>Description:</b><br/>Stockpiled concrete with in Zone 6.</p> | |

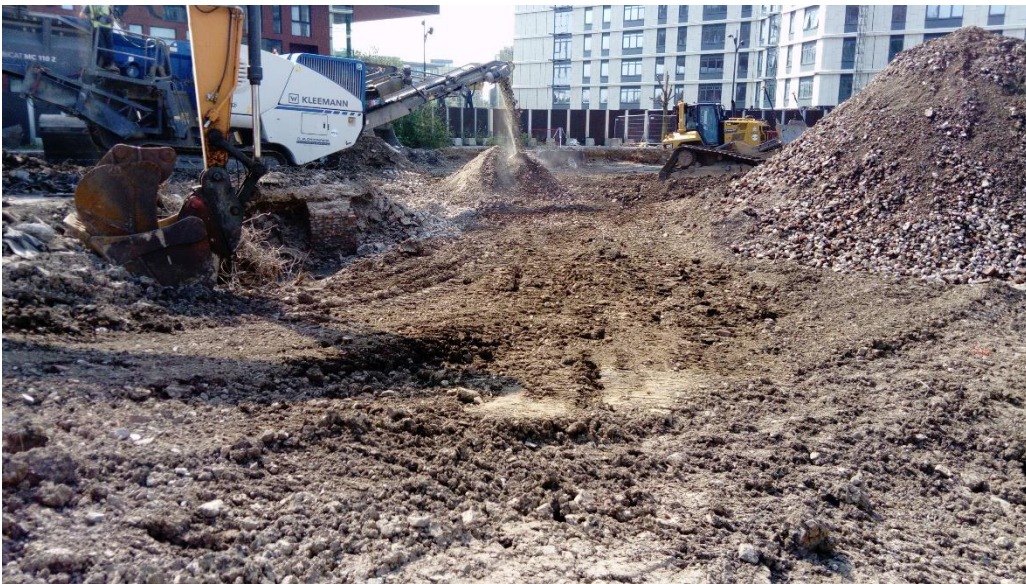
| <b>Photograph 6</b> | |

| <p><b>Direction:</b> Looking south across the site</p> <p><b>Description:</b><br/>Stockpiled concrete in Zone 6, crushed and placed in temporary stockpile in zone 5.</p> | |

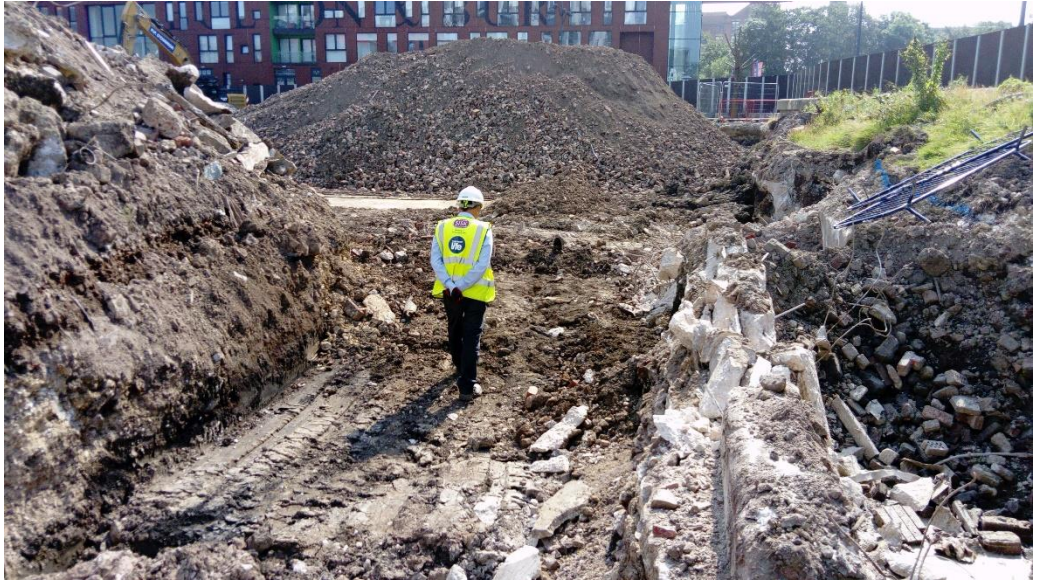
| <b>Photograph 7</b> | |

| <p><b>Direction:</b> Looking south across the site.</p> <p><b>Description:</b> Looking toward stockpiled processed material in Zone 4.</p> | |

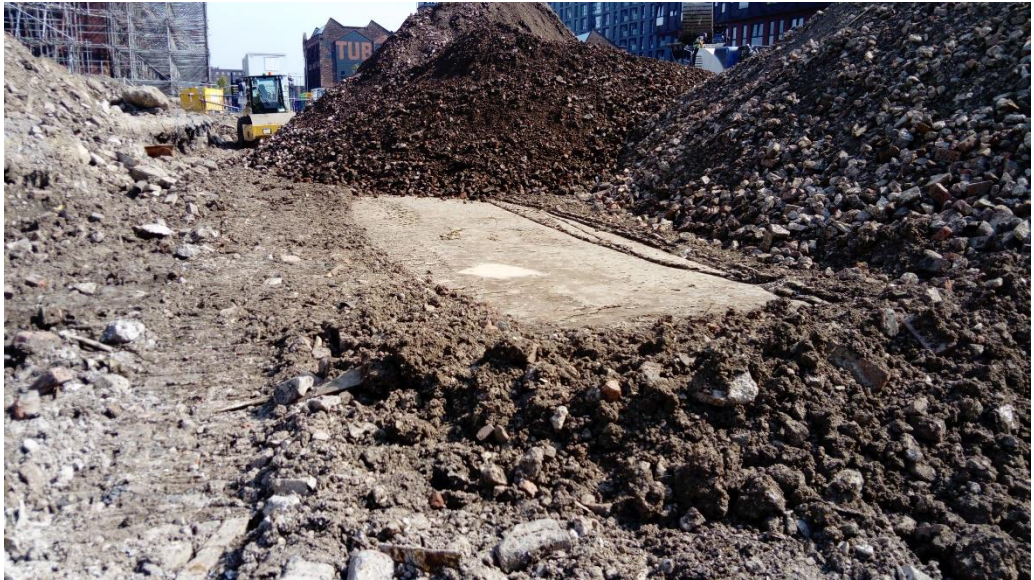
| <b>Photograph 8</b> | |

| <p><b>Direction:</b> Looking north east across the site.</p> <p><b>Description:</b> Looking at Stockpile C in Zone 2, some of the excess material from Stockpile C is being removed from site. This material is going to PPOC's aggregates processing facility.</p> | |

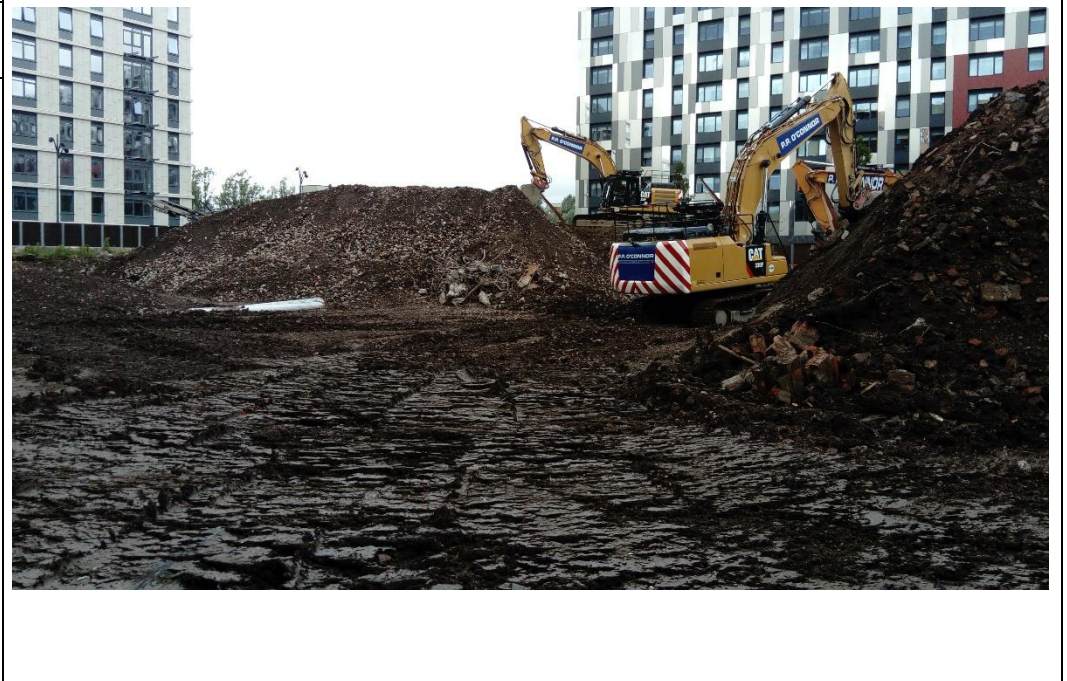
| <b>Photograph 9</b> | |

| <b>Direction:</b><br><br><b>Description:</b> Looking at stockpile of processed fill in Zone 10A. | |

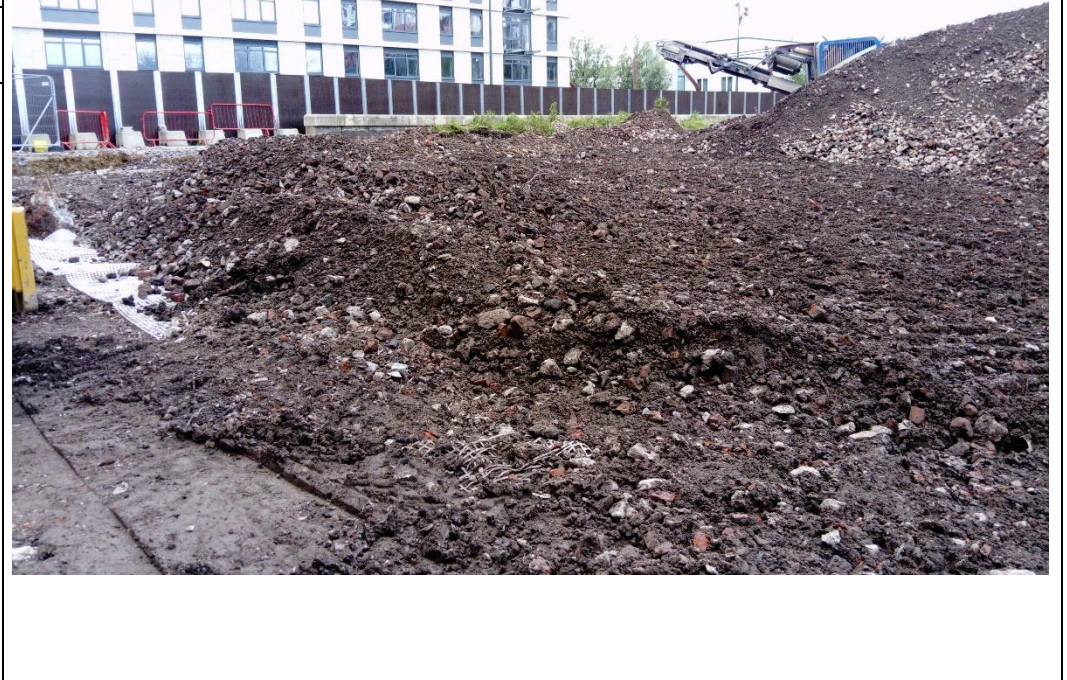
| <b>Photograph 10</b> | |

| <b>Direction:</b> Looking west.<br><br><b>Description:</b> Crushing operations and stockpiled processed material. | |

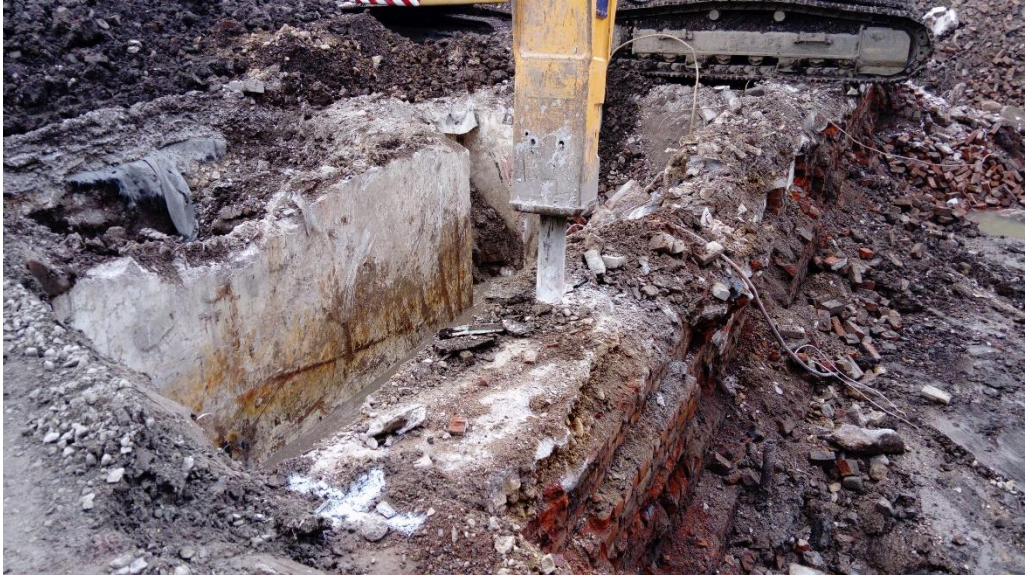
| <b>Photograph 11</b> | |

| <b>Direction:</b> Looking north.<br><br><b>Description:</b> Below ground brick and concrete structure being broken out in Zone 2. | |

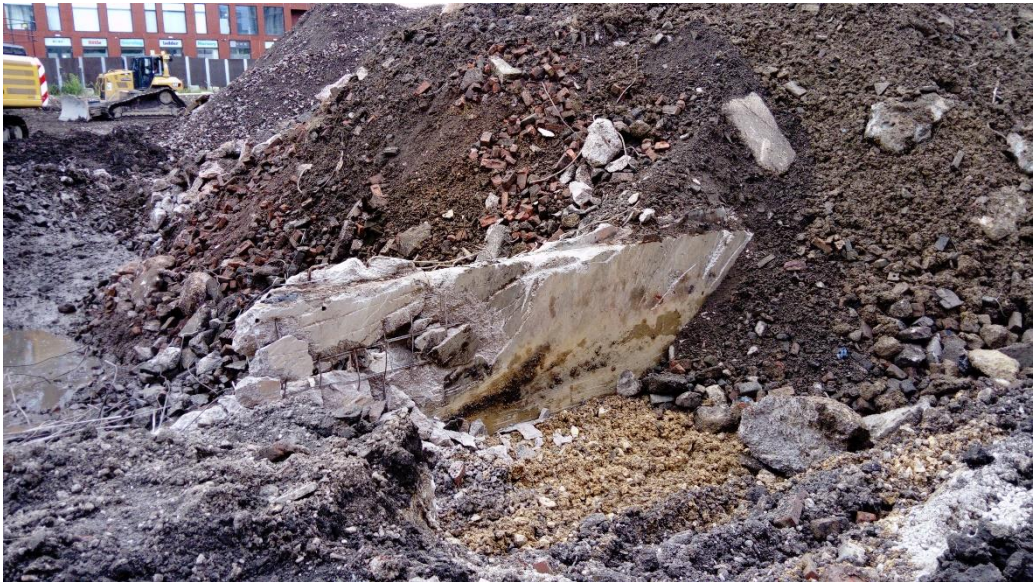
| <b>Photograph 12</b> | |

| <b>Direction:</b> Looking south east.<br><br><b>Description:</b> Below ground concrete structure being broken out in Zone 2. | |

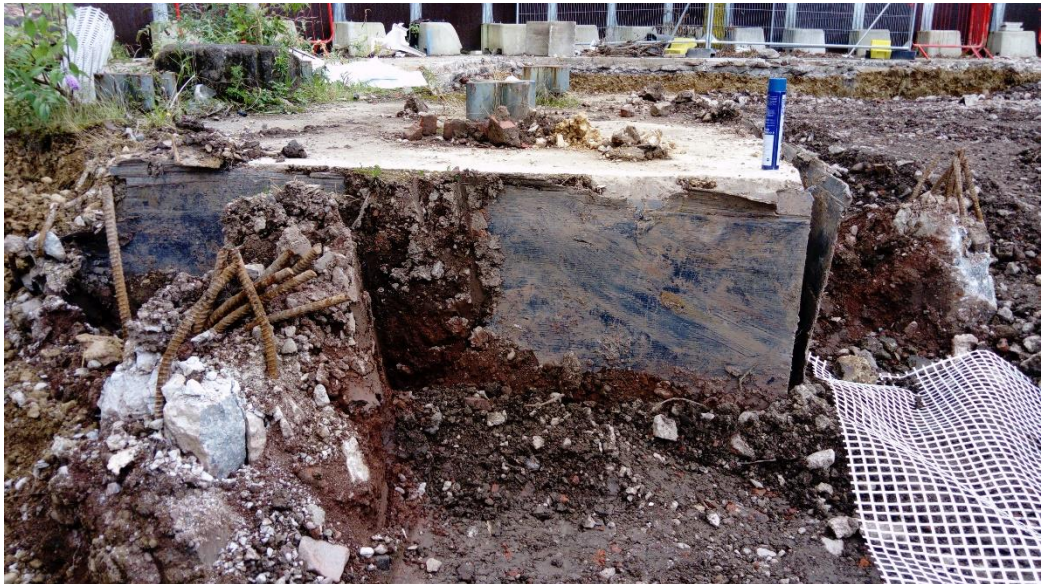
| <b>Photograph 13</b> | |

| <b>Direction:</b> Looking north east.<br><br><b>Description:</b><br>Concrete obstruction (remnant foundation) in Zone 2. | |

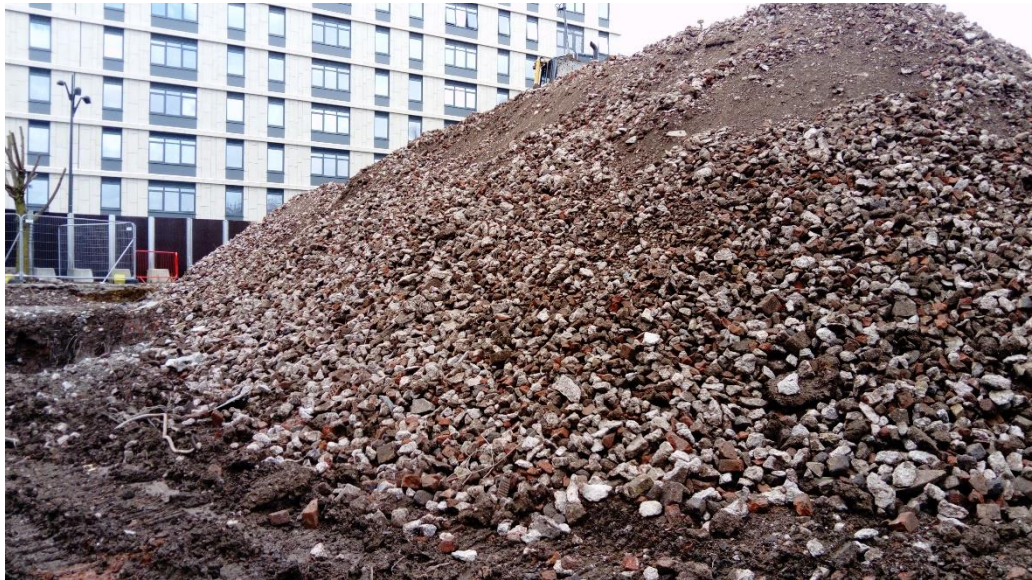
| <b>Photograph 14</b> | |

| <b>Direction:</b> Looking south west.<br><br><b>Description:</b><br>Stockpiled processed material in Zone 10A. | |

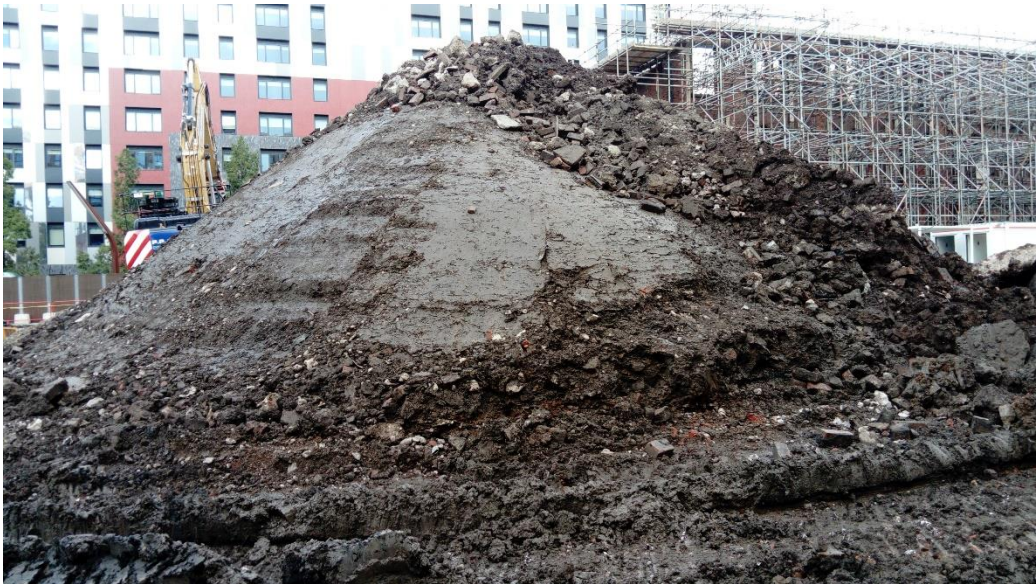
| <p><b>Photograph 15</b></p> | |

| <p><b>Direction:</b> Looking north.</p> <p><b>Description:</b><br/>Stockpile of clayey Made Ground in Zone 9 and 10.</p> | |

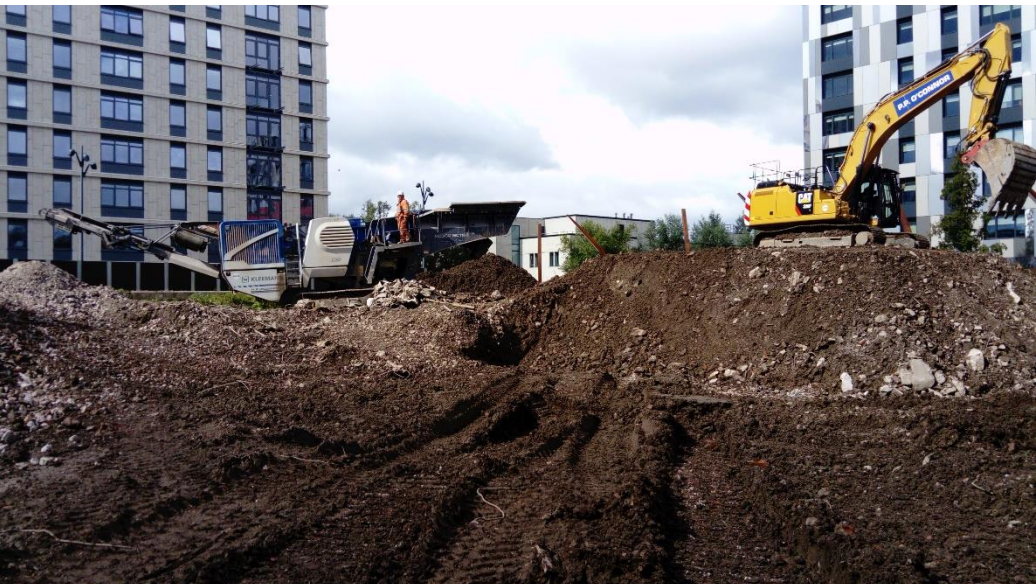
| <p><b>Photograph 16</b></p> | |

| <p><b>Direction:</b> Looking south.</p> <p><b>Description:</b><br/>Processing material from Stockpile C in Zone 3 and 10A.</p> | |

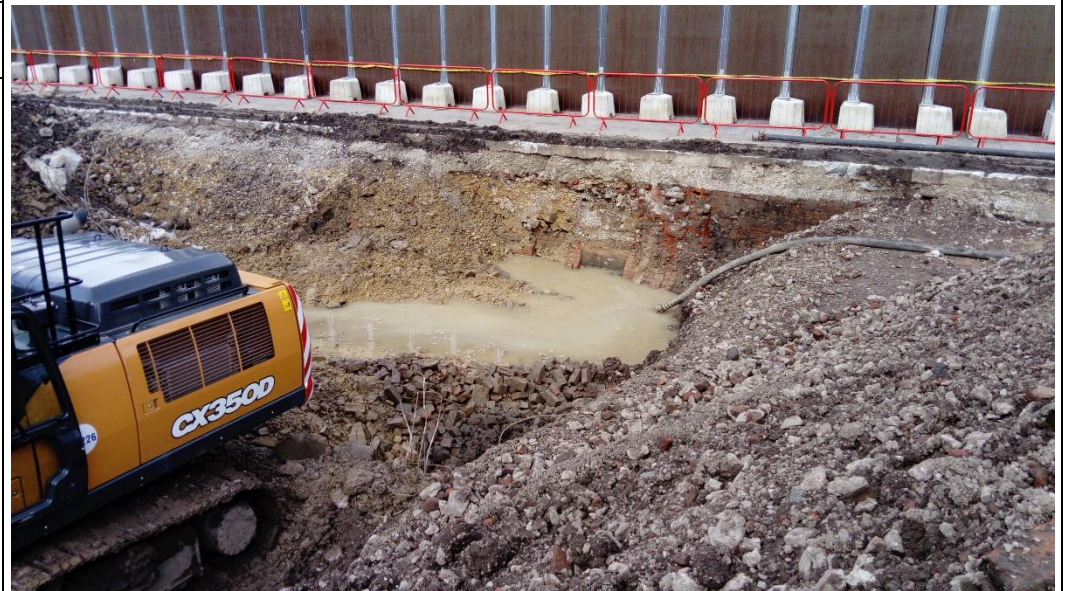
| <b>Photograph 17</b> | |

| <b>Direction:</b> Looking east.<br><br><b>Description:</b><br>Dewatering an excavation in the east of the site (Zone 6). | |

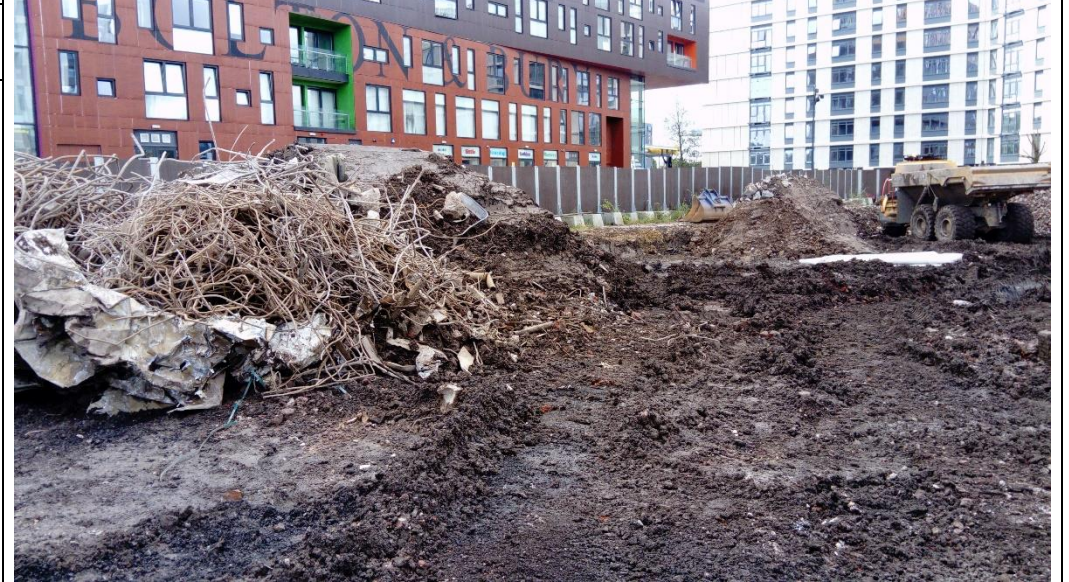
| <b>Photograph 18</b> | |

| <b>Direction:</b> Looking south.<br><br><b>Description:</b><br>Stockpiled rebar and other metal. | |
