## DOMIS CONSTRUCTION LTD

Victoria House, Great Ancoats Street, Manchester

Piling Risk Assessment

JM/C4742/10386

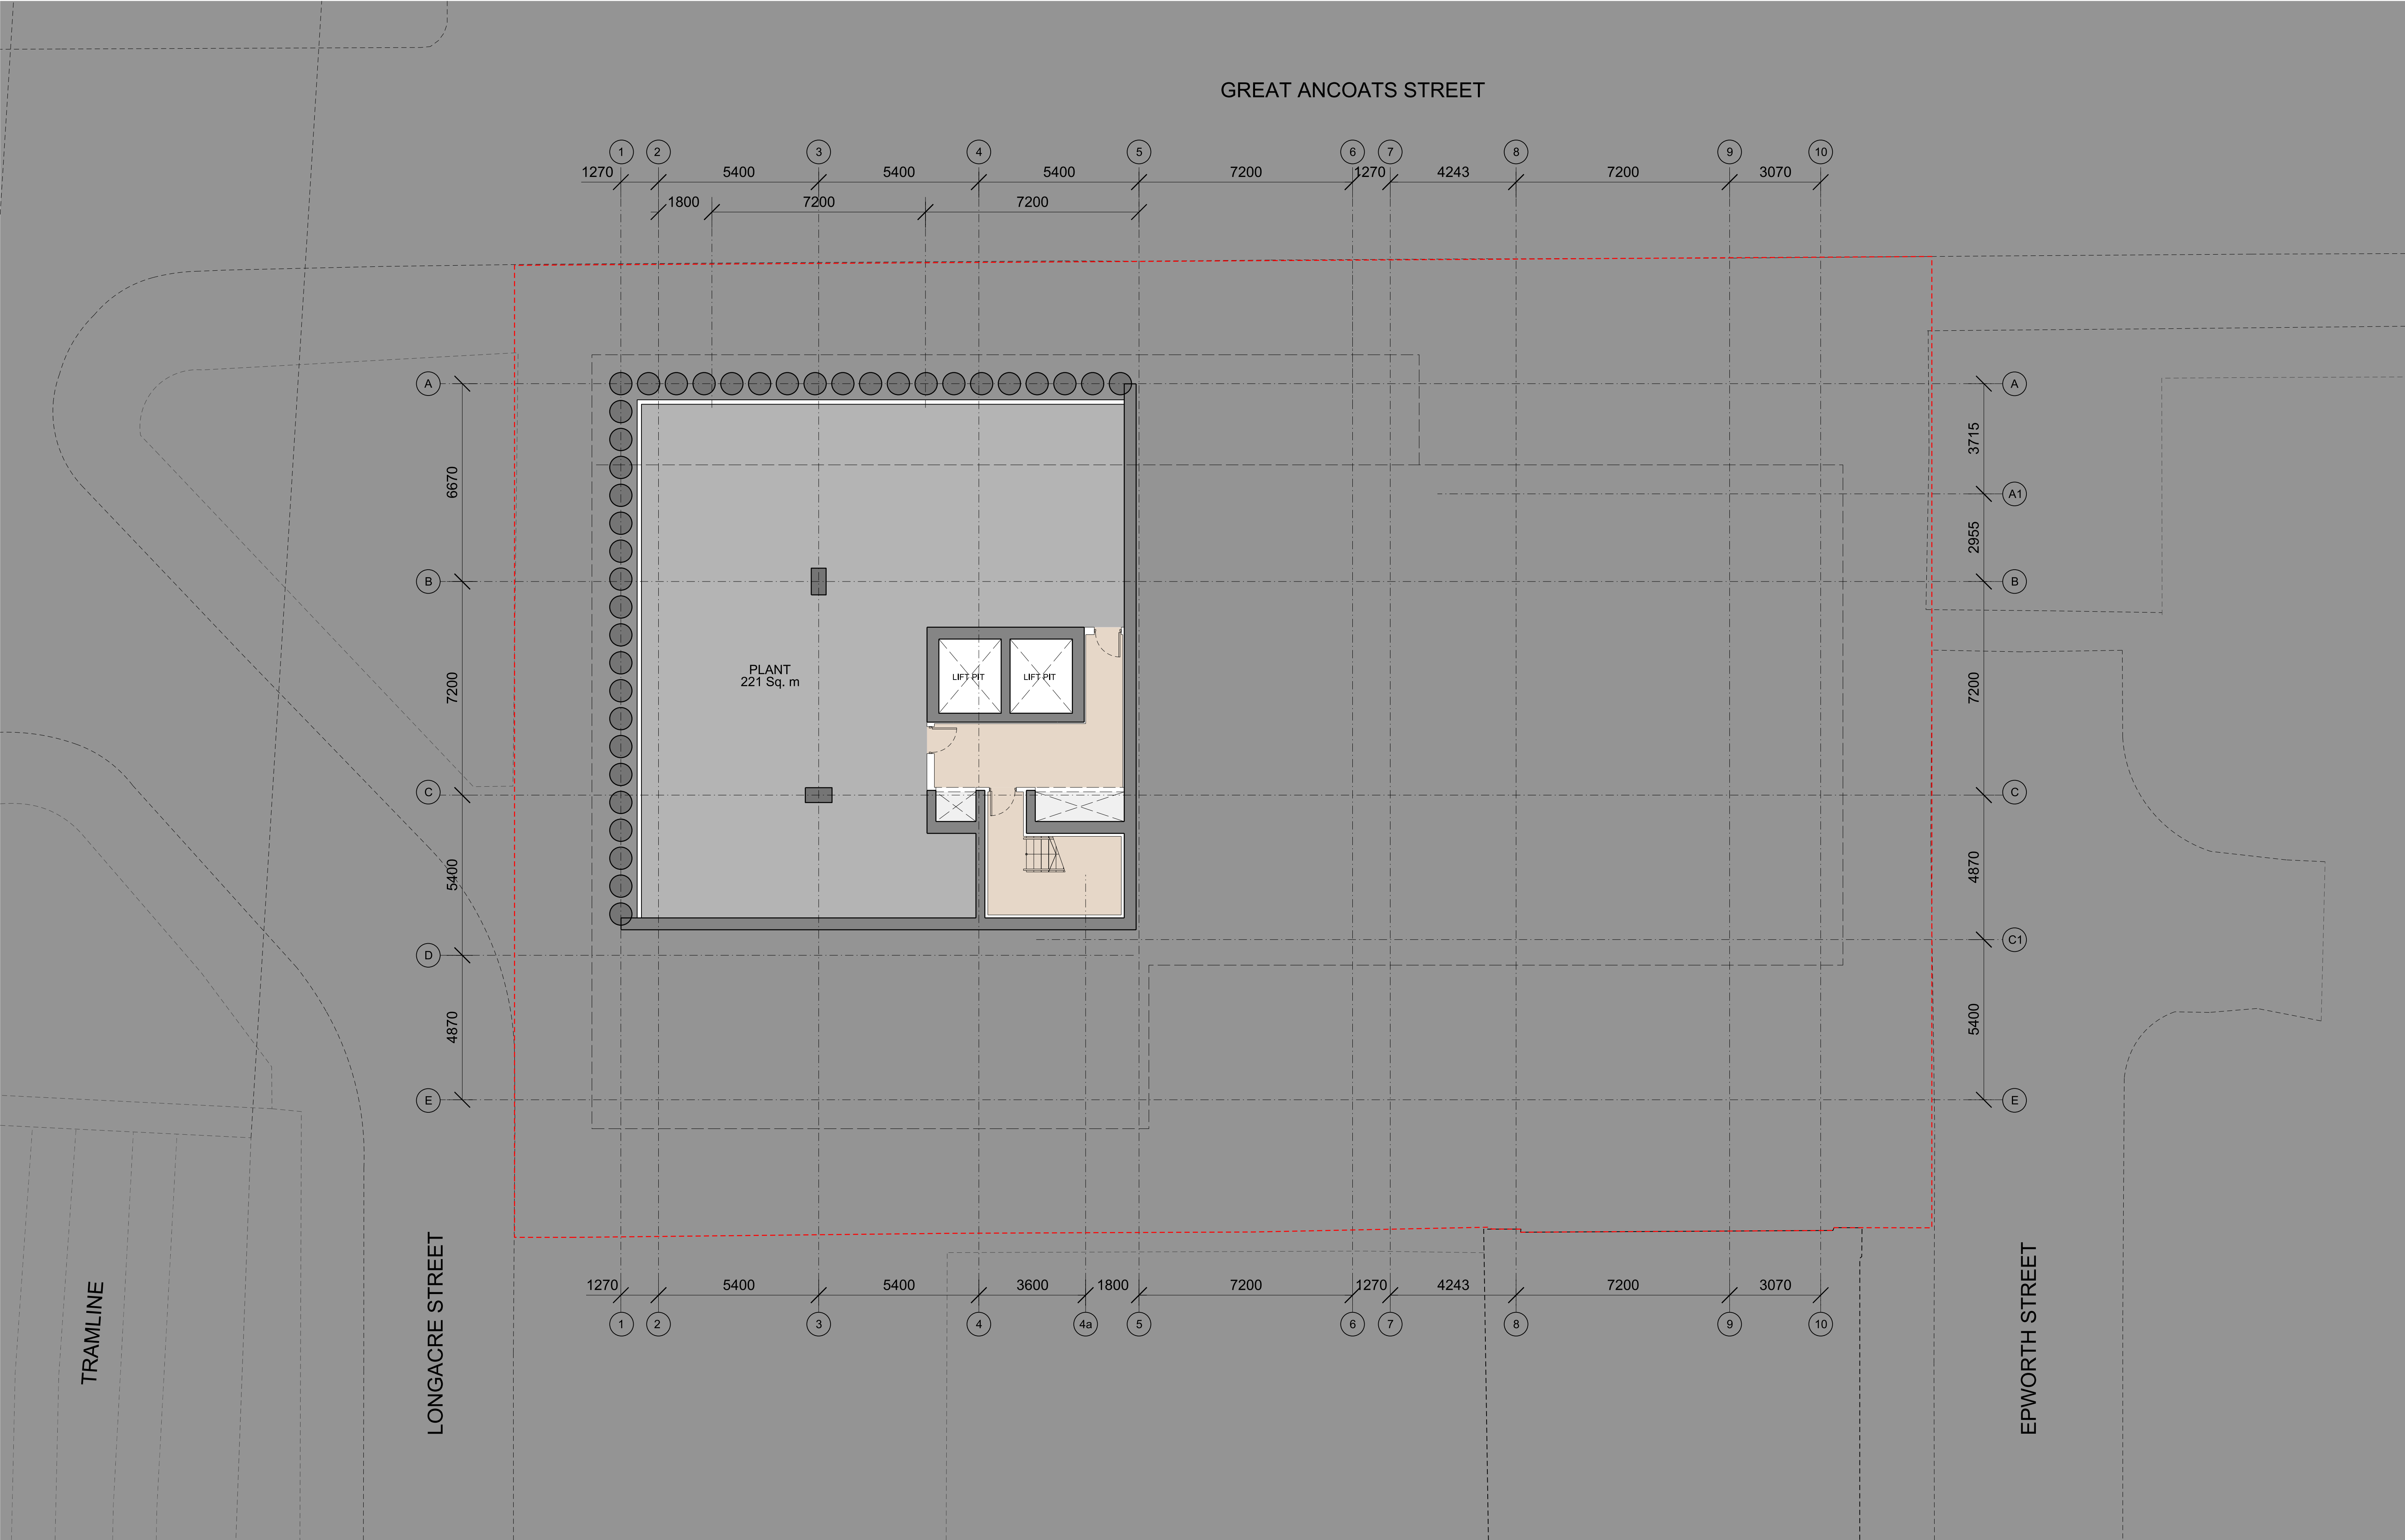
| Drawing Title | | |
|---|---|---|
| Drawing No<br><b>10122-A-B5D9-G200-P-B1-003</b> | Revision<br><b>00</b> | |

| Drawing Title | | |
|---|---|---|
| <b>BASEMENT PLAN</b> | | |

| Drawing Number | Rev | Title |
|---|---|---|
| 10122-A-B5D9-G200-P-B1-003 | - | Proposed Basement Plan |

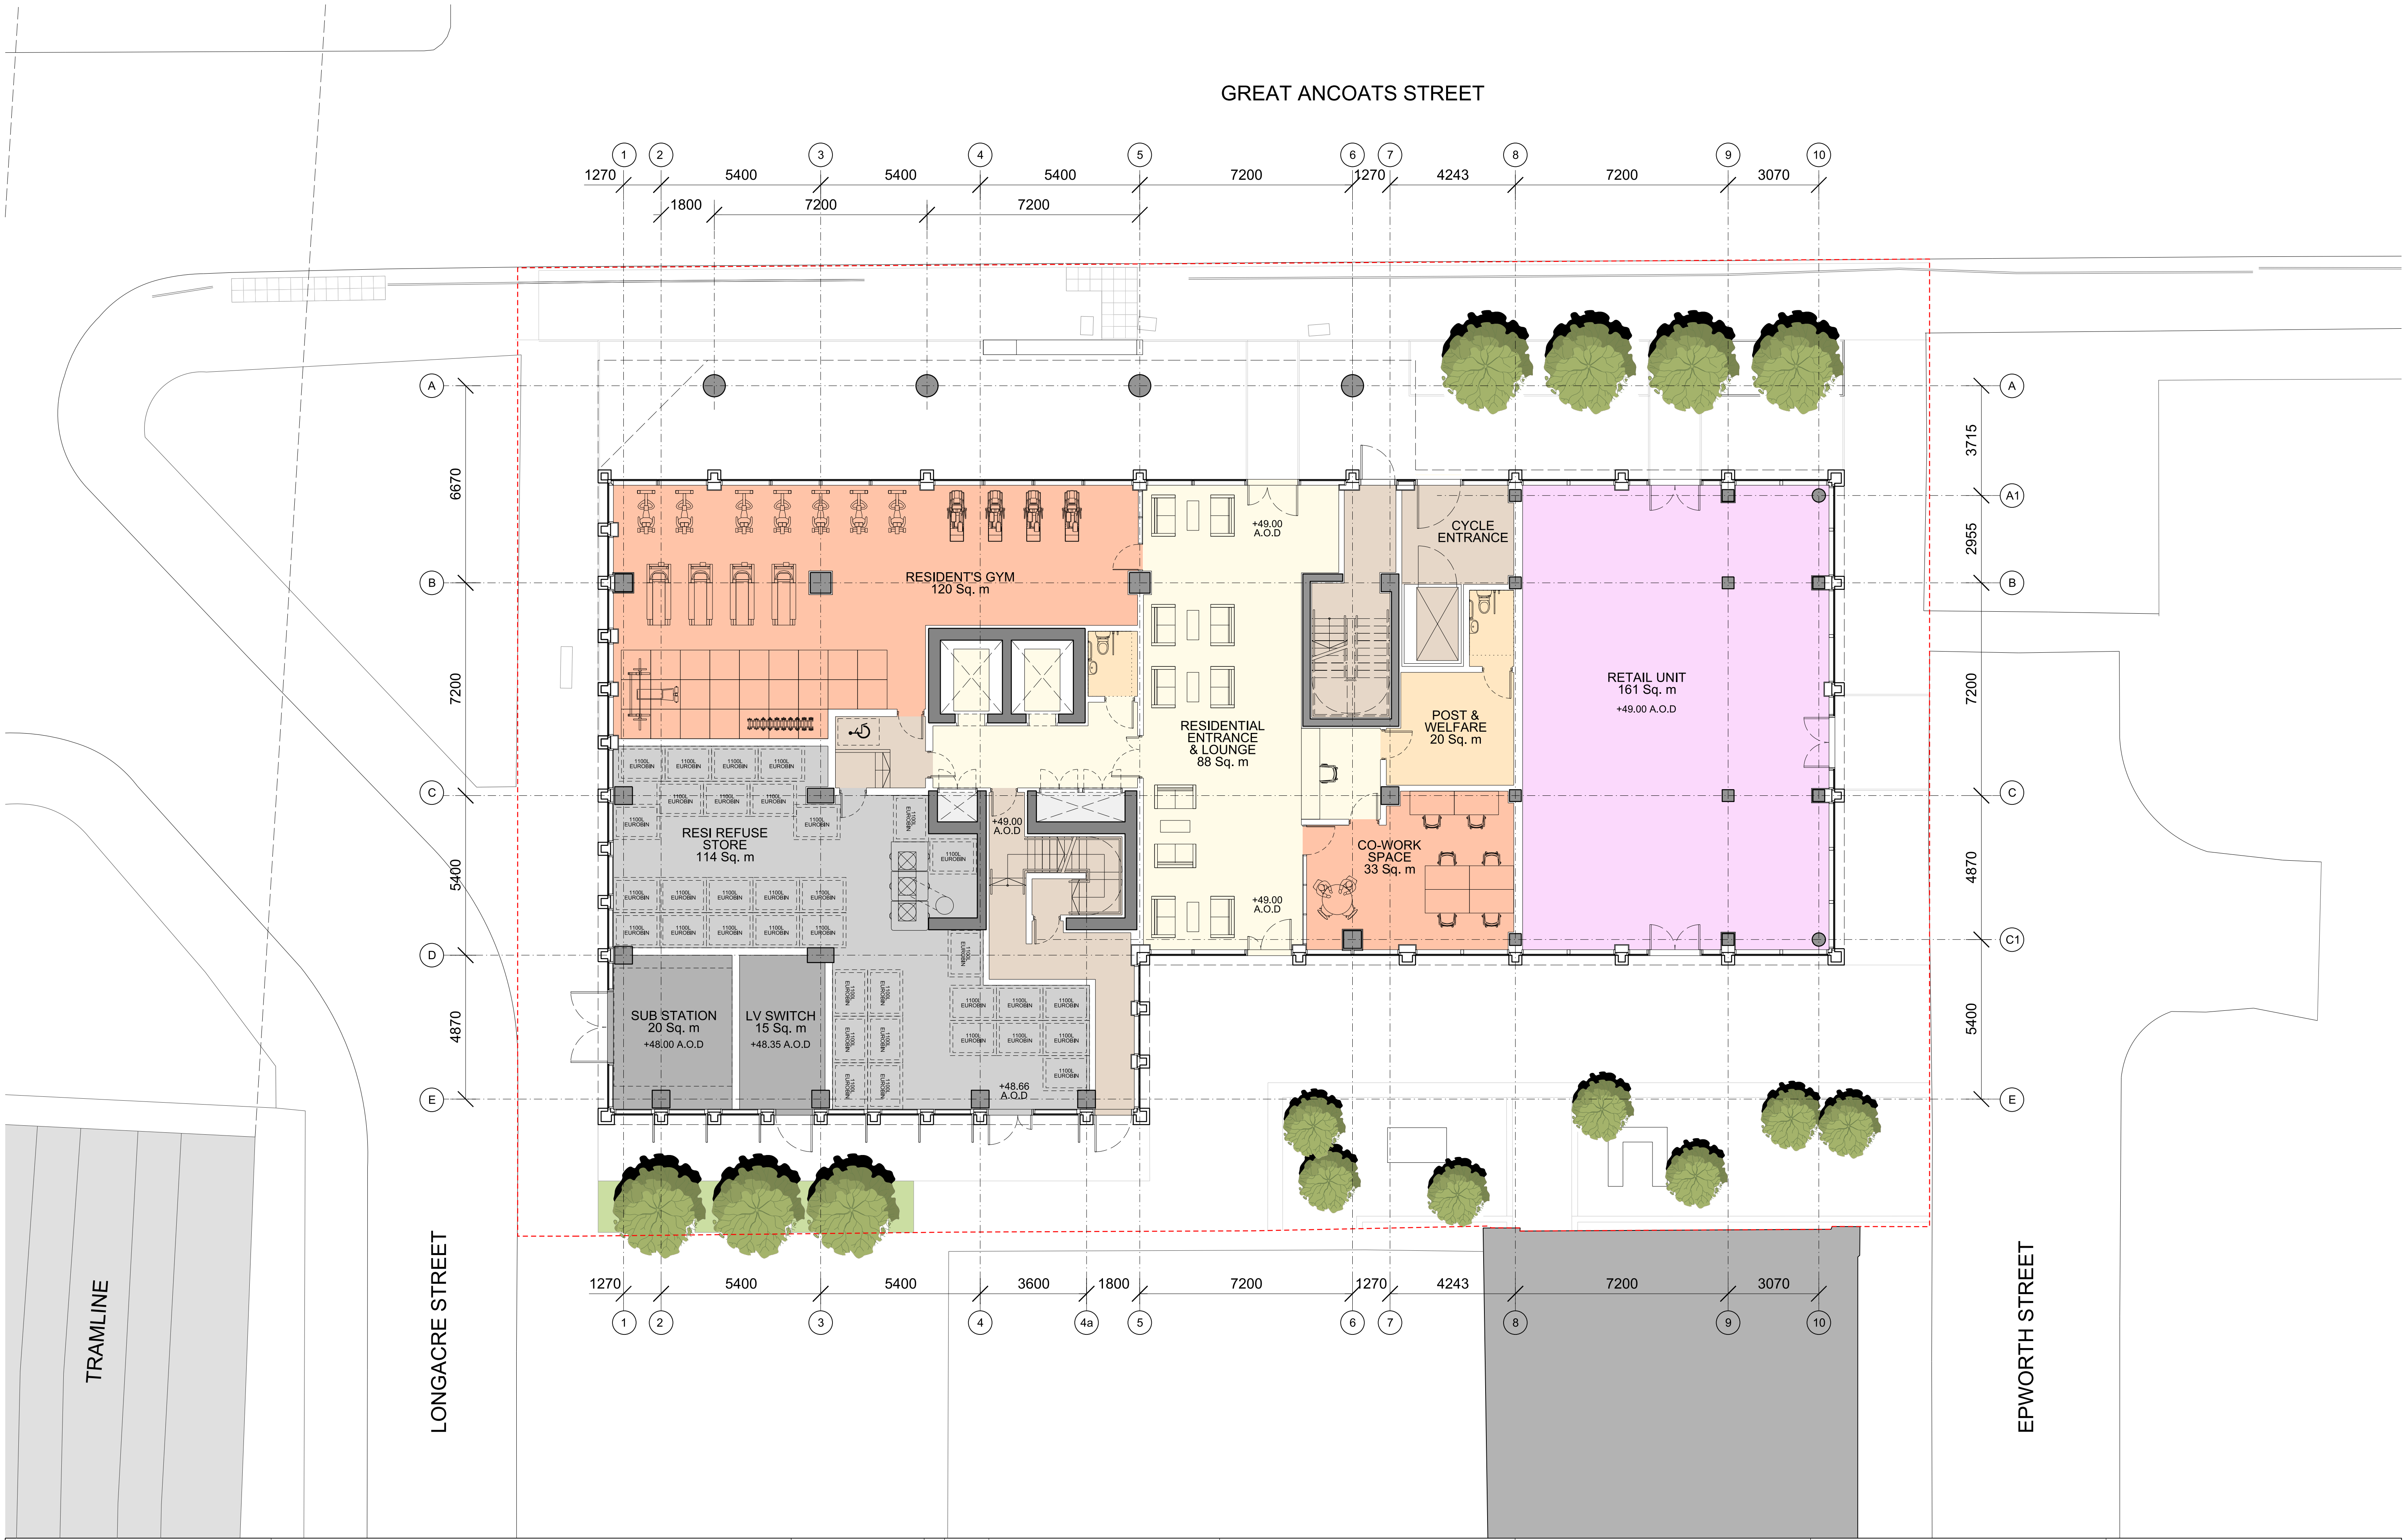
| Drawing No<br><b>10122-A-B5D9-G200-P-00-003</b> | Revision<br><b>00</b> | |

Drawing Title  
**GROUND FLOOR PLAN**

The proposed development is for a part 25 storey, part 3 storey residential tower with ground floor commercial space above partial basement level (north-west corner) and associated hard / soft landscaping as shown on the Proposed Ground Floor Development Plan, drawing No. 10122-A-B5D9-G200-9-00-003 provided to BSL by the client.
