**Conversion of existing unused toilet facilities and store rooms to form 1no  
self-contained flat.**

**6 Pollard Street, Manchester, M4 7AJ**

**APPLICATION NUMBERS 129658/FO/2021**

## **Discharge of Conditions Supporting information**

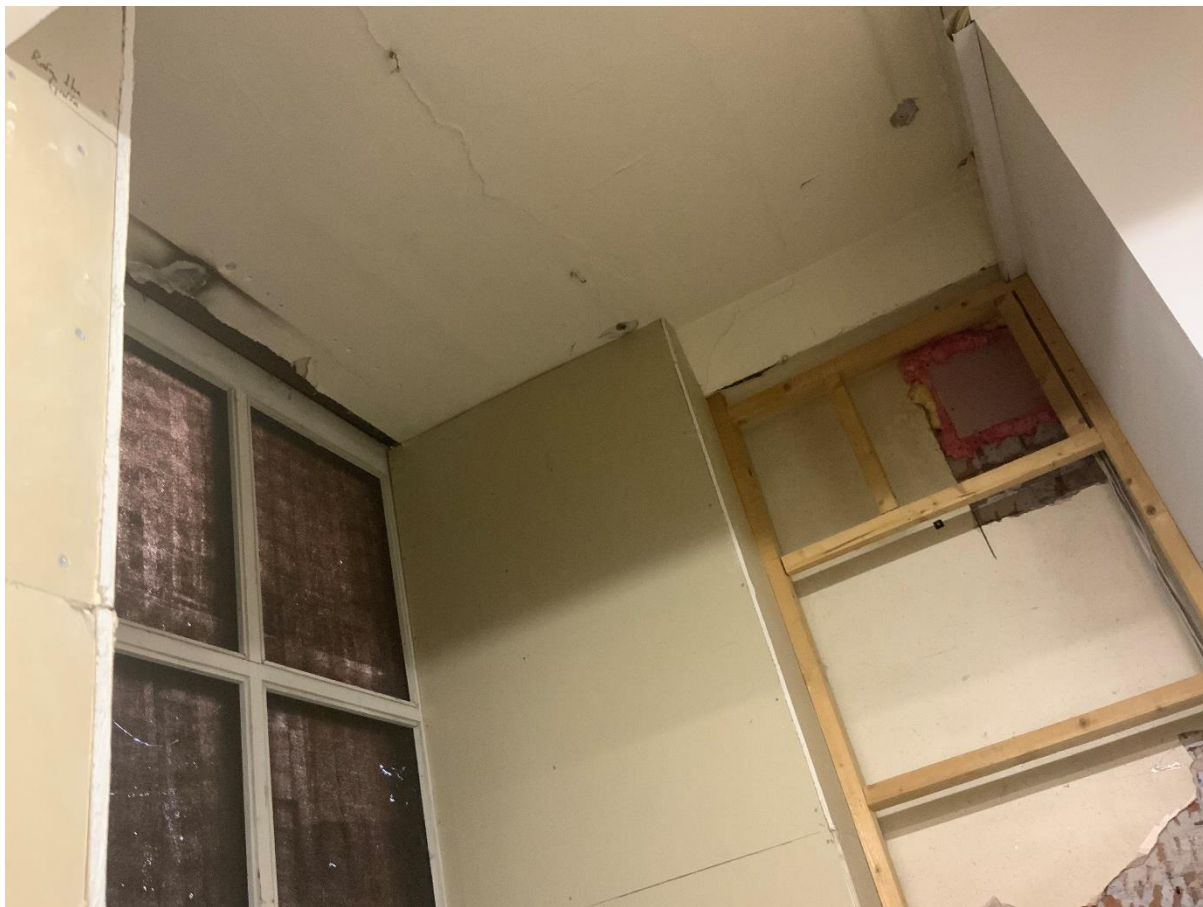
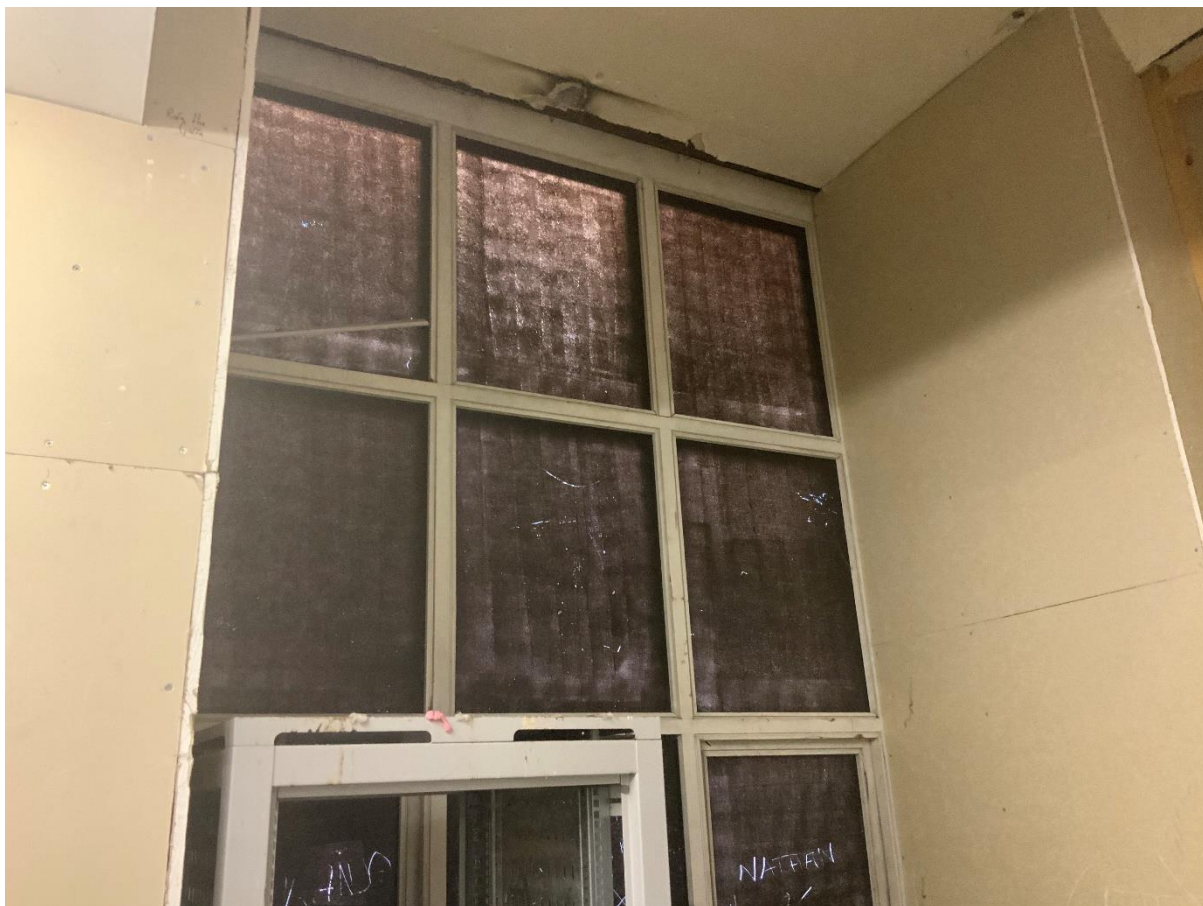
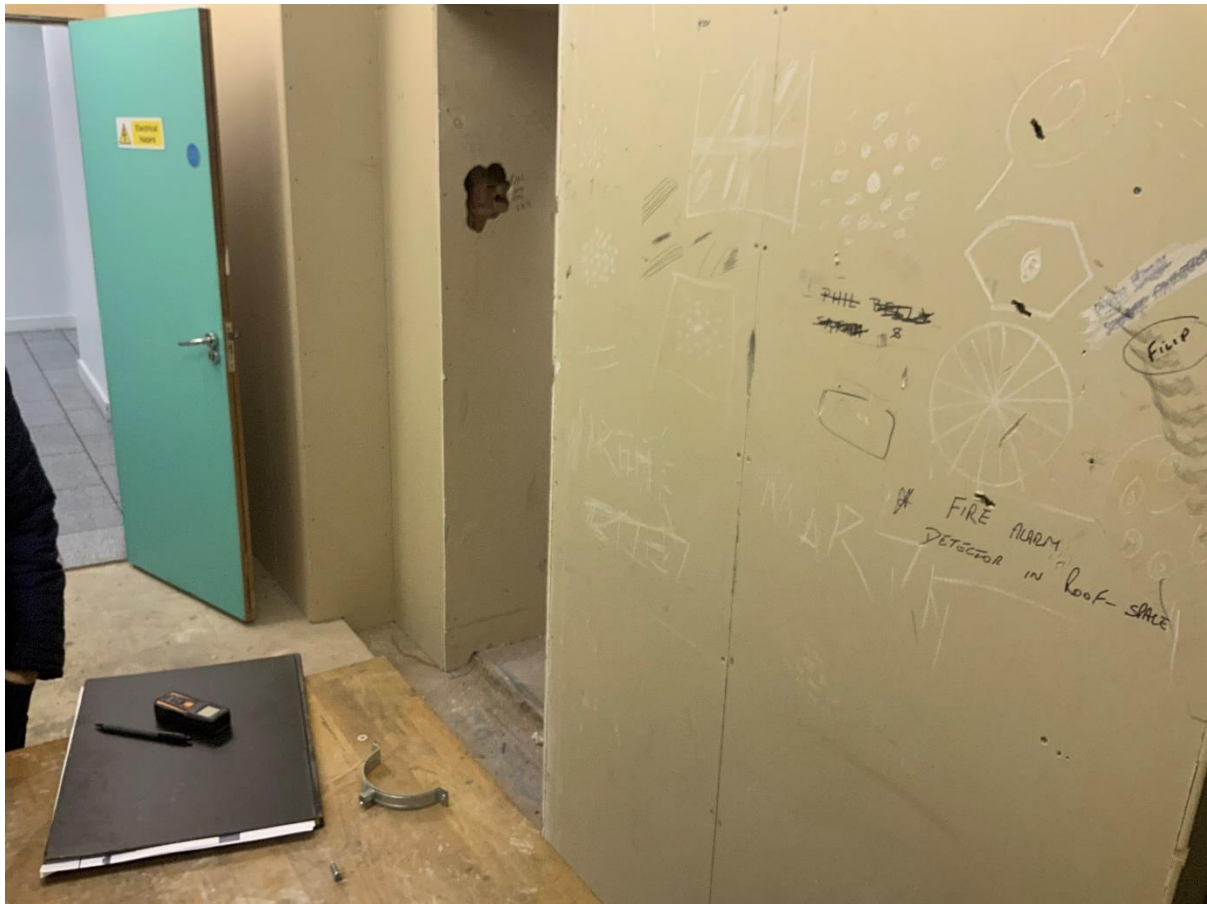
Currently the eastern elevation is covered up by non – original dry lining, as seen in the following photos.

The proposal is to Carefully remove all non-original installations.

- All the plasterboard has been fixed in place using screws, from tapping the boards it is suspected these are all screwed into a timber frame which sits in front of the original feature brickwork. Once the boards have been removed by unscrewing all the plasterboard fixings it will expose the timber frame.

- The timber frame may have been fixed into the original brickwork, if so, any fixings need to be delicately removed so not to cause any further damage to the bricks. Any screws will need to be carefully removed, there should be no power tools required for this task.

- The timber framework once removed will expose the original brick, this brickwork will provide a real feature to the new apartment as such its treatment is extremely important.

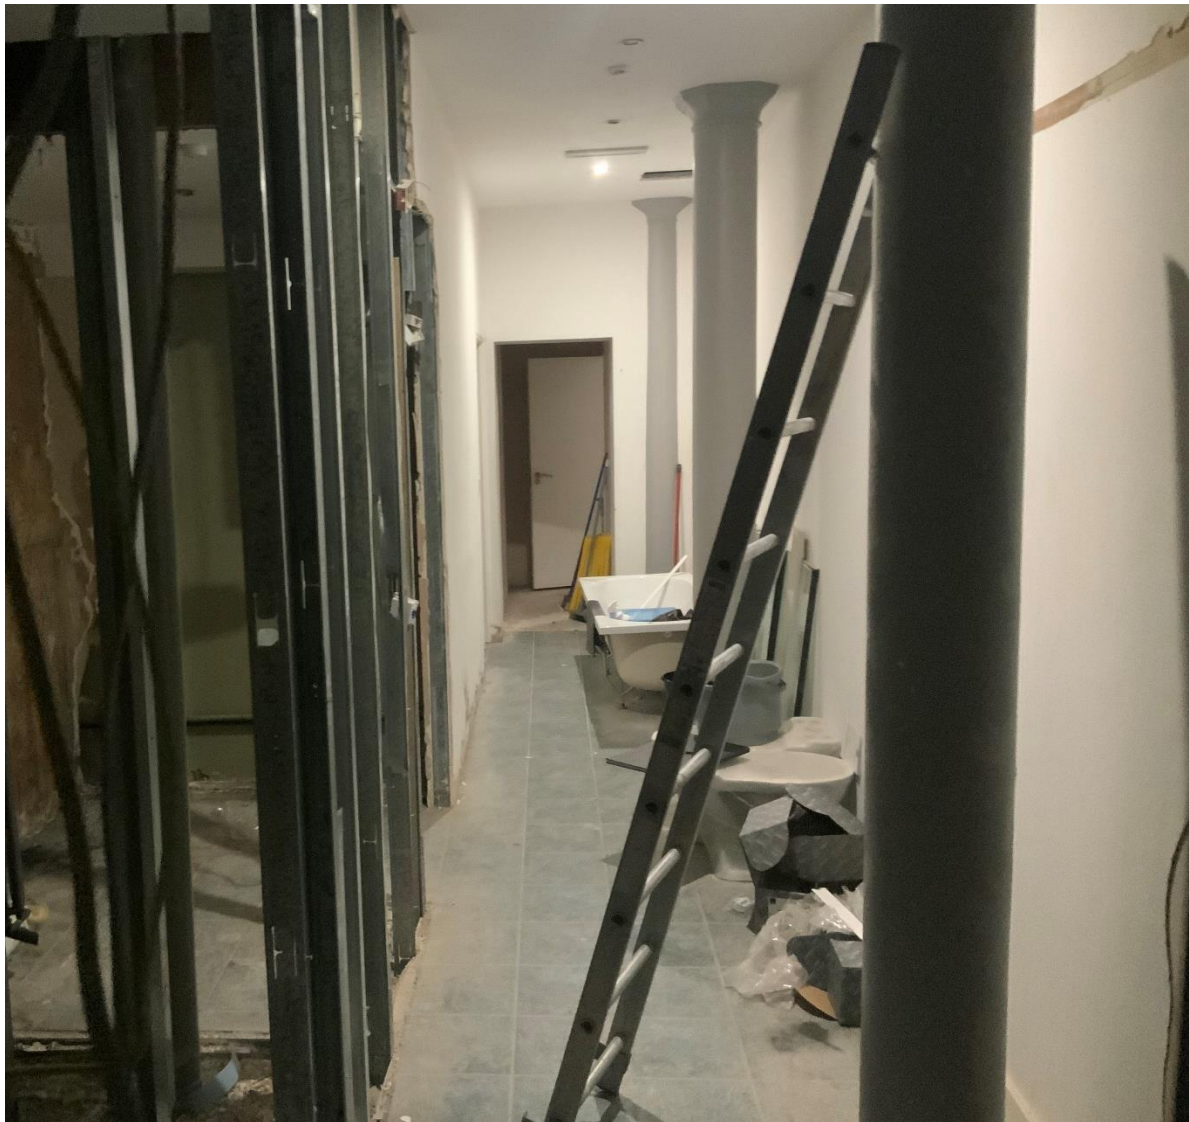
The following picture illustrates how the columns appear below the existing false ceiling. They are circular columns until they get to the ceiling where they appear to change shape into a more octagonal sectional column, this is the same for all columns.

- Remove carefully the false ceiling that intersects the columns, and fixings should be taken out with care so not to cause any damage to the surface of the columns.
- Remove and lose debris / plaster delicately from the ceiling / downstand structure. The columns are to be protected as the detail at the head needs to be preserved.
- The walls and soffit is then to be repaired with wet plaster, this will give back the original shape of the original ceiling – which will now be exposed.
- The soffit and columns will all be painted white, this will allow the form of the columns to be expressed better without any colours detracting from the form.

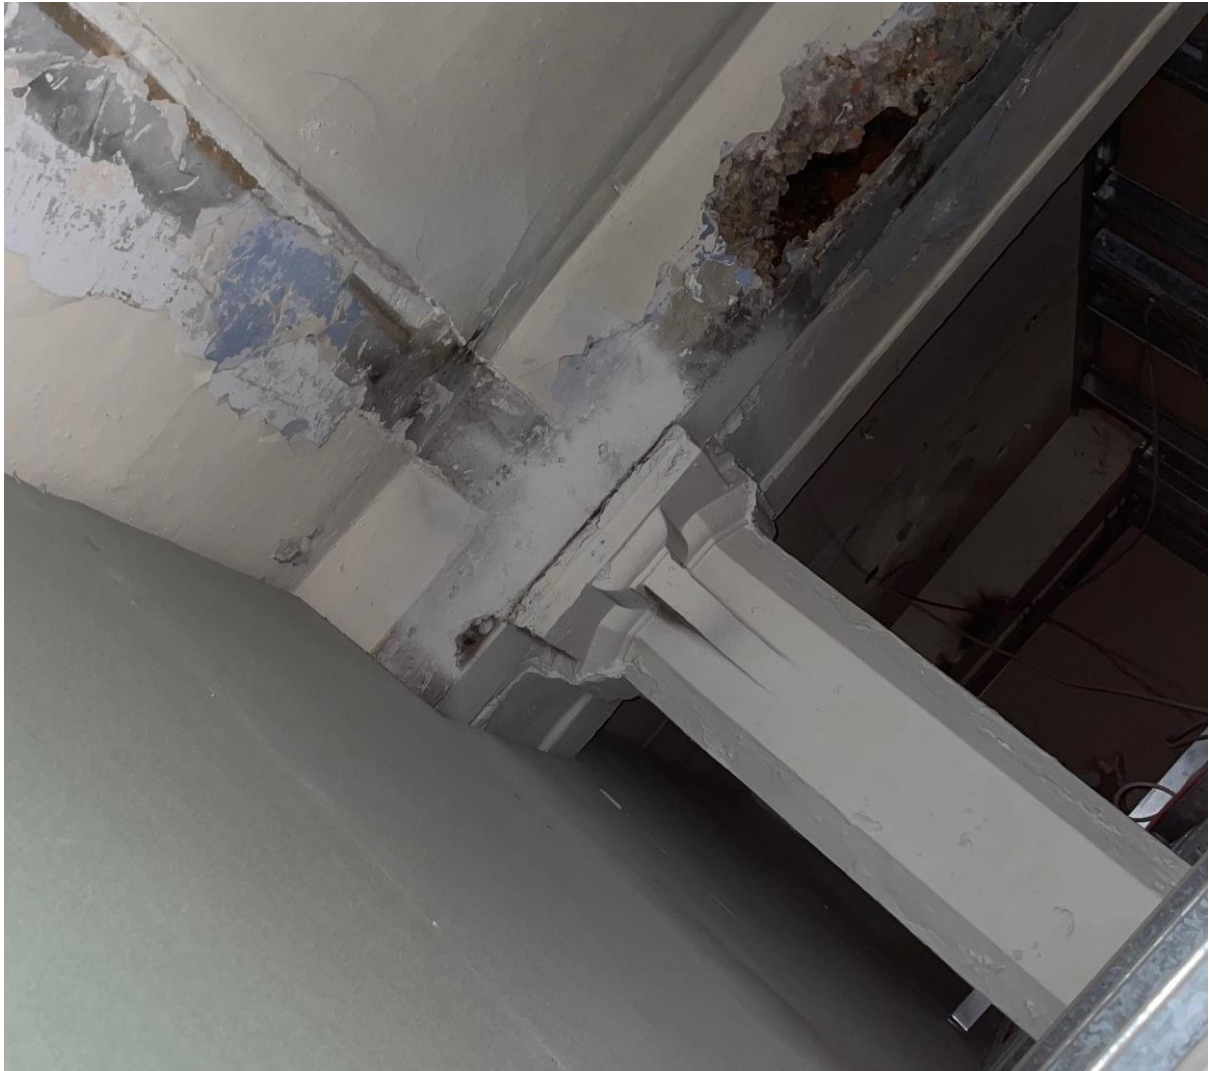
The following photo shows the free-standing column heads, these look to support the existing down-stand structural frame.

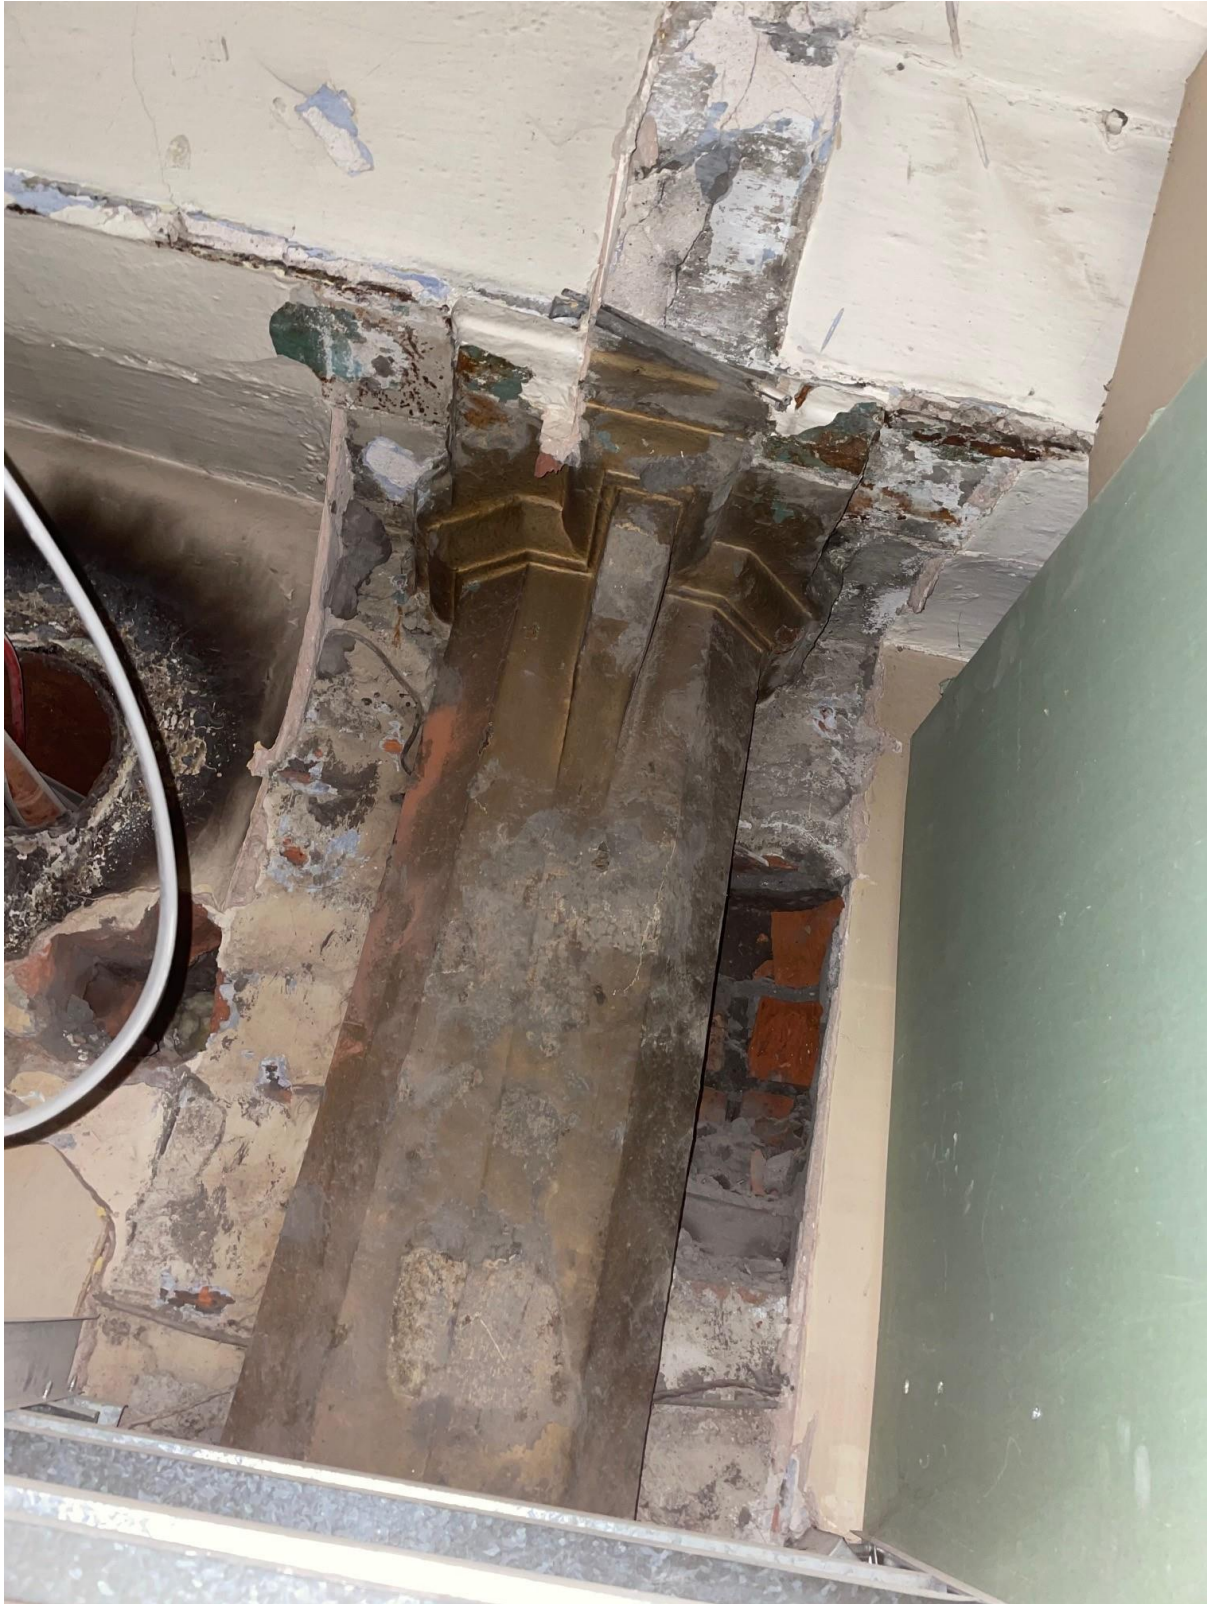
The following photo here shows that the partially exposed column is actually imbedded into the original brickwork of the building,
