# Power Hall & Decarbonisation Project

## Package 3b - M&E strategy report

Power Hall and Site Decarbonisation Works

18 August 2021

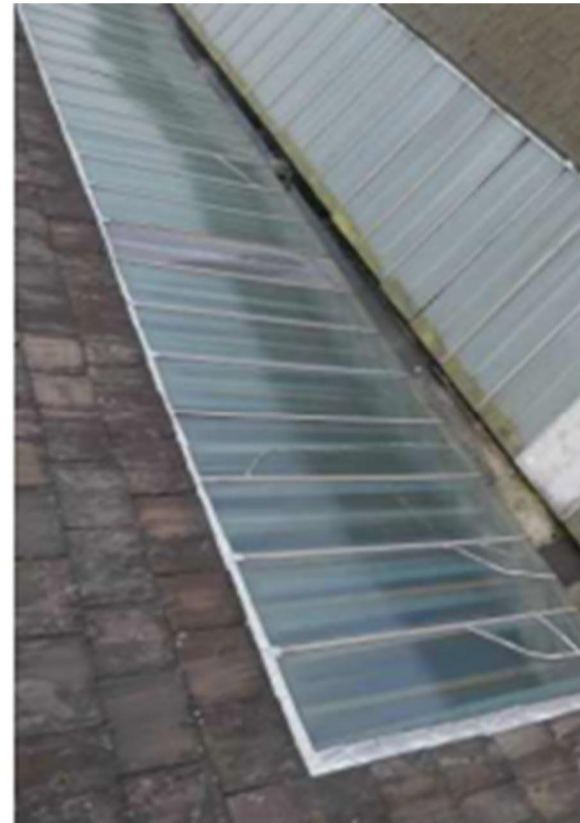
Figure 3-2 - Existing rooflight detail

The existing rooflights consist of Georgian Wired panels, several of which display fractures and are also displaced generally. There are rooflights on all four sides of the double-pitched roof structure.

The rooflights are problematic and have resulted in leaks within the Power Hall in recent years. Their location next to the valley gutter is not ideal since the valley gutter is not deep enough to enable rain water run-off. Furthermore, the Power Hall was previously prone to overheating. Reducing the number of rooflights will help to limit potential overheating as well as any risk of future water ingress.

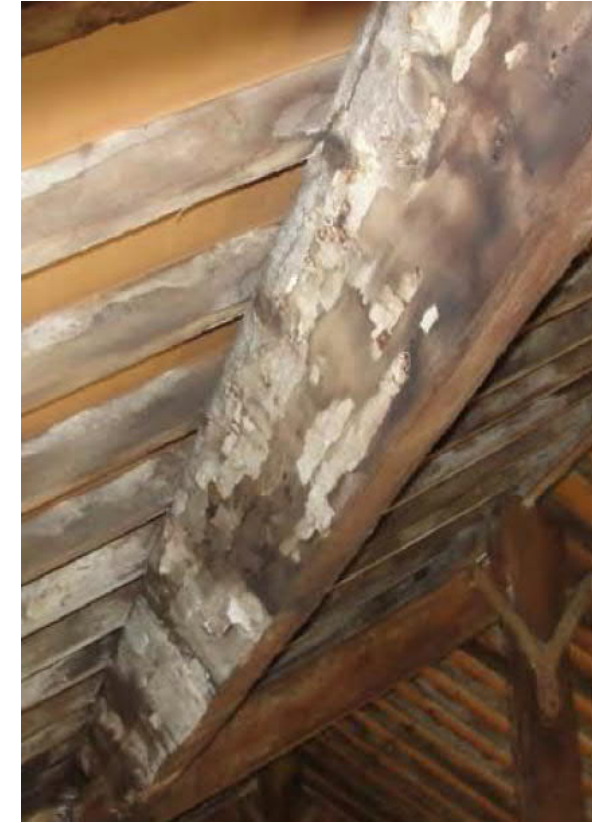
Figure 3-3 - Roof structure detail

The existing double-pitched roof of the Power Hall consists of a timber structure.

There are multiple areas of water ingress which will threaten the integrity of the timber structure if left: it is in poor condition and has visible signs of damp and timber decay. The lead-lined gutters have suffered ponding and silt build-up and display several felt-patch repairs generally.

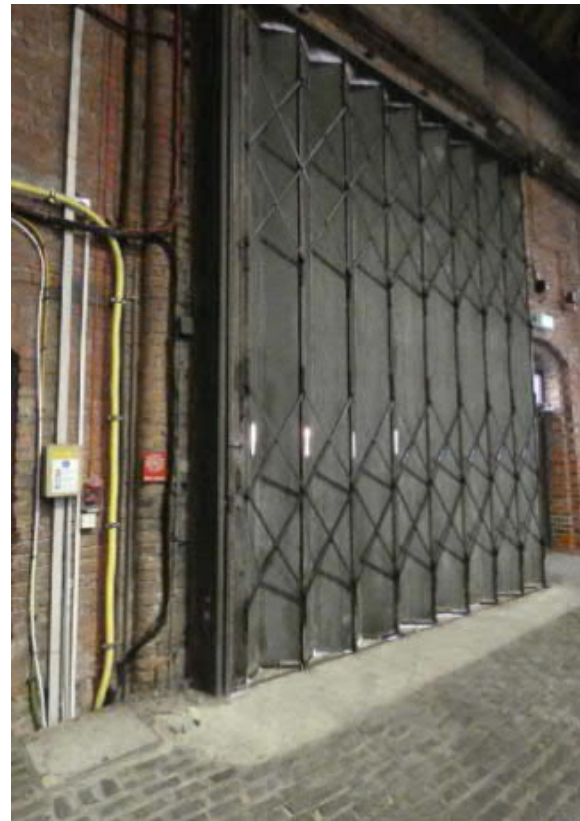
Figure 3-7 - Existing concertina door detail

There are two uninsulated steel concertina doors on the west façade (Figure 3-7). It is proposed that these are replaced with insulated doors of the same area as part of the Package 4

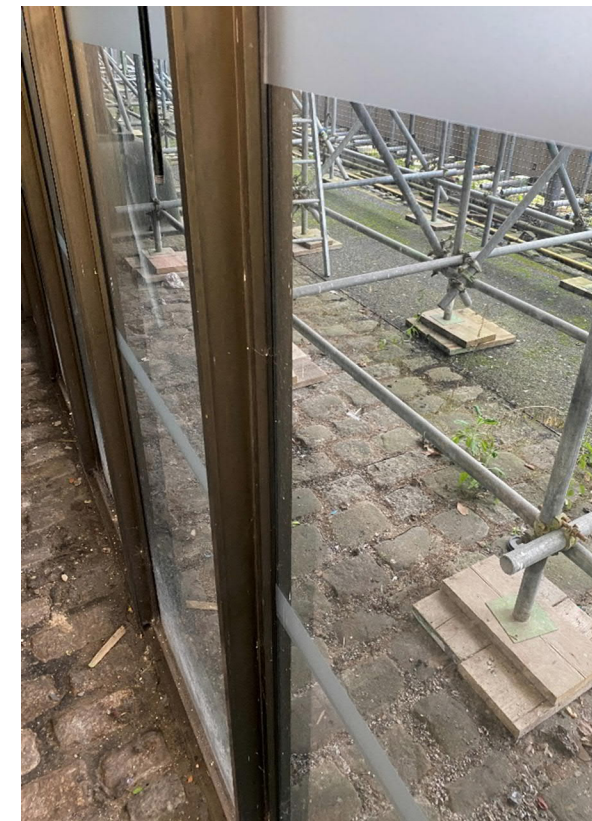
Figure 3-6 - Existing Window with integral door detail 1

There are six large windows with integral doors on the north façade and three large glazed doors on the south façade (including the entrance). The large glazed doors (Figure 3-6 Figure 3-5) are single glazed with some louvred elements manually operated for natural ventilation.

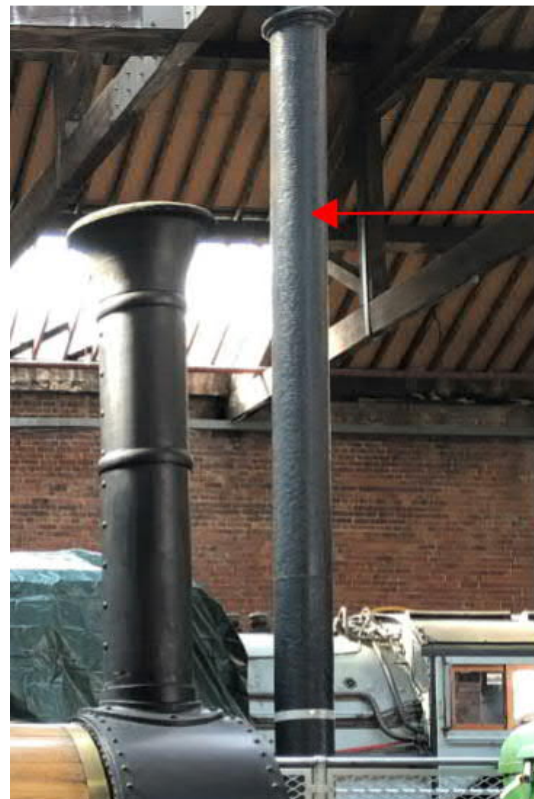
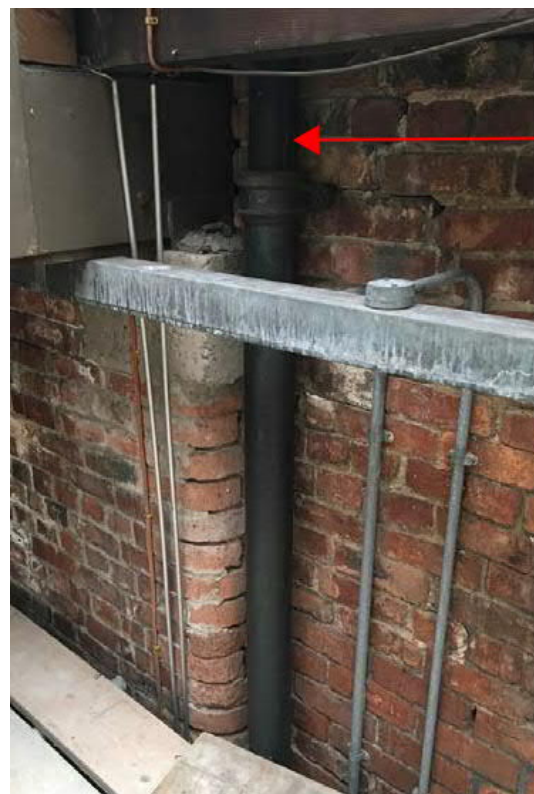
Figure 3-8 - Existing rainwater pipe details

The existing rainwater system consists in linear gutters along the perimeter and to the valley of the pitched roof. The gutters discharge via exposed cast iron rainwater pipes on the perimetral walls, while alternate columns are hollow to enable rain water run-off from the valley gutter.

Hollow column acting as rainwater pipe

Internal cast iron rainwater pipe

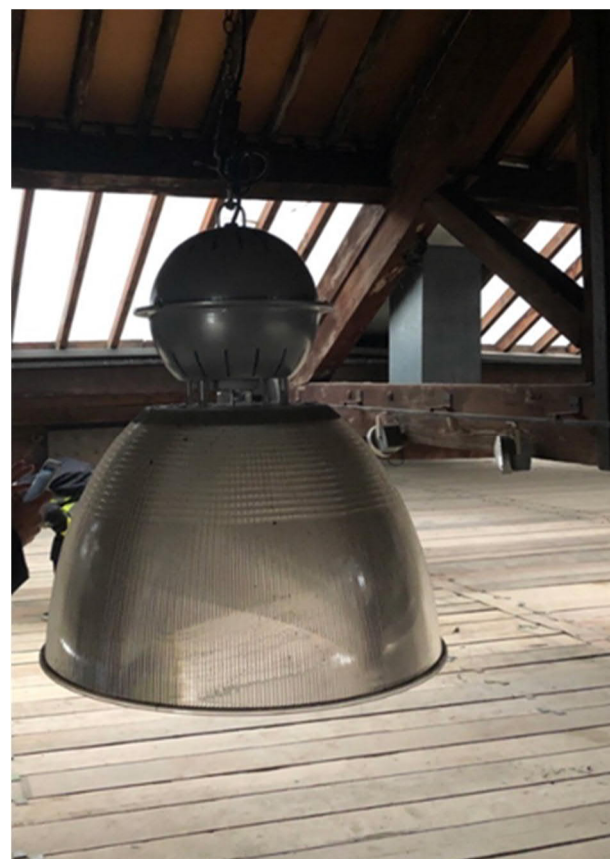
Figure 3-12 - existing lighting fixture detail

The high-bay fittings, as pictured in Figure 3-11, are high-pressure mercury-vapour high-intensity discharge lamps, now obsolete from an efficiency point of view.

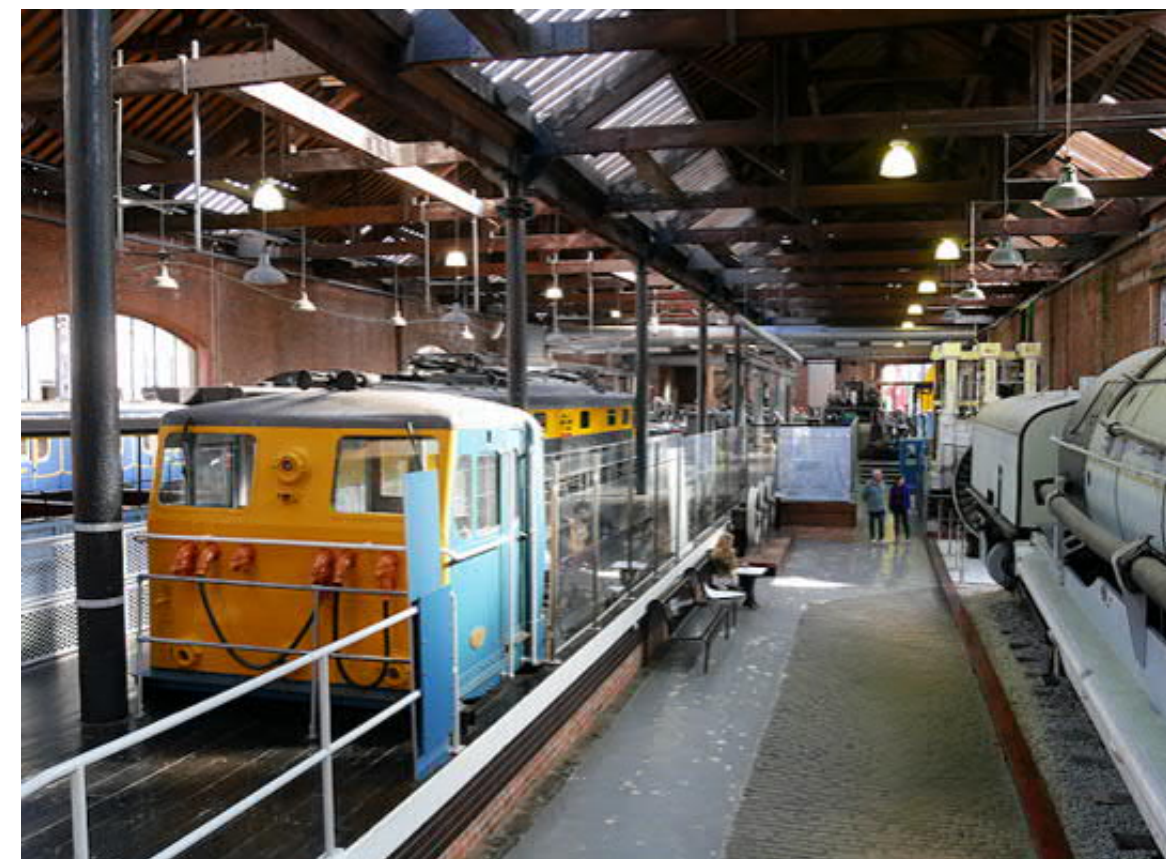
Figure 3-11 - existing lighting details

Lighting fixture efficiency is generally measured in lumen/circuit Watt (lm/cW), that indicates how much lighting effect is given for every watt of energy used. For these existing lamps the luminaires efficiency is in region of 50 lm/cW. Making them a very inefficient choice when compared to a modern LED luminaire whose efficiency levels are around three times better than the Halide fitting.

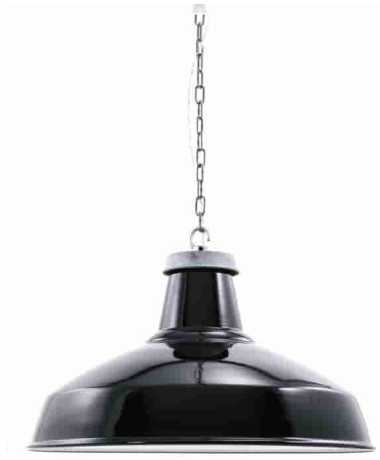
Figure 7-1 - Lighting fitting type considered for the new lighting strategy

The primary luminaire type proposed in the exhibition area is to be a pendant style fitting that will suspend from the pitched roof section. The exact fixing detail is to be coordinated but is currently proposed to be fixed from the purlins. This style of fitting has been chosen to closely match the style of some of the existing fittings and to keep in keeping with the space's heritage. A sample image is shown in Figure 7-1.

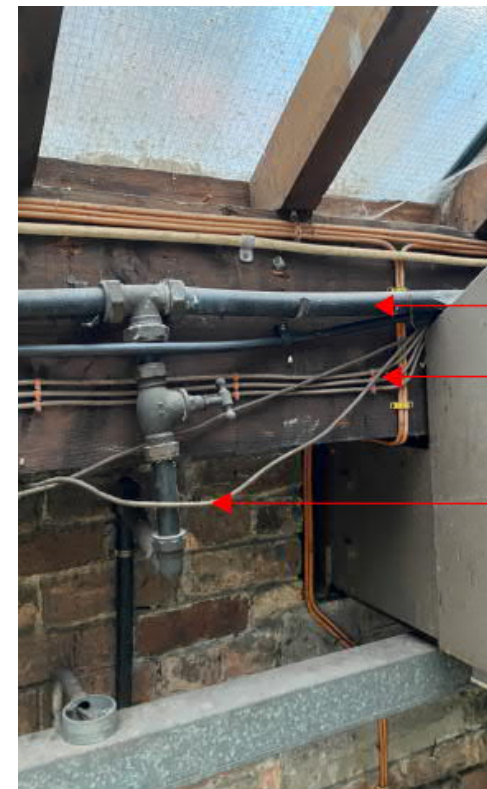
- Water pipe - to be changed
- Exposed cables for fire alarm and emergency lighting - to be removed
- Pending cables - to be removed

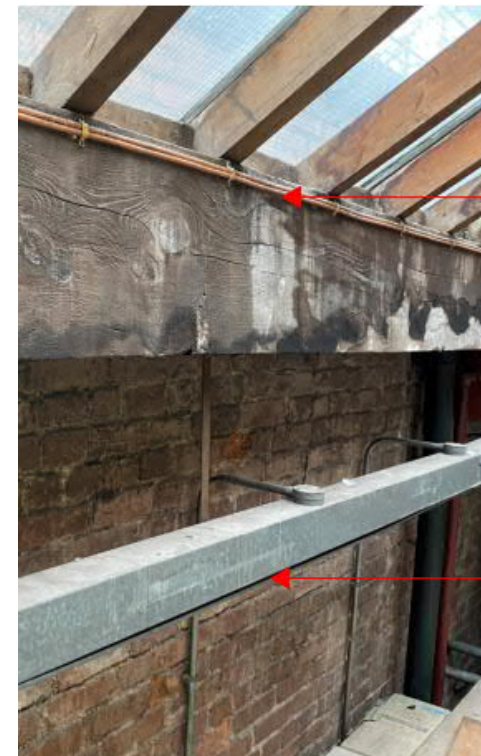
- Exposed wiring - to be removed
- Open trunking - to be removed
