| Windows | Abbreviated Window Repair Types |

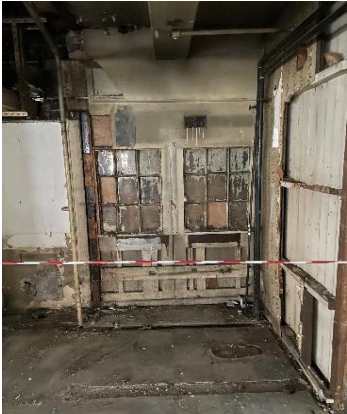
| Description | Photo |
|---|---|
| <p>– Existing window notably dilapidated and or distorted, with damaged sash / casement mechanisms and considerable timber decay due to prolonged saturation. Not deemed feasible to repair or restore the window as existing. Allow for carefully dismantling and removing the existing defective window, all associated glazing, putties, associated working parts, fixings etc, clean out existing surrounds and openings, carefully scrape back all perimeter mastic etc and prepare opening.</p> | |

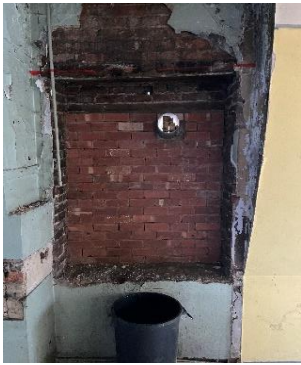
| <p>– Existing window notably dilapidated and or distorted, with damaged sash / casement mechanisms and considerable timber decay due to prolonged saturation. Not deemed feasible to repair or restore the window as existing. Allow for carefully dismantling and removing the existing defective window, all associated glazing, putties, associated working parts, fixings etc, clean out existing surrounds and openings, carefully scrape back all perimeter mastic etc and prepare opening.</p> | |

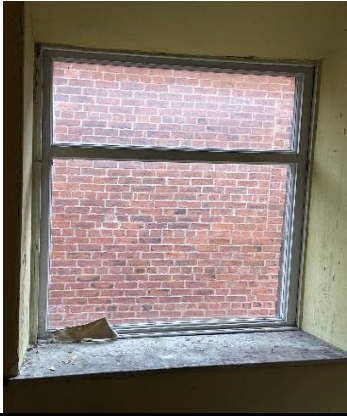
| <p>Non-original timber framed single glazed fixed light window with no opening casement. Retain window as existing. Allow for undertaking any localised repairs as required to ensure frames and glazing, putties etc are in good repair and sound working order.</p> | |

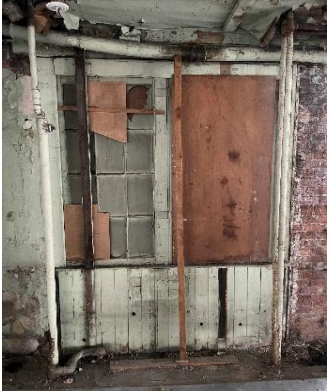
| <p>– Existing window notably dilapidated and or distorted, with damaged sash / casement mechanisms and considerable timber decay due to prolonged saturation. Not deemed feasible to repair or restore the window as existing. Allow for carefully dismantling and removing the existing defective window, all associated glazing, putties, associated working parts, fixings etc, clean out existing surrounds and openings, carefully scrape back all perimeter mastic etc and prepare opening.</p> | |

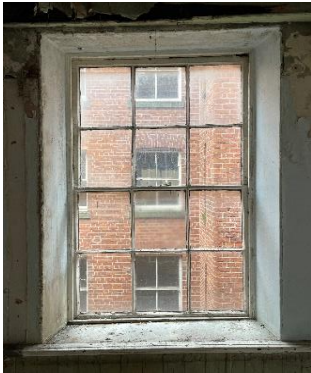
| <p>– Existing window notably dilapidated and or distorted, with damaged sash / casement mechanisms and considerable timber decay due to prolonged saturation. Not deemed feasible to repair or restore the window as existing. Allow for carefully dismantling and removing the existing defective window, all associated glazing, putties, associated working parts, fixings etc, clean out existing surrounds and openings, carefully scrape back all perimeter mastic etc and prepare opening.</p> | |

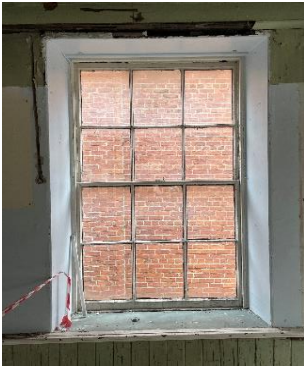
| <p>– Existing window notably dilapidated and or distorted, with damaged sash / casement mechanisms and considerable timber decay due to prolonged saturation. Not deemed feasible to repair or restore the window as existing. Allow for carefully dismantling and removing the existing defective window, all associated glazing, putties, associated working parts, fixings etc, clean out existing surrounds and openings, carefully scrape back all perimeter mastic etc and prepare opening.</p> | |

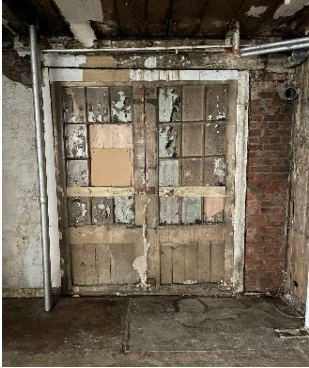
| <p>– Existing window notably dilapidated and or distorted, with damaged sash / casement mechanisms and considerable timber decay due to prolonged saturation. Not deemed feasible to repair or restore the window as existing. Allow for carefully dismantling and removing the existing defective window, all associated glazing, putties, associated working parts, fixings etc, clean out existing surrounds and openings, carefully scrape back all perimeter mastic etc and prepare opening.</p> | |

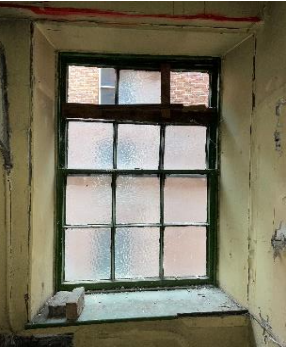
| <p>– Existing window notably dilapidated and or distorted, with damaged sash / casement mechanisms and considerable timber decay due to prolonged saturation. Not deemed feasible to repair or restore the window as existing. Allow for carefully dismantling and removing the existing defective window, all associated glazing, putties, associated working parts, fixings etc, clean out existing surrounds and openings, carefully scrape back all perimeter mastic etc and prepare opening.</p> | |

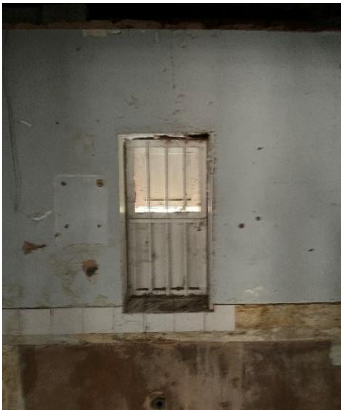
| <p>– Existing window notably dilapidated and or distorted, with damaged sash / casement mechanisms and considerable timber decay due to prolonged saturation. Not deemed feasible to repair or restore the window as existing. Allow for carefully dismantling and removing the existing defective window, all associated glazing, putties, associated working parts, fixings etc, clean out existing surrounds and openings, carefully scrape back all perimeter mastic etc and prepare opening.</p> | |

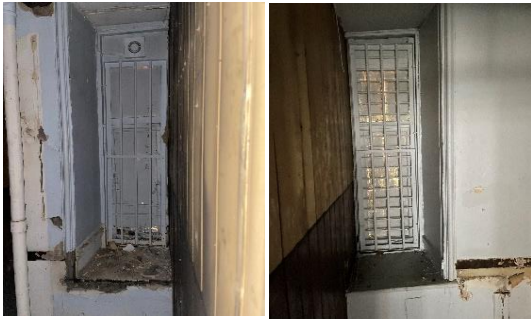
| <p>– Existing window notably dilapidated and or distorted, with damaged sash / casement mechanisms and considerable timber decay due to prolonged saturation. Not deemed feasible to repair or restore the window as existing. Allow for carefully dismantling and removing the existing defective window, all associated glazing, putties, associated working parts, fixings etc, clean out existing surrounds and openings, carefully scrape back all perimeter mastic etc and prepare opening.</p> | |

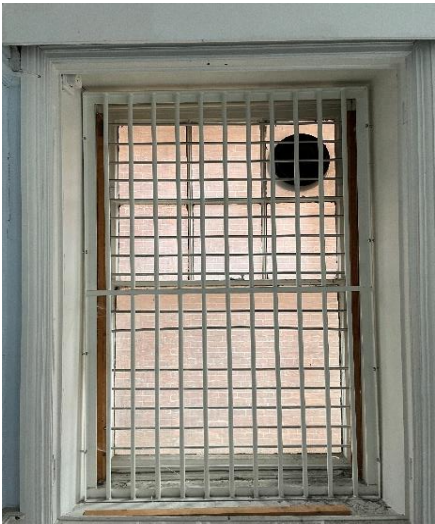
| <p><u>Include for overhaul works as WA</u> but, in addition, allow for carefully removing existing security window grilles and all associated battens, fixings etc taking care to minimise any damage to the original building fabric.</p> | |
