## **GROUND INVESTIGATION REPORT**

**FOR  
TRINITY C OF E HIGH SCHOOL,  
HIGHER CAMBRIDGE STREET,  
MANCHESTER,**

**PREPARED FOR  
TRINITY C OF E HIGH SCHOOL**

**REPORT NO. 7200  
MAY 2021**

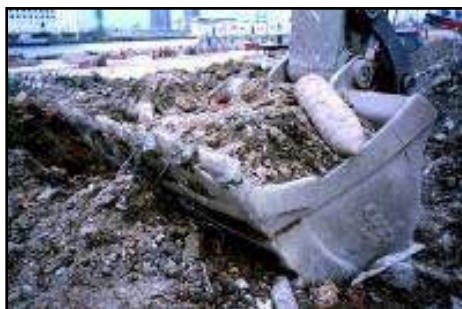
50kg bomb, London Docklands

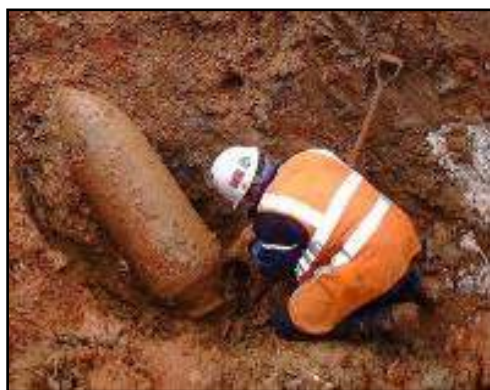
250kg bomb, Hawkinge

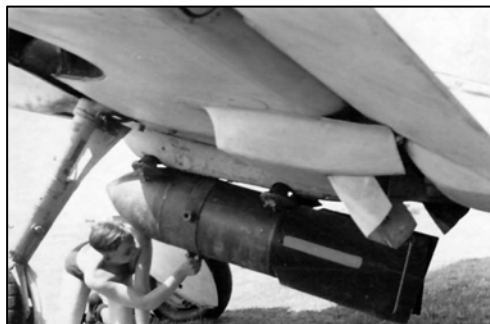
SC250 attached to undercarriage of Messerschmitt Bf109

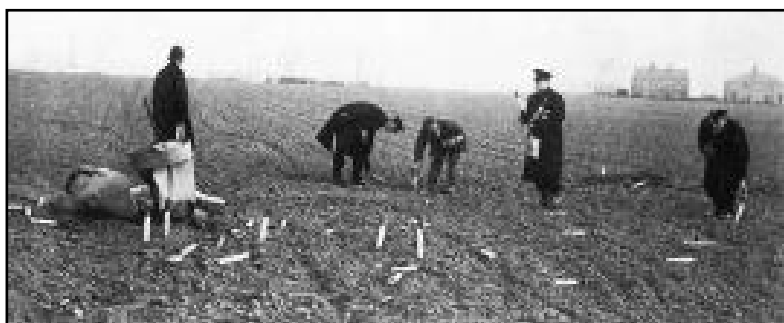
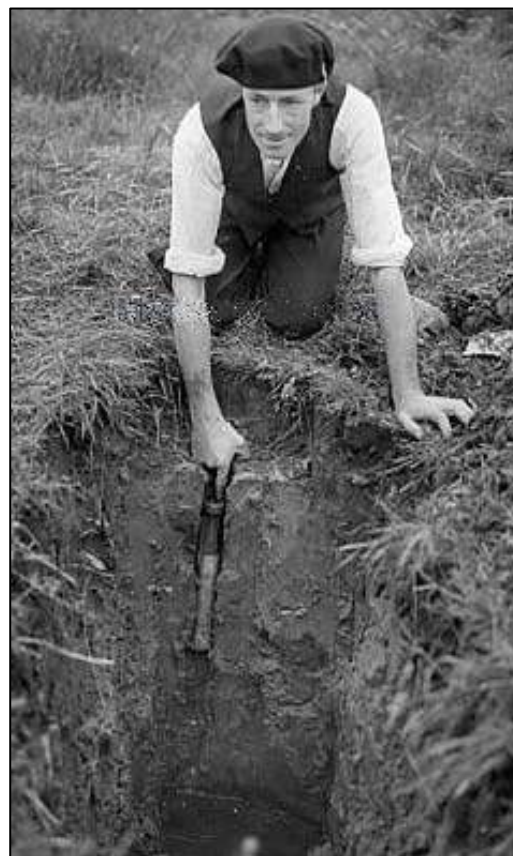
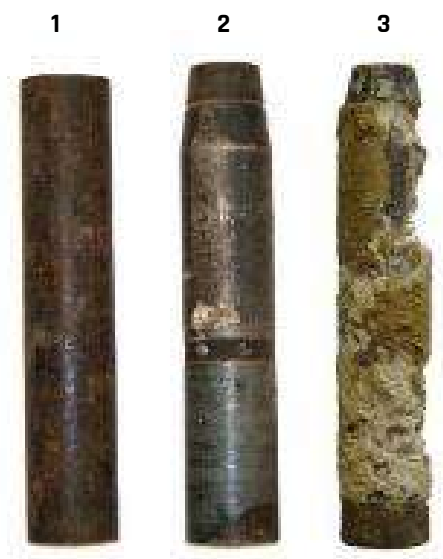
1. Ordinary scaffold pipe
2. 1kg incendiary bomb
3. Incendiary bomb recently found on site in UK

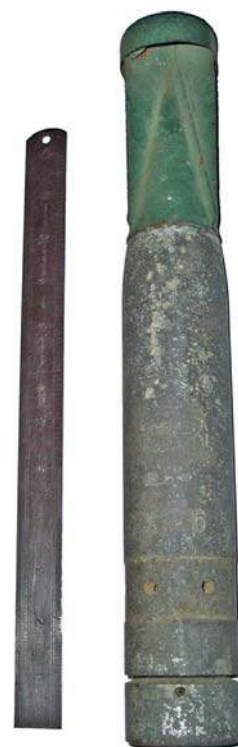
1kg German Incendiary Bomb next to a 30cm ruler

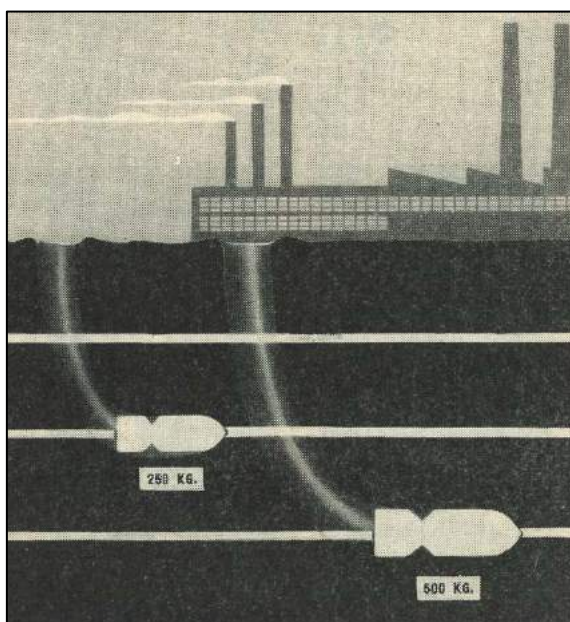
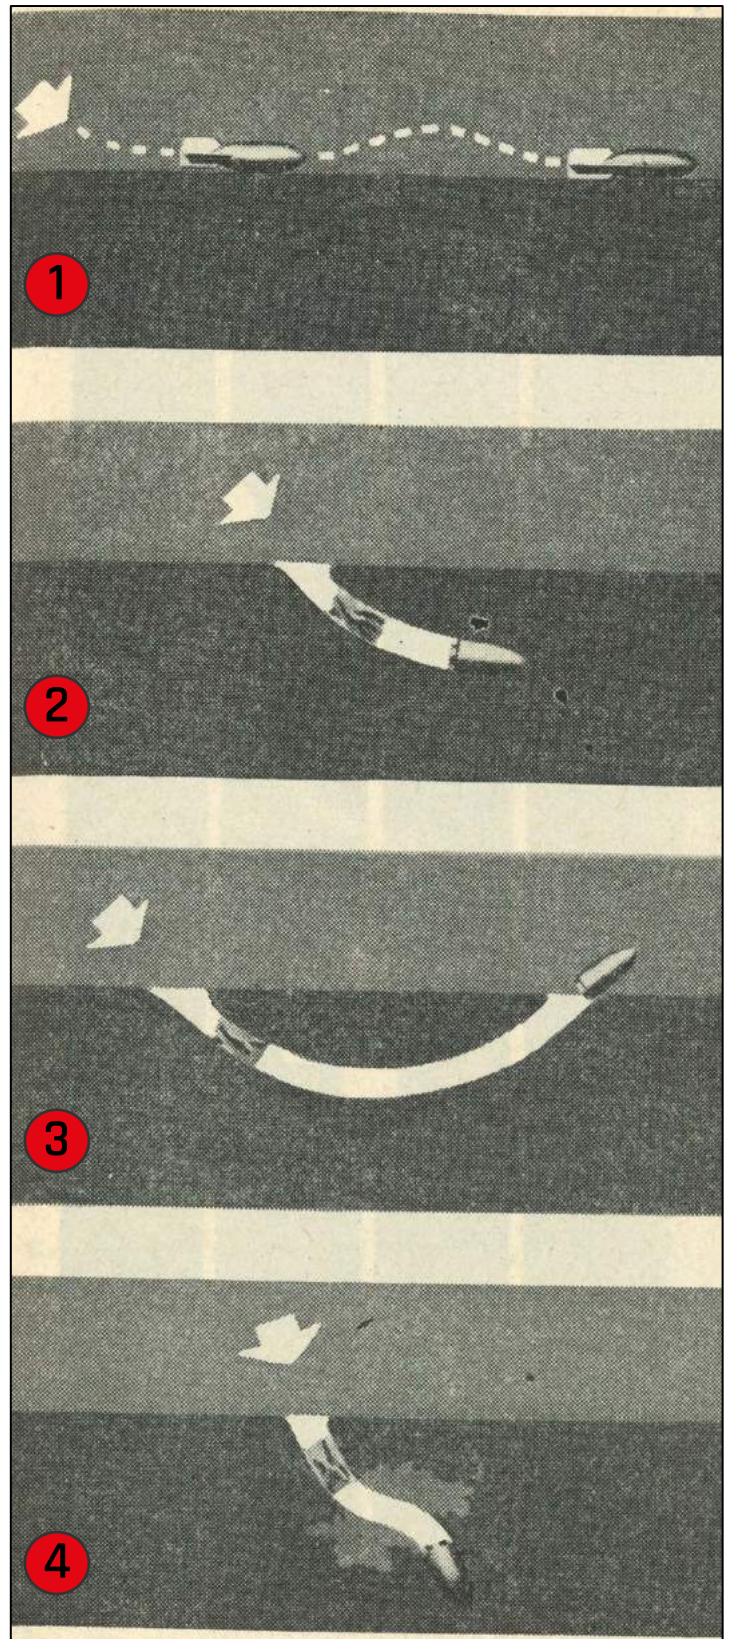
### Path of UXB in soft ground

1. **Ricochet resulting from low level attack:** UXB stays perpendicular to ground and rests at surface.
2. **Buried UXB with J-Curve:** Bomb curves horizontally and rests perpendicular to surface.
3. **UXB returning to surface due to J-Curve:** Bomb points towards surface but may remain partially or completely below ground level.
4. **UXB deflected by buried objects:** Results in unpredictable path and unusual shaft.

**Below:** UXB can come to rest beneath undamaged buildings due to the J-Curve effect if it lands in nearby soft ground.

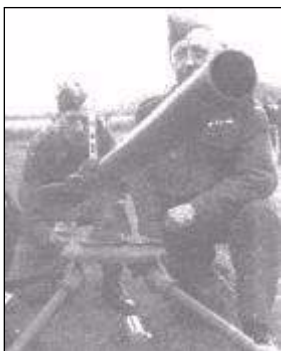
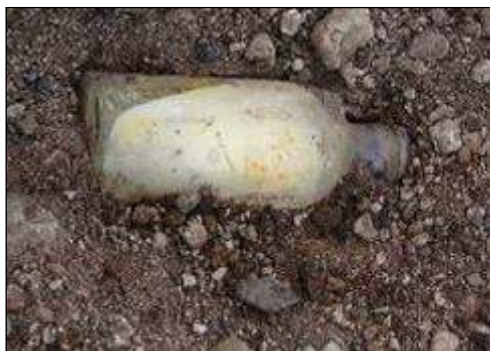
### Self Igniting Phosphorous (SIP) Grenades

The grenade comprised a glass bottle with a total volume of approximately one pint. It was filled with White Phosphorus, benzene, a piece of rubber and water. Over time the rubber dissolved to create a sticky fluid which would self ignite when the bottle broke. Fired by hand or Northover Projector. Sometimes called the "A & W" (Albright & Wilson) grenade.

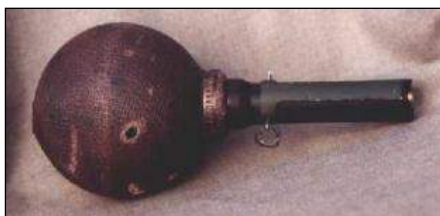
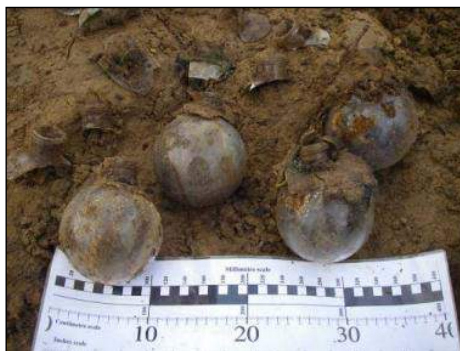
### No 74 Grenade (Sticky Bomb)

Designed as an anti-tank grenade and used by the Home Guard. The grenade consisted of a glass ball on the end of a Bakelite (plastic) handle. Inside the glass ball was an explosive filling whilst on the outside was a very sticky adhesive covering. Until used, this adhesive covering was encased in a metal outer casing.

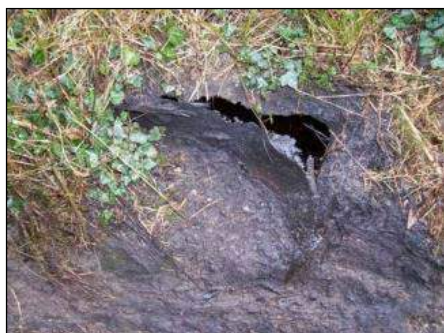
### Flame Fougasse Bomb

A Flame Fougasse was a weapon in which the projectile was a flammable liquid, typically a mixture of petrol and oil. It was usually constructed from a 40-gallon drum dug into the roadside and camouflaged. Ammonal provided the propellant charge which, when triggered, caused the weapon to shoot a flame 3m (10ft) wide and 27m (30 yards) long. Initially a mixture of 40% petrol and 60% gas oil was used, this was later replaced by an adhesive gel of tar, lime and petrol known as 5B.

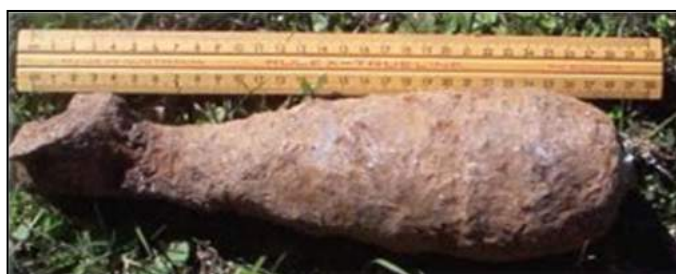
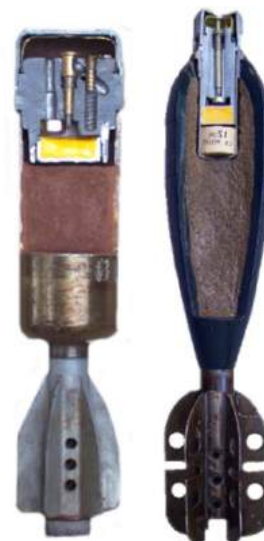
#### Typical 3 inch Smoke Mortar

Type: Smoke  
Dimensions: c490 x 76mm (19.3in x 3in)  
Filling: Typically white phosphorous  
Maximum Range: 2515m (2,750yds)  
Remarks: On impact, the fuze functions and initiates the bursting charge. The bursting charge ruptures the mortar bomb body and disperses the white phosphorous filler. The white phosphorous produces smoke upon exposure to the air.

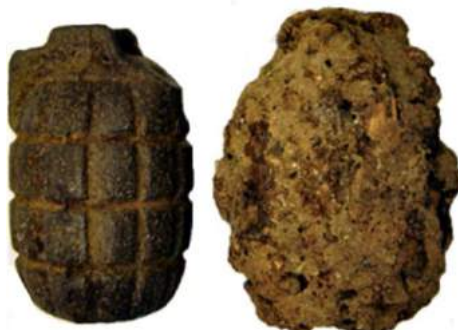
Weight: 0.7kg filled (1lb 6oz)  
Type: Hand or discharger, fragmentation  
Dimensions: 95 x 61mm (3.7 x 2.4in)  
Filling: Alumatol, Amatol 2 or TNT  
Remarks: 4 second hand-throwing fuse with approximate 30m range. First introduced May 1918.

Grenade, .303 inch rifle, No. 36M, Mark I.

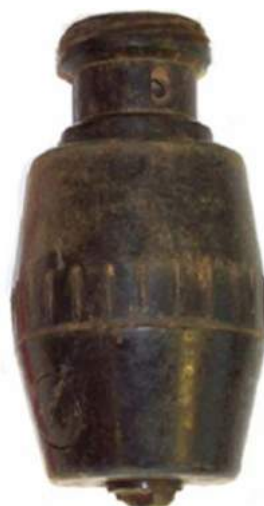
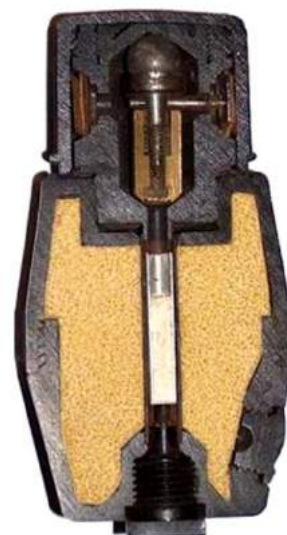
#### No. 69 Grenade

Weight: 0.38kg filled (0.8lb)  
Type: Percussion/Blast  
Date Introduced: December 1940  
Remarks: Black Bakelite body. Blast rather than fragmentation type. After unscrewing the safety cap, a tape is held when throwing the grenade releasing the safety bolt in the throwing motion. Detection is problematic due to its very low metal content.

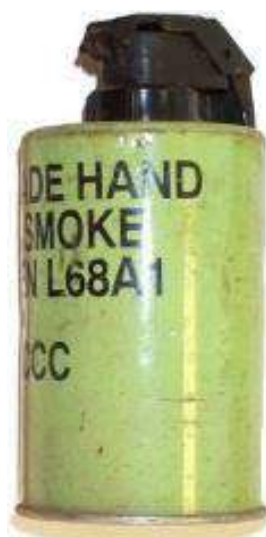
#### Typical Smoke Grenade

Dimensions: Approx. 65 x 115mm (2.5 x 4.5in)  
Type: Smoke  
Date Introduced: Current MoD issue  
Remarks: Smoke grenades are used as ground-to-ground or ground-to-air signalling devices, or landing zone marking devices, and screening devices for unit movement.  
target

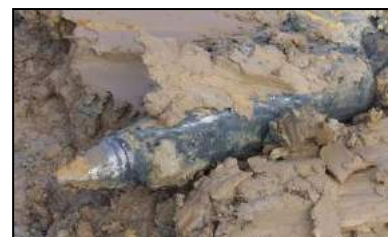
This AA shell was uncovered on a construction site in North London in February 2009.

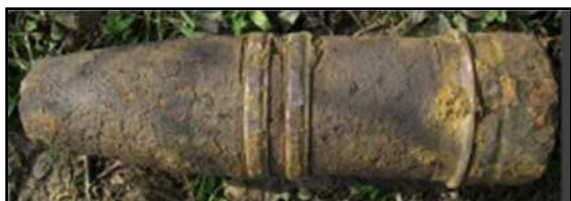
3.7 inch AA Projectile, Minus Fuze.

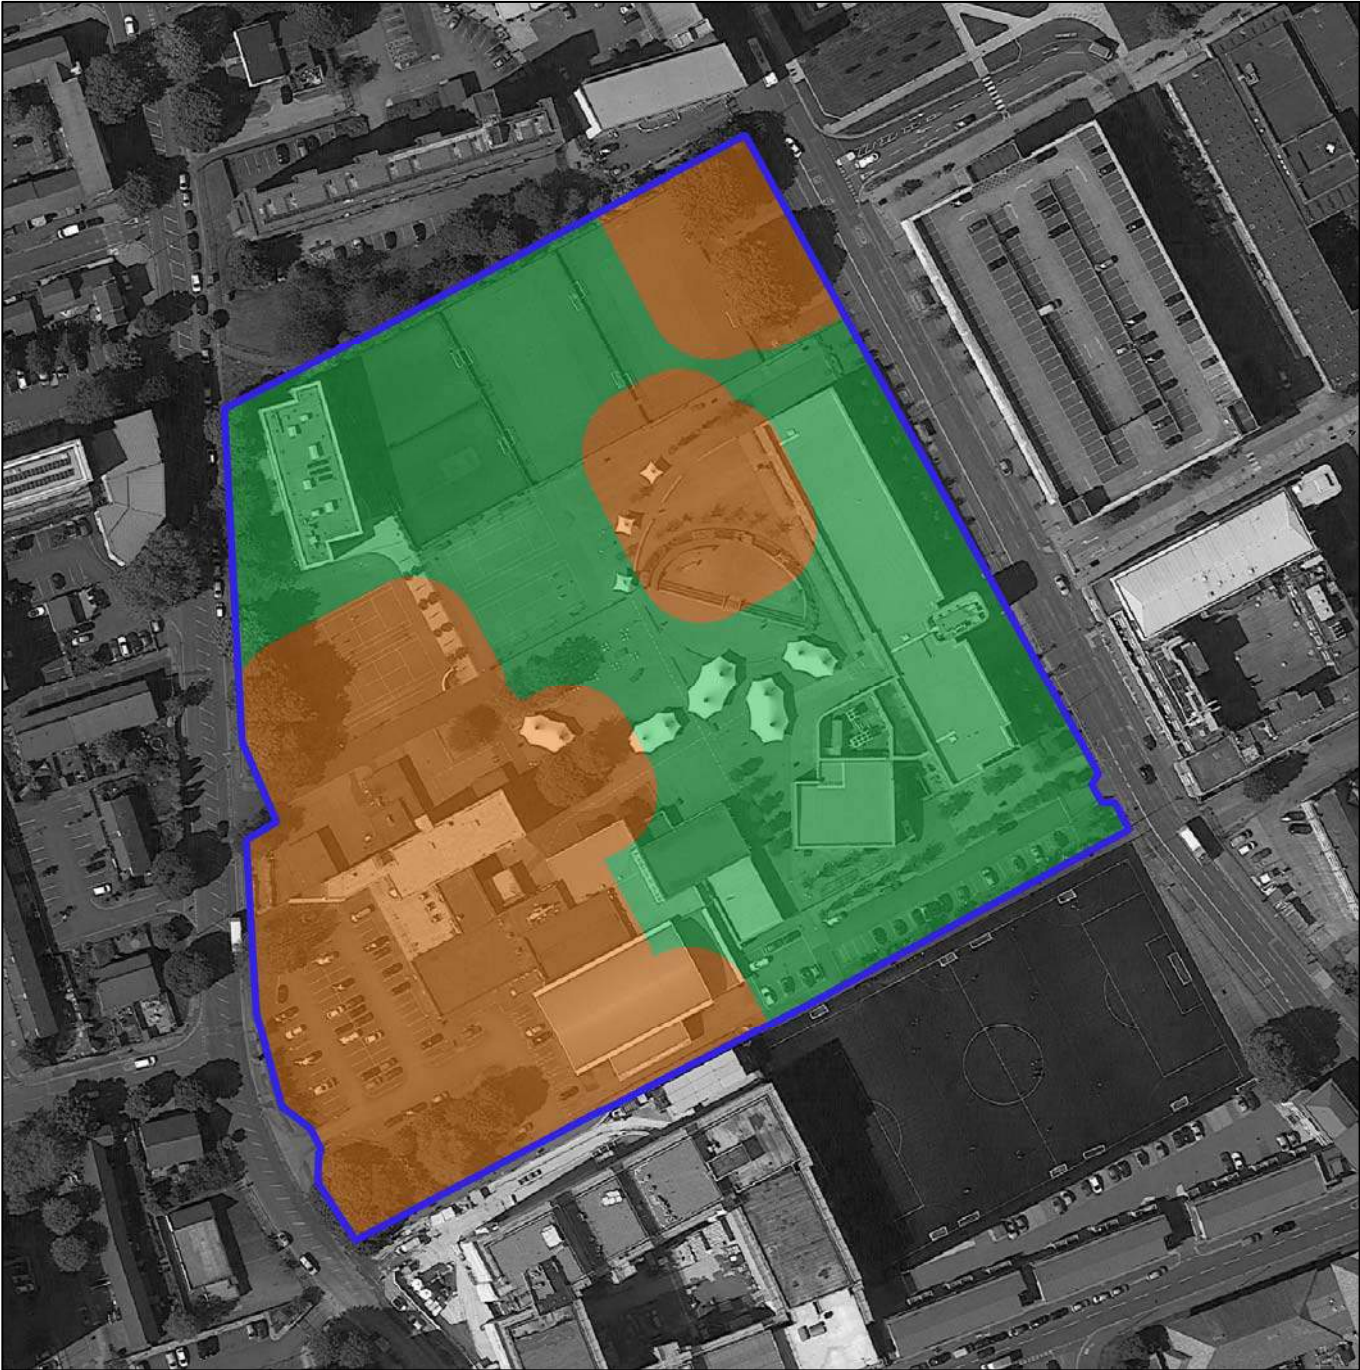
Low Risk Zone

Medium Risk Zone

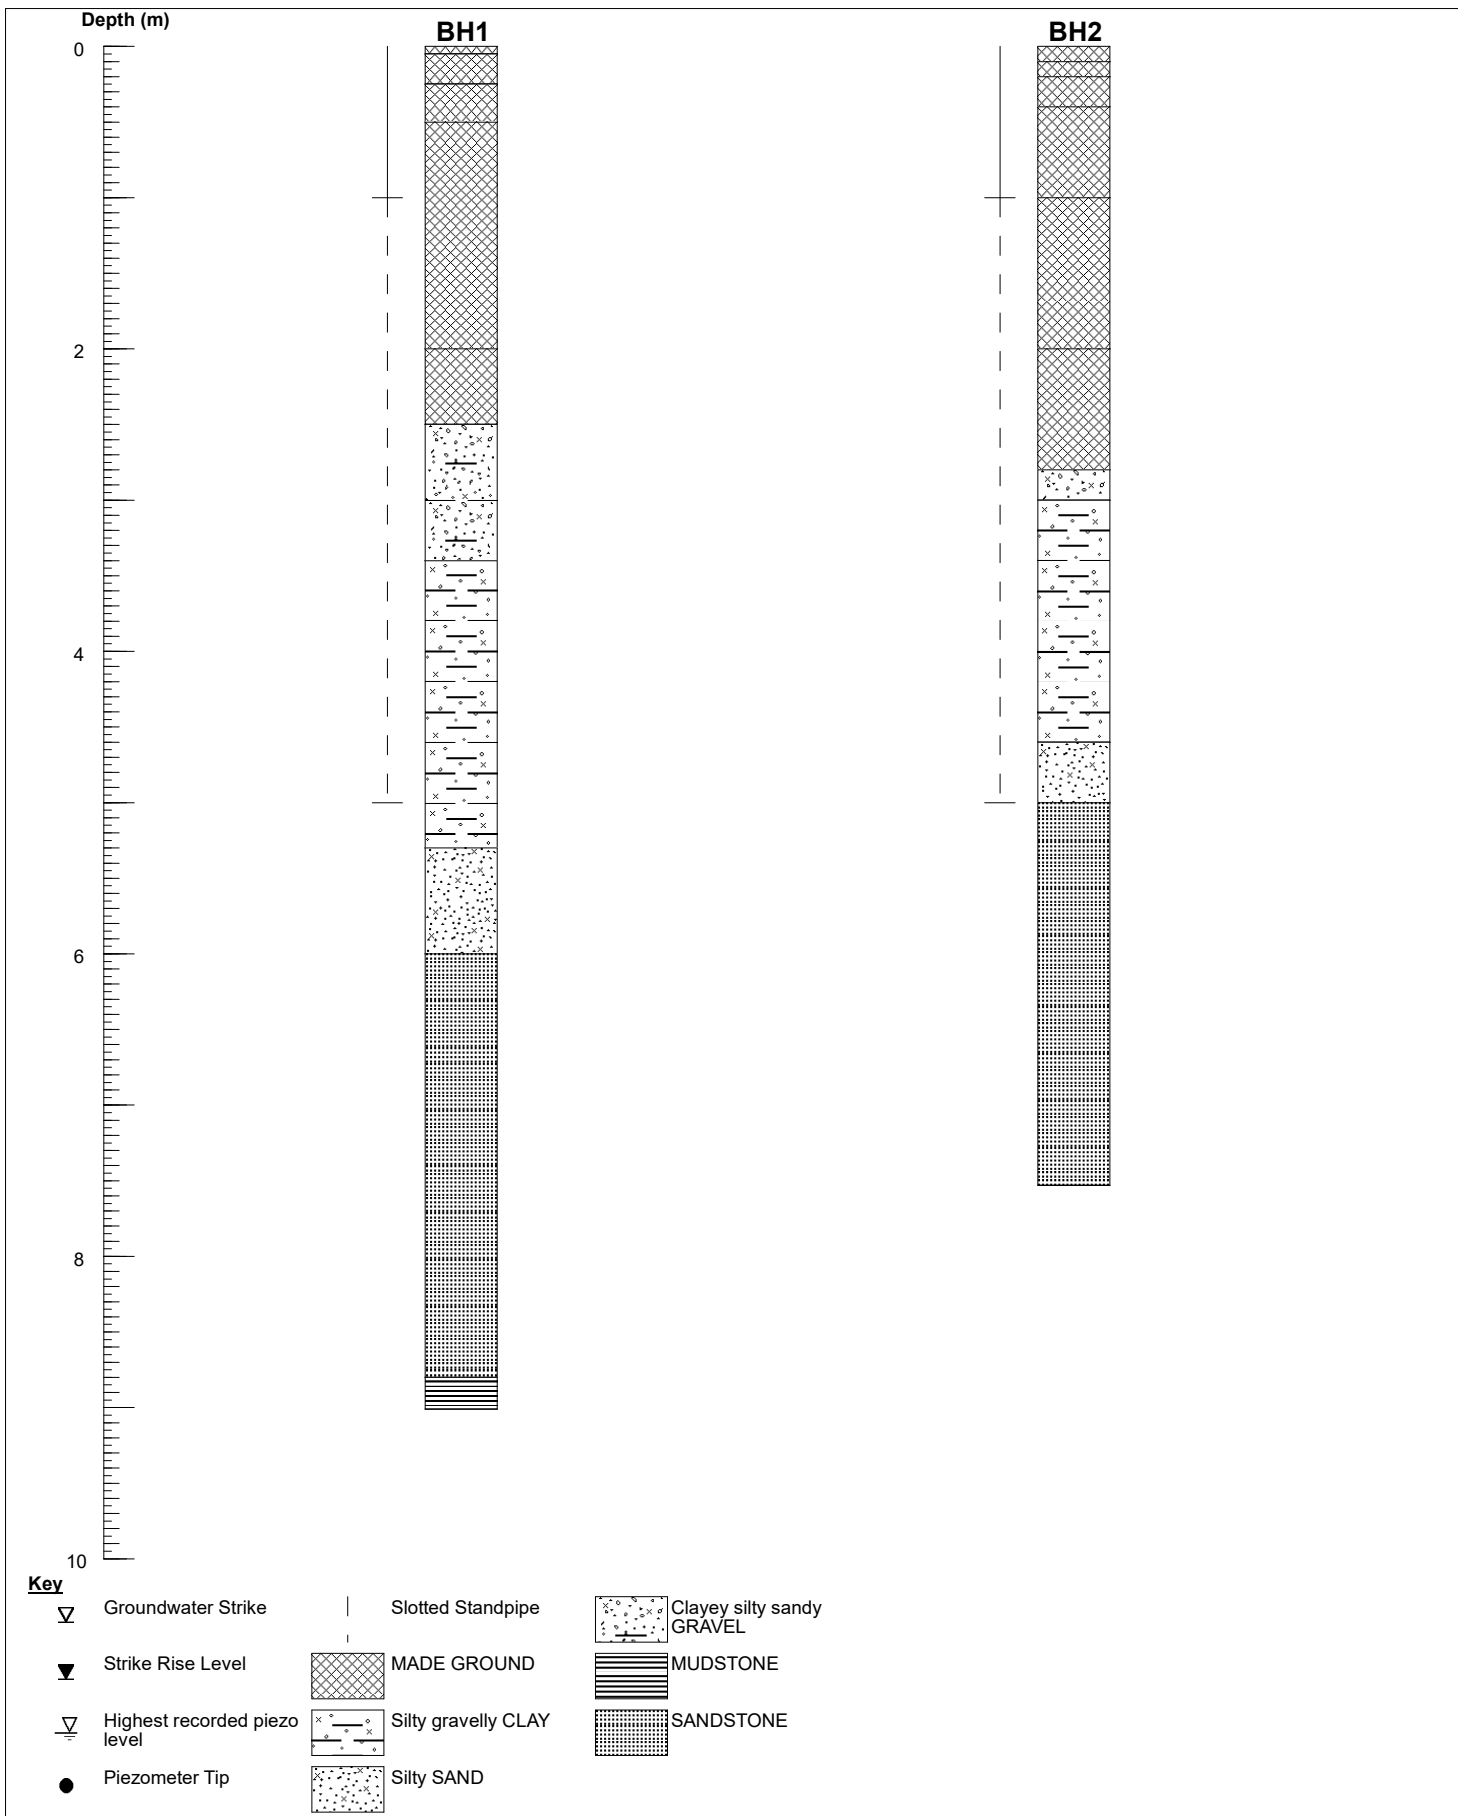
Details of the strata encountered in the ground investigation are given on the appended Borehole Records. The exploratory holes generally found Made Ground to depths of 2.50m and 2.80m, overlying brown very sandy gravel, overlying firm to stiff high strength in BH1 and soft low strength becoming firm medium strength in BH2 dark brown clay, overlying medium dense brownish red very silty sand (completely weathered sandstone), overlying extremely weak becoming very weak brownish red sandstone, overlying weak dark red mudstone. The depths of strata found were as follows:

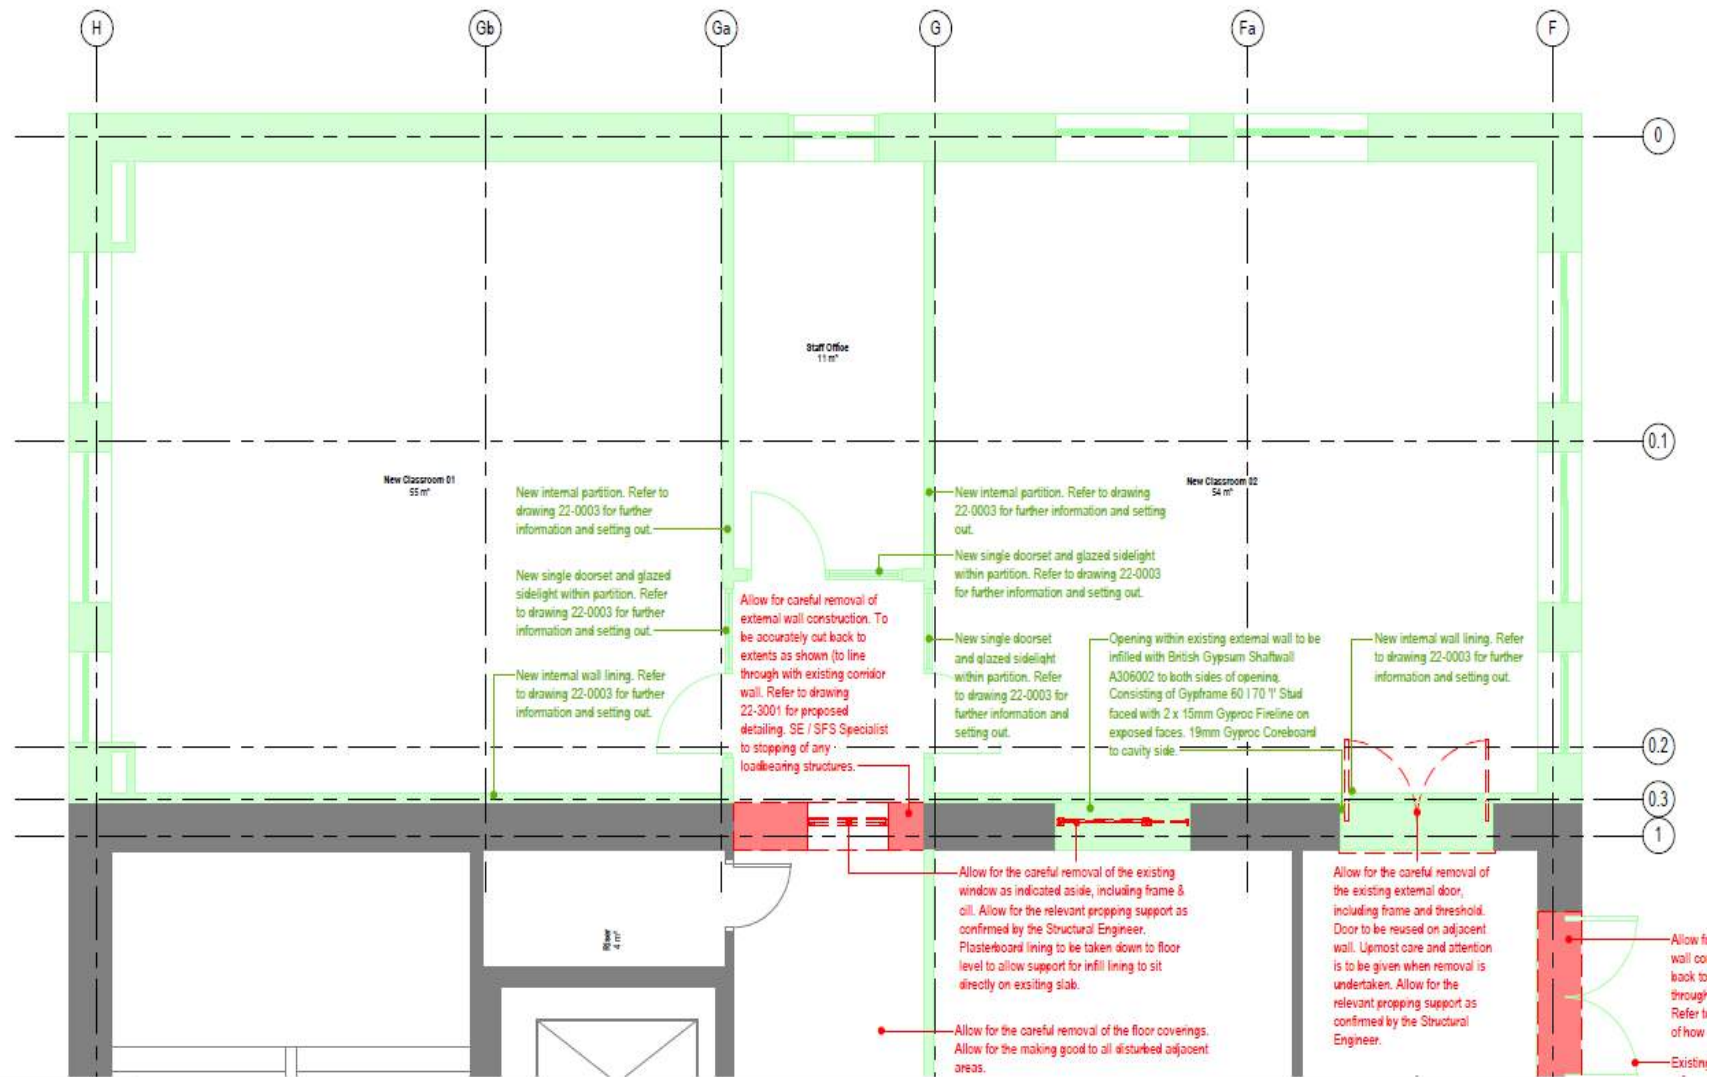
| Client | TRINITY C OF E HIGH SCHOOL | Drawn By | DM | Checked By | - | Scale | - | Figure No. | 3 |

We understand that it is proposed to build a three-storey school building extension, as shown on Figure 3. However, at the time of writing this report no specific details regarding the proposed foundations and design loadings were available and consequently the recommendations given are in general terms only.
