**PHASE II SITE ASSESSMENT  
BRUNSWICK STREET,  
MANCHESTER,  
M13 9SU**

**REC REFERENCE: LA102867P2R1**

**REPORT PREPARED FOR: BRUNSWICK LIVING LTD  
SEPTEMBER 2017**

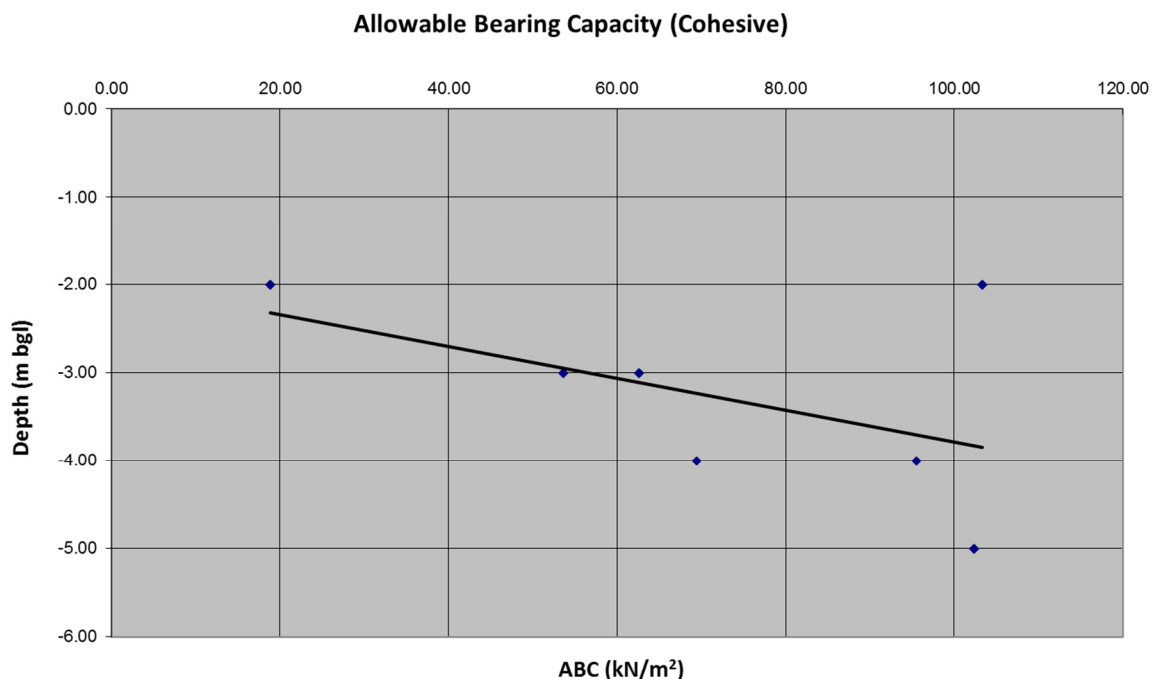
**Graph 7.1 ABC Cohesive**

Graph 7.1 shows that the shallow clay deposits across the site are highly variable of a low to medium strength, with an ABC between 53kN/m<sup>2</sup> and 102kN/m<sup>2</sup>. The natural glaciofluvial clay generally shows an increase in strength with depth.

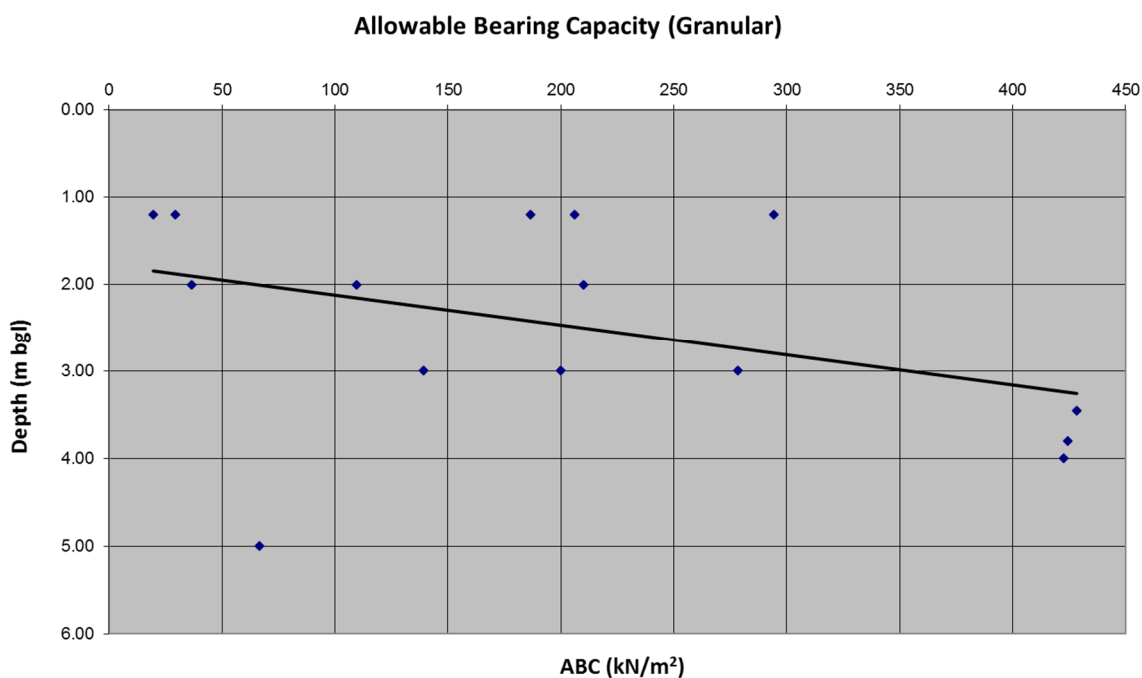
**Graph 7.2 ABC Granular**

Graph 7.2 shows that the shallow granular deposits across the site are highly variable of a very loose to very dense density, with an ABC between 18kN/m<sup>2</sup> to 428kN/m<sup>2</sup>. The natural glaciofluvial sand and

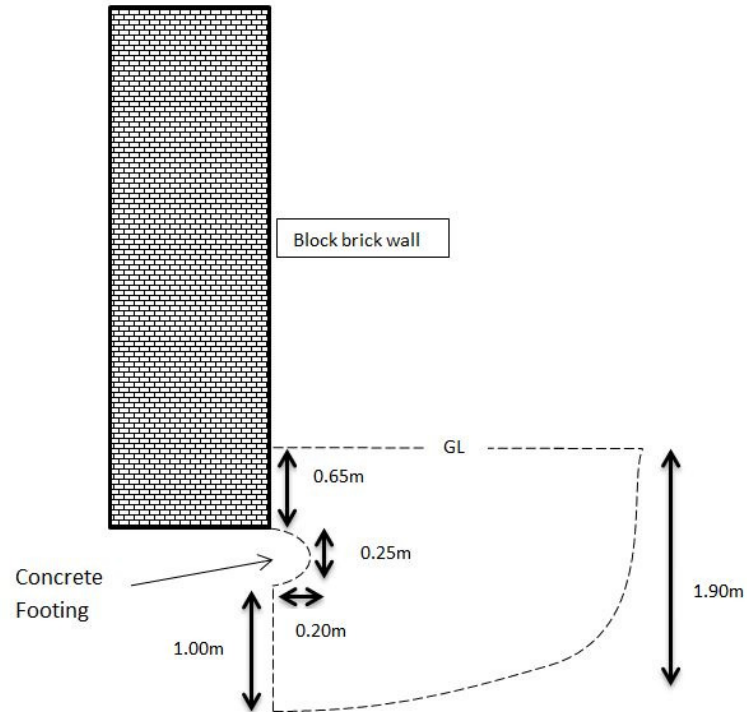
**TP104**

**CROSS SECTION**

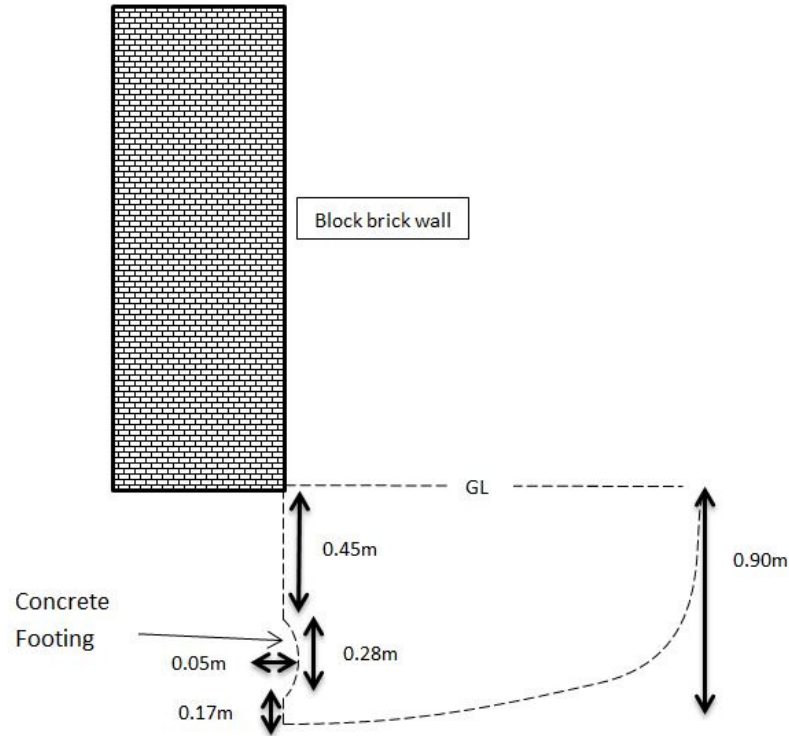
**TP105**

**CROSS SECTION**

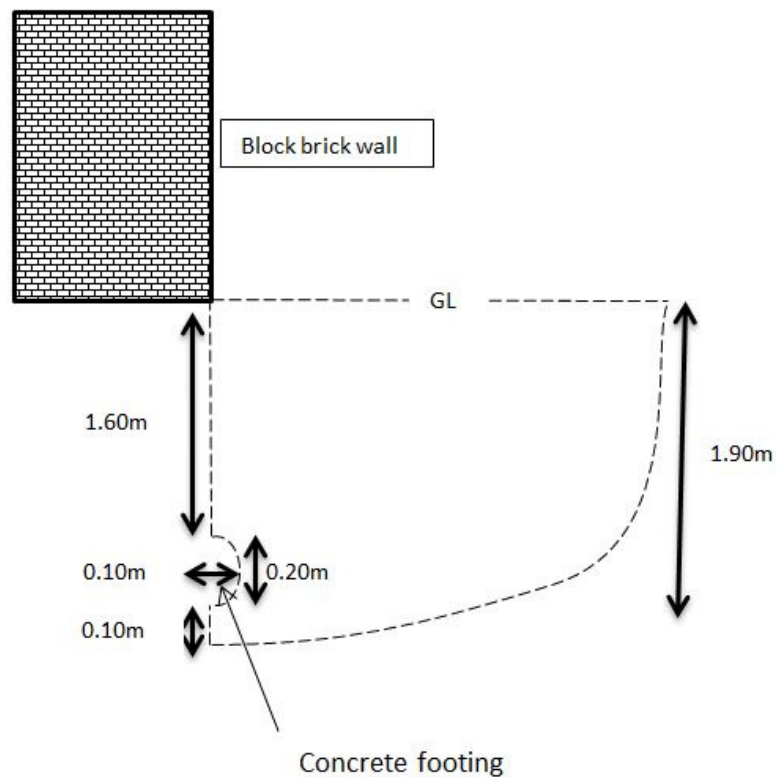
**TP106**

**CROSS SECTION**
