**PHASE I SITE ASSESSMENT  
BRUNSWICK STREET,  
MANCHESTER,  
M13 9SU**

**REC REFERENCE: 102867P1R0  
REPORT PREPARED FOR: BRUNSWICK LIVING LTD  
DECEMBER 2016**

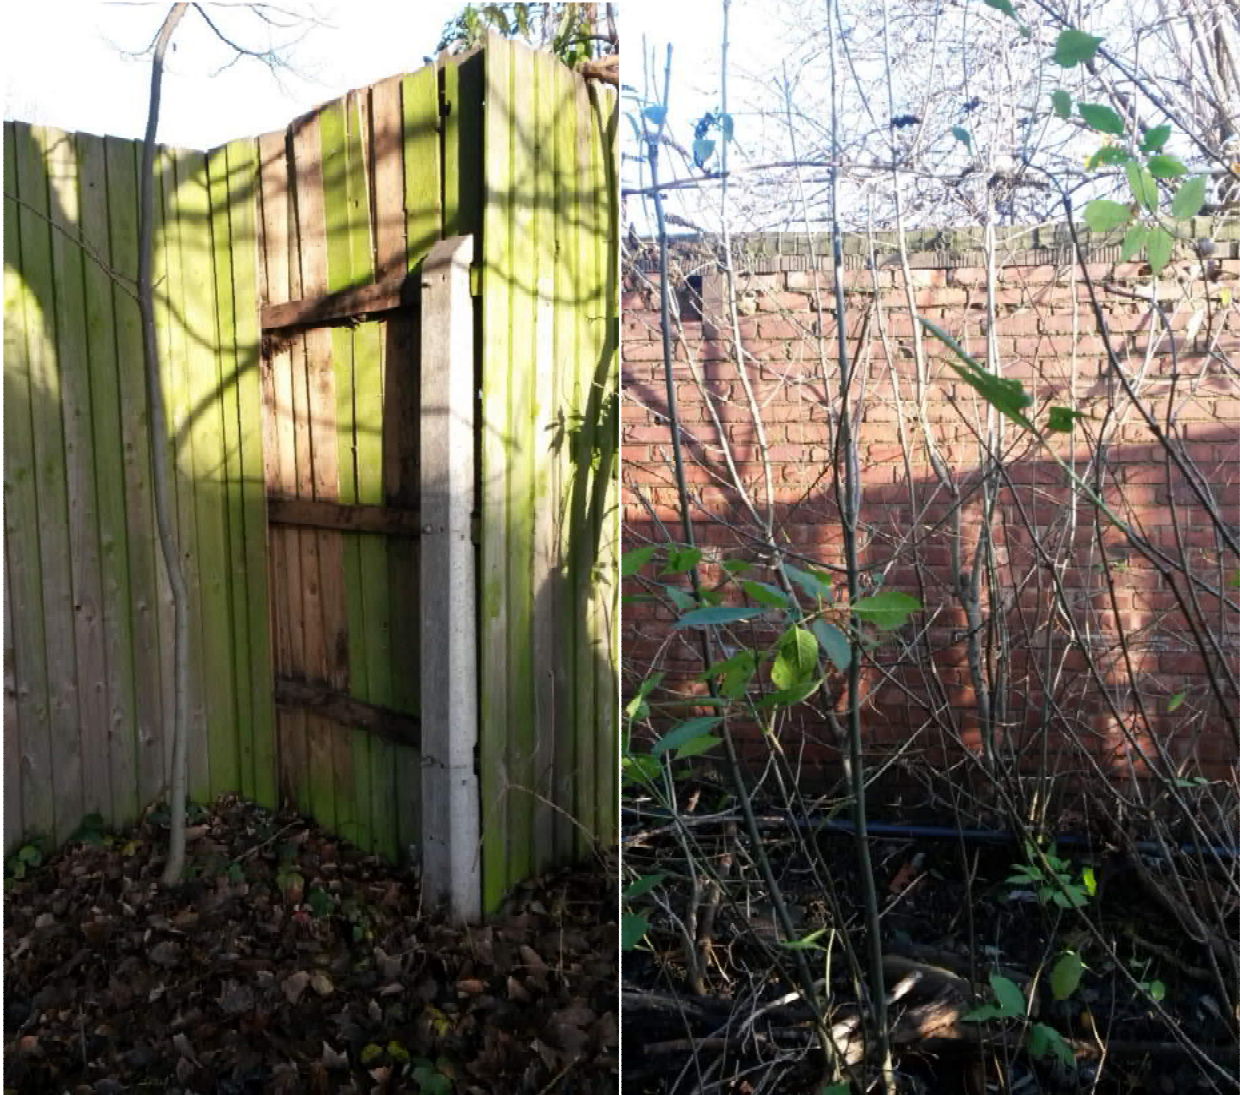
The perimeter of the site is fully enclosed, allowing no vehicular access and pedestrian access only upon removal of 4 No. wooden slats of the approximately 3m tall wooden fence along the south east facing boundary. The North West facing boundary comprises a wooden fence, supported by concrete posts, standing approximately 2m in height. The boundary to the north east is delineated by a brick wall, approximately 3m high with barbed wire running along the top. The south west boundary is defined by iron railings set into a small brick wall, standing at approximately 2m combined height.

Ground cover is gravel overlain by leaf litter with both being found across the full extent of the site area. Dense woody vegetation is found throughout the majority of the site area, consisting of various types of vegetation including some small trees, poplar (found throughout the site area), and rowan. Large established trees of pine, sycamore and beach were also found located towards and along the North West boundary fence.

Japanese Knotweed, an invasive plant species, was observed along the north east and south west facing boundaries of the site and sporadically around the centre during the site visit (please note this

**PLATE 1 – BOUNDARY FENCE FACING NORTH WEST, LOOKING NORTHWEST (LHS)**  
**PLATE 2 - BOUNDARY WALL FACING NORTH EAST, LOOKING NORTH EAST. JAPANESE KNOTWEED**  
**CAN BEE SEEN IN THE FOREGROUND OF THE PHOTO (RHS)**

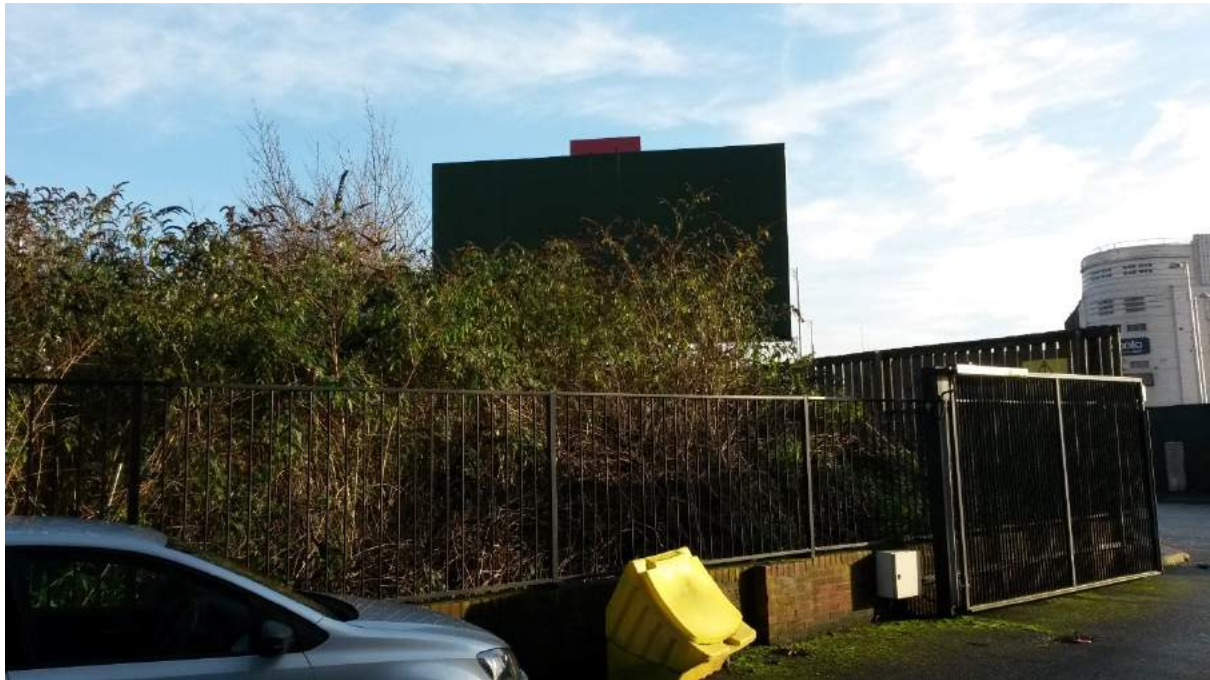
No equipment that may potentially contain PCBs was observed at the site; however, an electricity control box was found to be located at the base of the wall in the south west corner of the site. The box is external to the site and acts to control the security gate for the adjacent car park of the associated residential apartment block.

**PLATE 3 – BOUNDARY FENCE FACING SOUTH WEST, LOOKING SOUTH EAST. SHOWING AD HOARDING WITHIN SITE AREA AND ELECTRIC CONTROL BOX FOR GET OF CAR PARK**

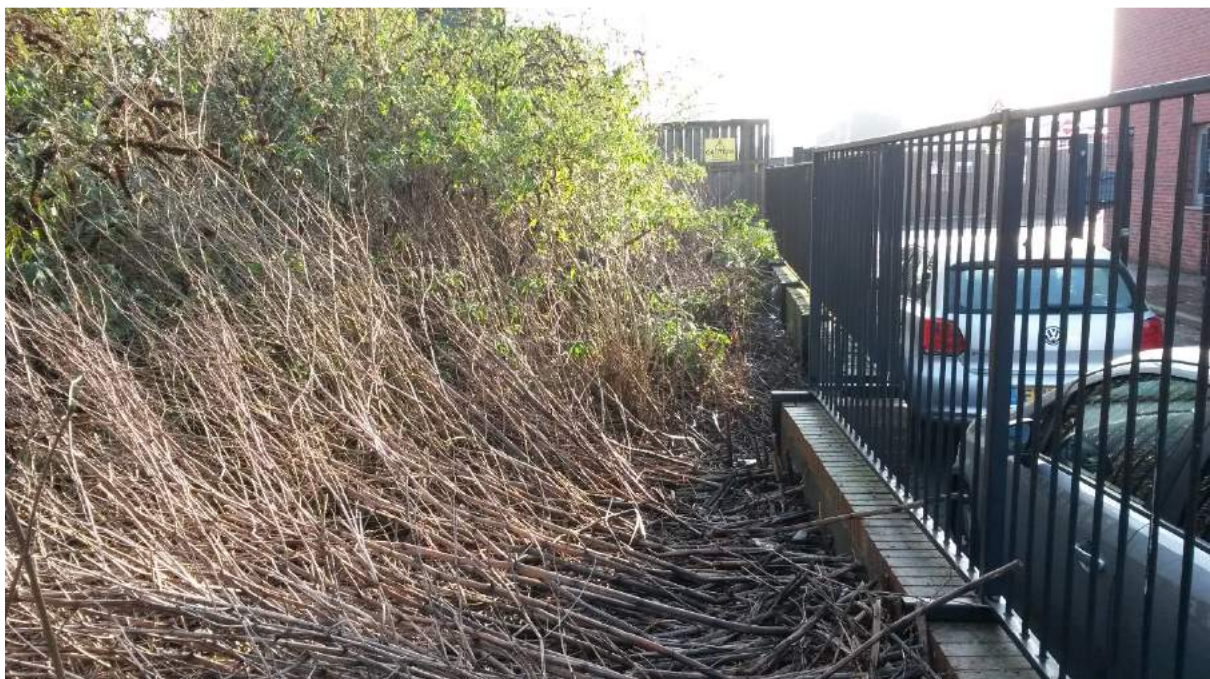
Japanese Knotweed was observed on-site. This is classified as an invasive plant species and as such the treatment of it is covered under current government legislation; Wildlife and Countryside Act 1981 and the Environmental Protection Act 1990 regulates and limits the growing of, removal and waste of Japanese Knotweed as controlled waste which requires a license. The Japanese Knotweed is currently undergoing treatment with two visits completed on November 2015 and September 2016 by Japanese Knotweed Control (JKC) Ltd.

**PLATE 4 – BOUNDARY FENCE FACING SOUTH WEST, LOOKING SOUTH EAST. SHOWING JAPANESE KNOTWEED IN THE FOREGROUND OF THE PHOTO WHICH HAS BEEN CUT**

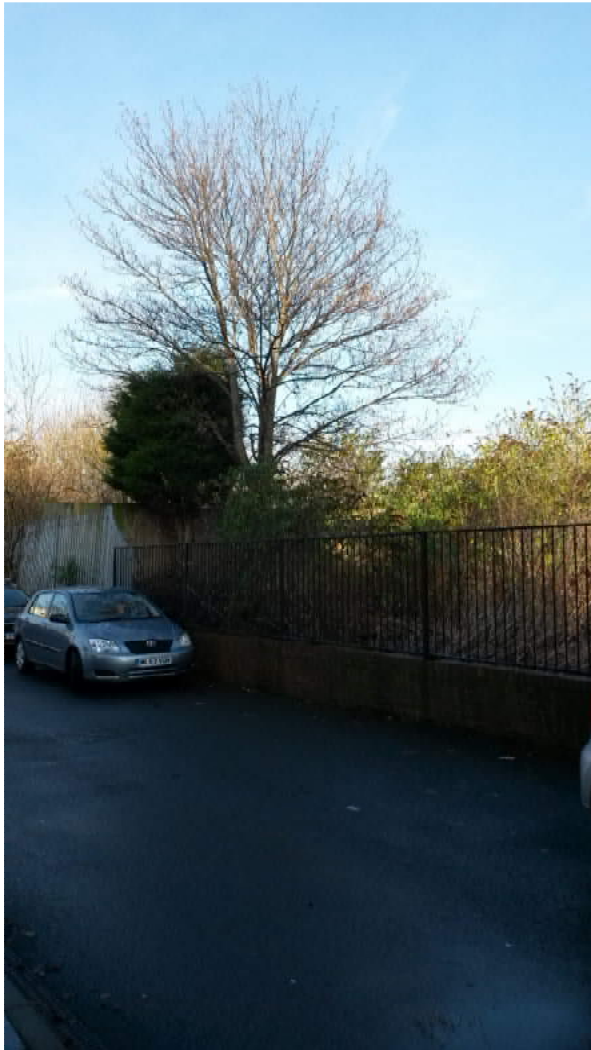
**PLATE 5 – LARGE MATURE TREES TO REAR OF SITE (LHS)**

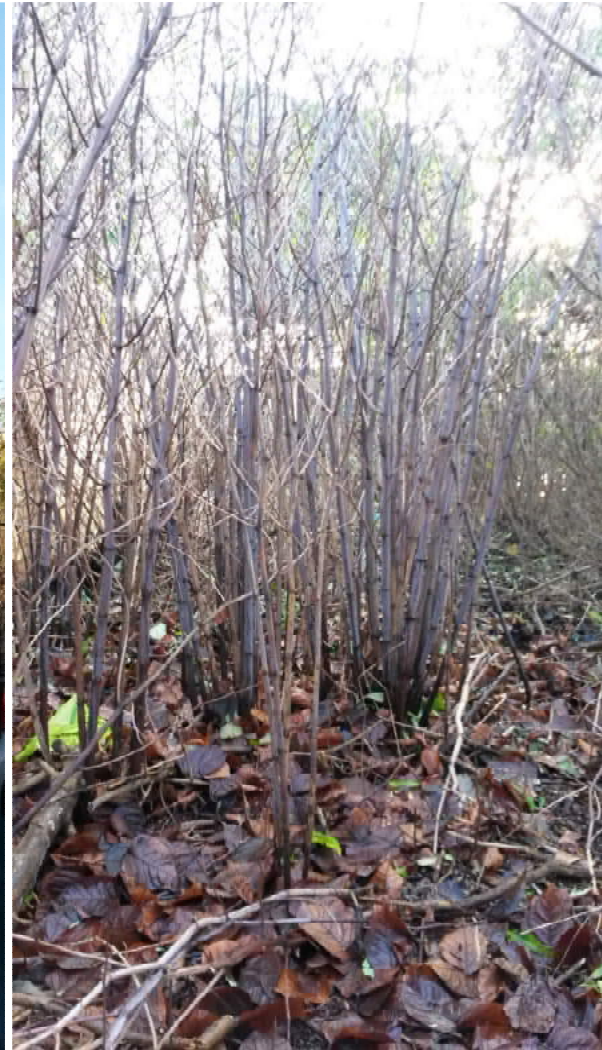
**PLATE 6 - JAPANESE KNOTWEED SHOWN BY THE NORTH EAST FACING BOUNDARY WALL (RHS)**

Japanese Knotweed, an invasive plant species, was observed on-site. The legislation covering Japanese Knotweed; Wildlife and Countryside Act 1981 and the Environmental Protection Act 1990 regulates and limits the growing of, removal and waste of Japanese Knotweed as controlled waste which requires a license. Section 33 of the EPA states that it is an offence to deposit, treat, keep or dispose of controlled waste without a licence. Treatment of the Japanese Knotweed is underway, with two visits completed during November 2015 and September 2016.

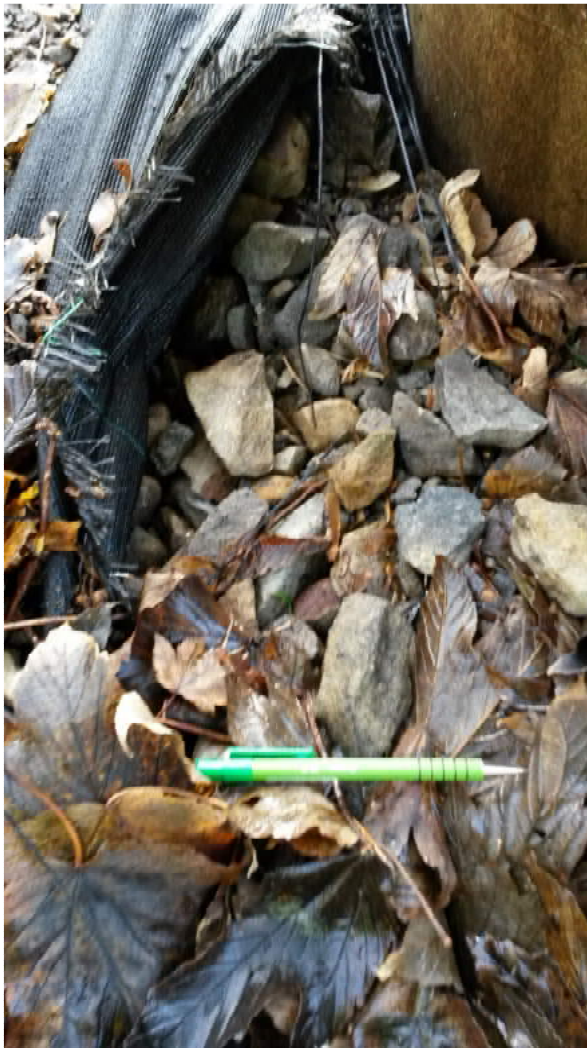
**PLATE 7 – GRAVEL GROUND COVER (LHS)**  
**PLATE 8 - FLY-TIPPED WASTE (RHS).**

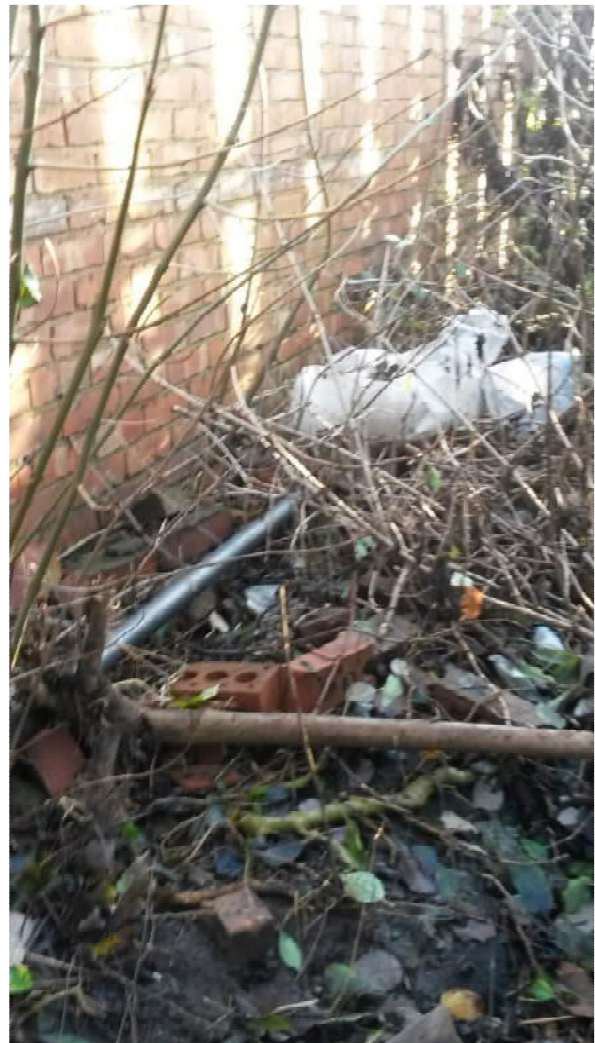
Fly-tipped materials and litter are present across the site area, with the bulk of the materials being confined to the outer edges along the boundary fence lines of the adjacent properties. Items identified include bricks, plastic pipes, wooden beams, traffic cones, child's pushchair, and general litter such as metal cans, plastic bags.
