Window W3-F - Office  
1:5

PROJECT MANCHESTER OPERA HOUSE

TITLE WINDOW REPAIR - W3-F

DRAWING NUMBER 19-143- WR3

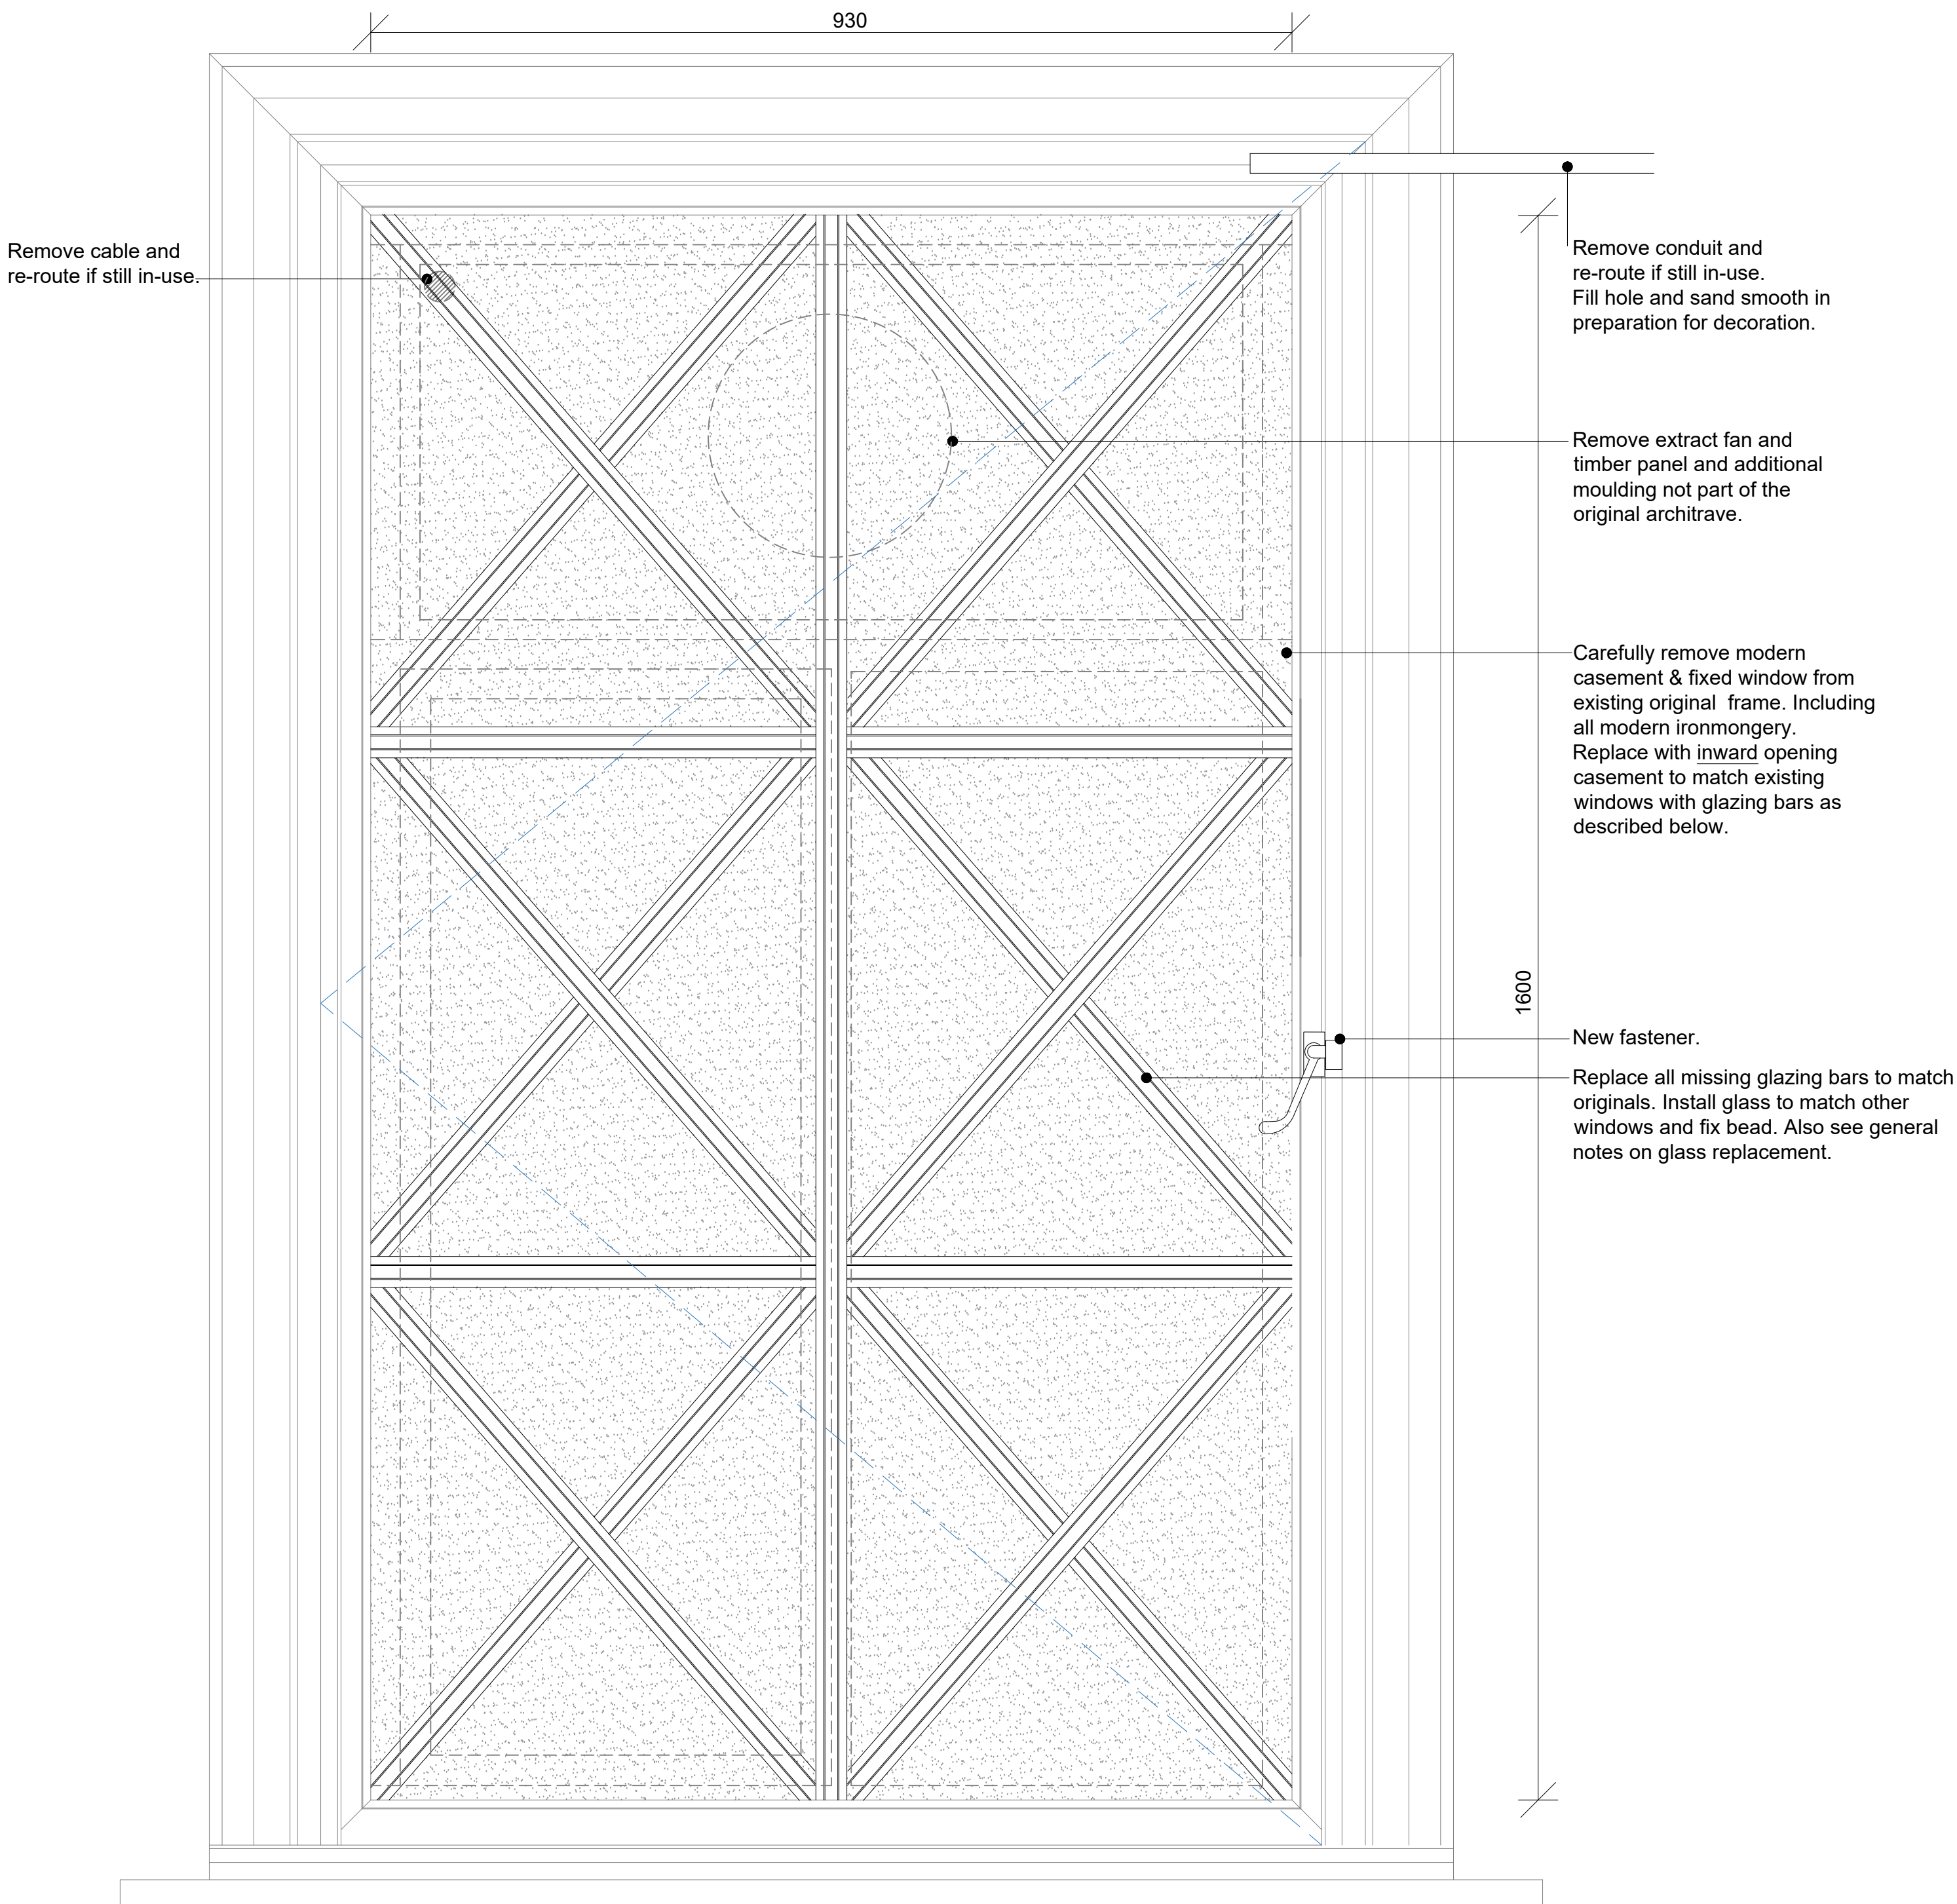
N.B. ALL DIMENSIONS SHOULD BE CHECKED ON SITE AND/OR IN WORKSHOP PRIOR TO ANY REPAIR OR REPLACEMENT AS NOTED IN THE REPAIRS SCHEDULE.  
N.B LIMITED ACCESS - FULL SURVEY AND CONDITION ASSESSMENT REQUIRED.

Once all repairs have been carried out.

Clean down and remove any loose paint. Prepare surface to receive new painted finish, preferably using specialized scrapers or heat guns where appropriate. Avoid using an alkaline based paint stripper as the surface needs to be ph.neutral.  
Repaint with linseed oil based paint to give long lasting preservation of the timber and breathability. Apply in 2-3no thin coats with 24hr drying time between coats as manufacturers recommendations.

Carefully clean glass and check for damage. If any glass needs to be removed during the course of the repair it must be labeled and re-used in its original location and orientation. Ensure rebates are clean, dusted given a thin coat of paint before linseed-oil bedding putty is applied. Once bead is re-fixed use more putty to seal between glass and frame joint.

Once casement has been removed and the existing frame has been left in-situ, check frame and cill for and damage or rot. Record areas and report to CA.

Where external cills are to be replaced - replicate the profile of the existing cill in a durable hardwood such as oak incorporating a drip detail to the underside. Any new cill parts should be butt jointed below the casement frame. Finish using linseed oil based paint as described above in the colour to match the existing colour.

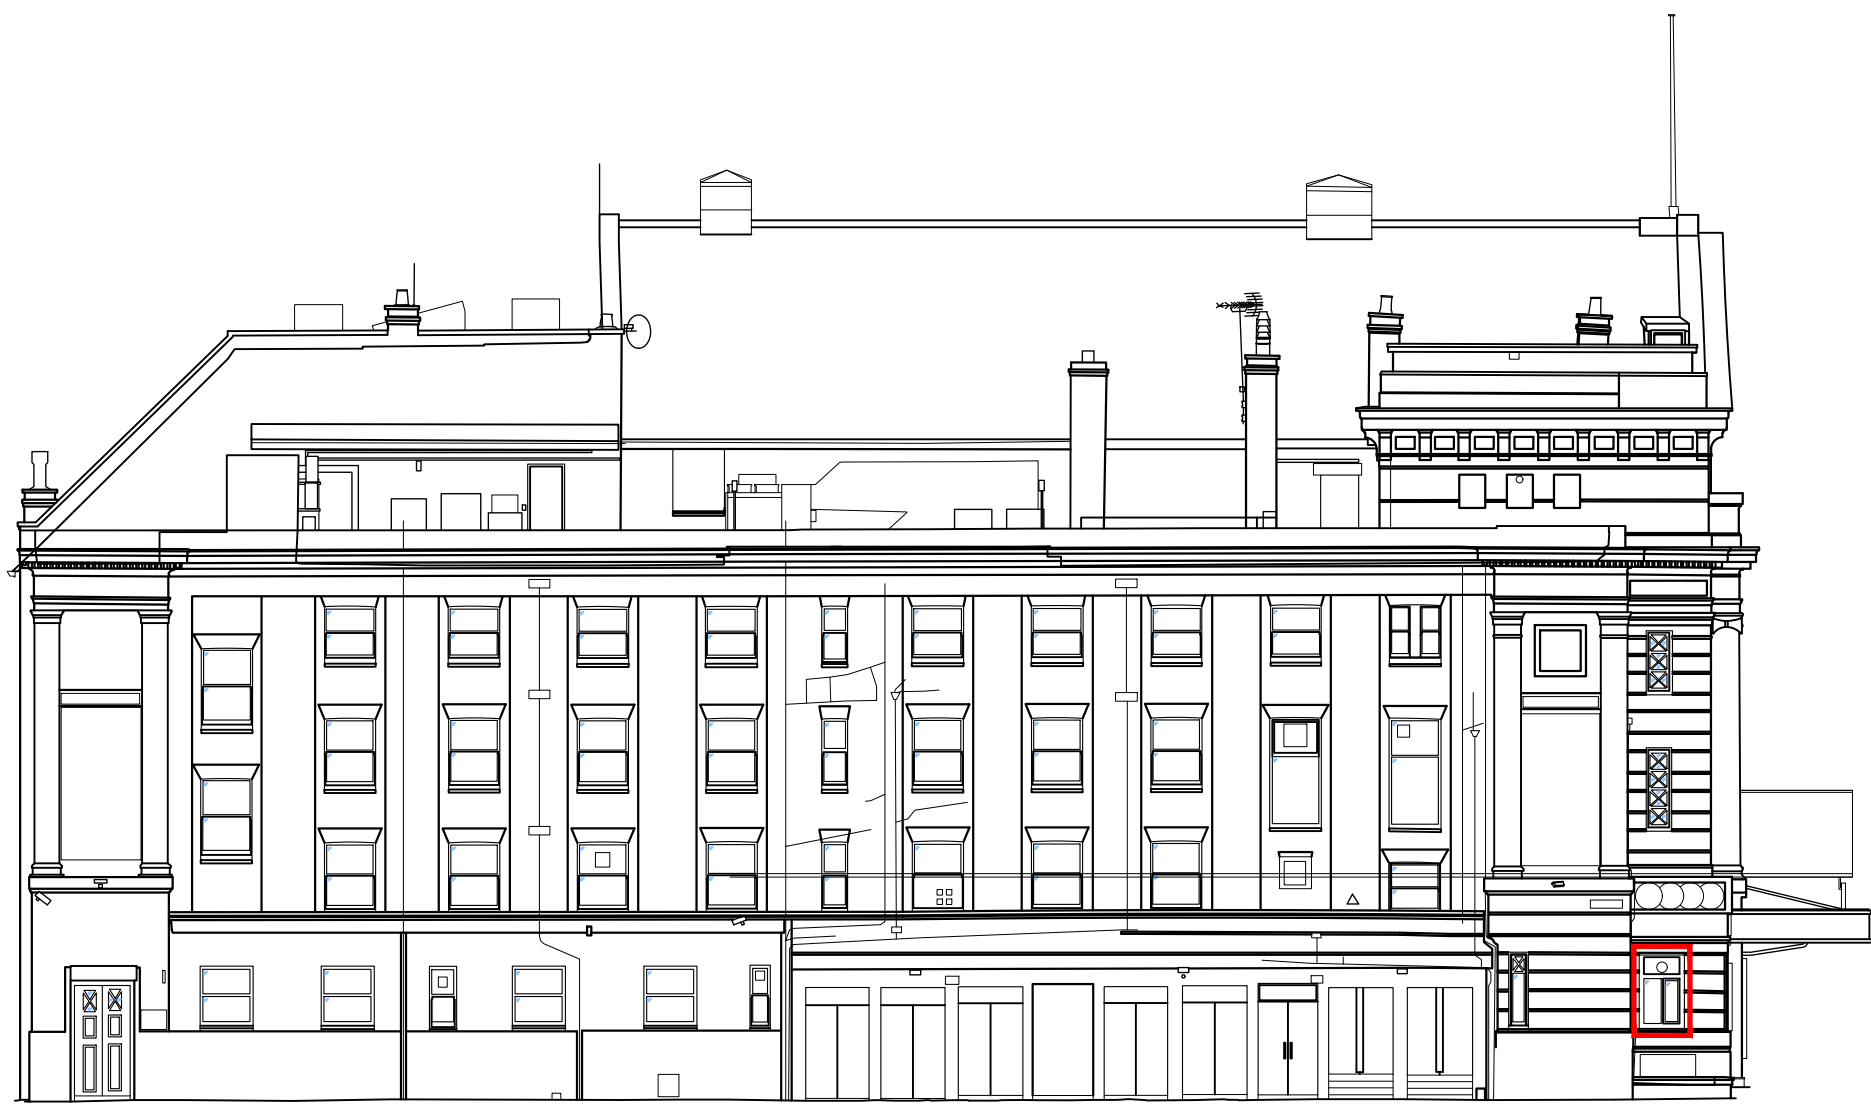
BYROM STREET ELEVATION  
NTS

N.B Read in conjunction with drawing 19-143 - CS3 for window Condition Survey and Repair Schedule 19-143 - Sch 1.

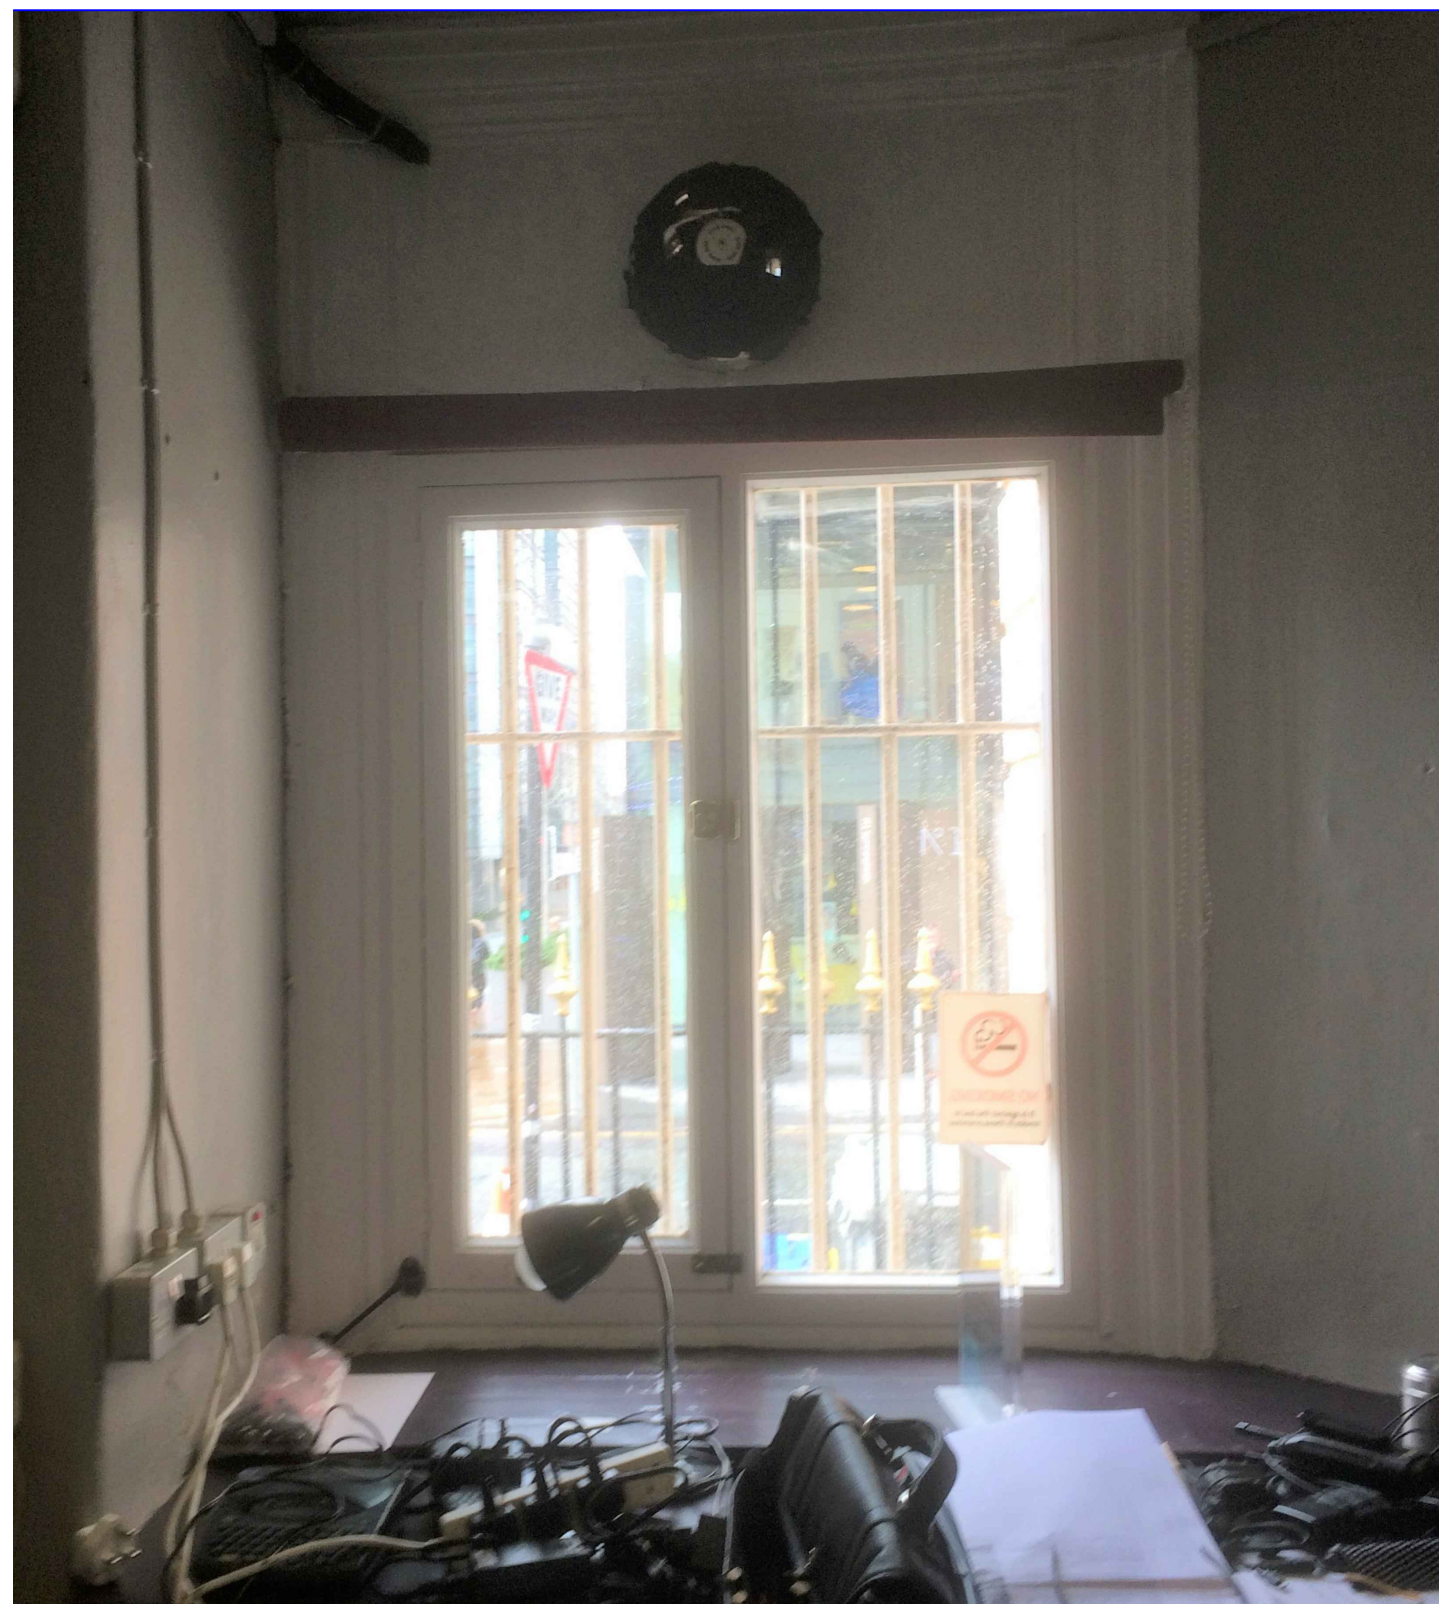
# W3-F

Window W3-F Office

Check all ironmongery is in sound working order. Ease any moving parts with lubricant if required. Ensure all hinges are sound, if not replace with like for like hinges using stainless steel fastenings. If replacement ironmongery is required source to closely match original black iron window fasteners and stays as indicated below.

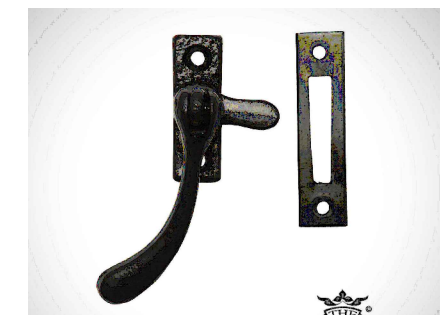
For reference these are available from 'The Victorian Emporium' - N.B ensure size is suitable to coordinate with existing ironmongery that is being retained.
