**Re: Preliminary Bat Roost Assessment and General Ecological Statement: 16 Saxon Street, Manchester, M40 7BY.**

PENNINE *Ecological* have been commissioned to undertake a daytime inspection for bats and provide a general ecological statement for the above site. The purpose of this study is to address any potential issues in relation to bats and other protected species resulting from the proposals to build two new semi-detached houses on the plot. The sites grid reference is SJ 8635 9920 and the location is shown below;

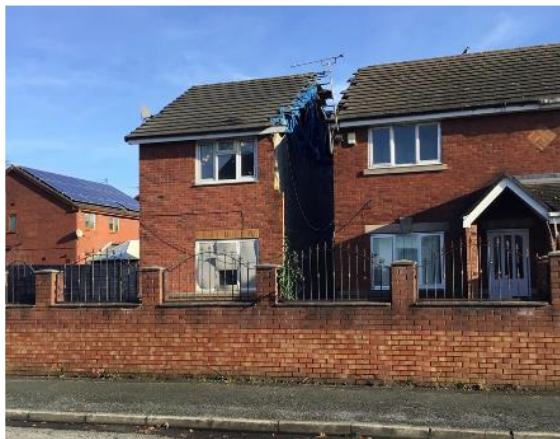
No. 16 Saxon Street comprises a semi-detached building which has been partly demolished and now stands as a detached building. The building is not currently occupied, however the property to the immediate south is occupied. The partly demolished building within the red line boundary is of brick construction with a concrete tile roof. The building is in poor condition and appears to be structurally unsafe. Due to the building being part demolished and in poor condition, several features have been identified which have the potential to support roosting bats:

**View of western aspect of partly demolished property (within red line boundary) and property to the immediate south.**

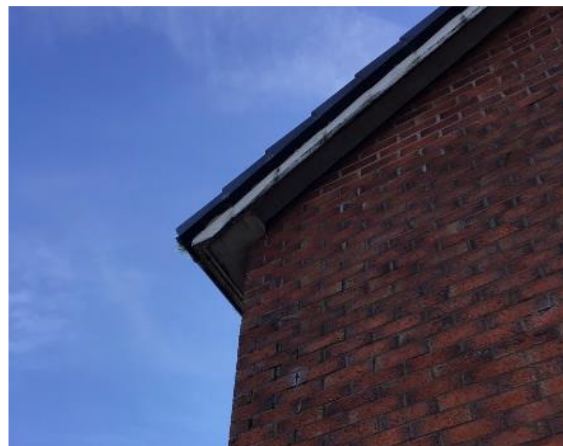
Along the northern aspect of the building there are gaps between the wooden soffit boards and the brick work, particularly on the north-east and north-west corners of the building.

**North aspect of building. Gaps between the wooden soffits and brick work. Present on north-east and north west corners.**

Since the building is concluded to possess moderate potential for crevice dwelling bats, it is recommended that dusk emergence and/or dawn re-entry surveys should be undertaken. Surveys are required to establish whether or not bats are using the building and if present how they are using it.

The surveys will need to be conducted during the main active season of bats i.e. between May – August. Two dusk/dawn surveys are accepted as being a reasonable level of survey effort where moderate potential has been identified. The surveys must be spaced between those months, at least 2 weeks apart. In addition, a data search of local bat records could be sourced to compliment the dusk emergence surveys.

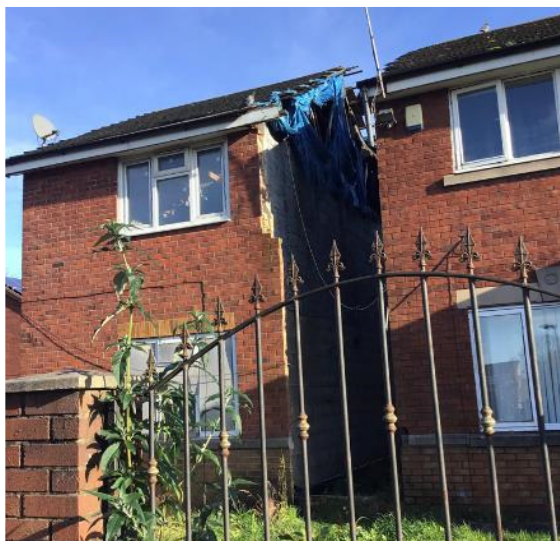
Feral Pigeons were recorded entering the partly demolished building and are likely to be nesting inside the building. The large open voids and gaps created by the part demolition provide suitable nesting opportunities for various bird species in addition to pigeon.

The building is infested with feral pigeons. There is potential that other birds such as house sparrow could nest in the building.

**South aspect of demolished building with large open void. Pigeon recorded nesting.**

No strategic bird surveys are required. Feral pigeons breed throughout the year. The client is advised that a specialist pigeon control contractor is contacted to deal with this issue. At the same time the contractor must make checks for other breeding birds if the demolition is scheduled in the breeding bird season (*March 1st - August 31st*).

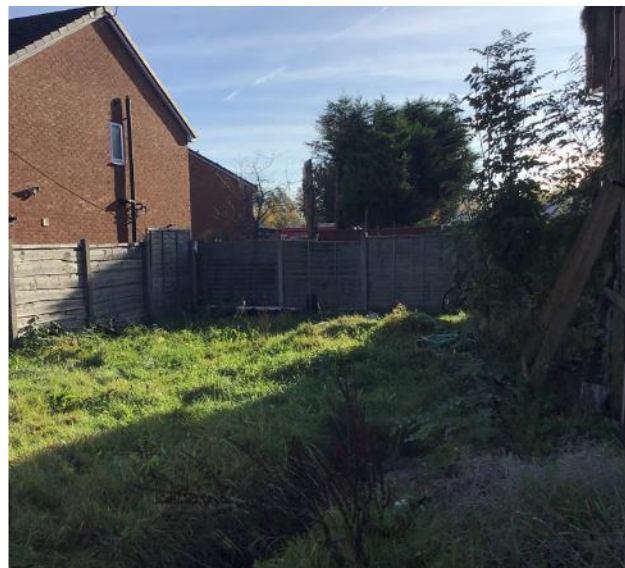
The remainder of the site is primarily an unmanaged garden comprising of hardstanding and overgrown amenity grassland which is transitioning into tall ruderal with areas of rank grassland. There is an area of rubble along the northern boundary and building debris near to the property entrance along the western boundary. Dominant grass species include false-oat grass, perennial rye grass and bent species. Herbaceous species include white clover, ribwort plantain, dock species, black medic and dandelion. Stands of hairy willowherb, nettle and bramble are present, particularly within the area of rubble. Ash saplings are also present along the foot of the eastern aspect of the property.

**View of the rear property. Overgrown garden landscape with areas of tall ruderal and ash saplings.**

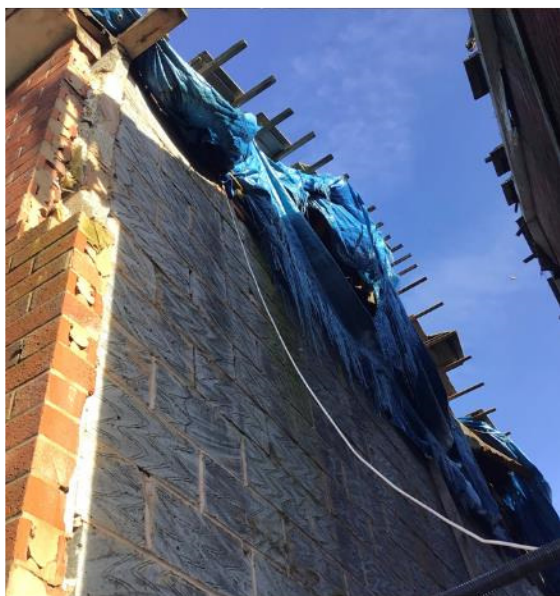
On the south aspect where the demolition has occurred, there are numerous voids which have been exposed which could be used by bats. These include gaps between the exposed concrete roof tiles and the internal roof structure; entry into the exposed soffit boards along the east and western faces; and gaps between the external (brick) and internal (breeze block) wall cavity along the entire aspect.

It is considered that roost potential overall for the partly demolished building is **Moderate**.

**South aspect. Bat roost potential present with gaps in wall cavities and gaps under roof tiles.**

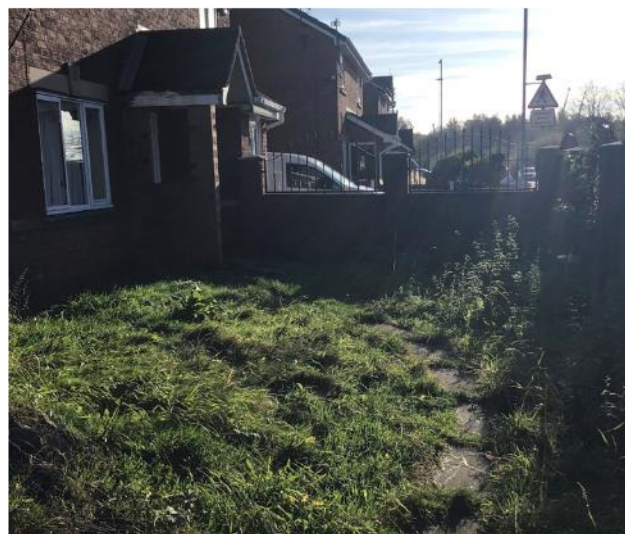
**Front of property with areas of tall ruderal and unmanaged grassland.**

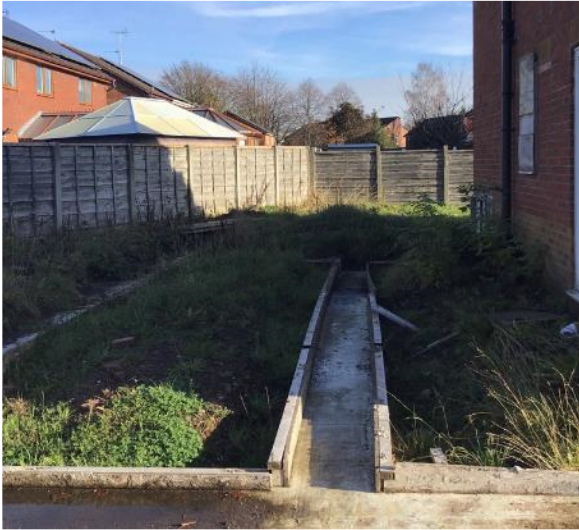
The site is located in a largely urban area and is surrounded by residential dwelling and street lighting. Saxon Saint Park, an area of unmanaged green space and Rochdale Canal are located to the north of the building and provide more suitable foraging and commuting habitat for bats.

**View of garden and land to the north of the partly demolished building.**
