**Miller Homes**

**Ground Investigation Report**

**Northenden College, Northenden**

**REPORT NO: 20MIL039/GI**

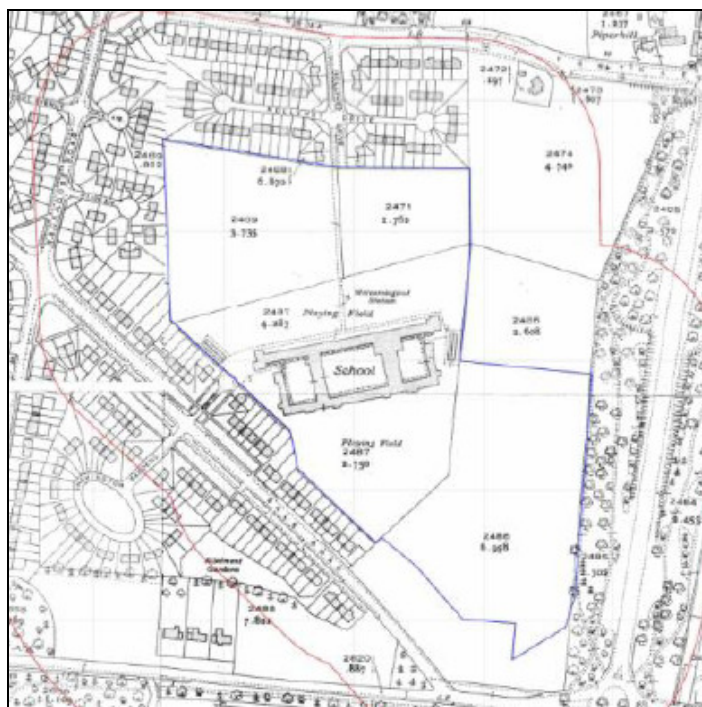
**1935 – 1956**  
**(1:2,500) (1:10,560) (1:2,250)**

*By 1935, the surrounding area had been heavily developed with residential properties. A school had been built in the centre of the site with associated playing fields. The road network began expanding to accommodate this growth around 1938. The school was then expanded with new buildings being constructed in the west of the site by 1956. By this time the school had been labelled as “Yew Tree School”.*

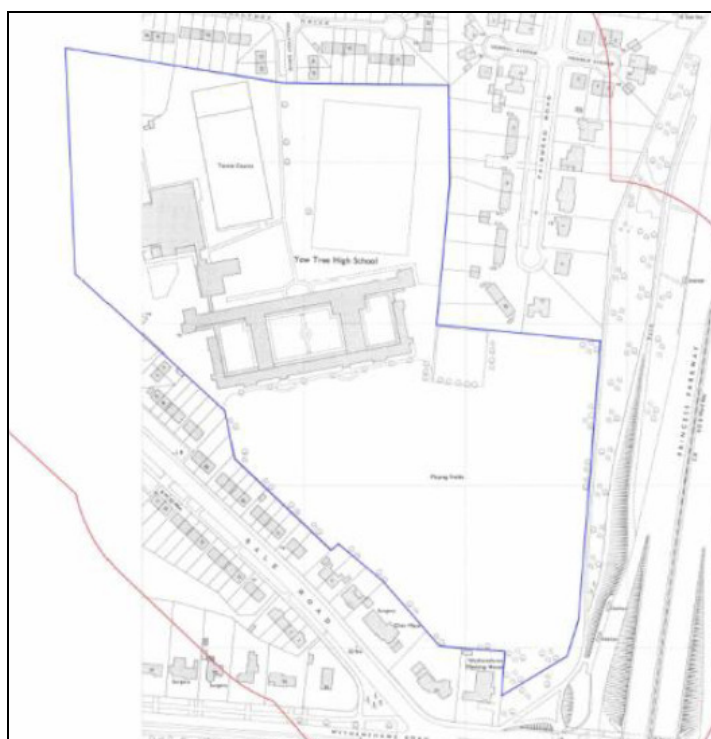
1977 (1:1,250)

The school was further developed by 1977 with the addition of extra buildings and a tennis court in the north. The road network has continued to expand, with the road directly east being converted into a dual carriageway.

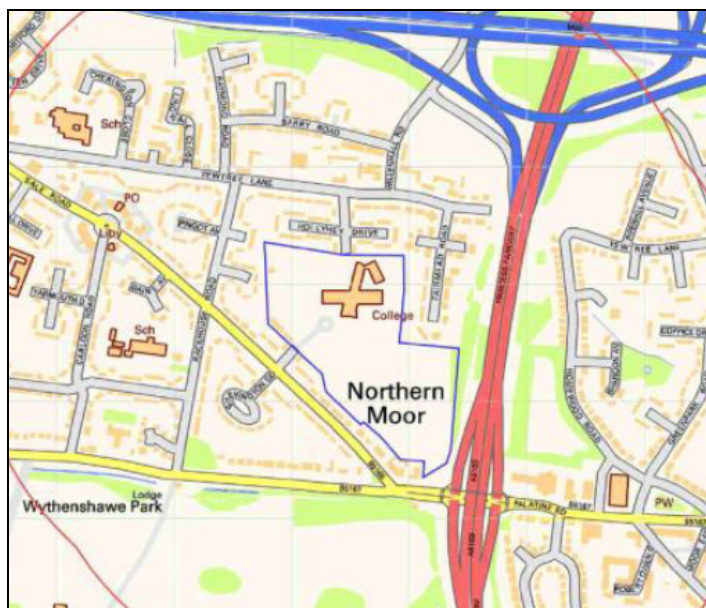
2010 (1:10,000)

By 2010 the school and its associated structures had been demolished and replaced with a building in the

north east of the site labelled as "College".
