Phase II Geoenvironmental Site Assessment  
Northenden College

Northenden College  
Moss Hey Drive  
Wythenshawe  
Manchester  
M23 0DH

**Report Ref: 13-969-R1-1**  
**Date Issued: 21/07/2020**

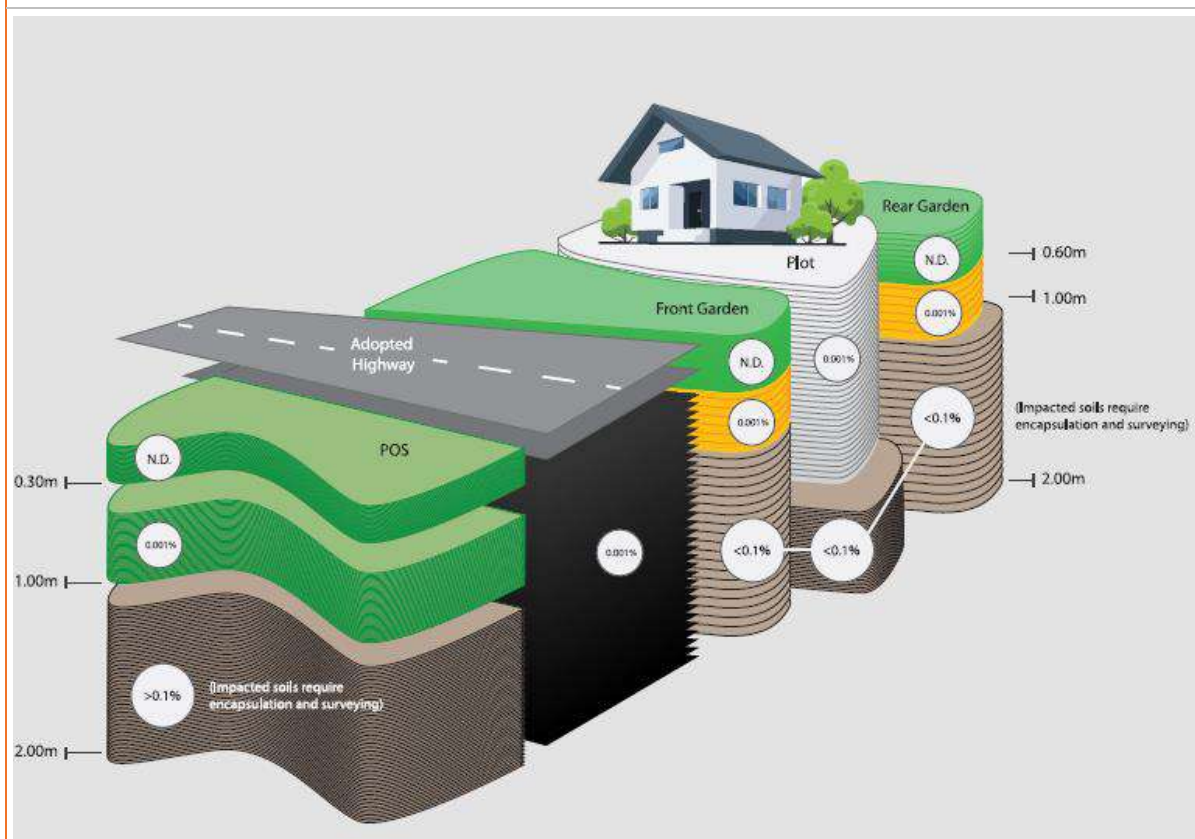
FIGURE 5.1 ASBESTOS RISK MITIGATION CONCEPTUAL SITE MODEL

Asbestos in the form of chrysotile has also been identified within one localised area within shallow Made Ground deposits at WS118 at 0.30m bgl. Asbestos quantification was undertaken to further assess where these soils may be placed and identified concentrations of 0.002%. No visual signs of ACM were encountered during the ground investigation; it is therefore likely that only trace fibres are present. Impacted soils should be managed according to the asbestos risk mitigation conceptual site model shown in Figure 5.1. It should be assumed at this stage that asbestos loose fibres are throughout the Made Ground on site.

| POLLUTANT LINKAGE | CONTAMINANT (SOURCE) | PATHWAY | RECEPTOR | PROBABILITY | CURRENT RISK | RESIDUAL RISK AFTER MITIGATION |
|---|---|---|---|---|---|---|
| <p><b>Assessment:</b><br/>Asbestos in the form of loose chrysotile fibres at a quantification of 0.002% have been identified within localised Made Ground at WS118 at 0.30m bgl.</p> <p><b>Recommendation:</b><br/>Placement of materials in line with E3P Asbestos Conceptual Site Model; materials from WS118 should be placed &gt;1.00 m below garden plots or POS areas. Cover system to garden and landscaped areas will prevent exposure to future site users and materials must be placed within an area of low future sensitivity. Construction works completed with PPE and provision of welfare.</p> | | | | | | |

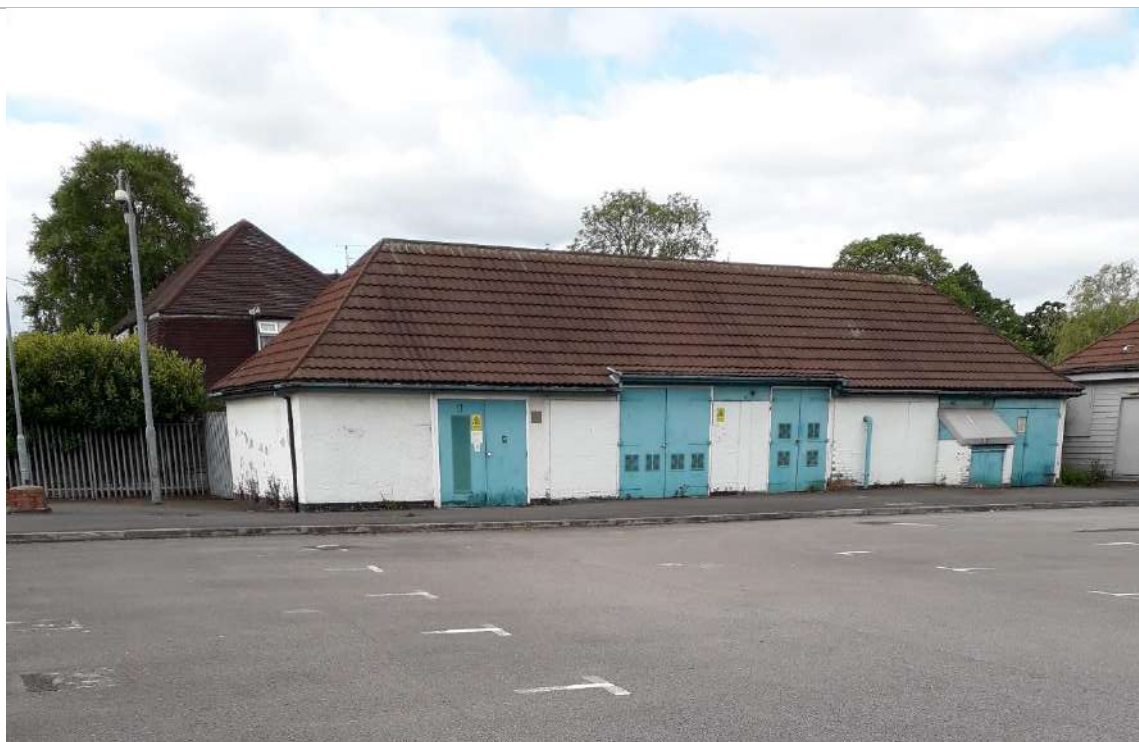
PLATE 2 ELECTRICITY SUBSTATION BUILDING ON WESTERN BOUNDARY OF SITE

| <b>PCB &gt; 1 mg/kg</b> | <p>The electrical substation situated in the west of the site may be a potential source of PCBs, however analysis was inhibited as the substation is currently active and therefore unsafe to investigate.</p> <p>It is recommended that further investigation of the area is completed during the remediation and enabling works.</p> |

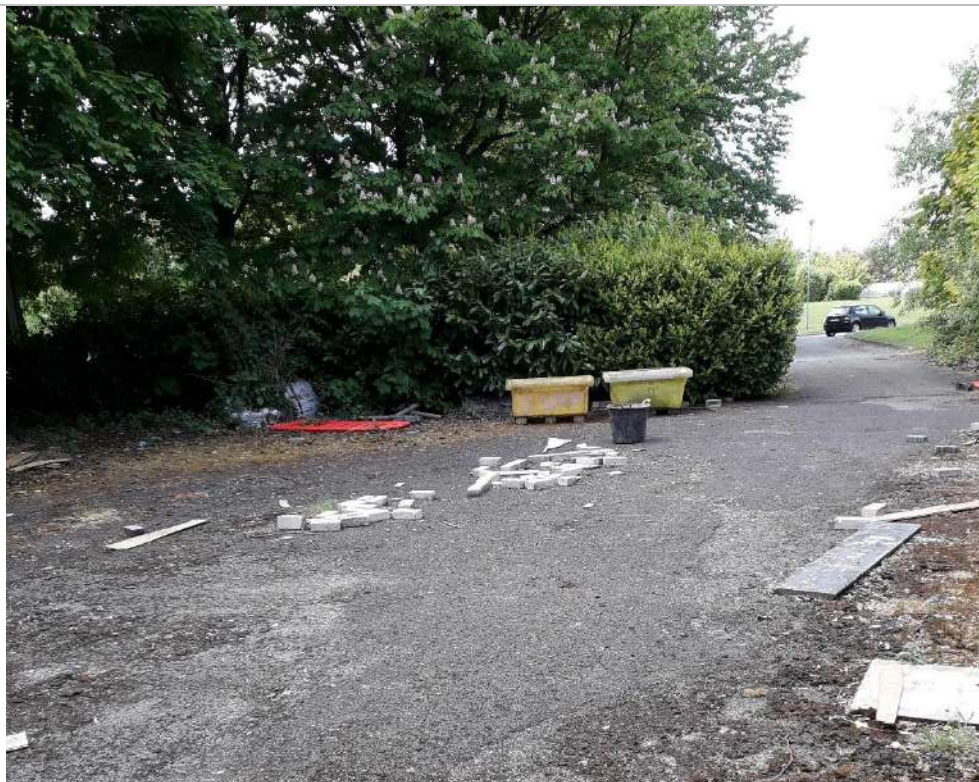
PLATE 8 FLYTIPPED WASTE AREA NORTH EAST OF FIELD (1)

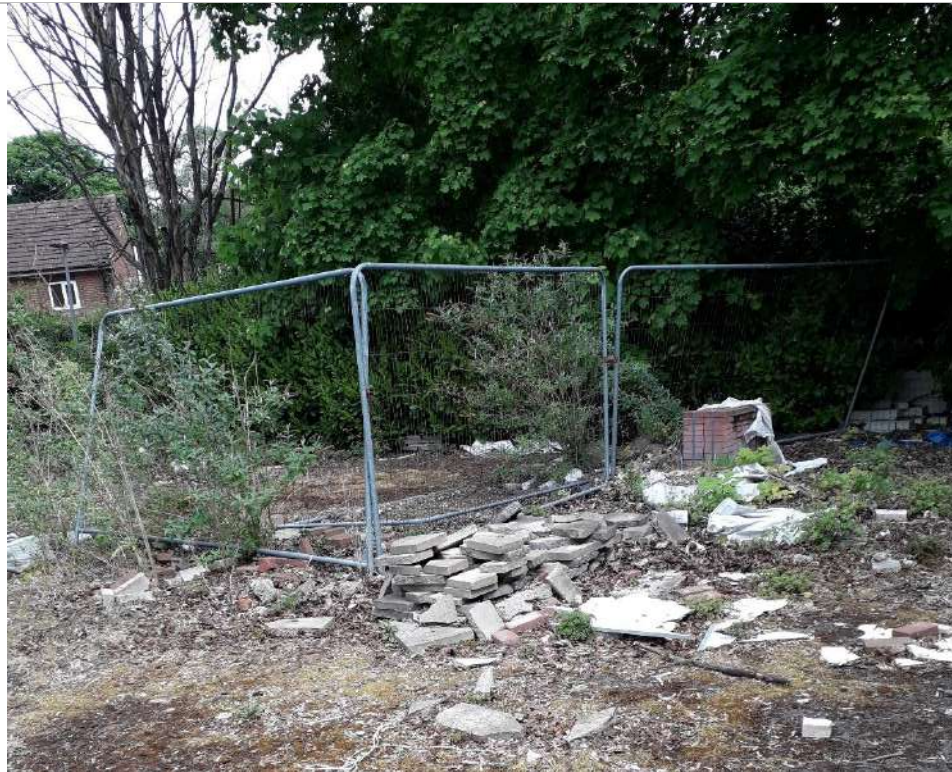
PLATE 9 FLYTIPPED WASTE AREA NORTH EAST OF FIELD (2)

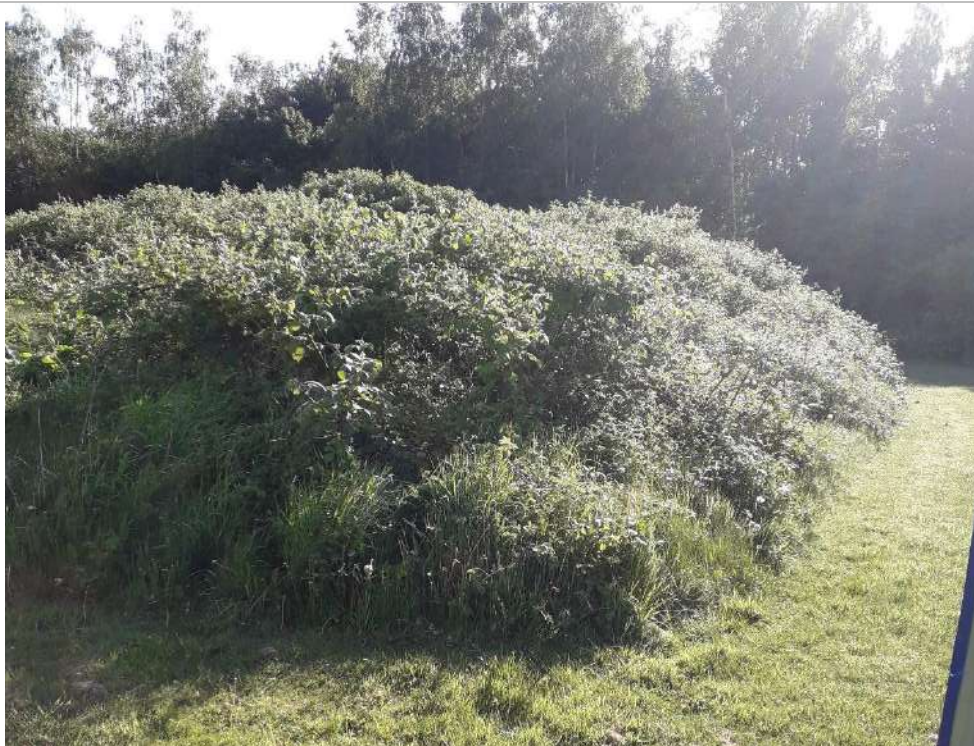
PLATE 10 AREA OF VEGETATION REQUIRING A NEST BIRD CHECK – NEAR WS125

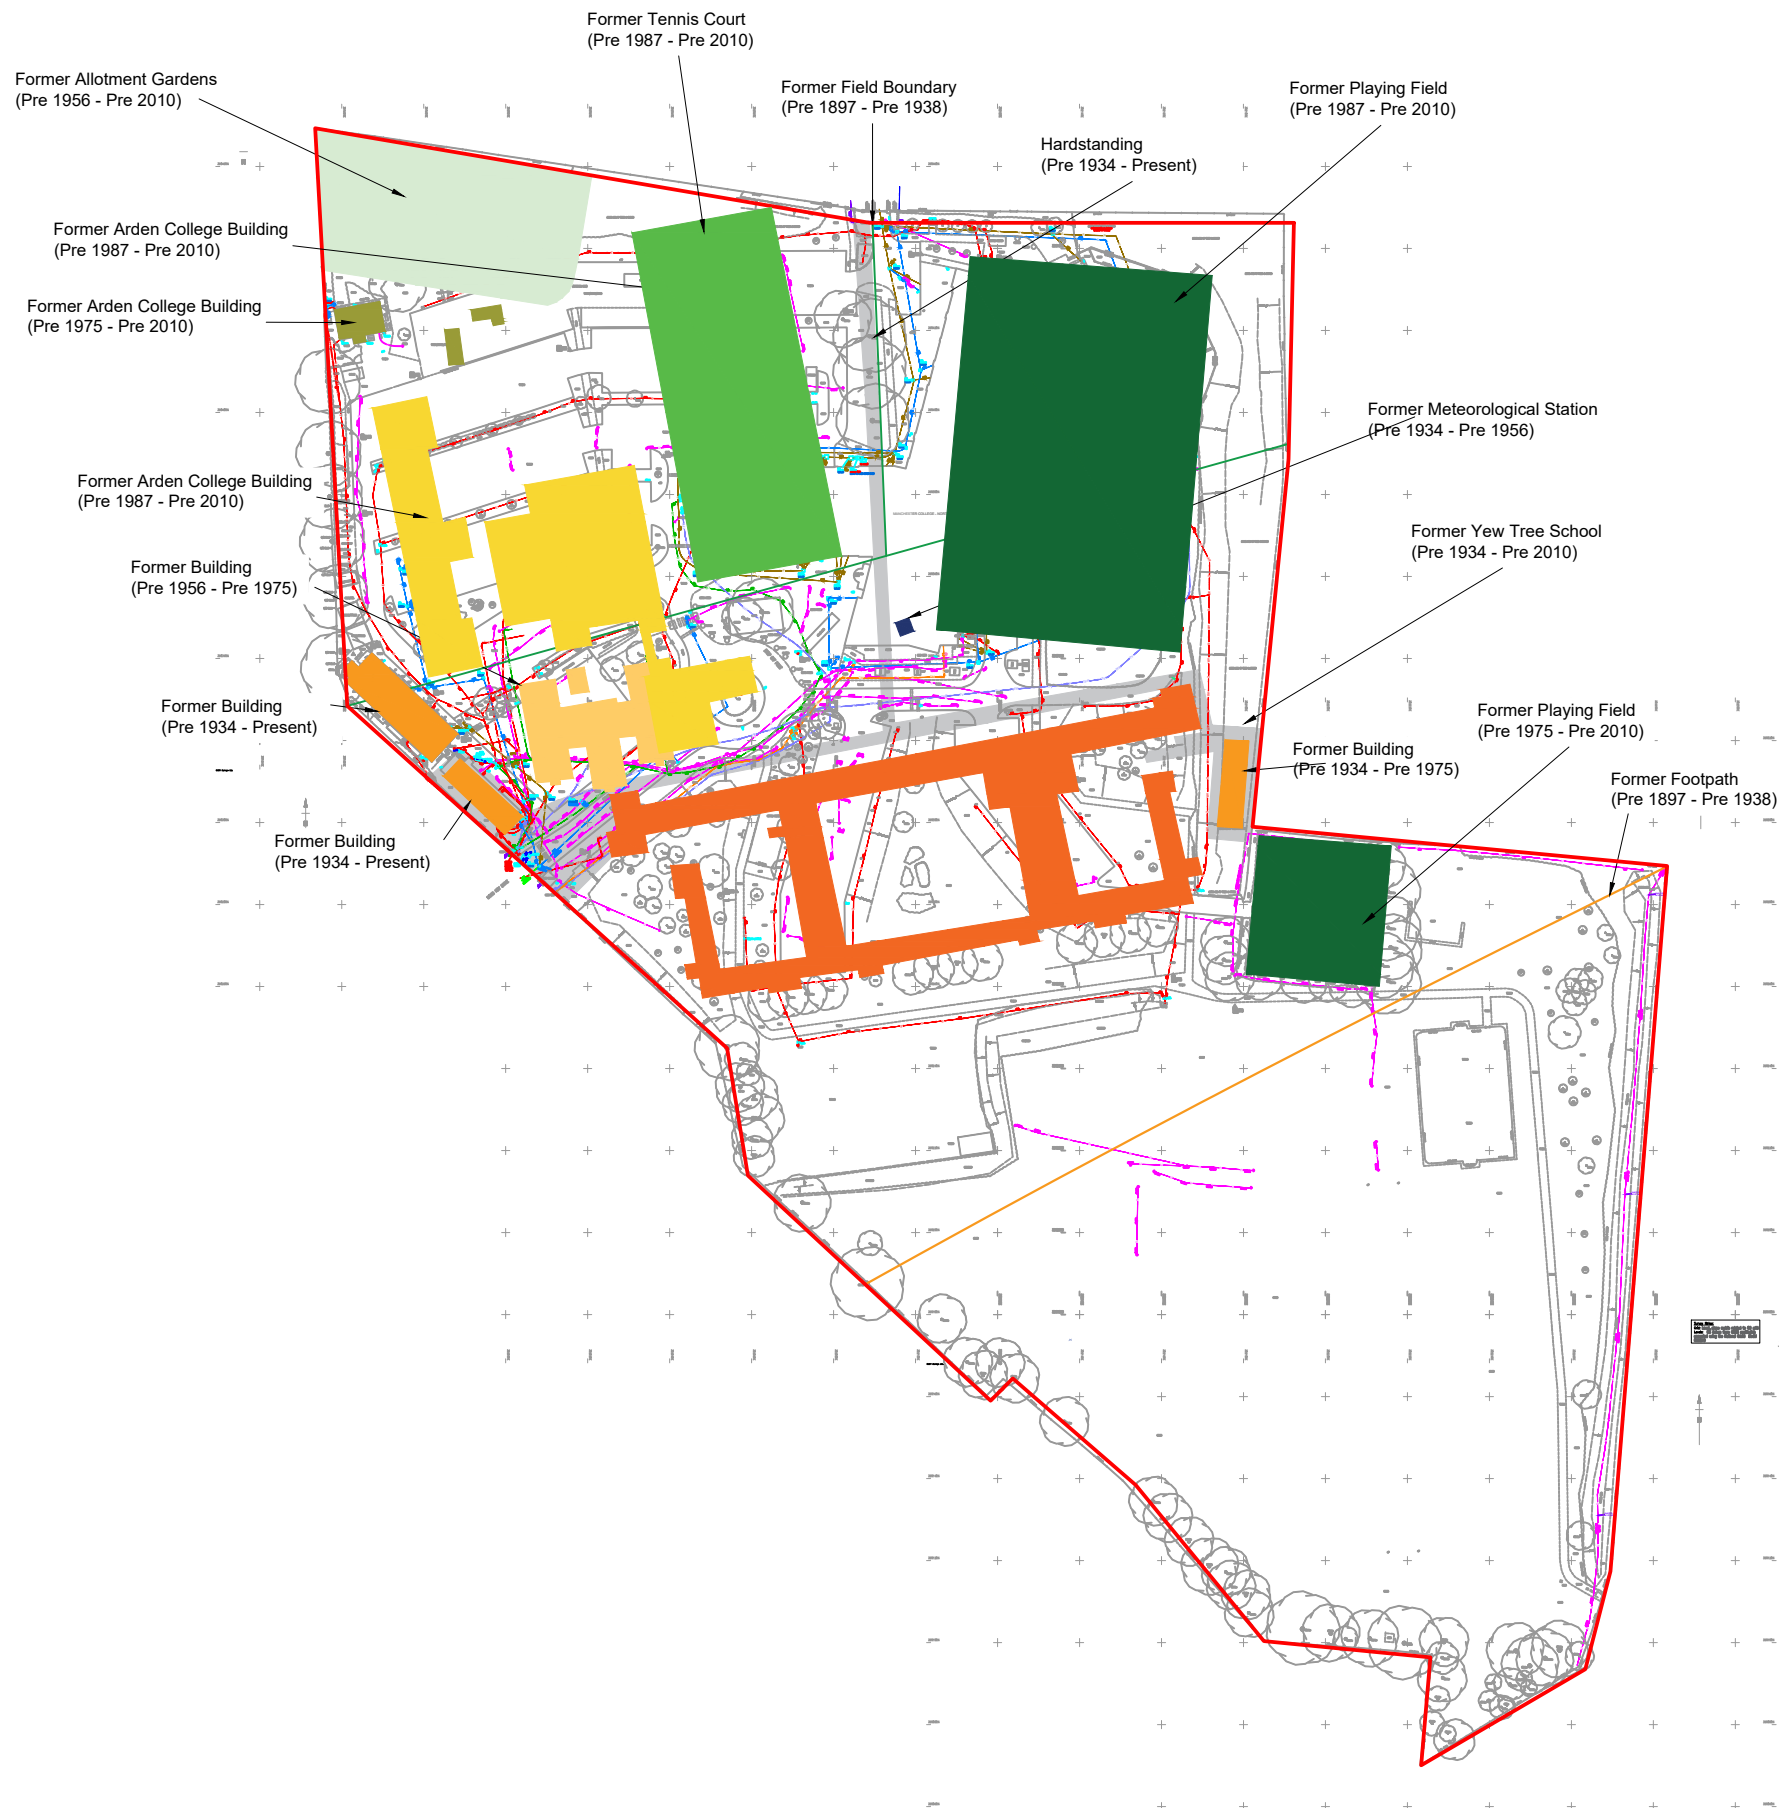
Historical Features

- Former Allotment Gardens (Pre 1956 - Pre 2010)
- Former Tennis Court (Pre 1987 - Pre 2010)
- Hardstanding (Pre 1934 - Present)
- Former Playing Field (Pre 1987 - Pre 2010)
- Former Arden College Buildings (Pre 1975 - Pre 2010)
- Former Arden College Building (Pre 1987 - Pre 2010)
- Buildings (Pre 1934 - Present)
- Former Yew Tree School (Pre 1934 - Pre 2010)
- Former Footpath (Pre 1897 - Pre 1938)
- Former Field Boundary (Pre 1897 - Pre 1938)
