# **North Manchester General Hospital**

**Bat Survey Report – Buildings 45b, 45c**

**2481604**

**JUNE 2021**

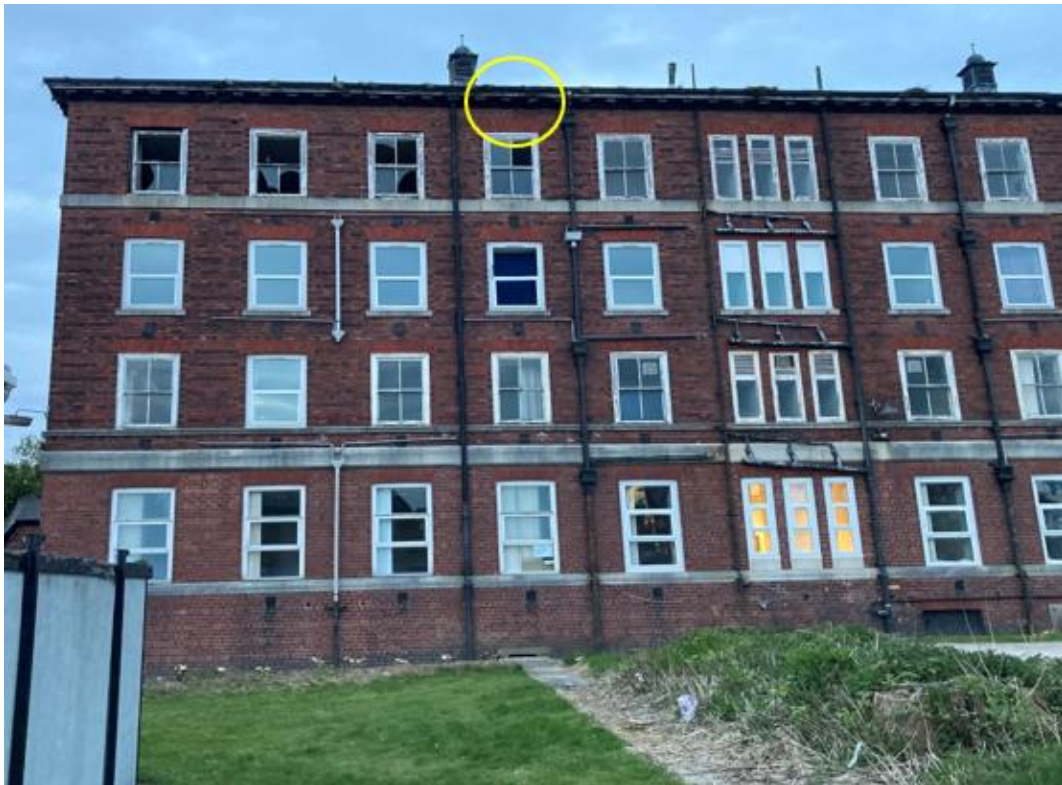
**Plate 1. Location on eaves where single common pipistrelle emerged at 20:41.**

- 3.1.1 A single common pipistrelle (*Pipistrellus pipistrellus*) emerged from the eaves (see *Plate 1*) on the south-west facing aspect of B45b at 20:41 (12 minutes after sunset), before flying south over the carpark and circling back to head north.

- Common pipistrelle **day roost** with single bat emerging from eaves of B45b on the first dusk survey. Bats were not observed using this feature during the remaining surveys and therefore the low usage of this access point is sufficient to conclude this feature is used for day roosting.
- Common pipistrelle **day roost** with access point within a ridge tile gap on B45c. Bats were not observed using this feature during the remaining surveys and for similar reasons as above it is concluded this feature is used for day roosting.

4.2.2 Mitigation under the BMCL will be finalised by the registered consultant. Broadly, this will comprise of:

- Provision of two bat boxes (one per roost) on suitable trees within the woodland to the east of B45b and B45c.
- A toolbox talk to all contractors to discuss working methods, risk of bats being present work areas, what to do if bats are found unexpectedly in and legal status of UK bat species;
- Working methodology will be agreed in collaboration between the BMCL holder and contractors on site.

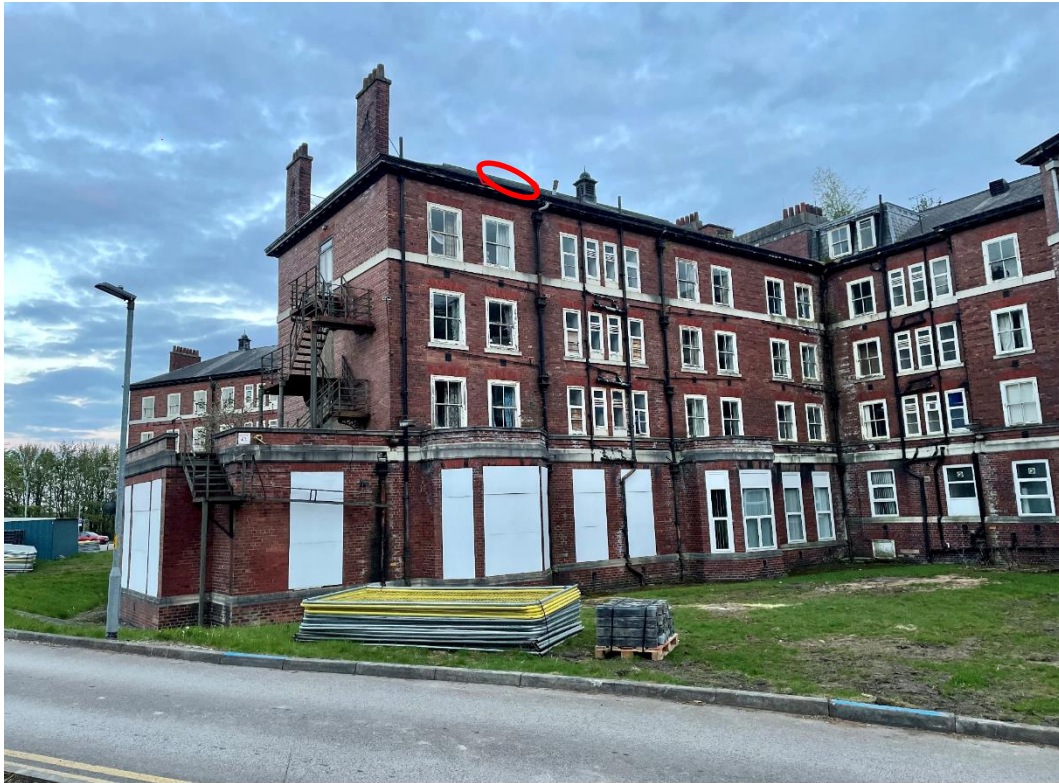
**Plate 2. Location on ridge line where single common pipistrelle emerged at 20:59.**

- 3.2.1 A single common pipistrelle emerged from a gap beneath ridge tiles towards the north-eastern end of the roof (see *Plate 2*) on B45c at 20:59 (26 minutes after sunset), before commuting south.

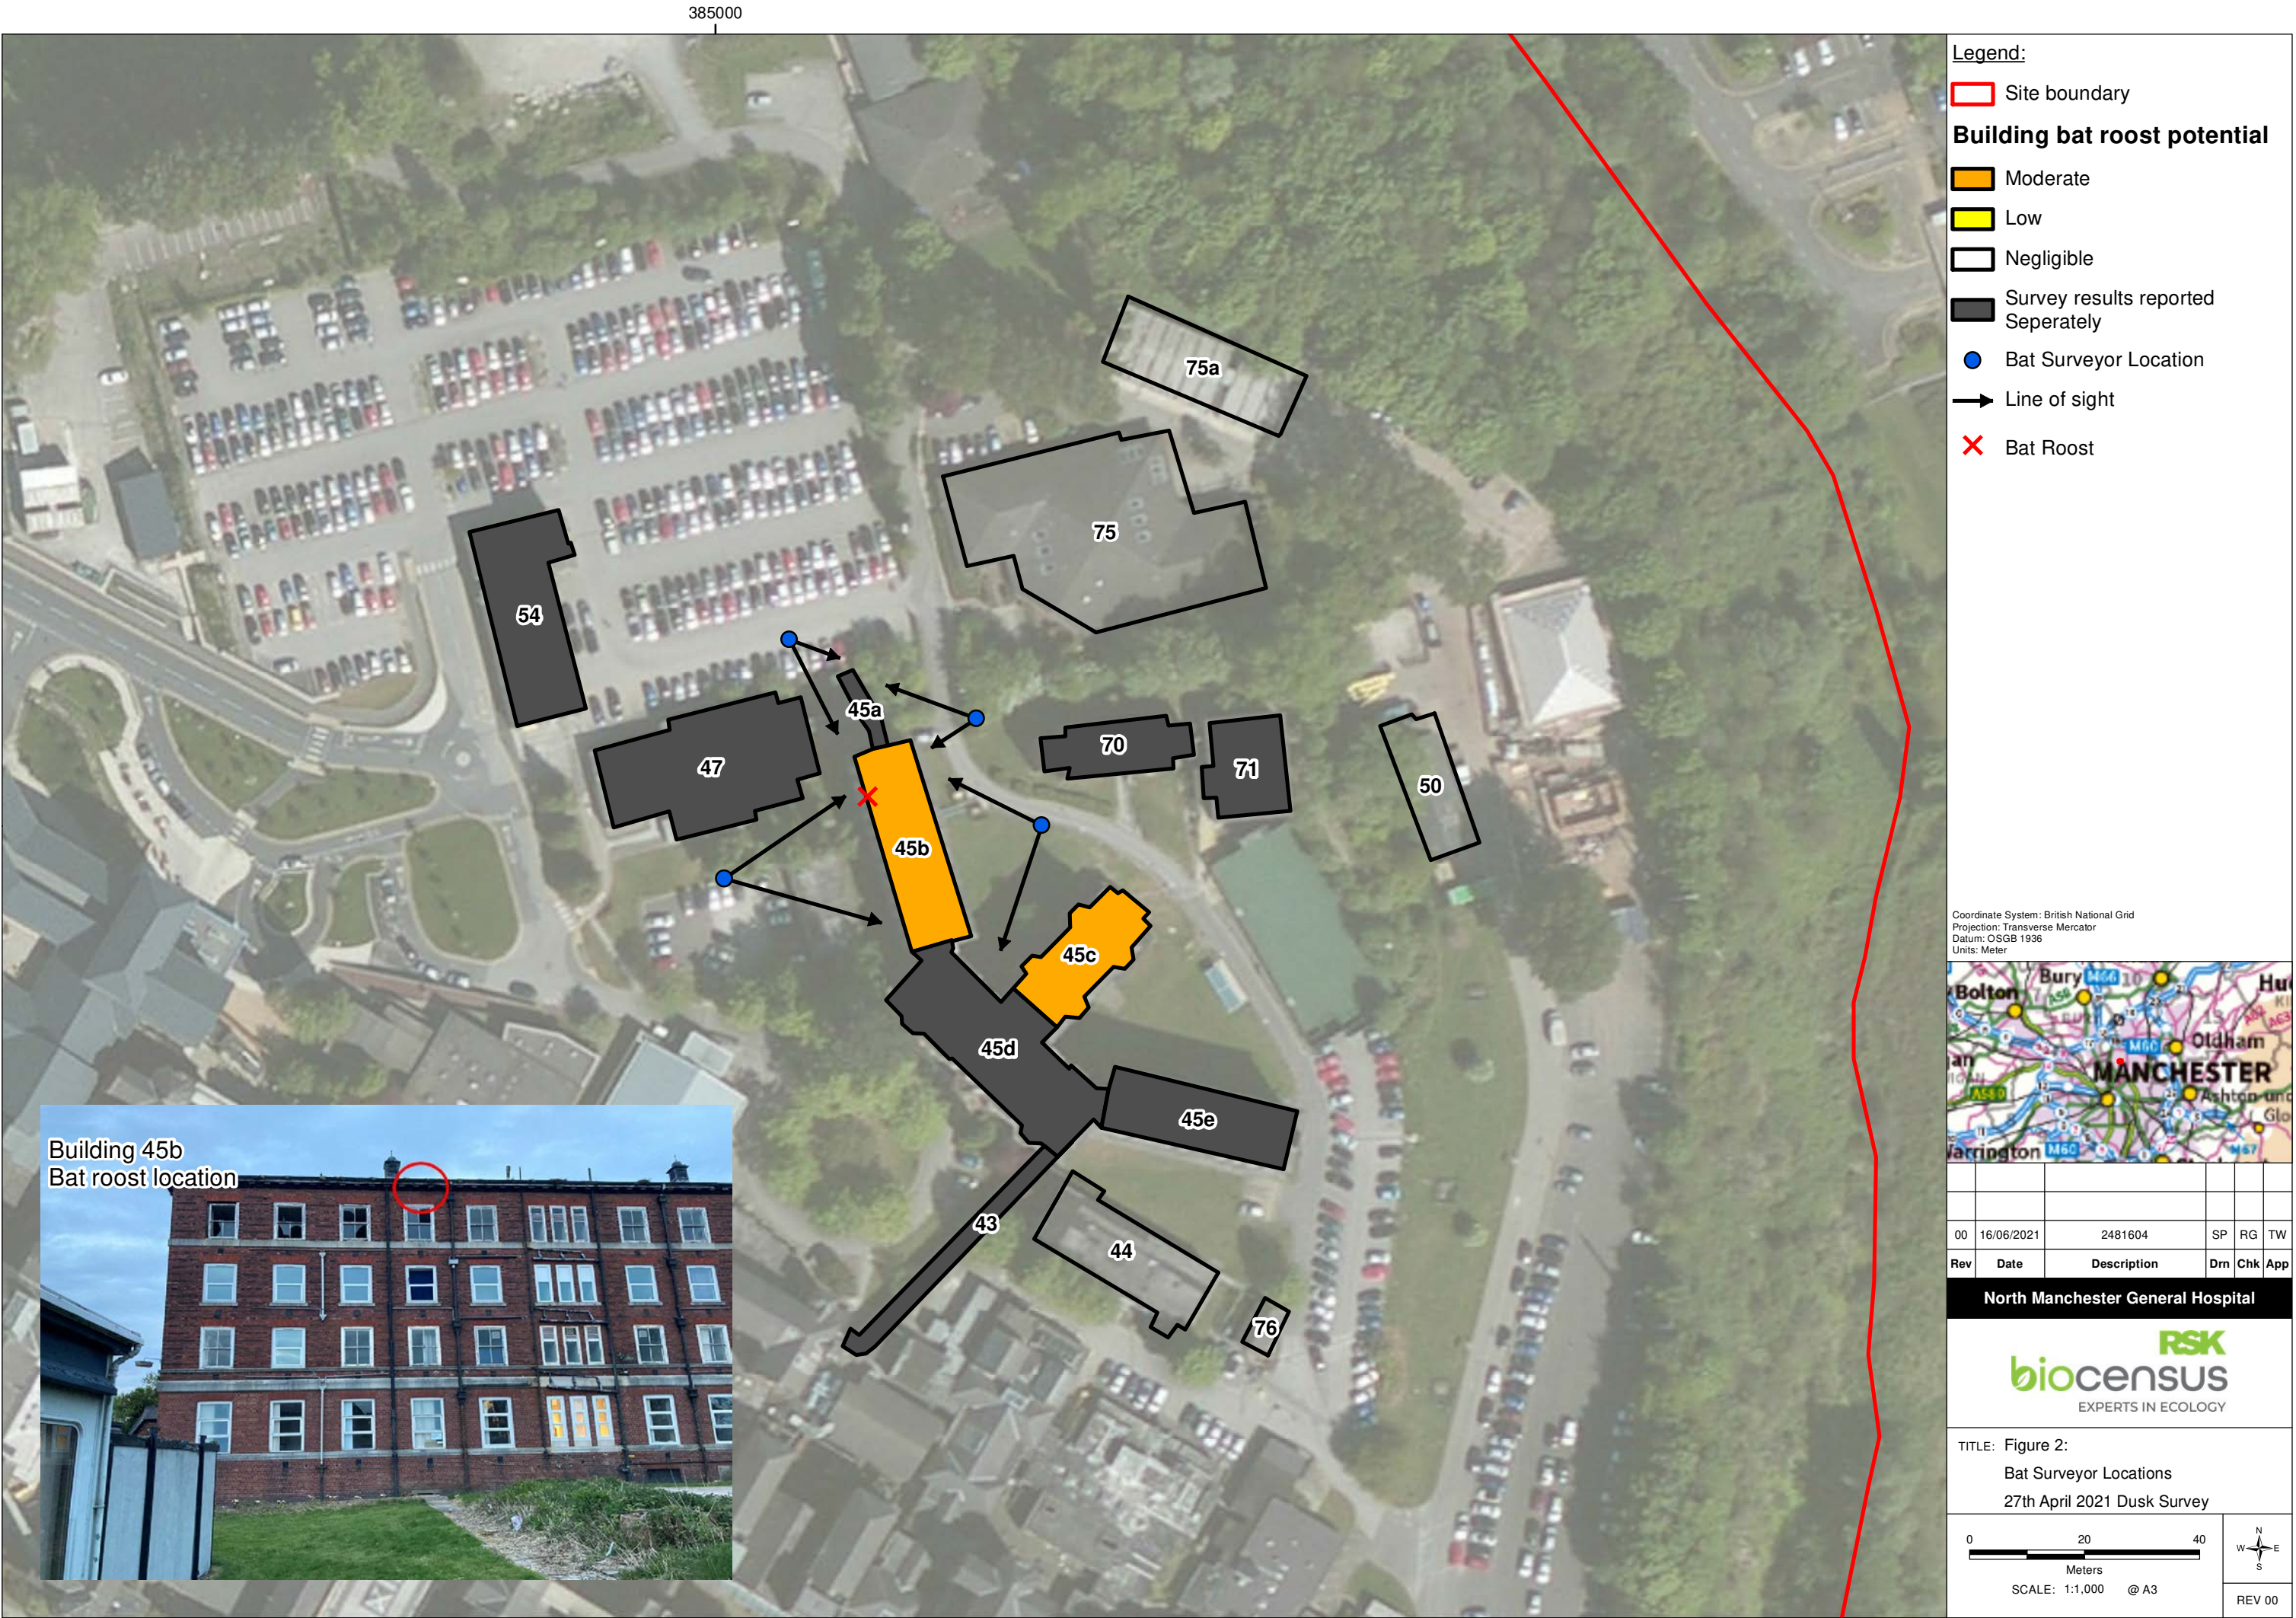
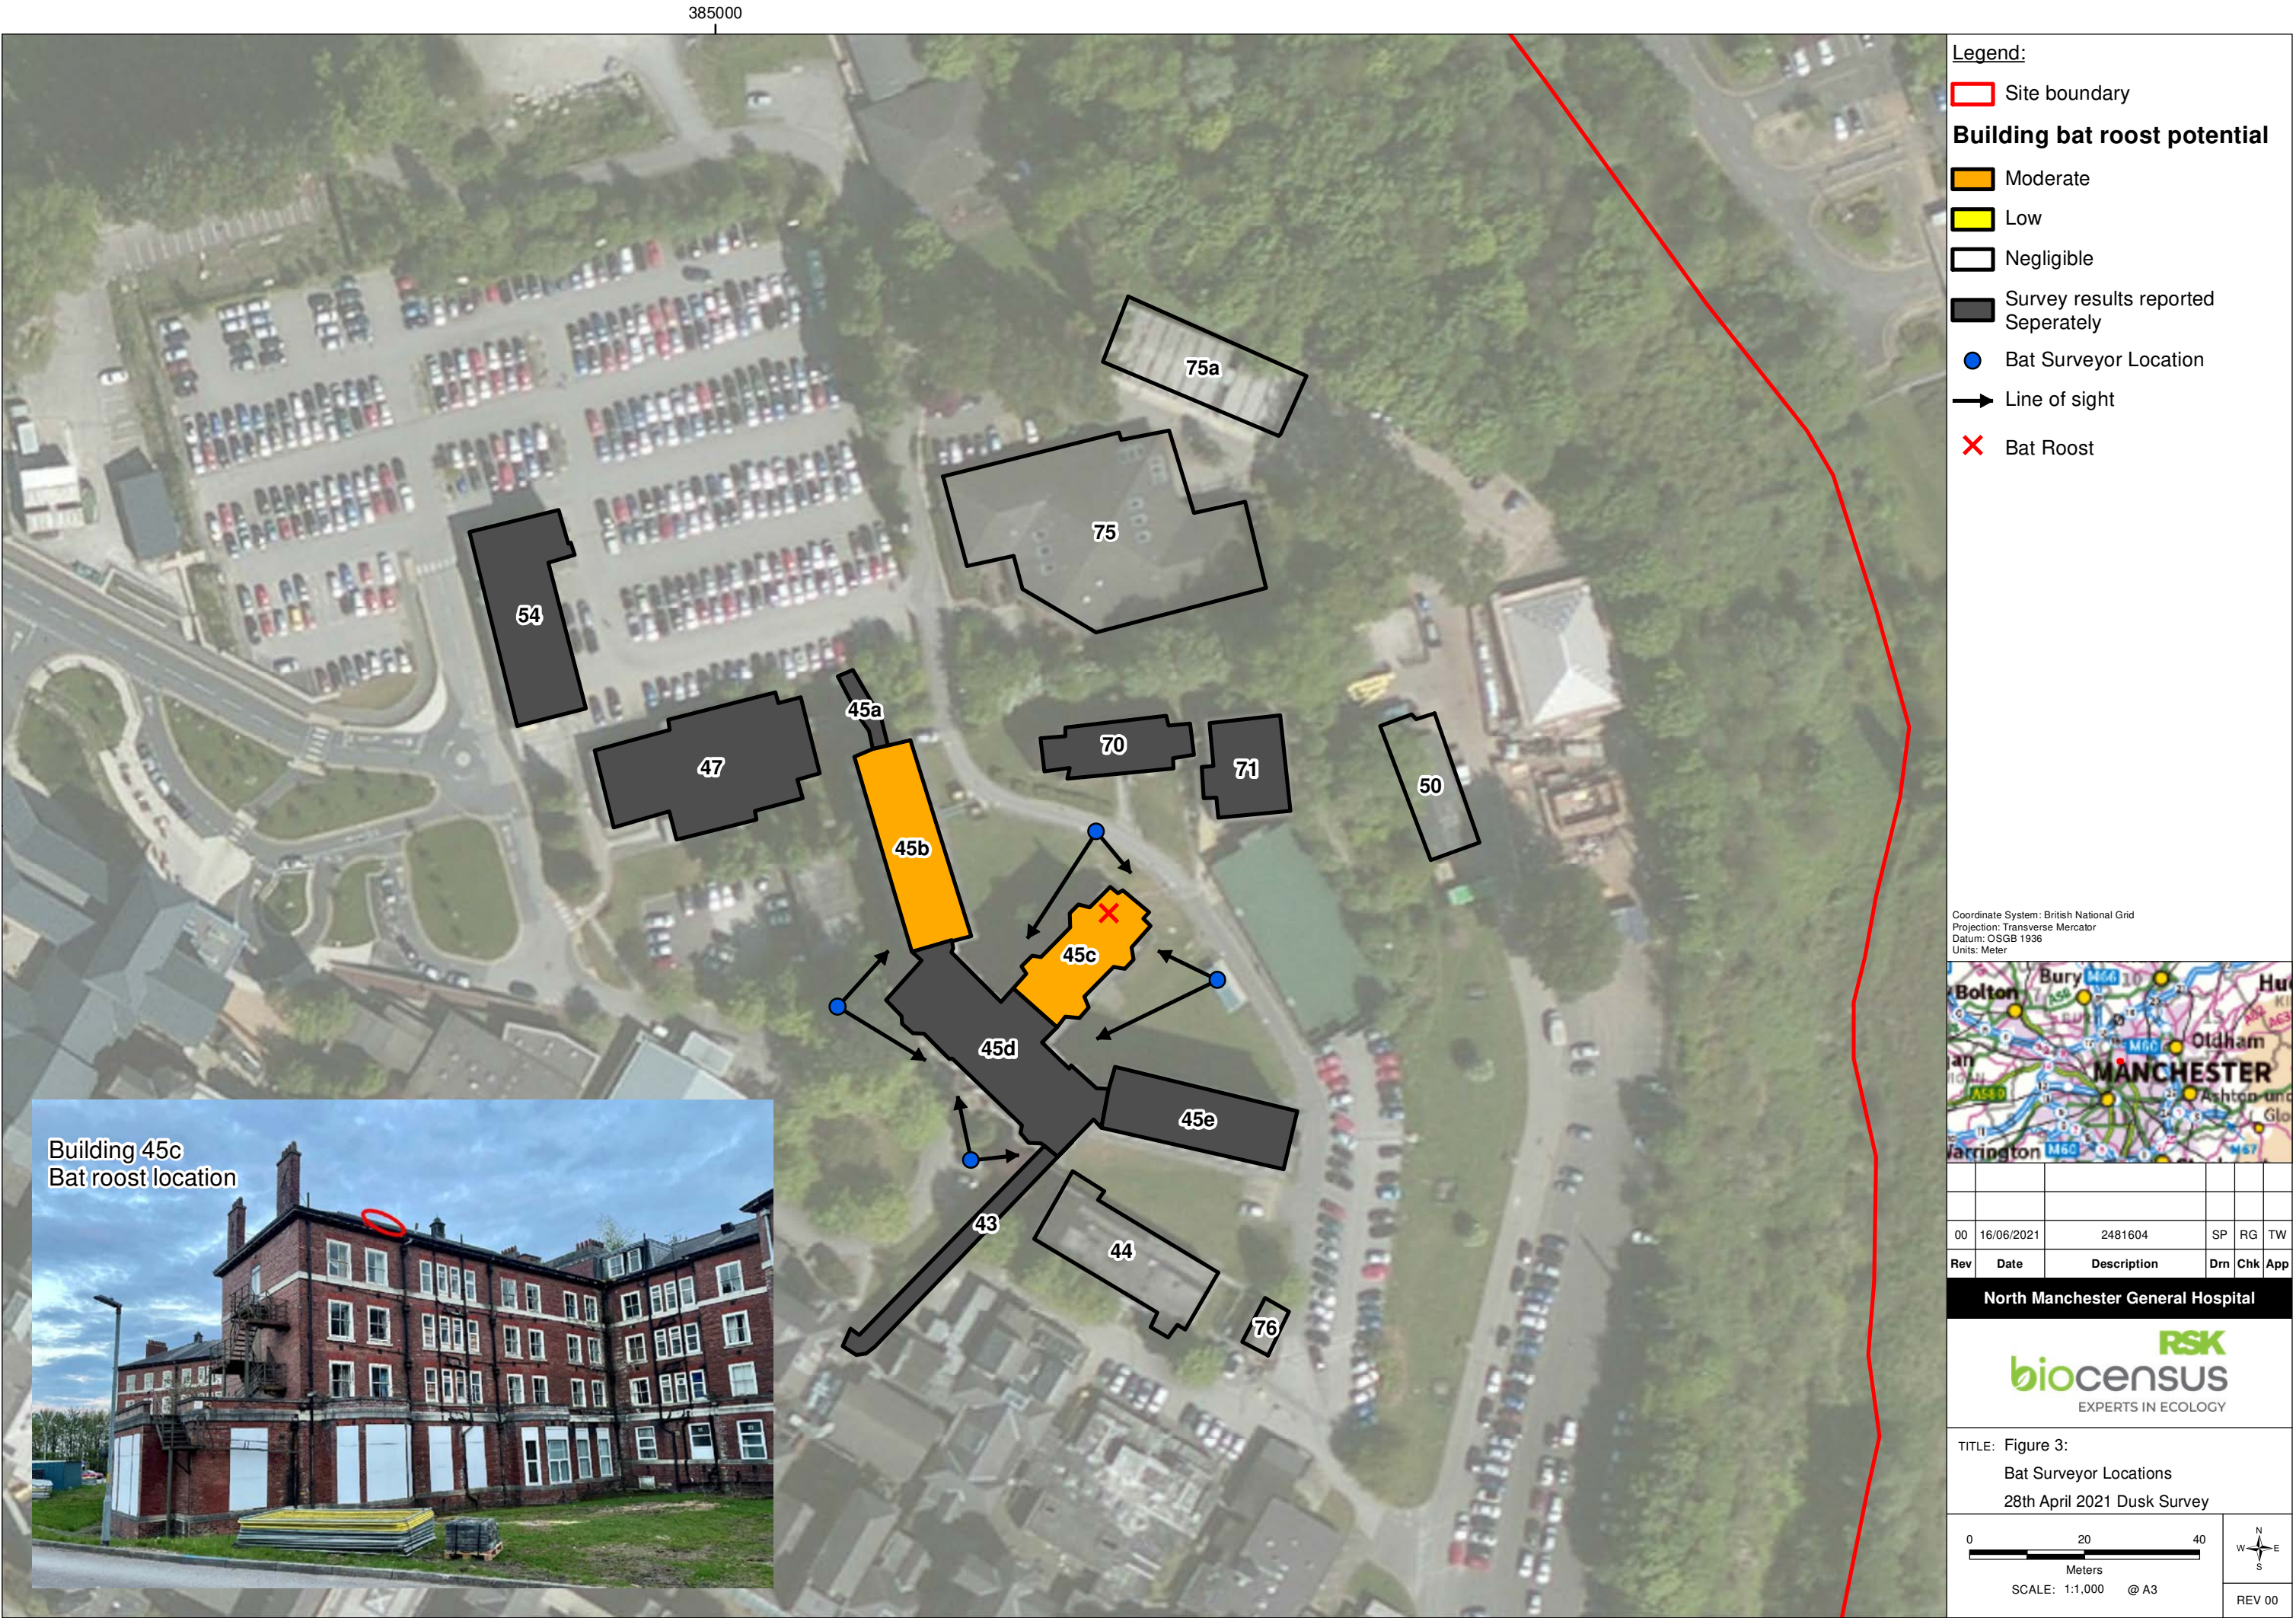
TITLE: Figure 3:  
Bat Surveyor Locations  
28th April 2021 Dusk Survey

- 2.2.1 Surveyors were positioned in locations with a good view of potential roost access points identified during the PRA (*Figure 2*). The dusk emergence surveys started 15 minutes before sunset and continued for 90 minutes after. The dawn re-entry surveys started 90 minutes before sunrise and continued for 15 minutes after.

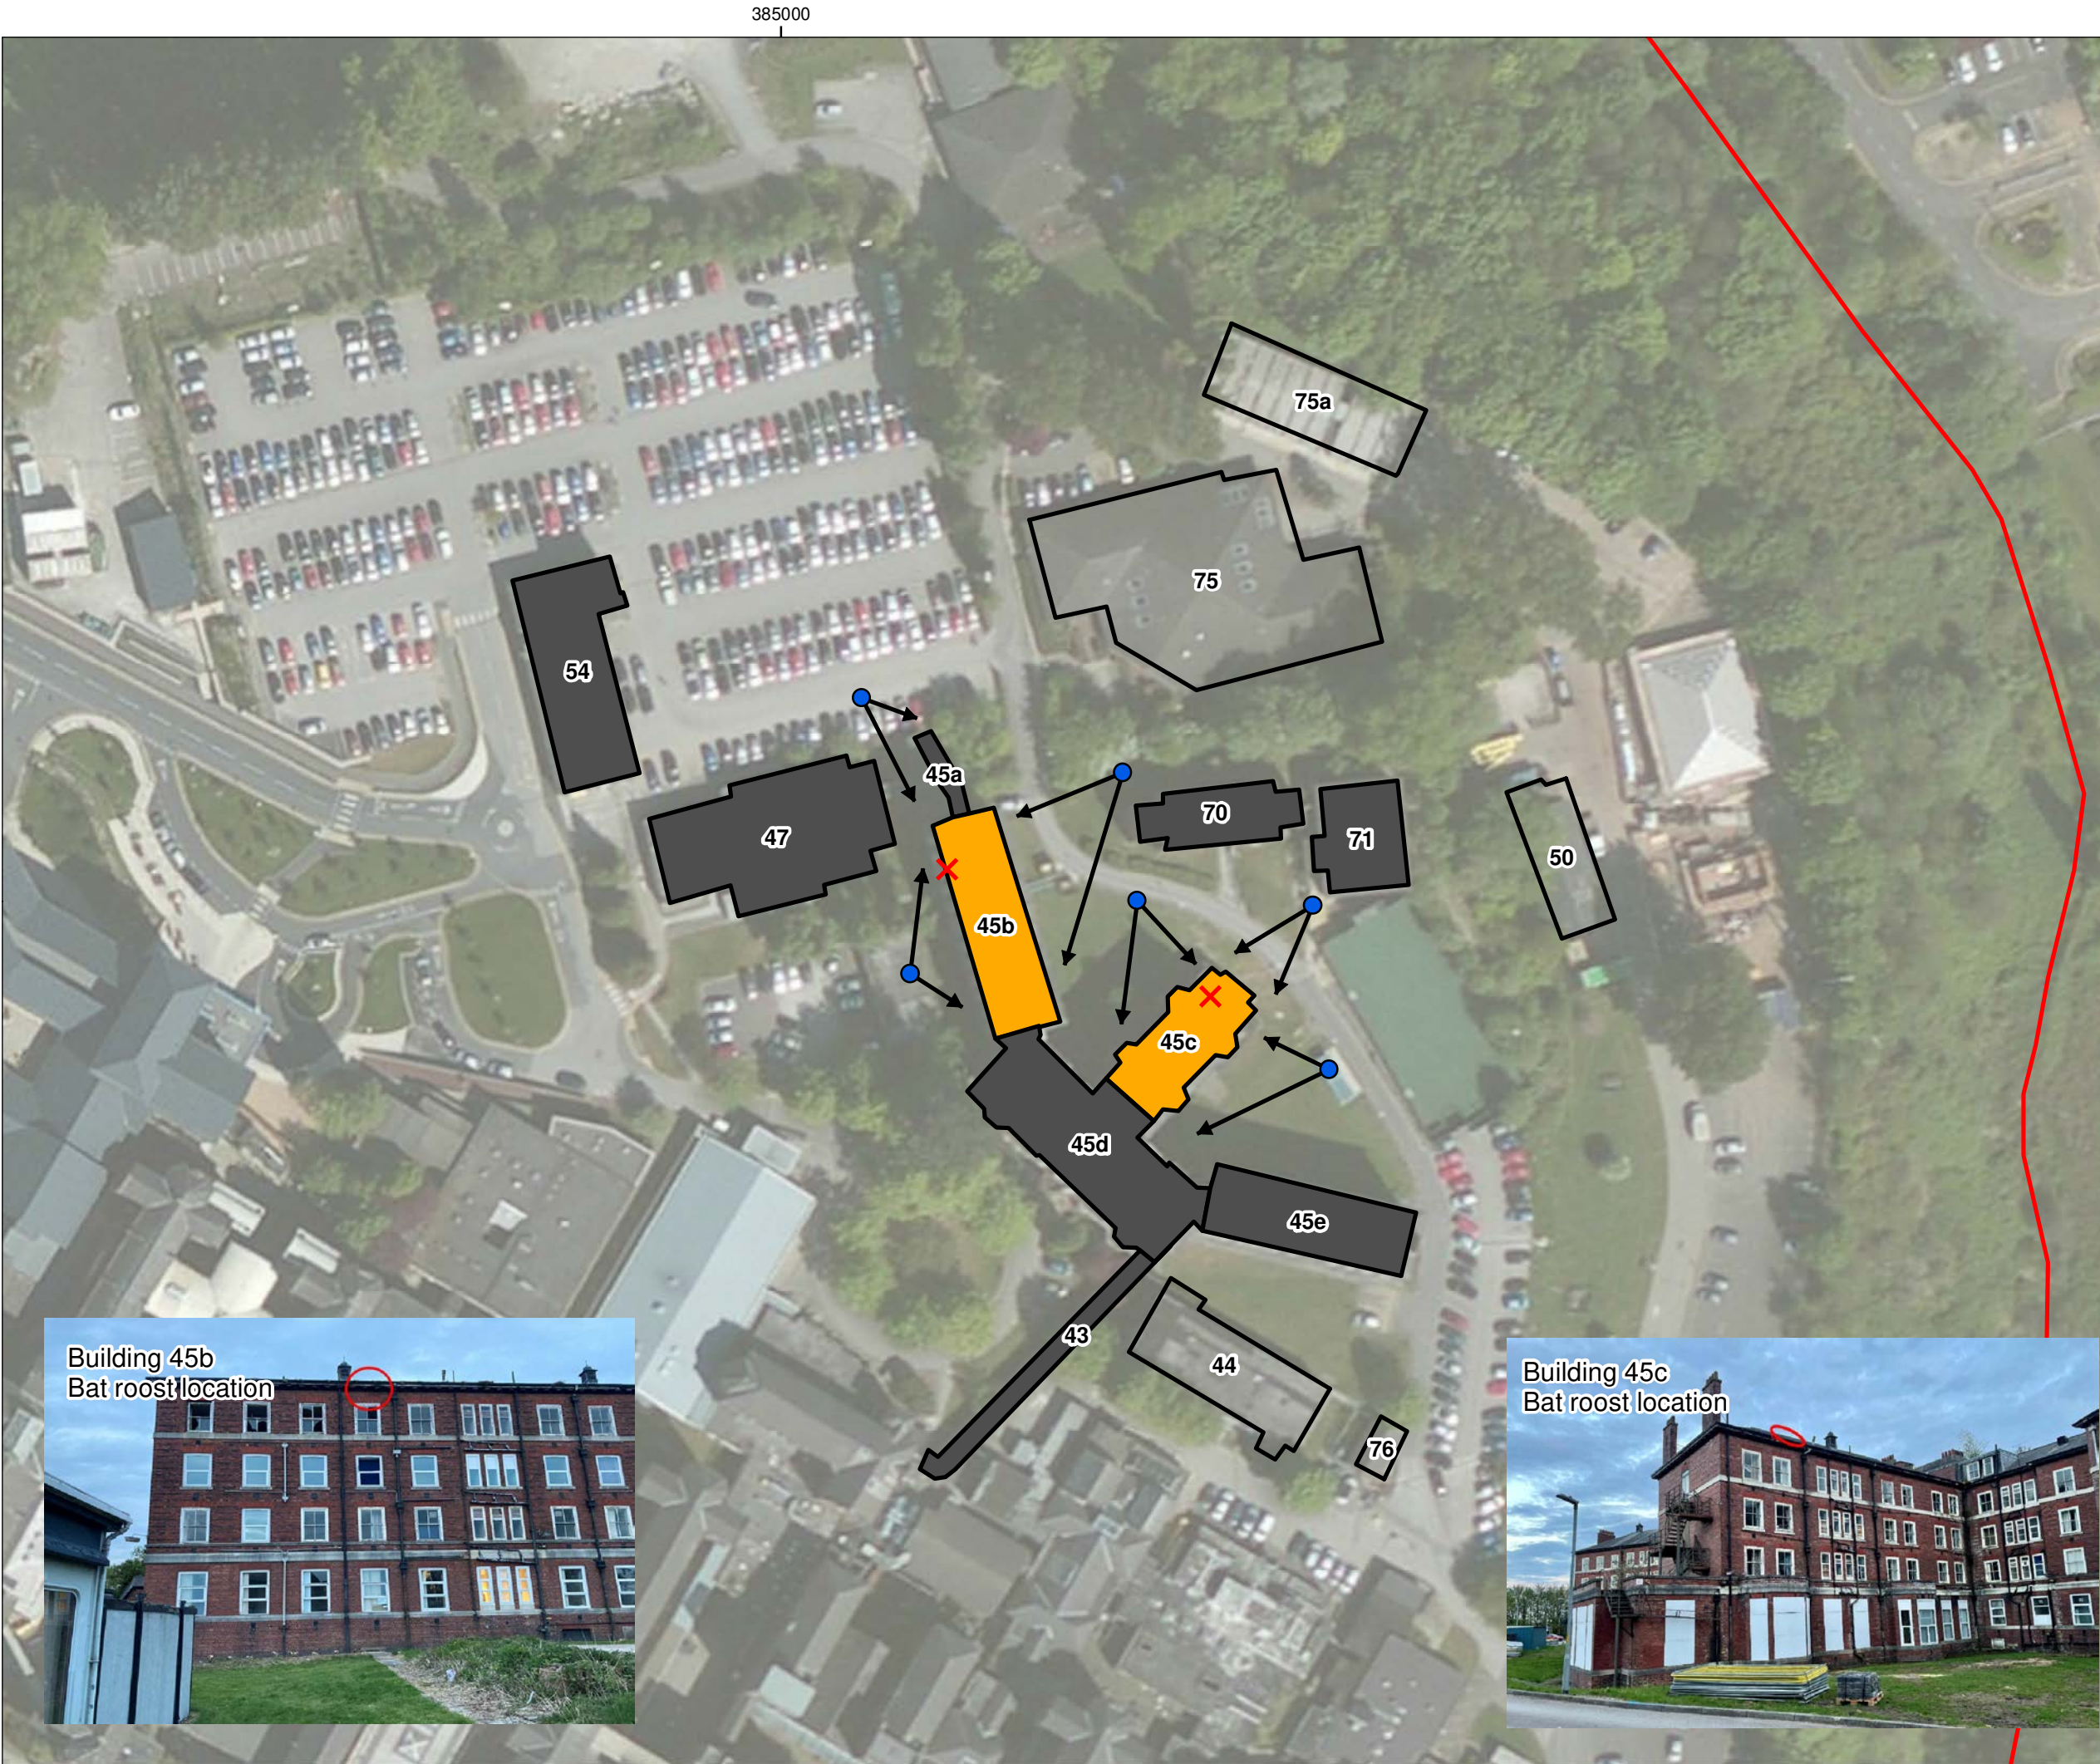
TITLE: Figure 6:  
Bat Surveyor Locations  
8th June 2021 Dusk Survey

- 3.5.1 No bats were recorded emerging from any aspect of B45b or B45c.
- 3.5.2 The first bat recorded was a common pipistrelle at 21:47 (13 minutes after sunset), heading west to east over B45b. Sporadic passes from common pipistrelle and soprano pipistrelle were recorded throughout the survey, with most activity foraging along the east of B45b and commuting south-north and north-south. A single noctule pass was recorded at 23:03 (1 hour, 29 minutes after sunset).
