**New Moston Primary School,  
Moston Lane East,  
New Moston,  
Manchester.  
M40 3QJ**

**Preliminary Survey & Assessment  
in Respect of  
Bat Species and Nesting Birds.**

**5<sup>th</sup> April 2022**

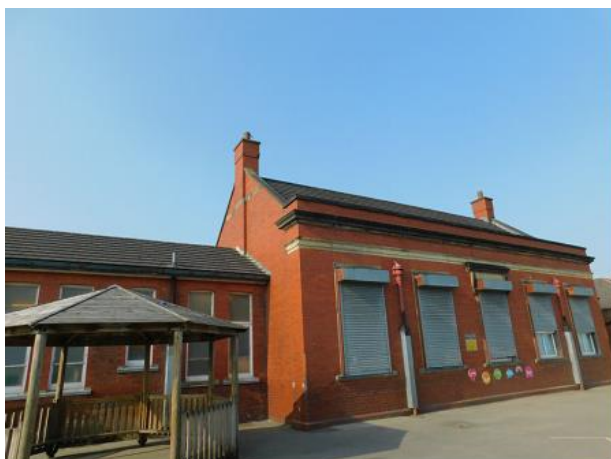
**PHOTO 1**  
**North-western Corner of Complex**

The targeted classroom building was a single storied, rectangular building, constructed from brick, with a pitched roof covered in concrete tiles, and underlined with timber panels mounted on timber beams and purlins, and with a well-insulated roof void. The building was regularly used, and was fully insulated and heated, well-maintained, and in an excellent condition, with a well-sealed roof, soffits and gable ends, and as such it was deemed to offer low bat roost suitability, (refer to **figs 3, 4 and 5**, and **photos 1 to 10**).

it was both unheated and insulated, and as it had mainly open sides, the gazebo was cold, draughty, and damp, and as such, was deemed unsuitable for breeding bats. Also, as frost and bad weather were likely to penetrate the interior of the gazebo in the colder months, it did not offer the optimum humidity, and constant low temperatures, that hibernating bats require. The resulting conclusion was that the gazebo was deemed to offer low potential bat roosting suitability. It was also felt that the copious amount of light, that would enter the interior of the gazebo through the open sides, which would further restrict the number of dark corners that bats require for roosting purposes, (refer to **figs 3, 4, and 5**, and **photos 1 to 4**).

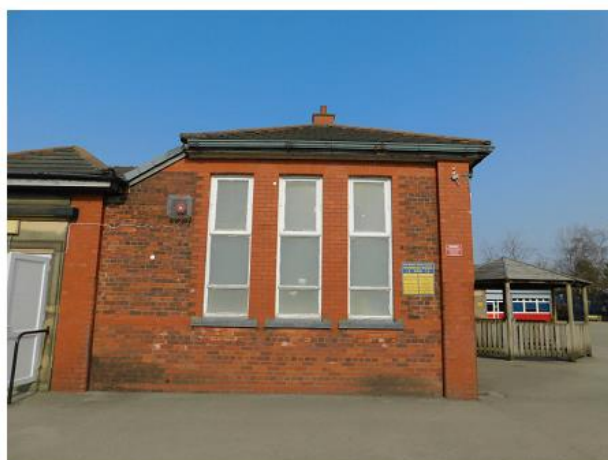
**PHOTO 4**  
**Eastern Elevation**

- There was hole between the building wall and the rear of the guttering at the south-eastern corner of the eastern elevation, but an inspection of this using an endoscope, and a physical inspection of the wall and floor beneath, found the gap to be heavily cobwebbed, and therefore offered low roost suitability, (refer to **figs 3, 4 and 5**, and **photo 4 and 5**).

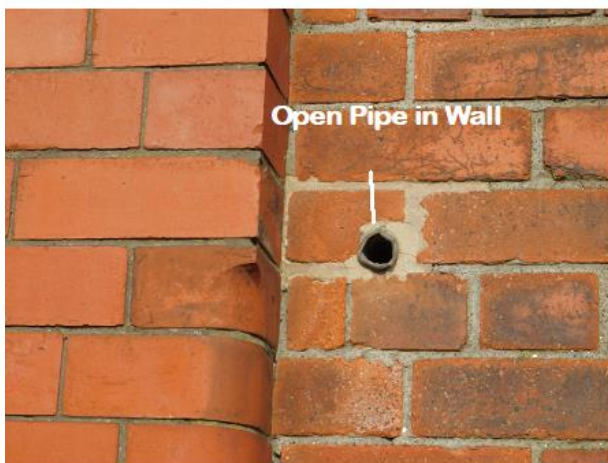
**PHOTO 9**  
**Part of Eastern Elevation**

- Located at the south-western corner of the eastern elevation, an open pipe emerged from a hole within the brickwork. However, an internal search of this using an endoscope found the pipe to be internally mashed, and therefore was deemed to have low roost suitability, (refer to **figs 3, 4 and 5**, and **photo 9**).

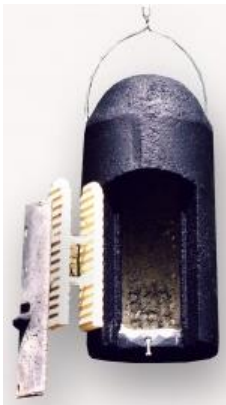
### Schwegler 1FD Bat Box

This Schwegler 1FD bat box has been developed specifically for smaller bats. The interior and the type and size of the entrance hole match the requirements of smaller species. It features a special layout inside the domed roof, an increased interior height, and two grooved internal wooden front panels with precise spacing between them.
