# LAND AT BLACKLEY MERE UPPER RESERVOIR MANCHESTER

## GEO-ENVIRONMENTAL INVESTIGATION

**Job Number:** LKC 19 1139

**Date:** May 2019

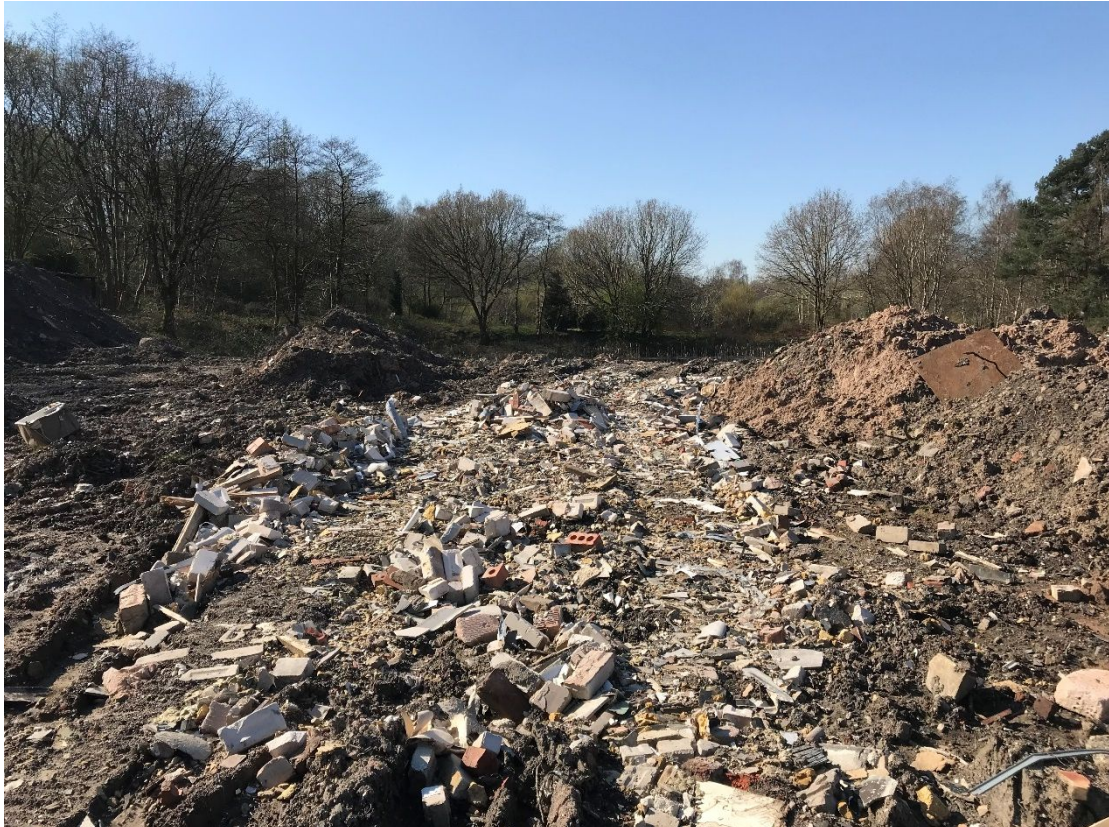
Allied to this an abundance of likely cement bound asbestos pieces was noted across the surface of the site. This is illustrated on Plate 6-1 below.

Plate 6-1: Visible pieces of likely ACMs on the site surface.

Given the size of the site, the presence on the surface of ACMs and the number of samples containing asbestos (12 out of 27 samples), then ACMs are considered to be present in significant quantities across the site.

Asbestos may affect future site users in soft landscaping and garden areas. The probability is considered to be likely. With a severe consequence the risk is assumed to be high and remediation is recommended.

Therefore, additional precautions shall be taken when working with the material. The presence of asbestos in the site soils presents a potential risk of generation of airborne fibres if this material is disturbed, such as for excavations to construct new foundations.

This risk can be managed by careful procedures and site monitoring to reduce the risk of airborne fibres, and it is recommended that an appropriate 'Asbestos Management Strategy' is developed and adopted for all intrusive ground works which disturb the made ground in the area of concern. This should be carried out in line with CIRIA C733<sup>44</sup>.
