# Oxygen Towers Planning Condition 12

## **1.0 Oxygen Towers Planning Permission 122258/JO/2018**

### **Condition 12 (Suds 2)**

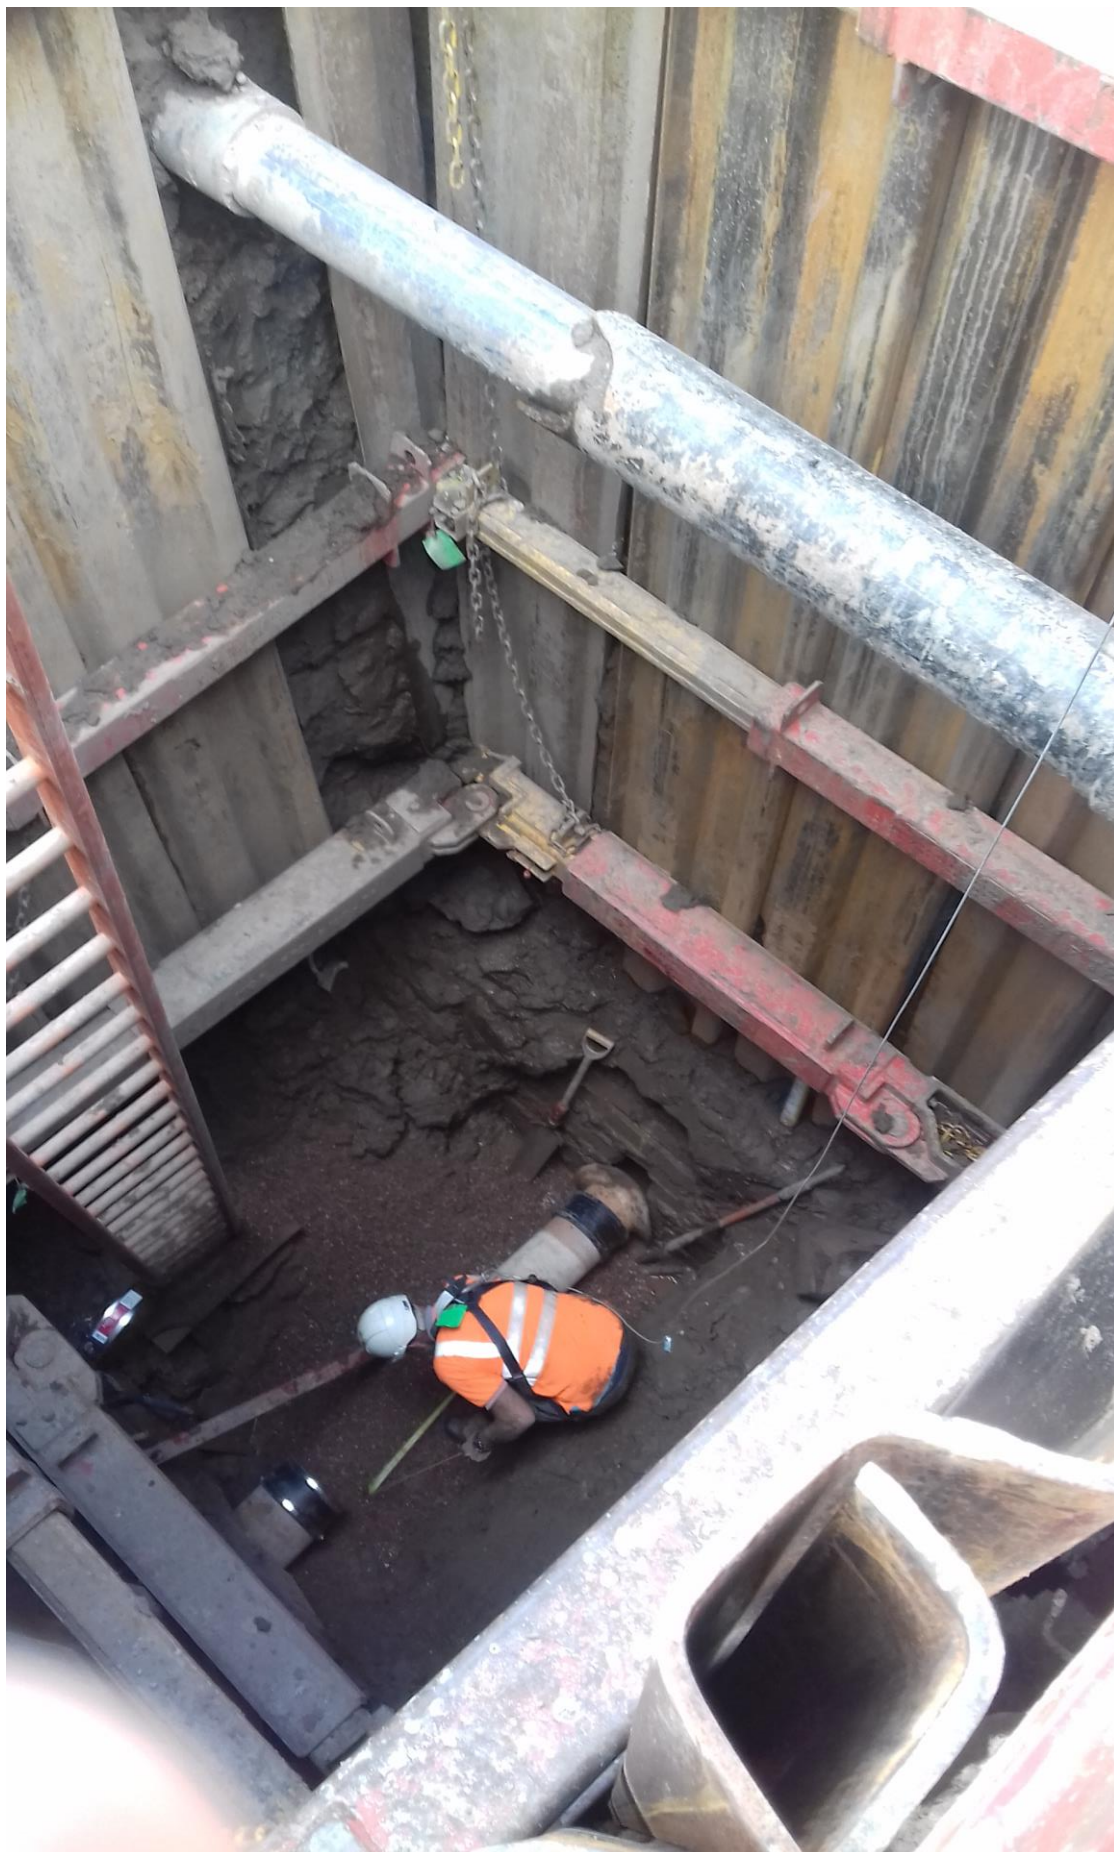
**Sept 2019**

Due to the depth of the existing sewer in Store St (circa 7m ) & the quantity of other services in the footpath on Store St it was decided to thrust bore the connection between site and the existing sewer prior to the main works commencing .

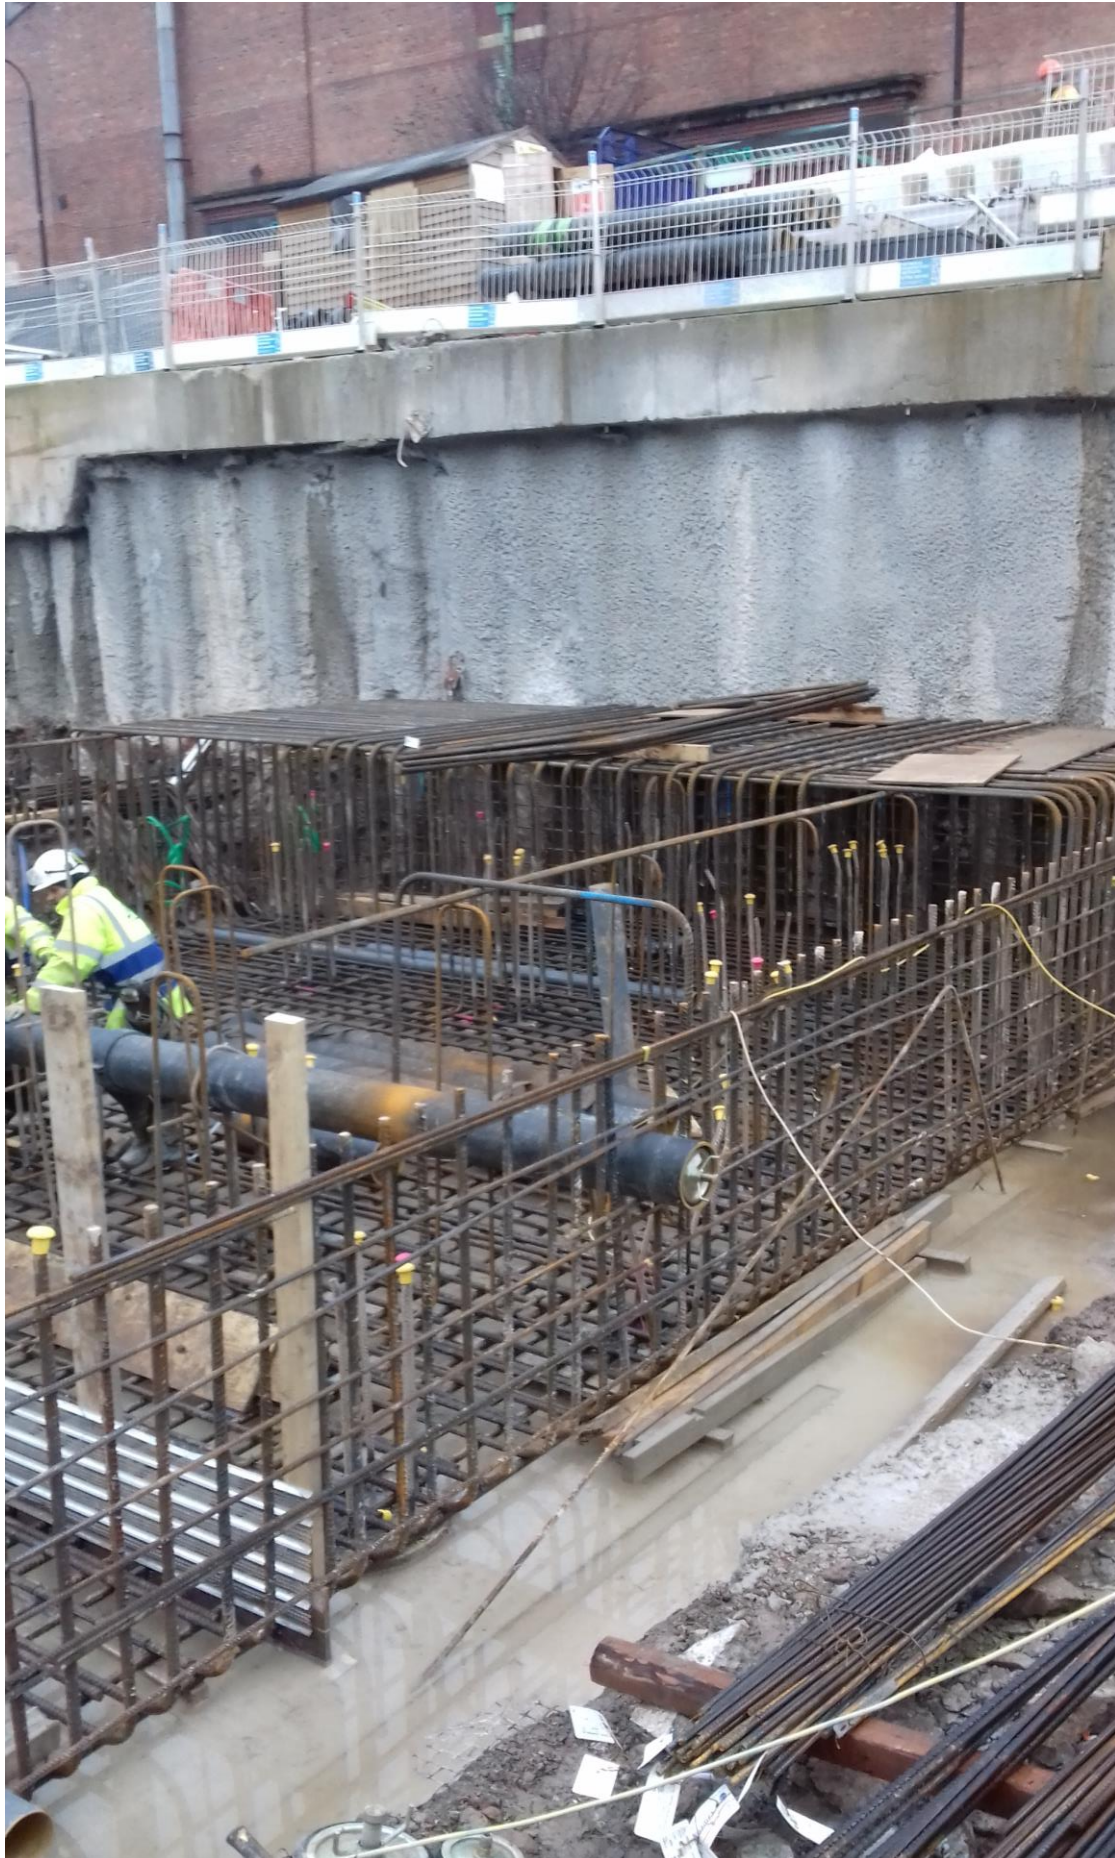
**January 2019**

Photograph below indicates a typical example where drainage pipework had to be threaded through pile cap bases.

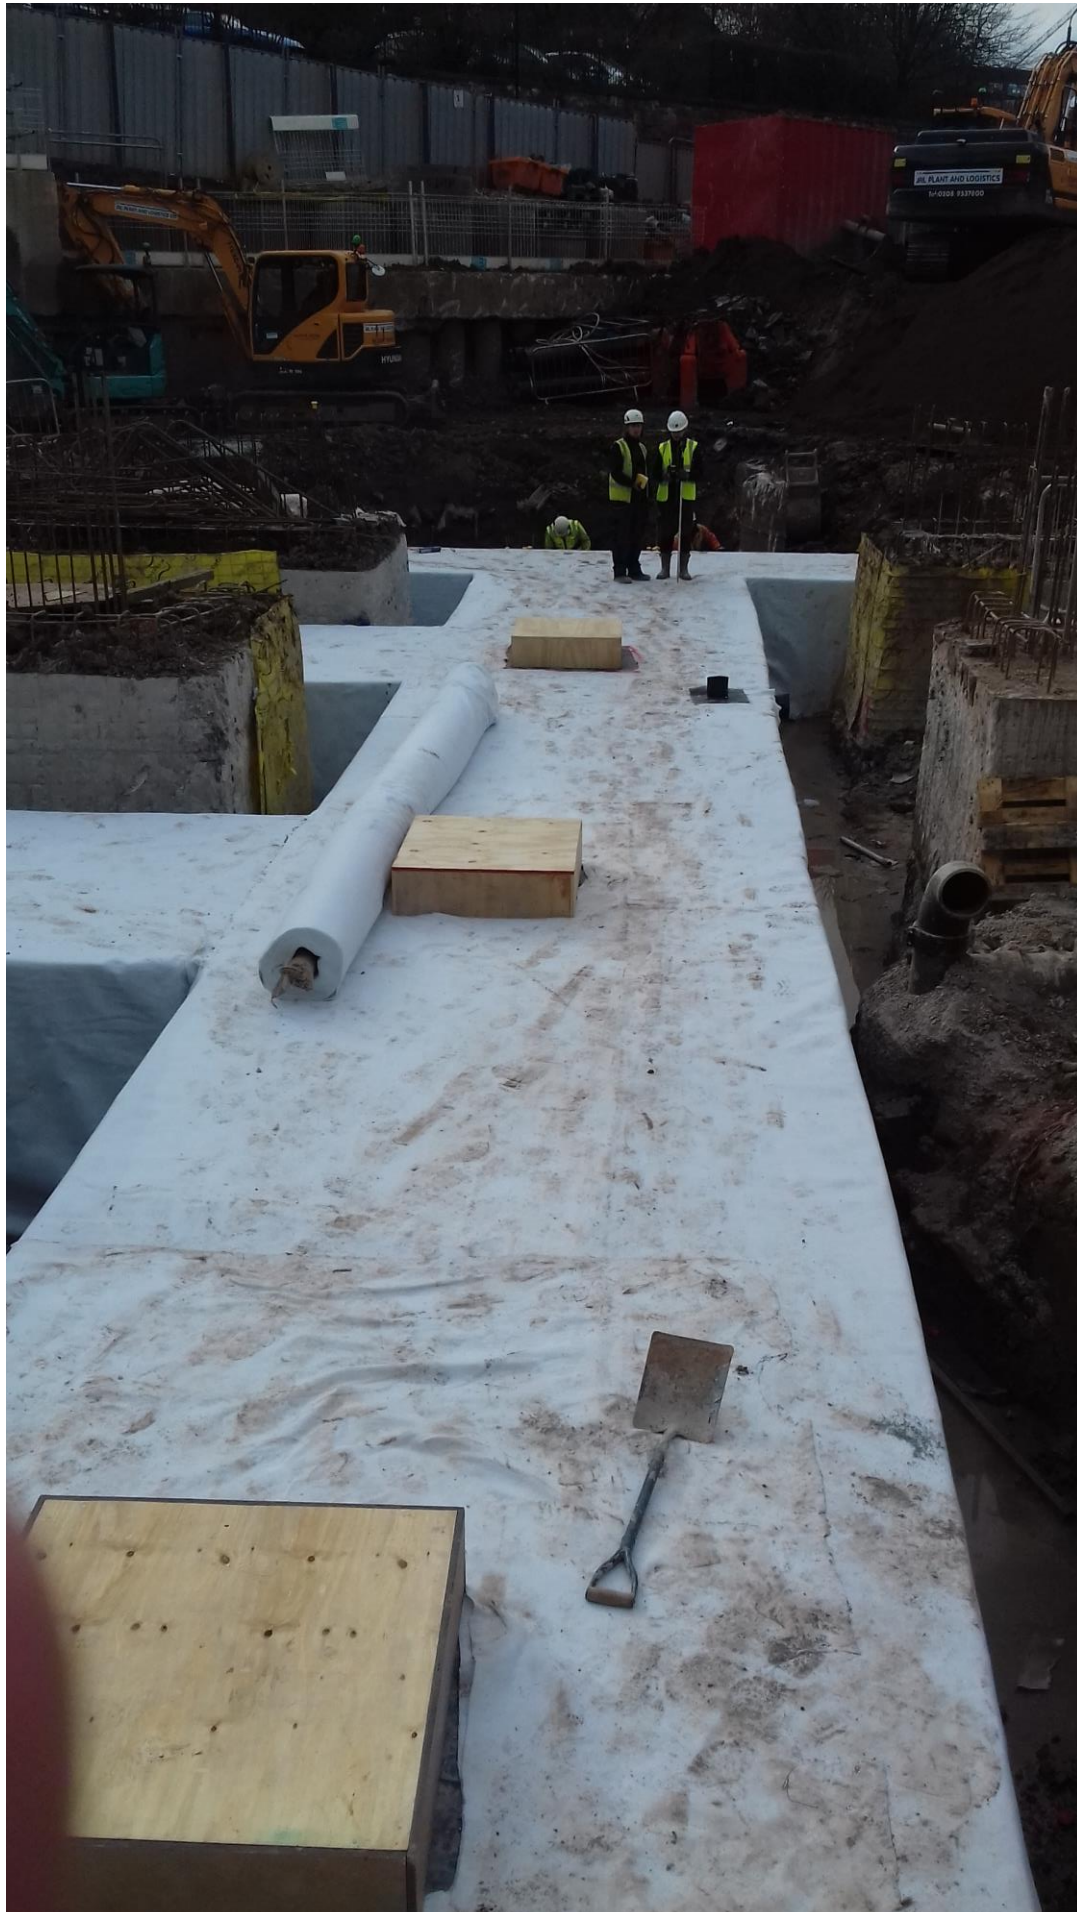
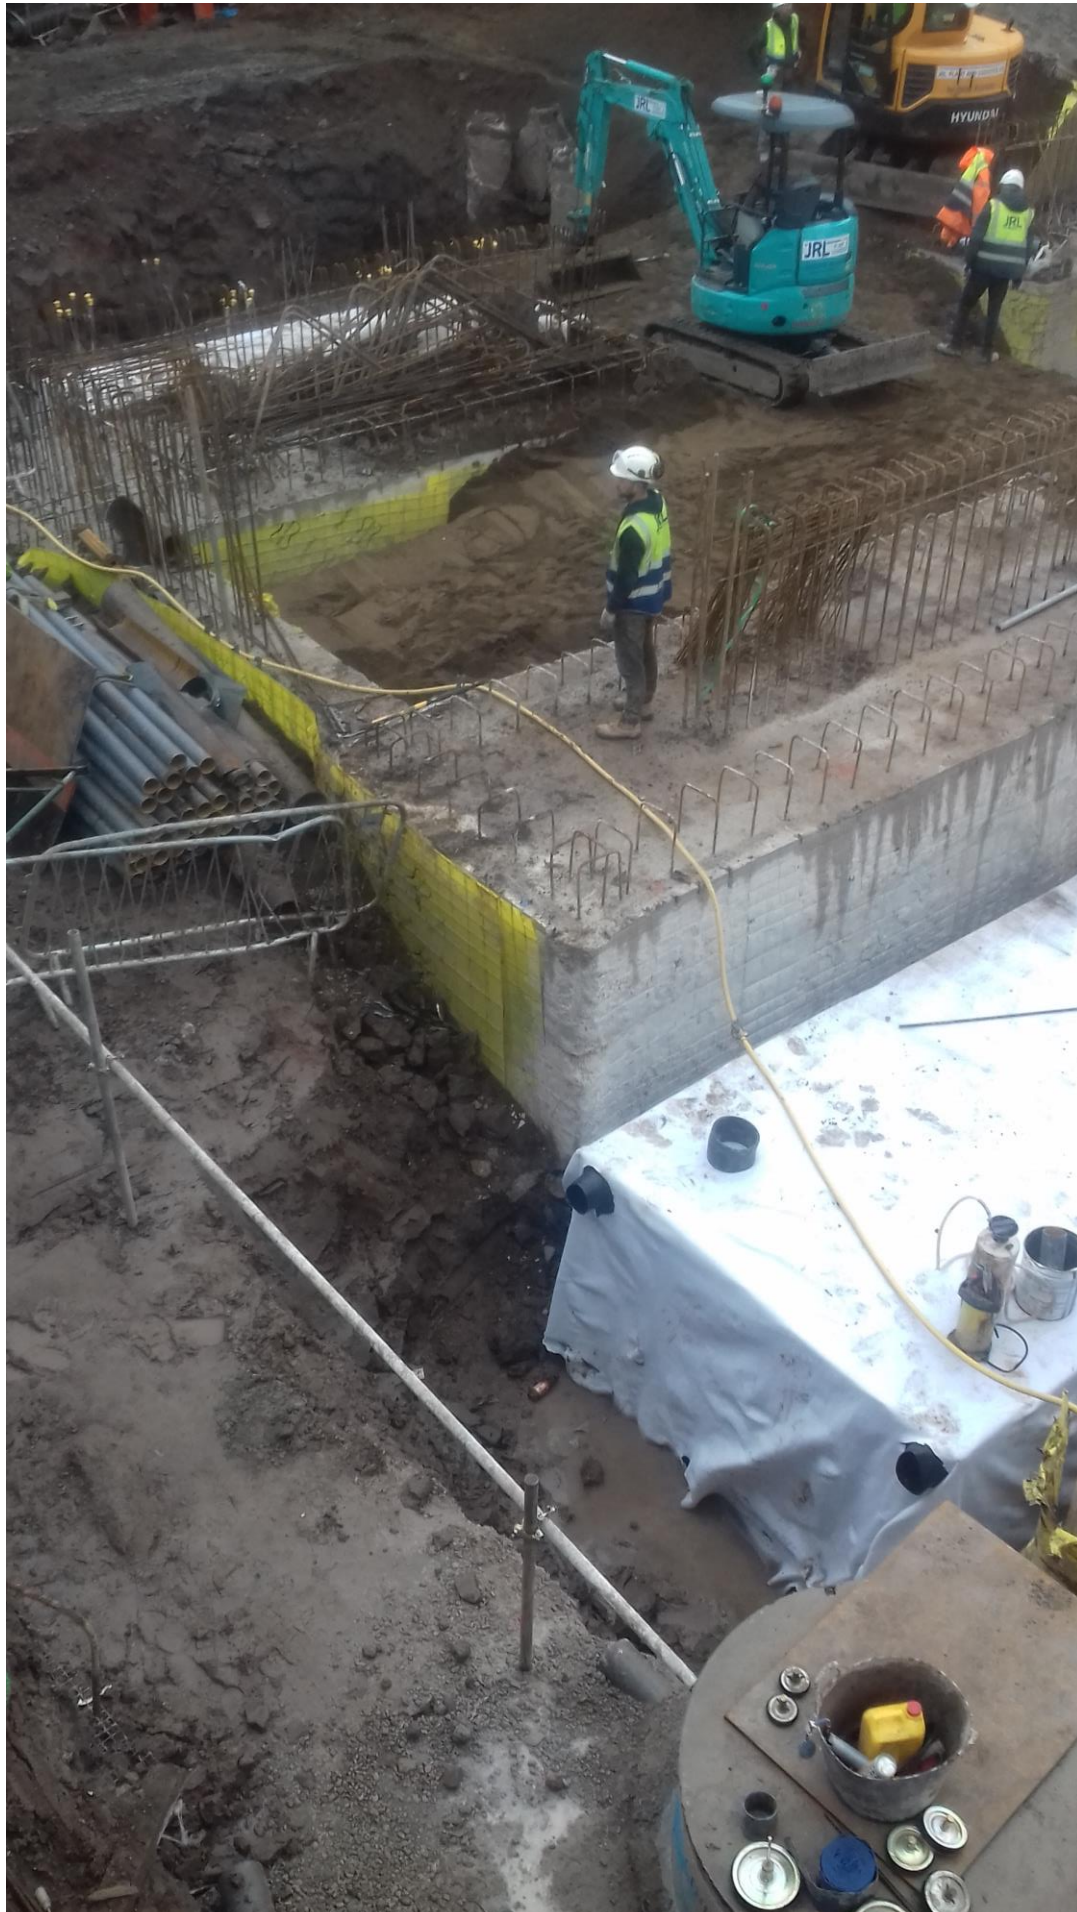
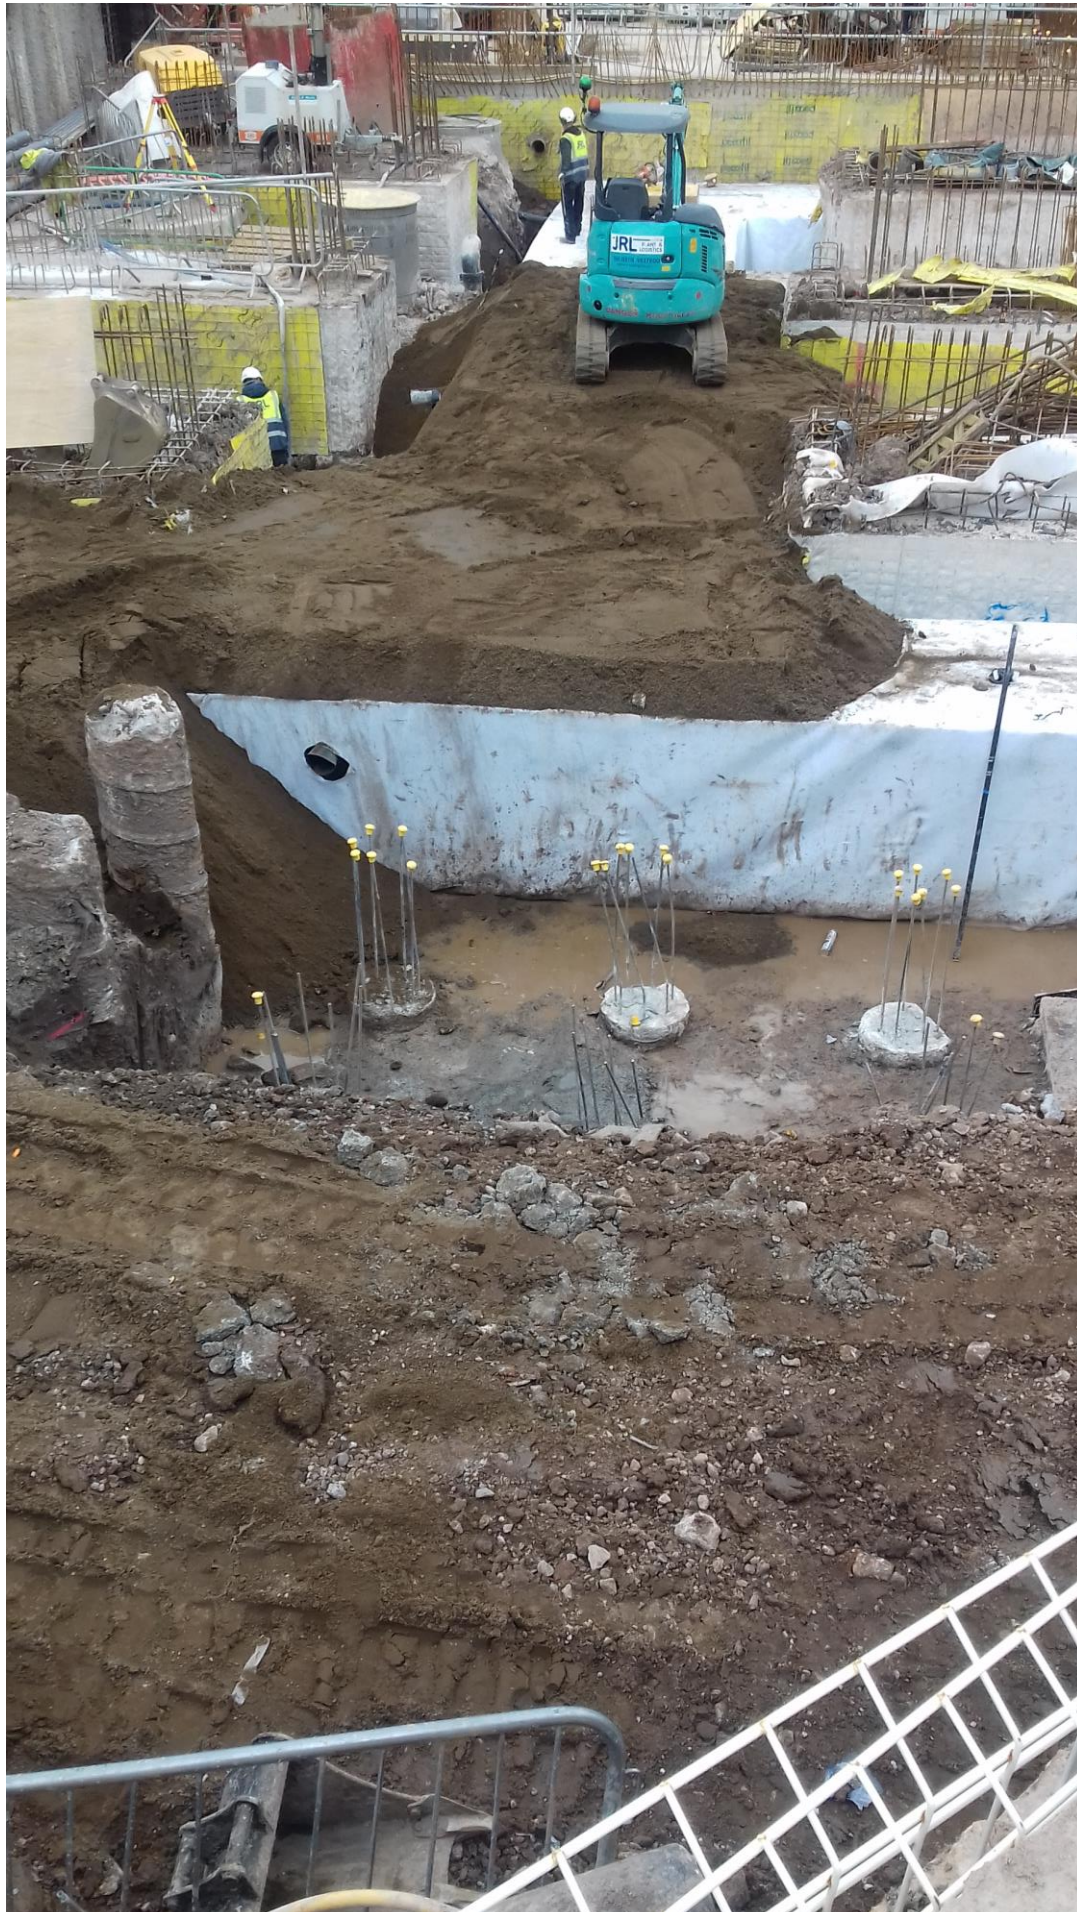
**February 2019**

Selection of photos indicating the attenuation tank

The attenuation tank has been sized to store a 1/100 year storm plus 30% for climate change .The rate of discharge from the tank is controlled a rate of 5l/s by a hydro brake installed within the last upstream man hole prior to water entering the United Utilities sewer on Store St .

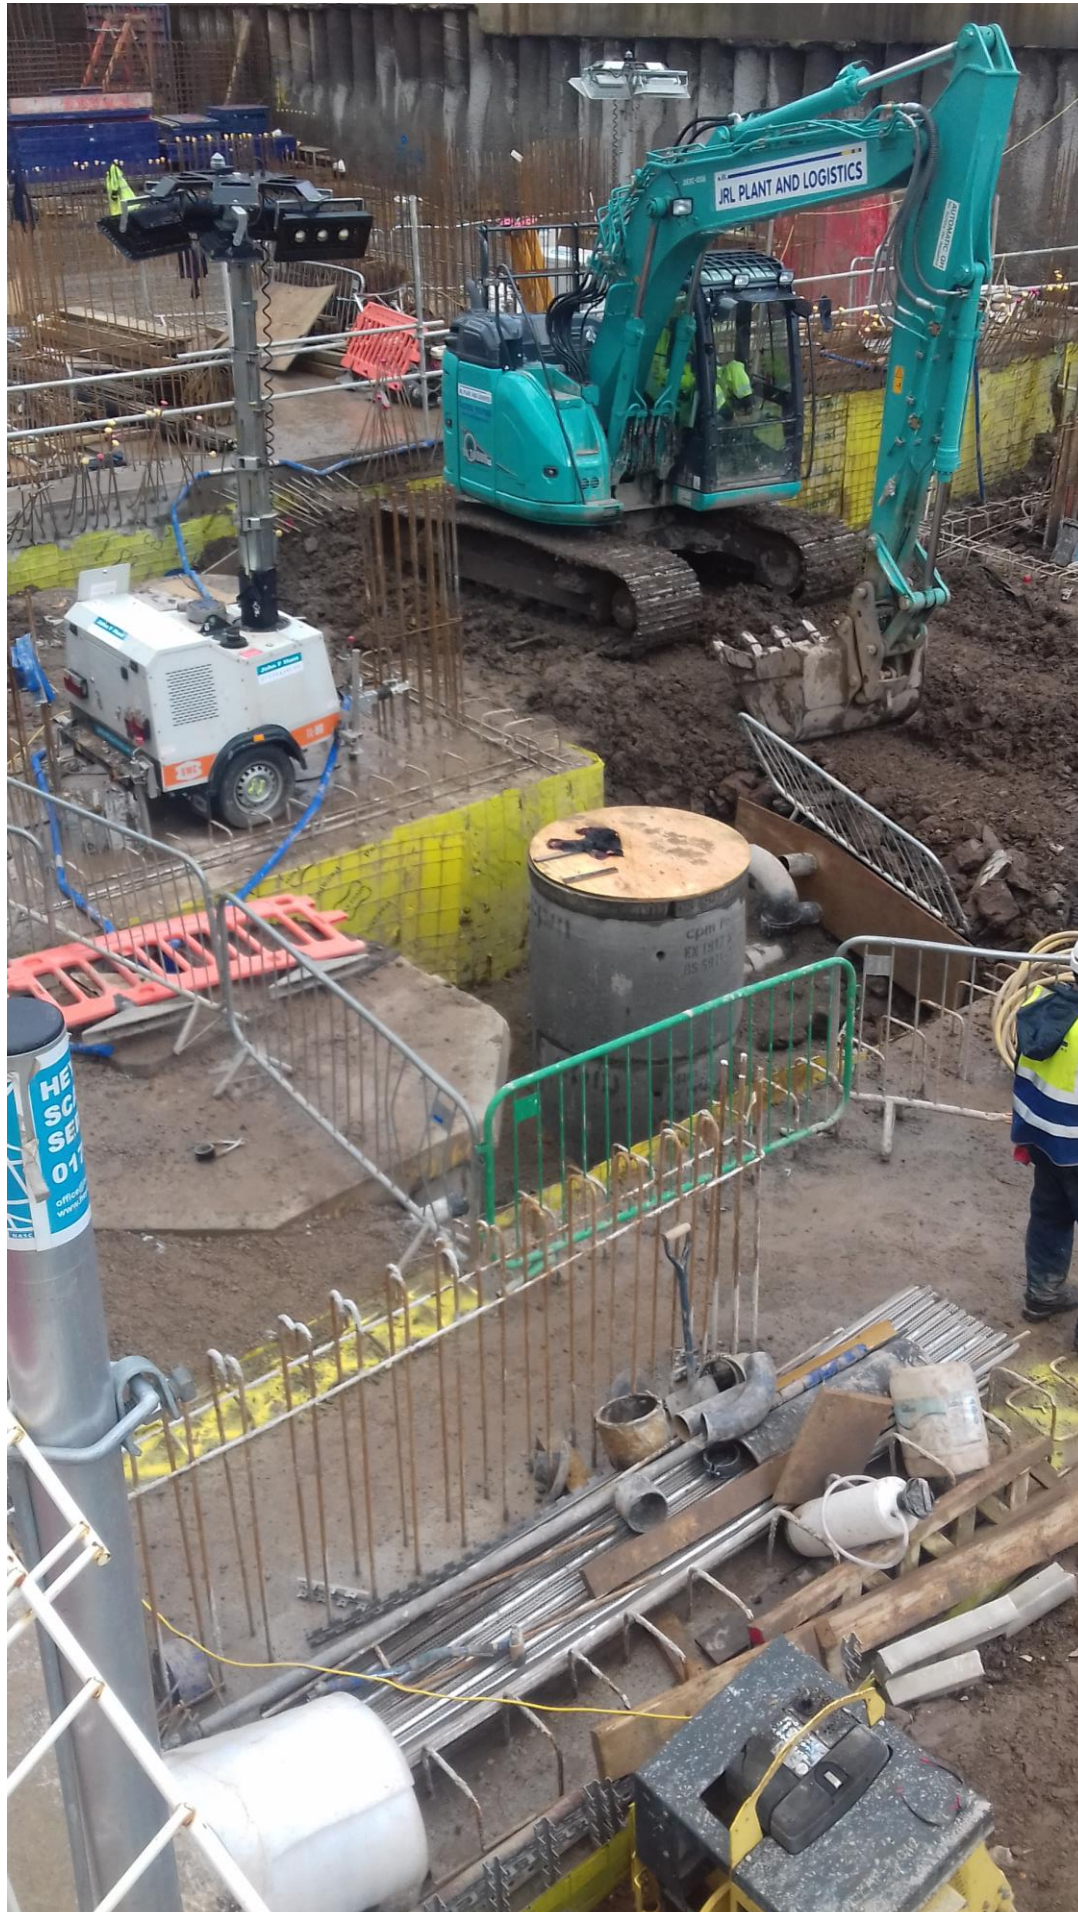
**February 2019**

Further, photograph of drainage being installed.
