## Remediation Strategy

Kingsley Road

Northenden

**Report A3939/22/RMS**

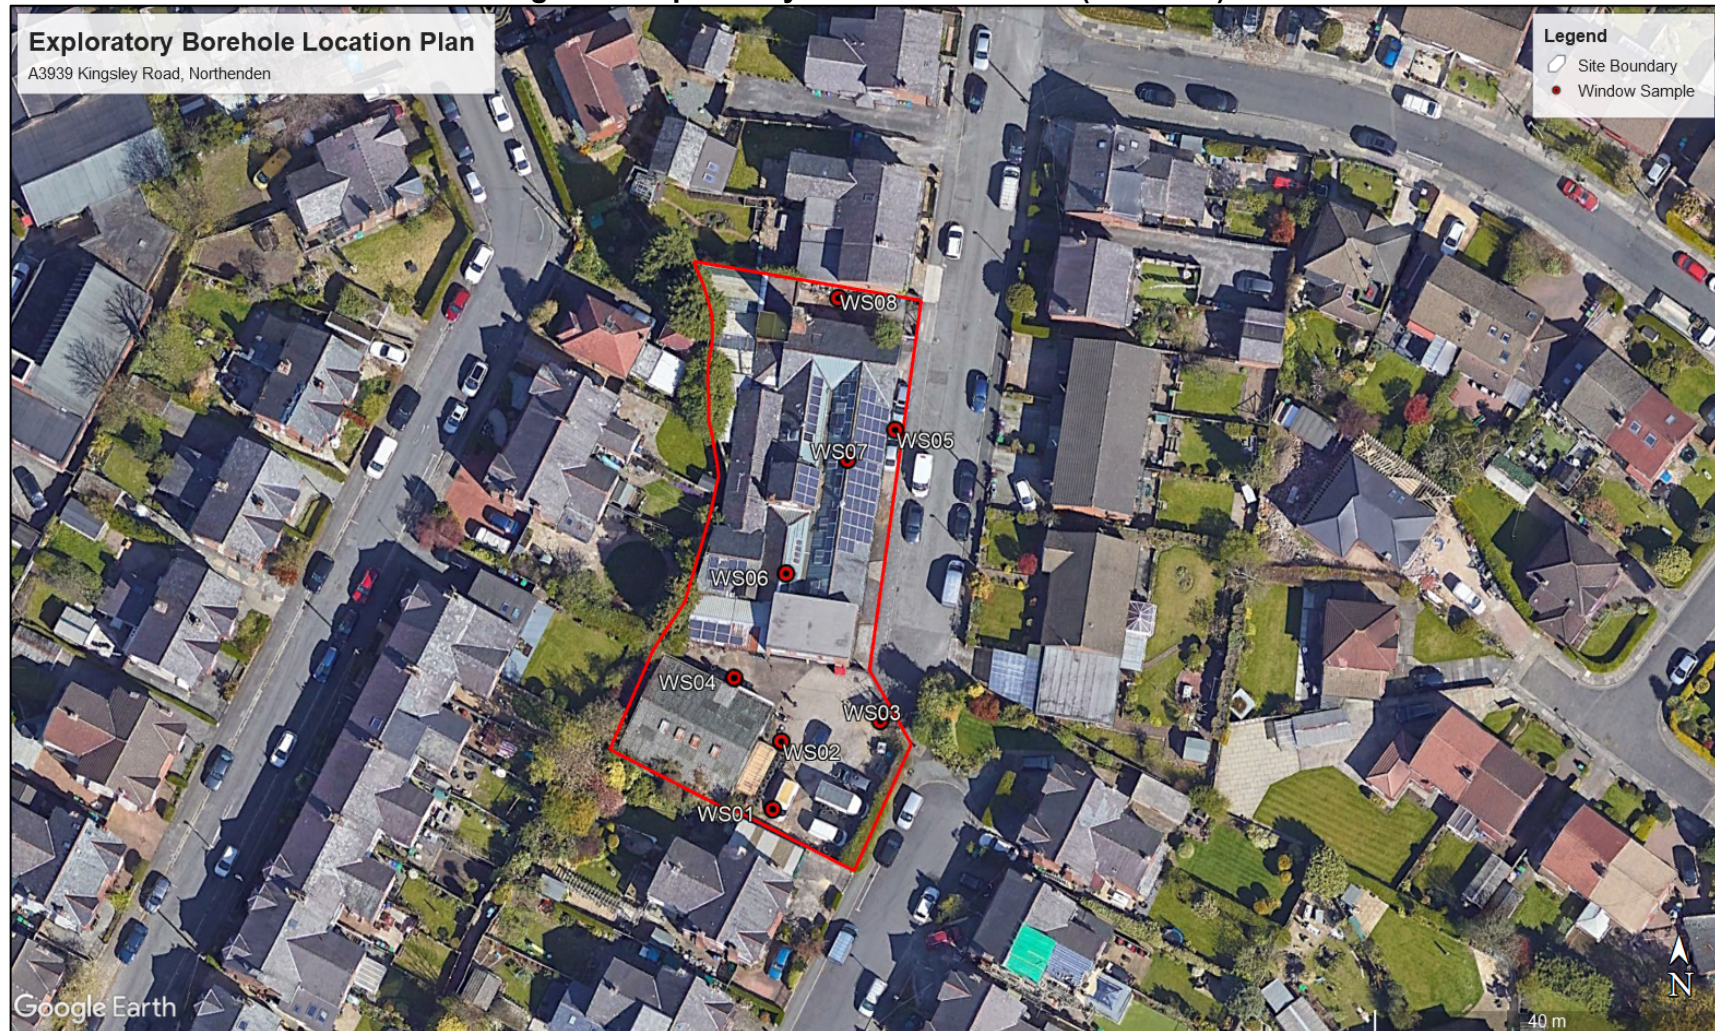
**Figure 3: Exploratory Hole Location Plan (A3939/21)**

- Eight window sample boreholes (WS1 – WS8) to a maximum depth of 6.00m bgl;

Standard Penetration Tests (SPTs) were conducted in the window sampler boreholes, and soil samples were retrieved from the exploratory holes at regular intervals for geotechnical and chemical analysis. Soils were logged by an on-site engineer.

An exploratory hole location plan is presented as Figure 3, overleaf.
