# Kincardine Court, Manchester

## Ground Investigation

Curtins Ref: 072071-CUR-00-XX-RP-GE-001

Issue Date: 19 August 2020

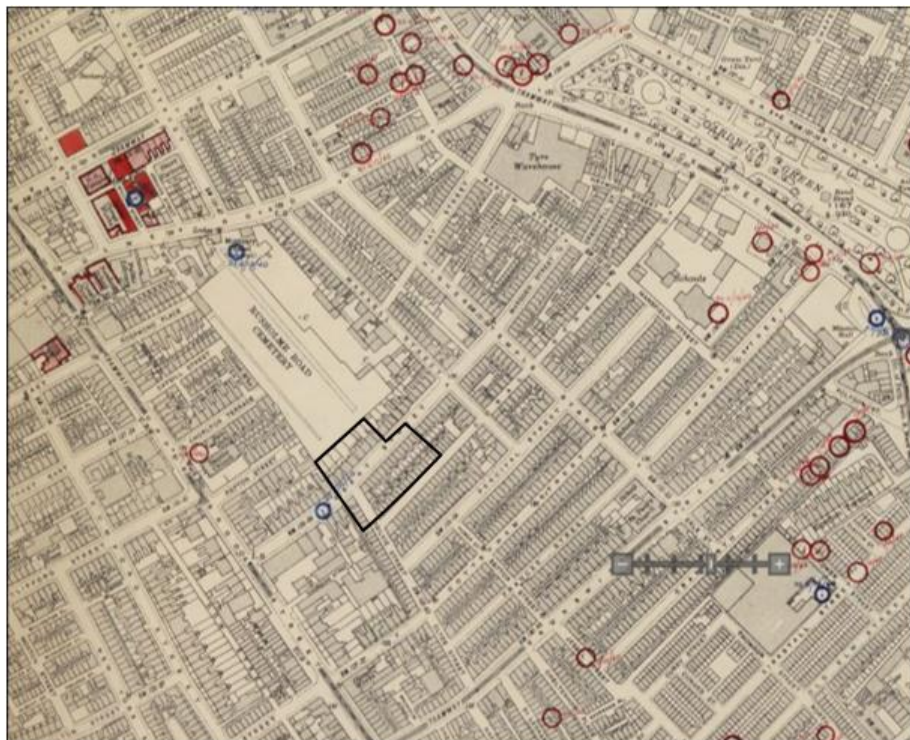
- Explosives were dropped 40m to the west of the site on 04/12/1940
- A bomb was dropped 100m north west of the site on 11/10/1940
- Significant disappearance of terraced residential housing on and off site from 1960 possibly due to bomb damage

**Figure 2.6** – WWII Bomb Damage Mapping (site boundary shown in pink). Red circles for fire bombs; blue circles for high explosives; pink shading for damaged buildings; red shading for demolished buildings; green marks: line mines, indicating bomb damage by the Luftwaffe during the Blitz

Analysis of historical bomb mapping from the University of Manchester (*Figure 2.6*) indicates the following:

Based on the foregoing commentary, the likelihood of encountering UXO on site as part of the ground investigation or development works in Moderate, and on this basis, it is recommended that a Detailed UXO Assessment is procure prior to any intrusive works commencing at the site.

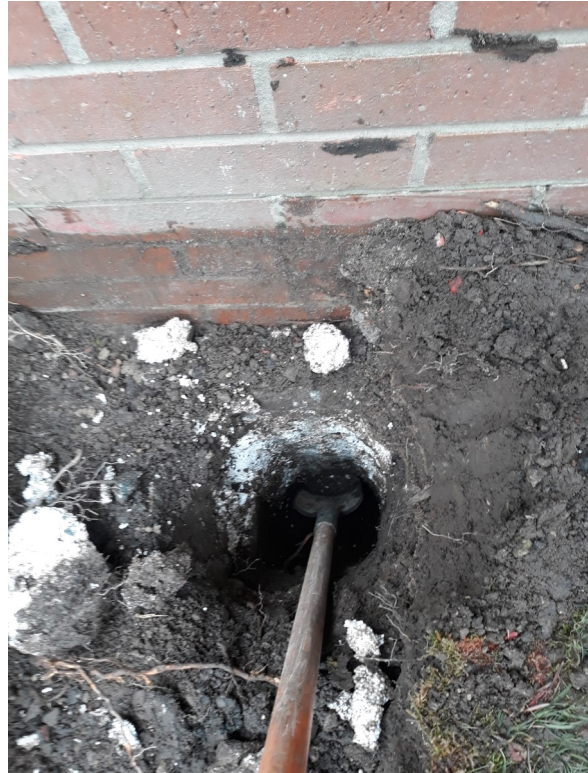
### FP01

Terminated at 0.90m bgl due to base of foundation being encountered

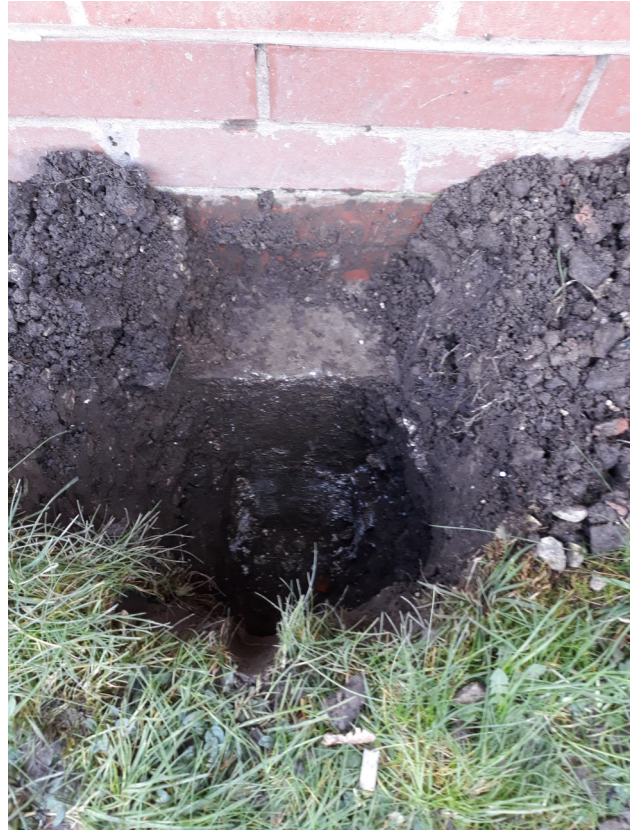
### FP05

Terminated at 0.90m bgl due to base of foundation being encountered

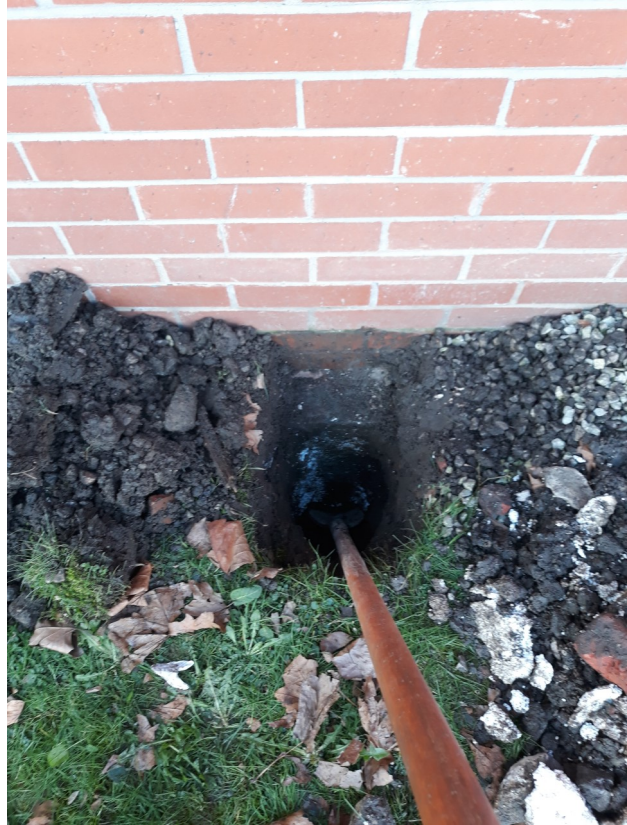
**FP06**

Terminated at 0.87m bgl due to base of foundation being encountered

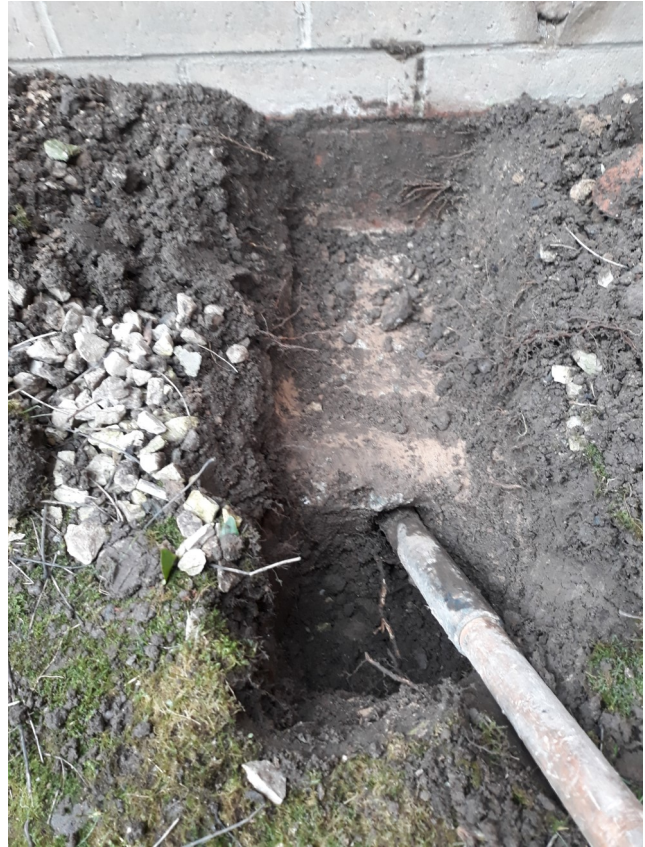
**FP08**

Terminated at 0.40m bgl due to base of foundation being encountered.
