## Geotechnical & Environmental Site Investigation

Kingsley Road

Northenden

**Report Ref: A3939/21**

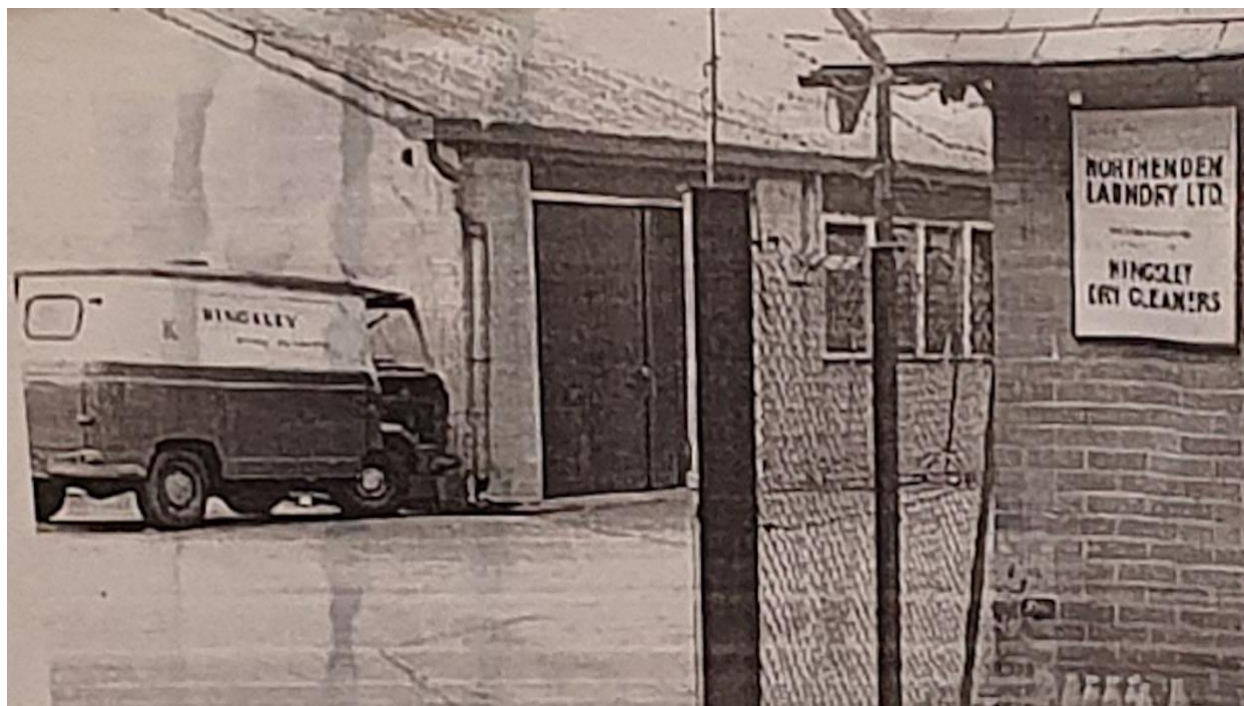
**Figure 1: Historical Photograph of Laundry**

Figure 1 shows a historical photograph of part of the former laundry.

There has been a steam laundry on the site for over 100 years. As the laundry element of business shrank, parts of the factory were let as industrial units and as of today there is a mixed industrial use on the site.

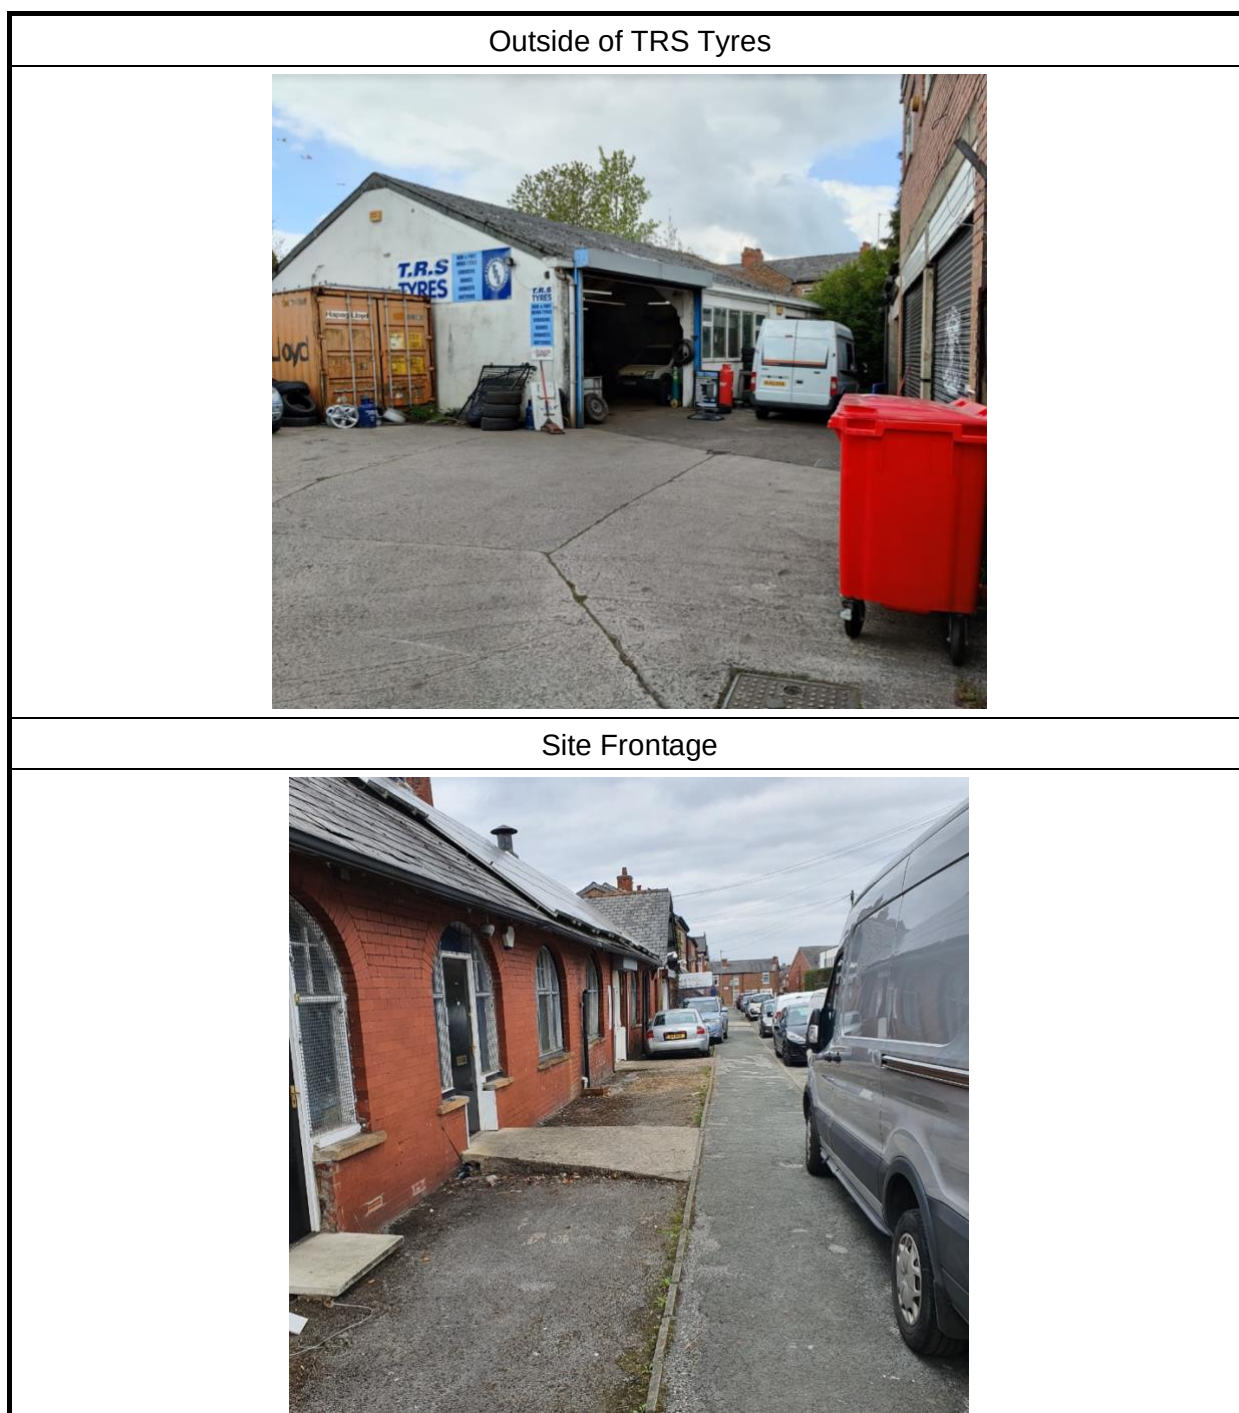
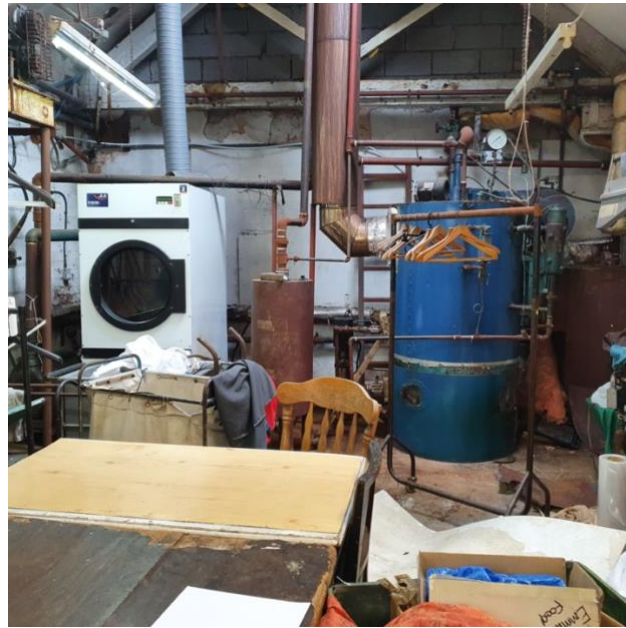
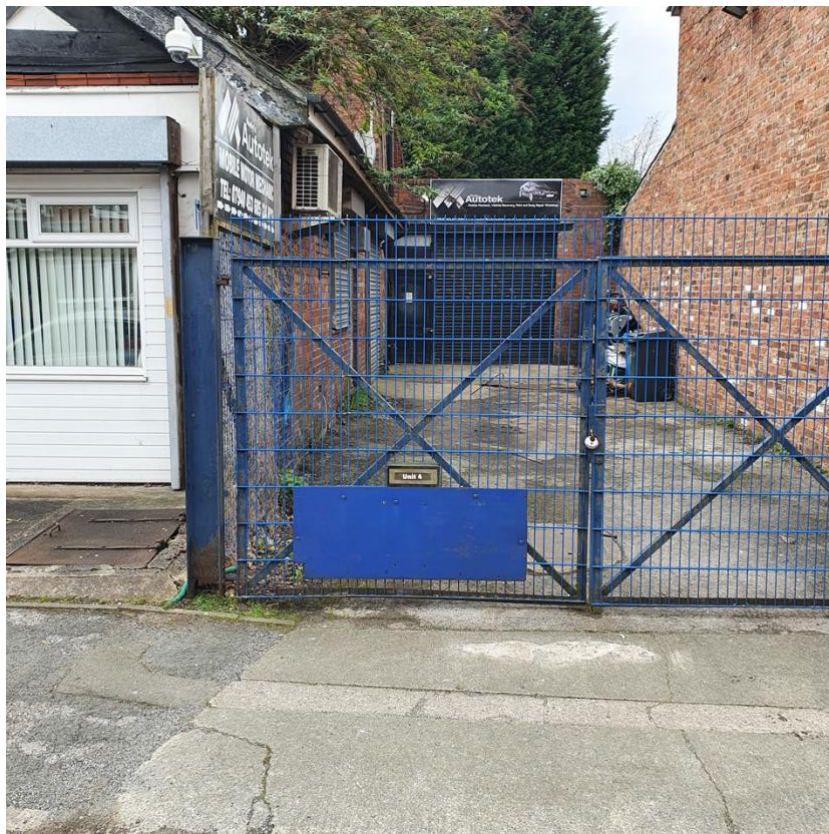
**Figure 3: General Site Photographs**

General site photographs are presented in Figure 3 overleaf.

The site currently serves various business tenants ranging from workshops to rent to a Tyre business. The building was first occupied in the late 19<sup>th</sup> century and served the local community as a laundry for many years.

There is a large parking area in front of the Tyre business on the south end of the site. Parking areas in front of the old laundry building are also used directly of Kingsley Road.

Interior of Laundry

Entrance to car repair faciity with external waste oil tank

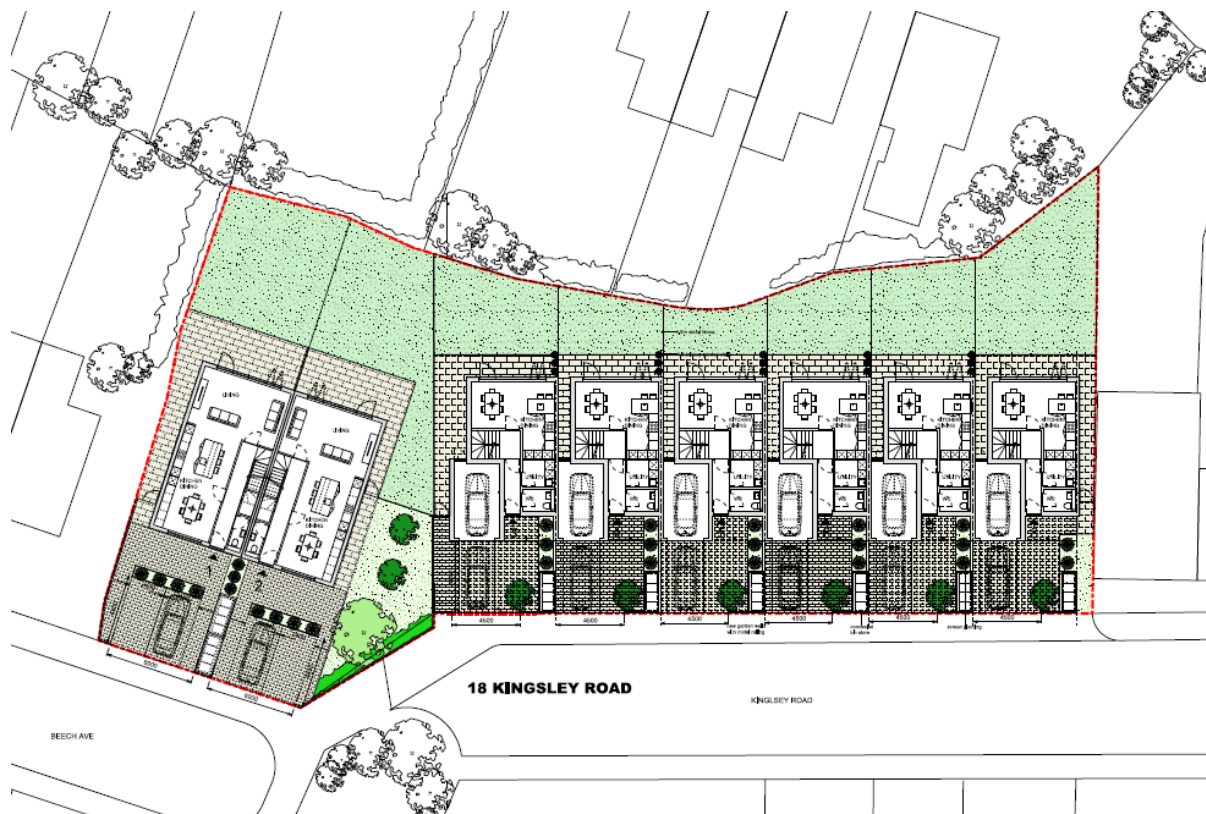
**Figure 4: Proposed Development Plan**

It is understood that the Client intends to build eight residential properties on site with associated soft landscaping and parking. Access will be provided via Kingsley Road and Beech Avenue.

The proposed development layout details are shown in Figure 4 below.

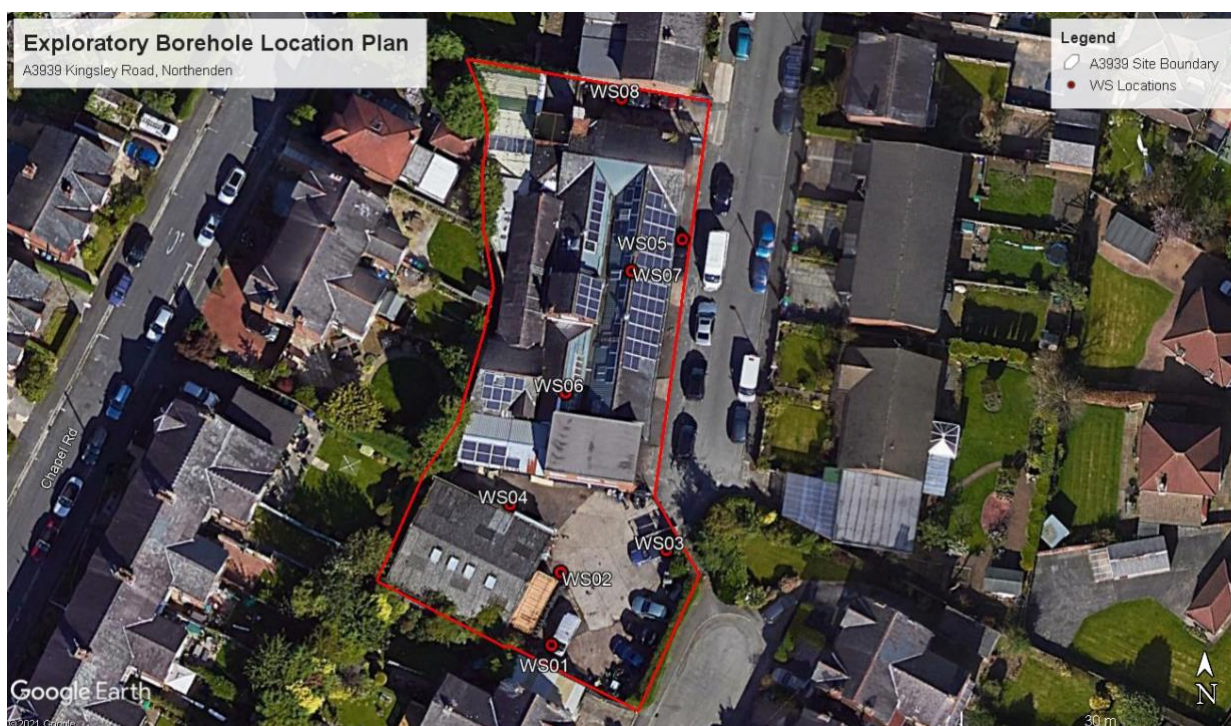
**Figure 5: Exploratory Hole Location Plan**

An Exploratory Hole Location Plan is presented as Figure 5, overleaf.
