# DAYTIME BAT SURVEY

39 ANCOATS STREET,  
MANCHESTER

MAY 2022

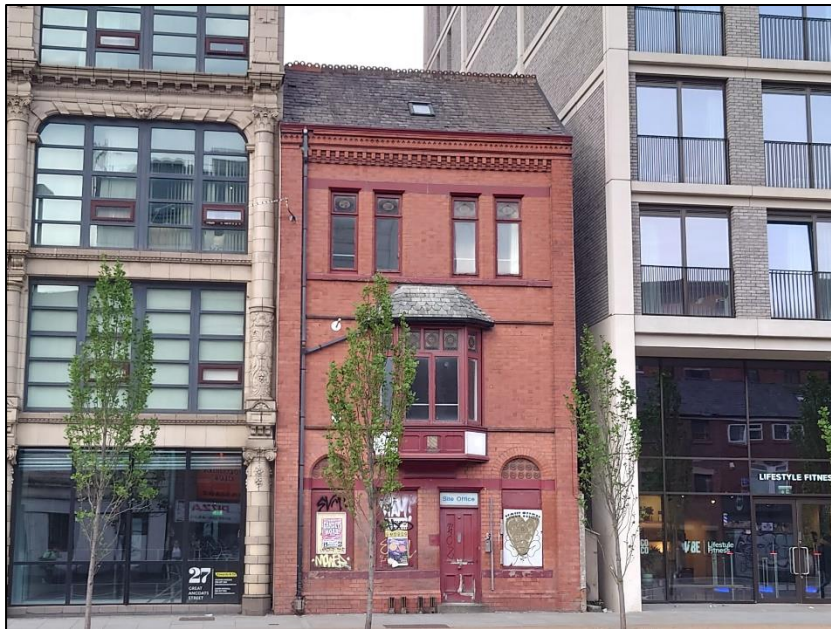
- 3.2 The external brickwork is in good condition with no significantly damaged bricks or recessed mortar cavities (see Photographs 1 and 2). One section of brickwork at the rear, where part of the building has been removed, has exposed the wall cavity, but no onward cavity is present, and no evidence of bat usage found between the bricks. The window and door frames are flush to the surrounding masonry. The ground floor windows are boarded at the front. The brick chimney stacks are complete and mortared.

*Photograph 1 showing the exterior of the property*

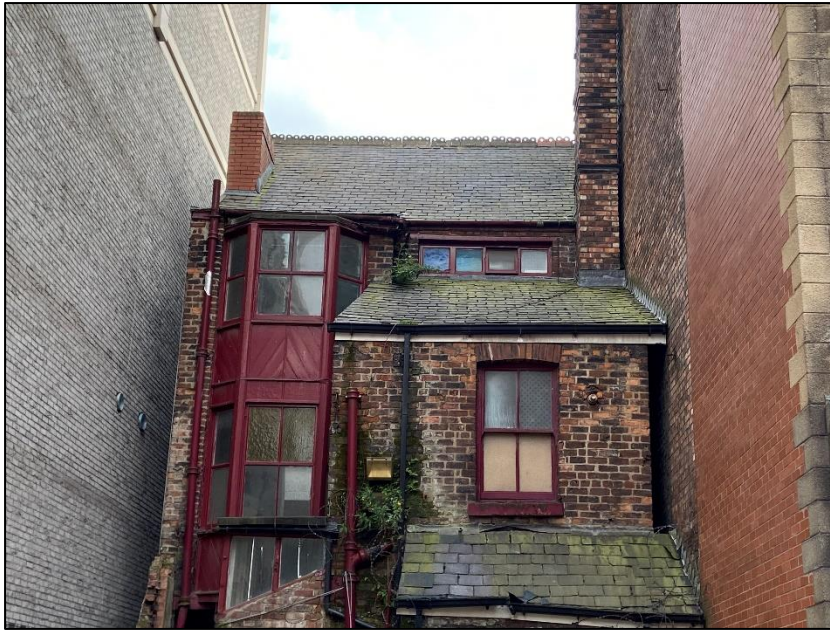
*Photograph 2 showing the rear of the property*

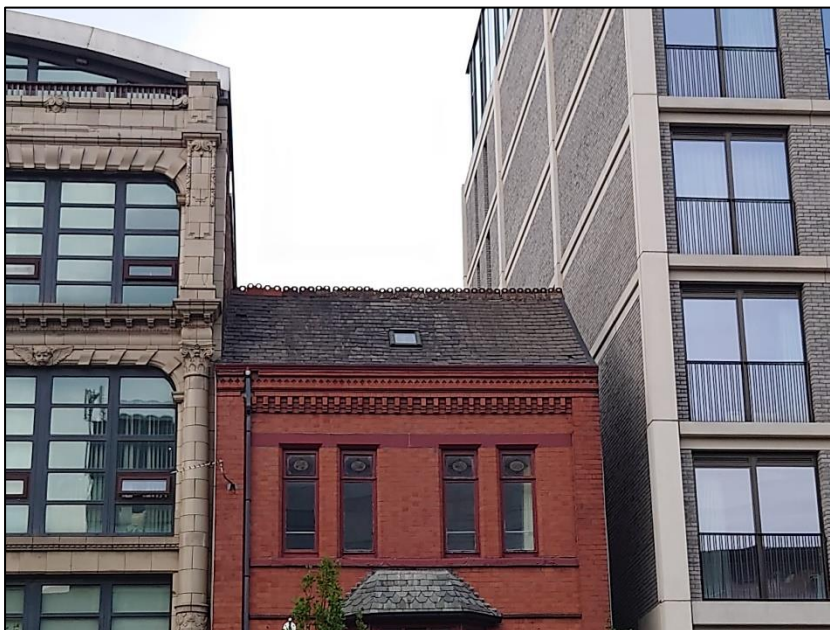
- 3.3 The roof of the property is pitched and tiled, with just one slipped tile on the front elevation (see Photographs 3 and 4). The front Velux window is sealed to the tiling. The decorative ridge tiles are in situ and sit flush to one another. A small amount of lead flashing occurs at the base of the chimney stacks, and this is flat and flush to the tiles.

*Photograph 3 showing the roof of the property*

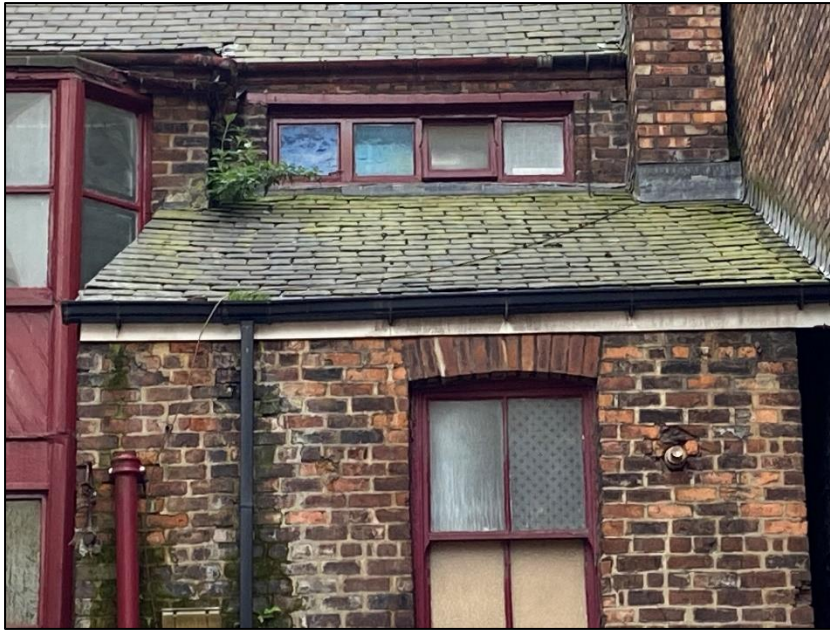
*Photograph 4 showing the roof of the property*

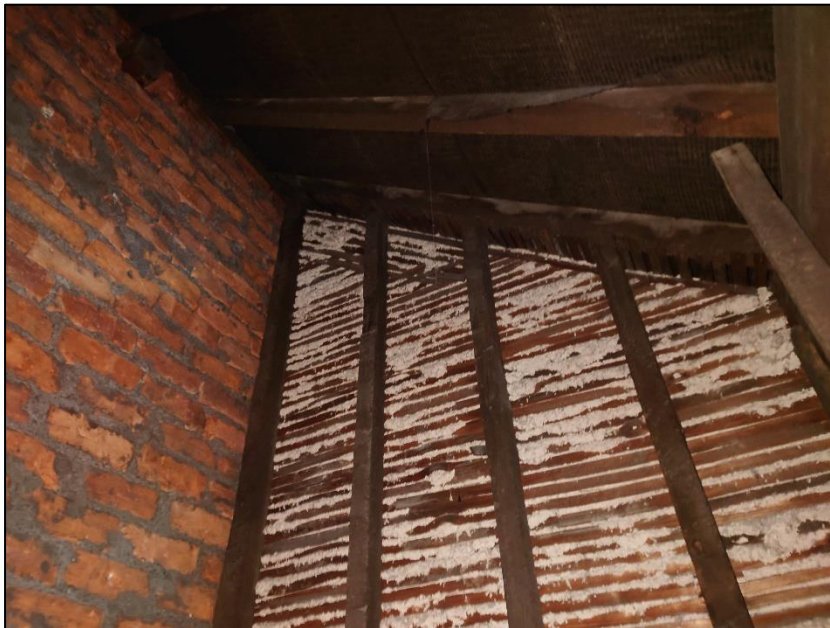
- 3.5 The property is unoccupied, and the former commercial spaces do not offer suitable bat roosting habitat. The upper floor has been partially converted into office space, with the rear half of the roof retaining a roof void (see Photograph 5). The wooden beams are complete and intact, offering no cavities for bats to exploit. The roof is lined with roofing felt, with no tears or rips in the lining. The internal brickwork and breeze block wall are complete and intact, offering no damaged bricks or recessed mortar (see Photograph 6). No evidence of bat activity was found inside the roof void.

*Photograph 5 showing the roof void*

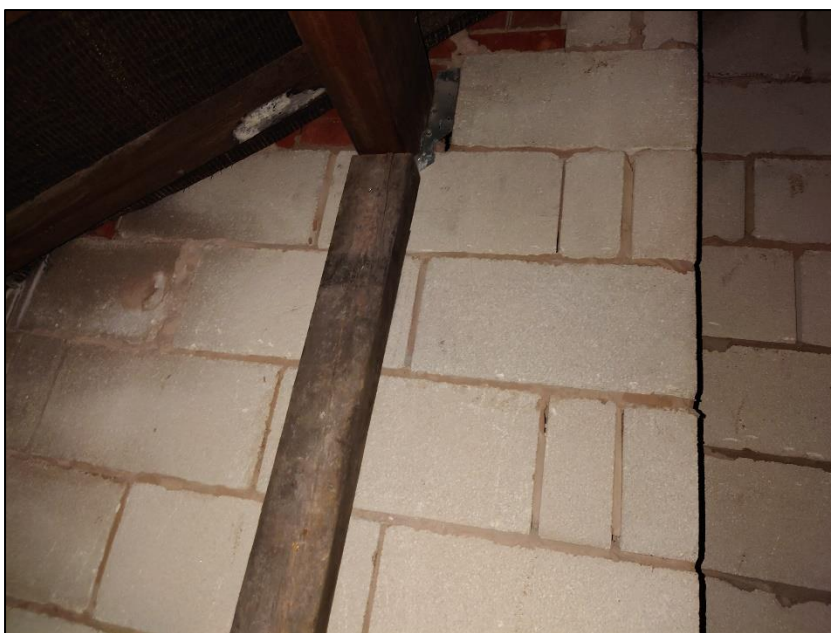
*Photograph 6 showing the internal breezeblock inside the roof void*

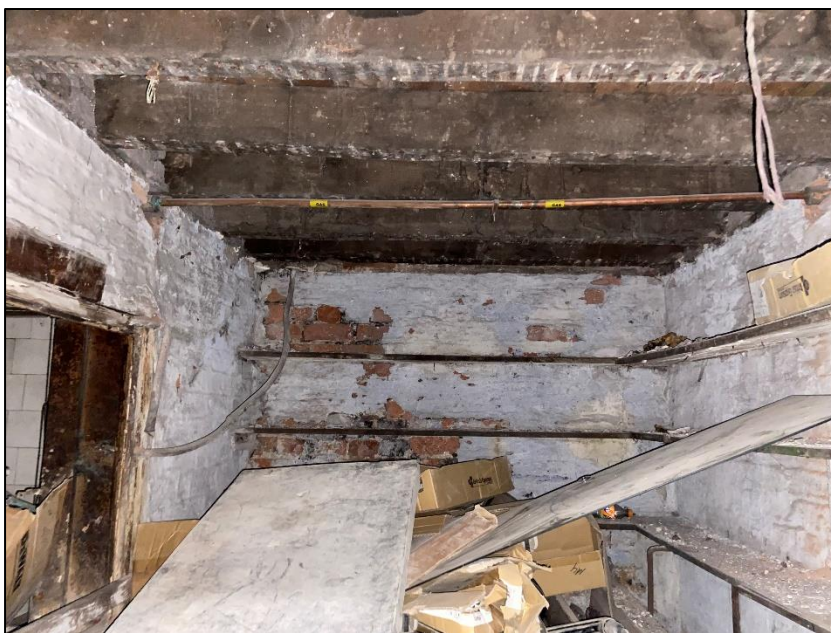
- 3.6 The property has an extensive cellar space (see Photograph 7). The cellar space is sealed internally, offering no potential bat access points. No suitable bat roosting cavities are present in the cellar, and no evidence of bat activity was found.

*Photograph 7 showing the cellar space*
