Phase II  
GeoEnvironmental  
Investigation

The Manchester College

Harpurhey

**SITE INVESTIGATION**  
**THE MANCHESTER COLLEGE**  
**HARPURHEY**  
**Report Ref: A3545/20/SI**  
**AUGUST 2020**

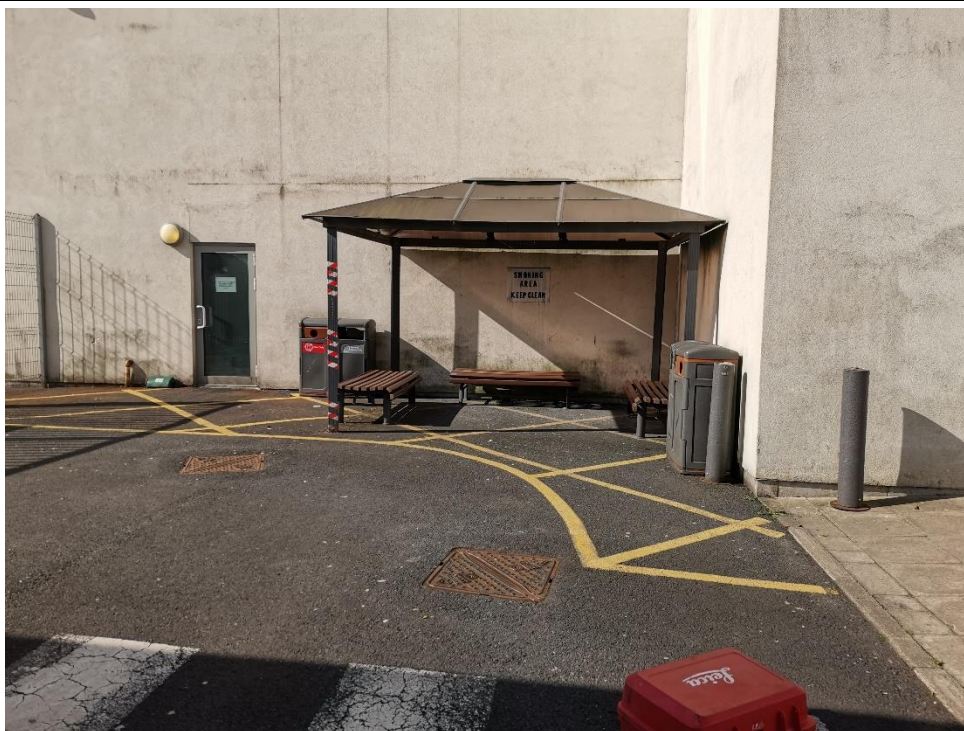
**Figure 2: General Site Photographs**

View of the investigation area, looking south west

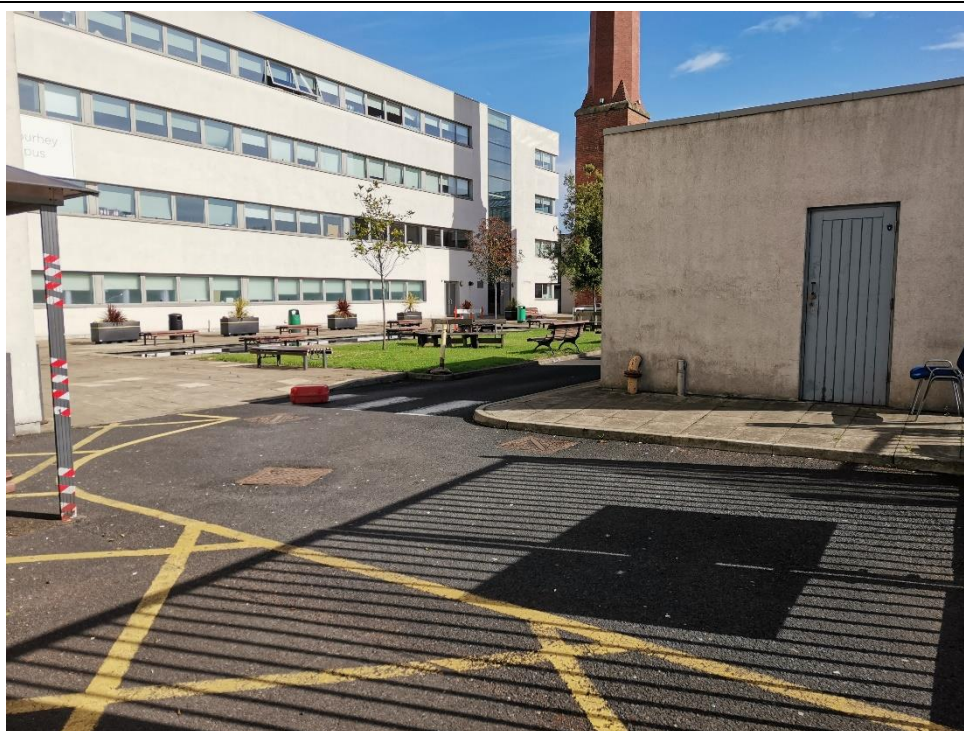
View across the rest of the site and Manchester College, looking north

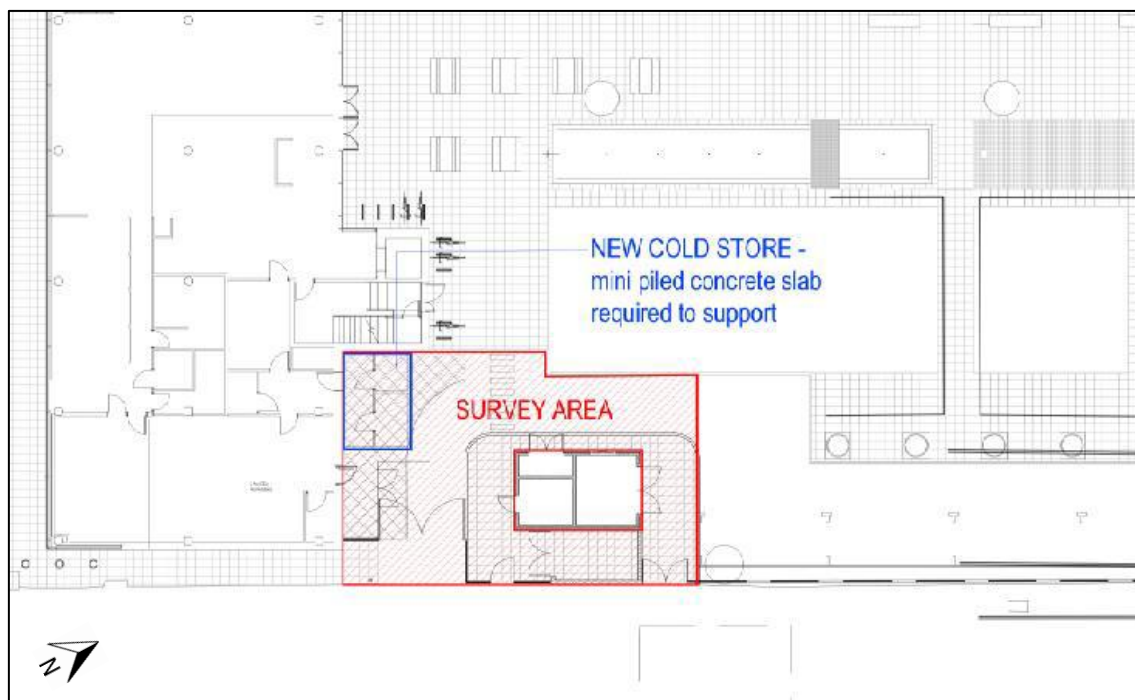
**Figure 3: Proposed Development Plan**

It is understood that the Client intends to construct a new cold store. The current site access will be retained.

The proposed development layout details are shown in Figure 3 below.
