**ADDITIONAL PHASE 2 SITE INVESTIGATION REPORT**  
**FOR LAND AT**  
**1 COMMERCIAL STREET, KNOTT MILL, MANCHESTER M15 4PZ**

**T195 SFK (TLC1143) rep AI Infill 300621**  
**June 2021**

***Additional Phase 2 Site Investigation Report for Land at 1 Commercial Street, Knott Mill,  
Manchester M15 4PZ.***

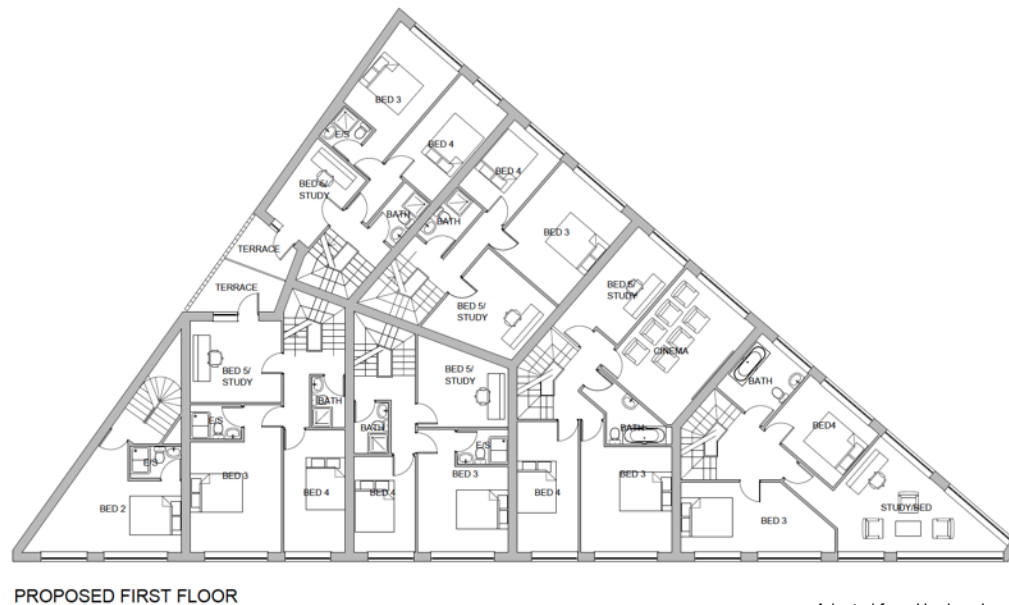
**Drawing No.: TLC1143/03a**

Adapted from Harrison Ince Architects Drawing No. AL01 dated October 2020

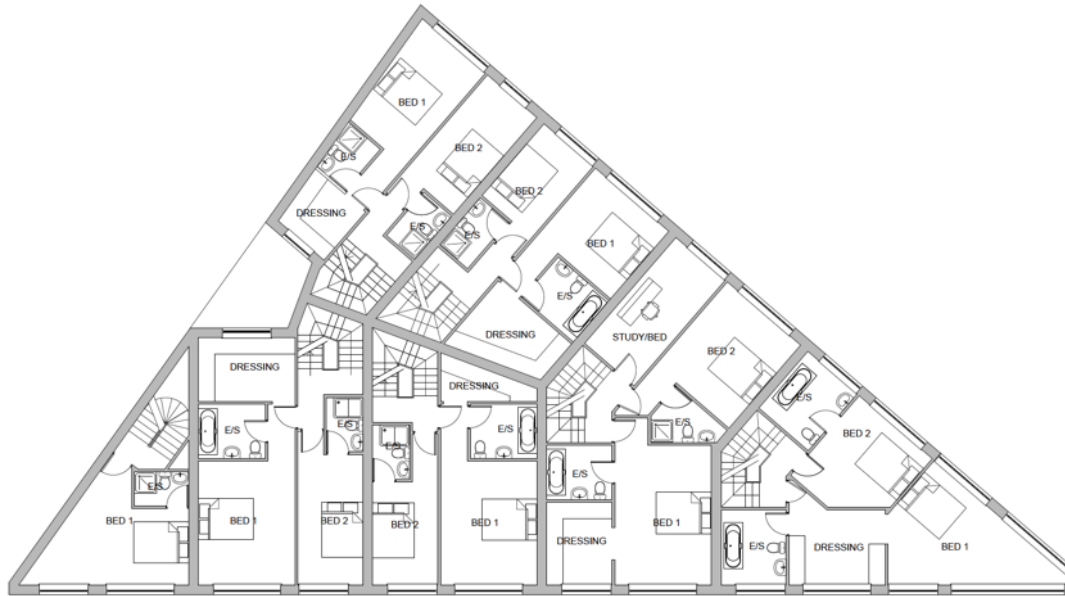
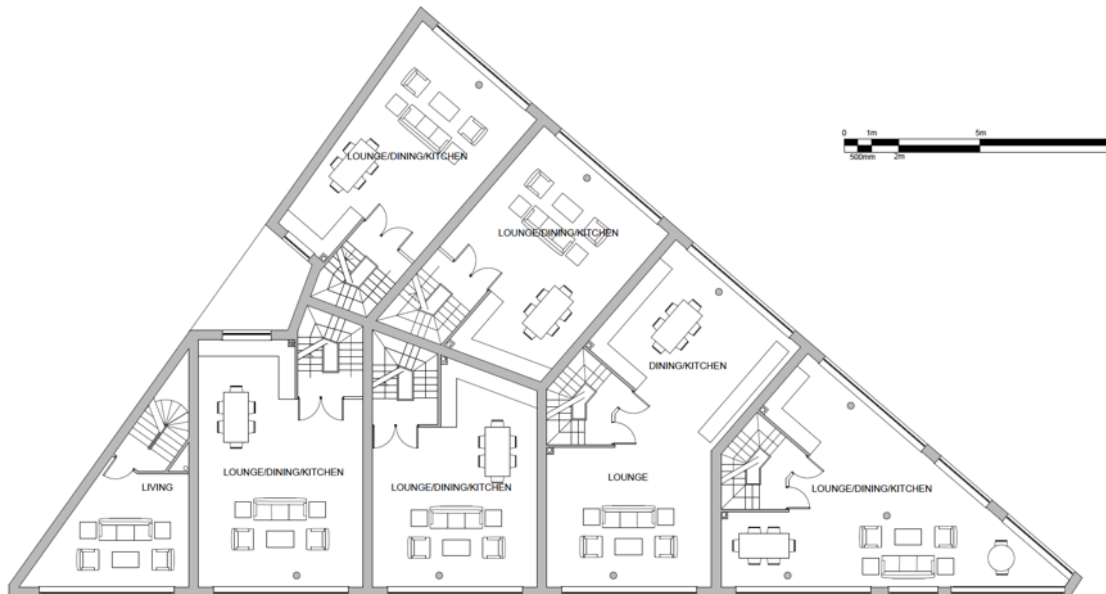
**Drawing No.: TLC1143/03b**

PROPOSED SECOND FLOOR

PROPOSED THIRD FLOOR

Adapted from Harrison Ince Architects Drawing No. AL02 dated October 2020

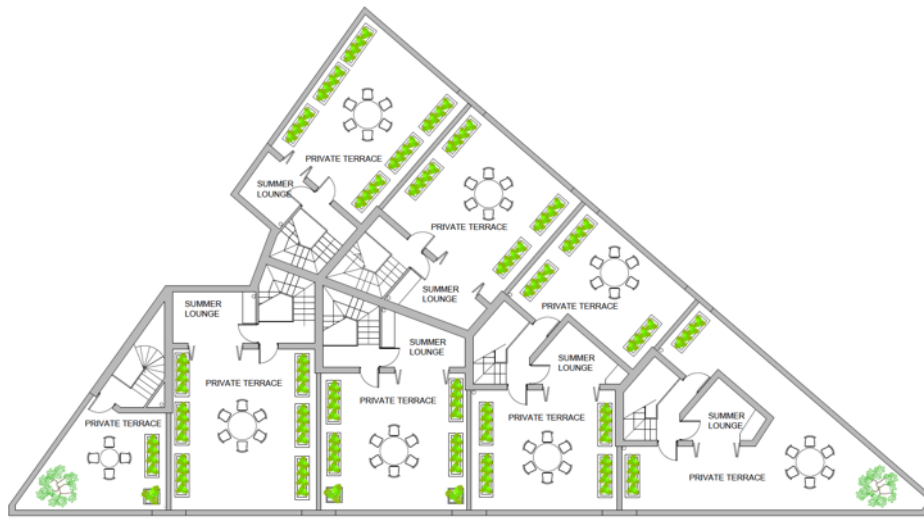
**Drawing No.: TLC1143/03c**

PROPOSED FOURTH FLOOR

Adapted from Harrison Ince Architects Drawing No. AL03 dated October 2020
